Great Lakes Coastal Hazard Study

Appendix F – Coastal Slope Risk Assessment, Seal Rocks

Project Name:	Great Lakes Coastal Slope Risk Assessment
Project Number:	3001829
Report for:	Great Lakes Council

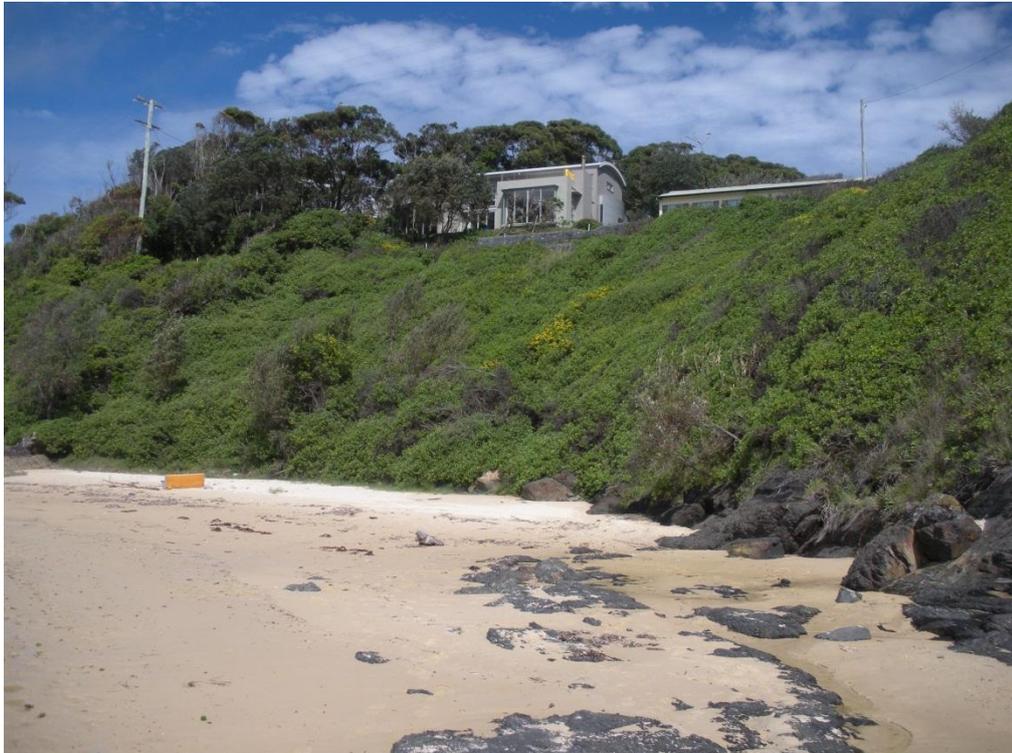
Evidence of a previous debris slide was observed in the slope face in the centre of the site. Even though the slope is heavily vegetated it is possible to see that the slope is concave in shape indicating the presence of a failure scar. A gabion wall is located at the top of the failure scar at the same level as Kinka Road. Approximately 140 m³ and 25 m in length of old debris slide material can be observed at the toe of the slope. This is heavily vegetated, but the uneven appearance indicated that it is not in situ material.

At the southern end of the gabion wall the crest of the slope is affected by gully erosion and the crest of the slope is soft under foot. This is probably due to runoff from the road and potentially accentuated by a speed hump, located on Kinka Road approximately 5m from the southern end of the gabion wall that also directs water on to the slope. Anecdotal evidence provided by local residents indicates that the slope has failed three times in the last thirty years.

It is noted that the exposed rock comprises grey to dark grey, fresh to slightly weathered, strong to very strong, well bedded siltstone. There is little evidence of rock falls occurring with no boulders or cobble sized rocks visible on the beach. A few areas, at the northern end of the slope, were identified where there is potential for rock fall to occur

Photo 1: View of the area inspected on Boat Beach including the gabion wall at the crest of the slope.

and potentially erode the slope below and undermining the gabion wall. Consideration should be given to the placement of a geotextile to prevent surface erosion. It is recommended that the flow of surface water is controlled so that it does not impact on the slope.

- Further inspections should be carried out at regular yearly intervals regarding the stability of the slope and to determine whether any deterioration has increased the risk to loss of life or property.

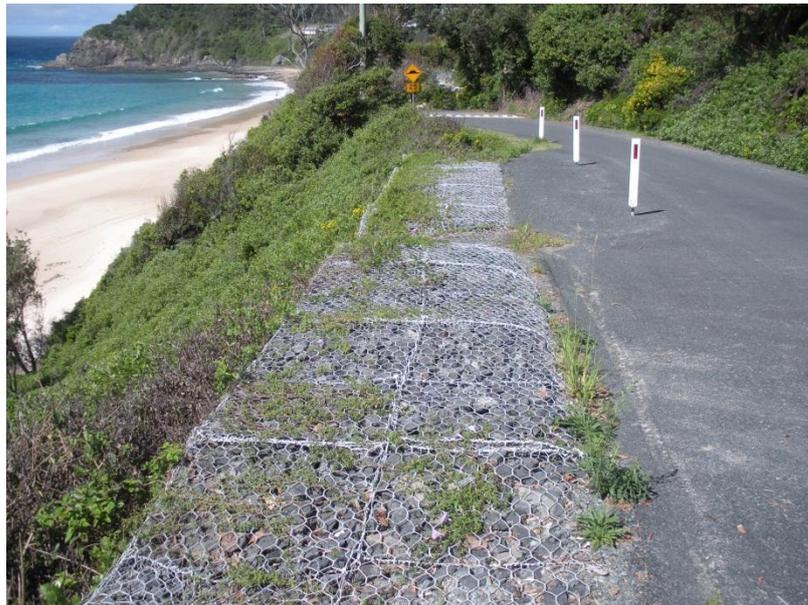
The gabion wall is formed from three levels of gabion baskets each 1m in height and 2m in width. The gabion wall is approximately 16 m in length. The edge of the gabion wall is approximately 1.7 m from road edge. It is understood that the gabion wall is approximately two years old and appears to be in good condition.

Photo 2: View of the gabion wall at the crest of the slope and alongside Kinka Road.

The risk to property, in this case the gabion wall and Kinka Road varies from very low to moderate risk. A debris slide on the slope of below Kinka Road could possibly cause the failure of the gabion wall and possibly undermine the pavement. A debris slide may potentially cause damage to the road and pavement and could also potentially affect any buried services in the roadway.

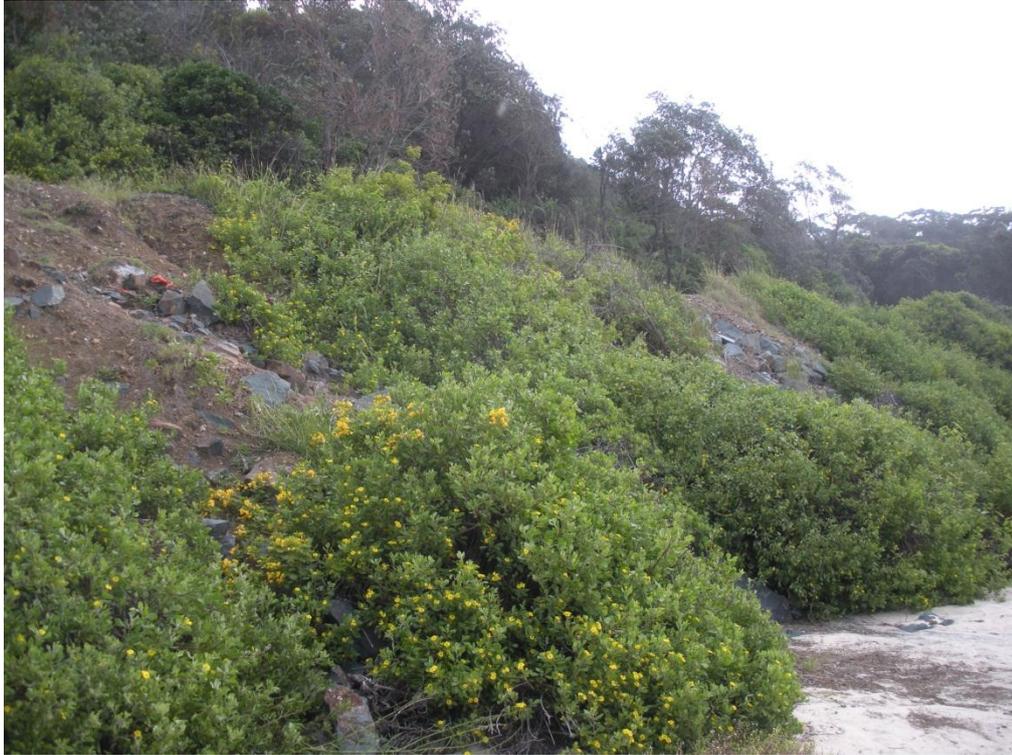
Evidence of previous debris slide at three locations was observed in the slope from the beach. Slip scars were visible with exposed soil and rock. The slip scars were between 3.5 m and 8 m wide and encompassed the total height of the slope. The crest of the slope is approximately 1.2 m to 1.4 m from the edge of the road.

Visual evidence indicates the water runoff from Seal Rocks Road is causing gully erosion in the exposed soil of the slip scars. This could potentially lead to further failures in these

areas. During the site visit it was noted that vehicles park along the crest of the slope and people regularly use the slope to access the beach.

Photo 3: View of the slope failures along Number One Beach.

The risk to property, in this case Seal Rocks Road is a moderate risk. A debris slide on the slope below Seal Rocks Road could possibly cause the undermining of the road. As well the potential to cause damage to the road this will potentially affect any buried services in the roadway. The continued soil creep will not cause a catastrophic slope failure but unless treated and the soil is left exposed it will continue to erode back from a combination of rainfall, stormwater runoff, wave action and sea level and eventually undermine the road.

- Protective measures need to be implemented at the locations of the existing failure scars. These should at a minimum comprise a geotextile to prevent further erosion of the slope. This should be overlain by rip rap, boulder sized rocks, to further protect the slope.
- Control of surface water runoff on to the slope should be considered. This may require additional drainage along the road.
- Consider putting up signs and barriers to stop the general public parking above the slope and accessing the slope and thereby eroding the slope surface.
- Further inspections are required in future years regarding the stability of the headland and to determine whether any deterioration has increased the risk to loss of life or impacted on the coastal road.
