APPENDIX B: SITE INSPECTION NOTES

SITE INSPECTION OLD BAR

Gary Blumberg, Patrick Lawless (Haskoning Australia)
23 September, 1.45 pm to 4.30 pm.

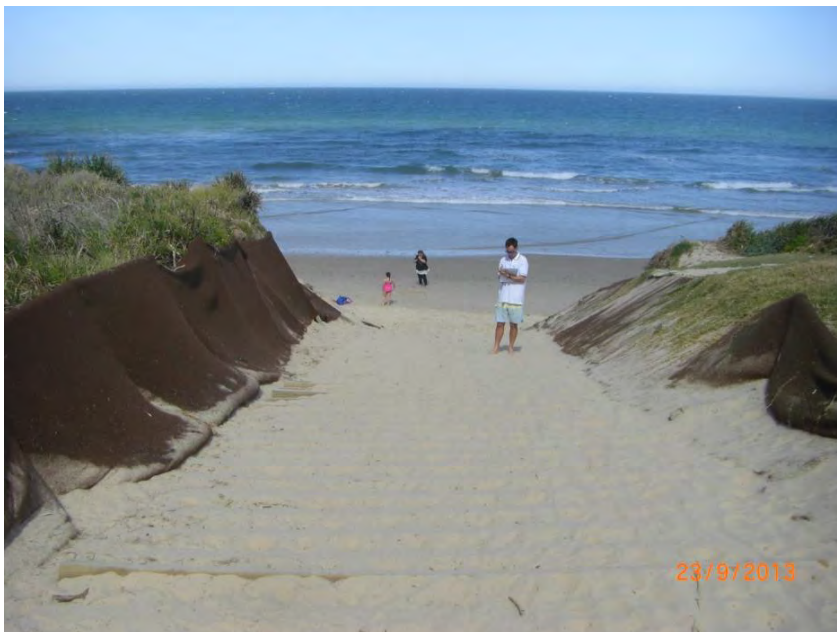
The board and chain accessway fronting the Surf Club was inspected. This comprises 150 x 75 thick timbers chained together at the underside. A synthetic fabric sand screen is placed up the sides of the beach entry to guard against wind erosion.

Photo 1 – Accessway fronting Surf Club

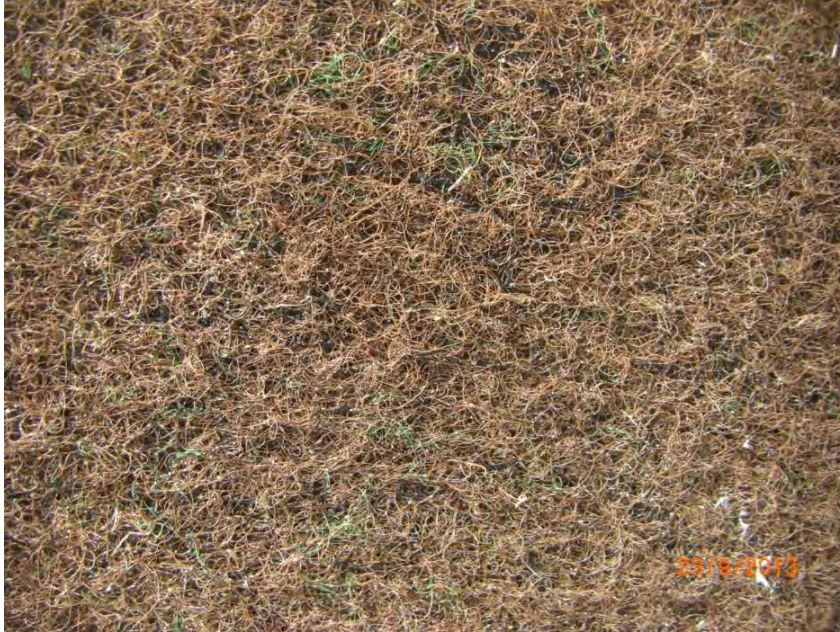
Photo 2 – Fabric sand screen beside Surf Club accessway

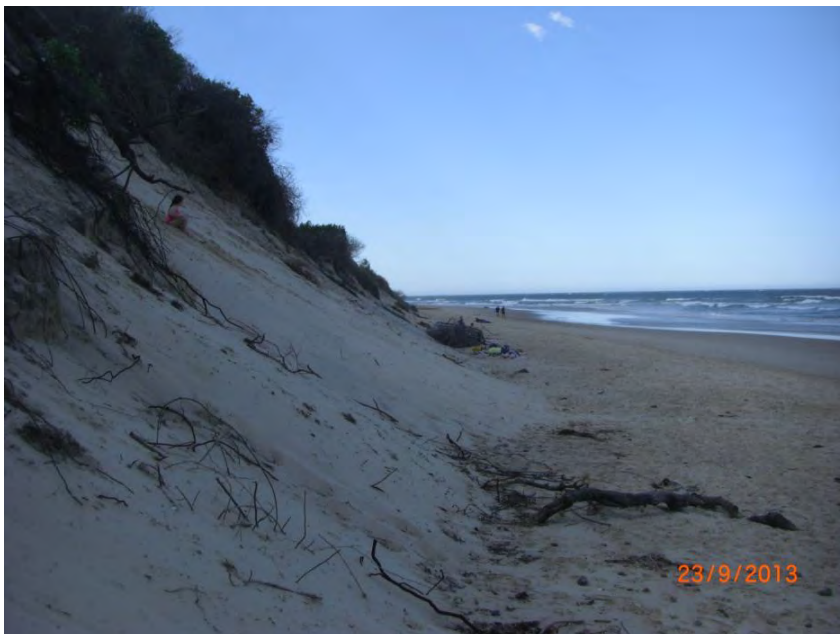
Photo 3 – Steep eroding dune face

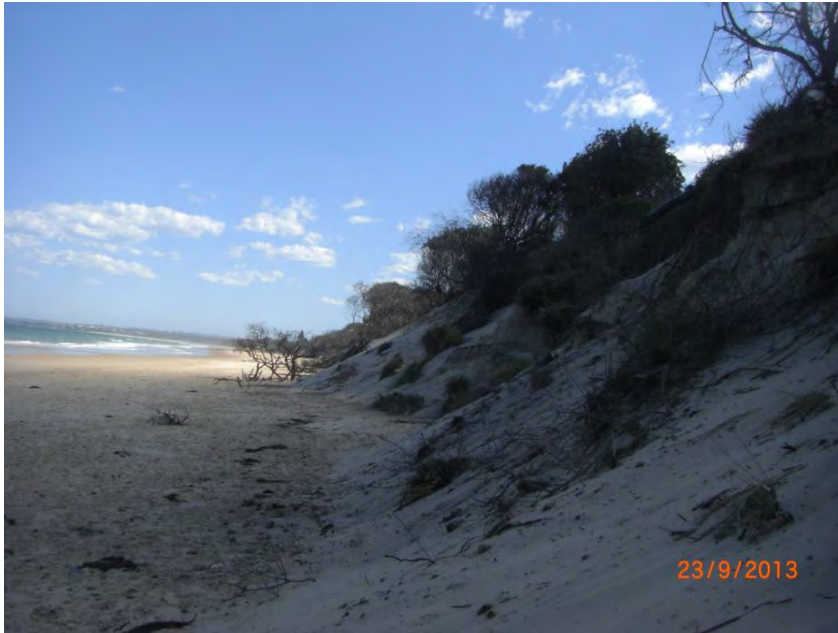
Photo 4 – Steep eroding dune face

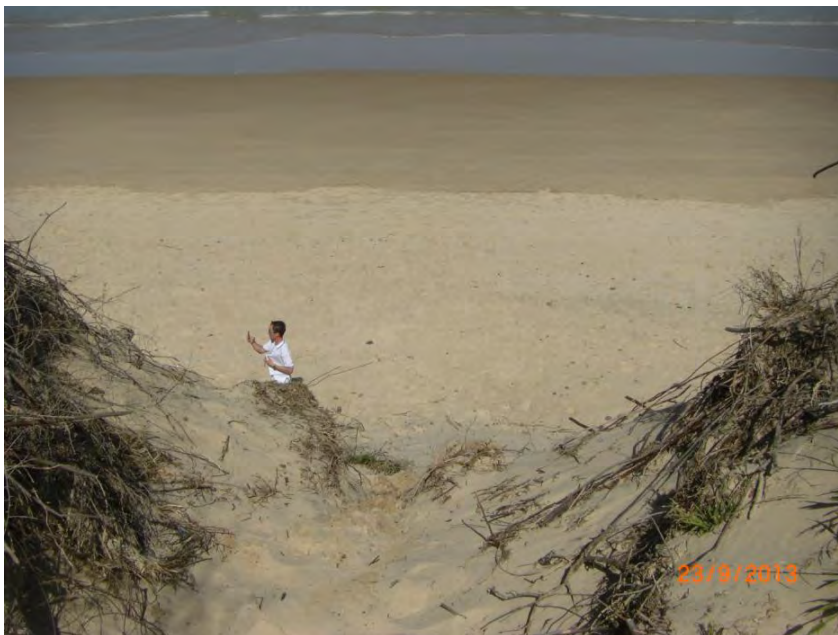
Approximately 150 m S of the Surf Club a small blow out was observed near the crest of the dune.

Photo 5 – Blow out 150 m S of Surf Club

The toe of the escarpment was estimated at approximately RL 2 and the eroded crest at say RL 7 to 8. The size of the blow out measured some 8 m x 8 m in plan.

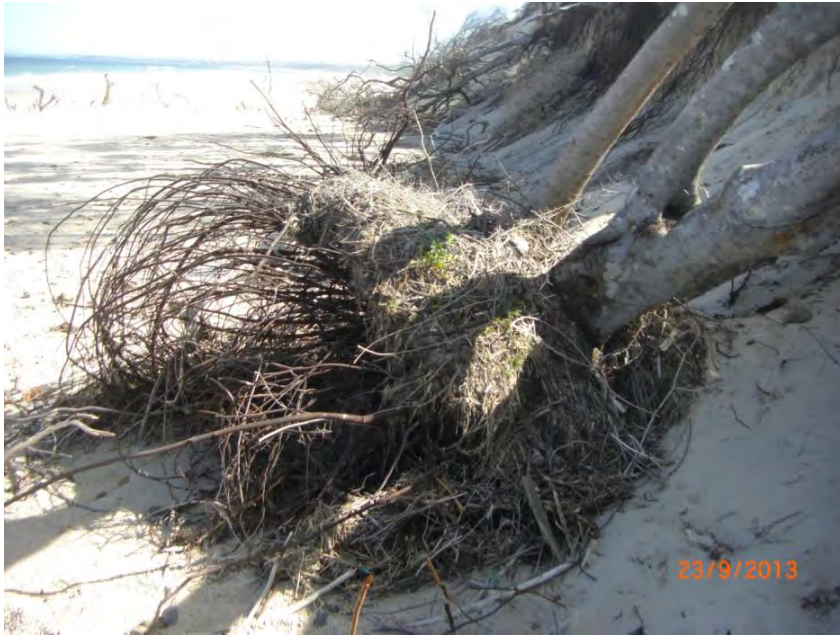
Photo 6 – Trees fallen onto the beach

Active erosion was evident along this section of shoreline with Banksia trees cascading down the escarpment (S 31° 58' 21.0", E 152° 35' 24.5").

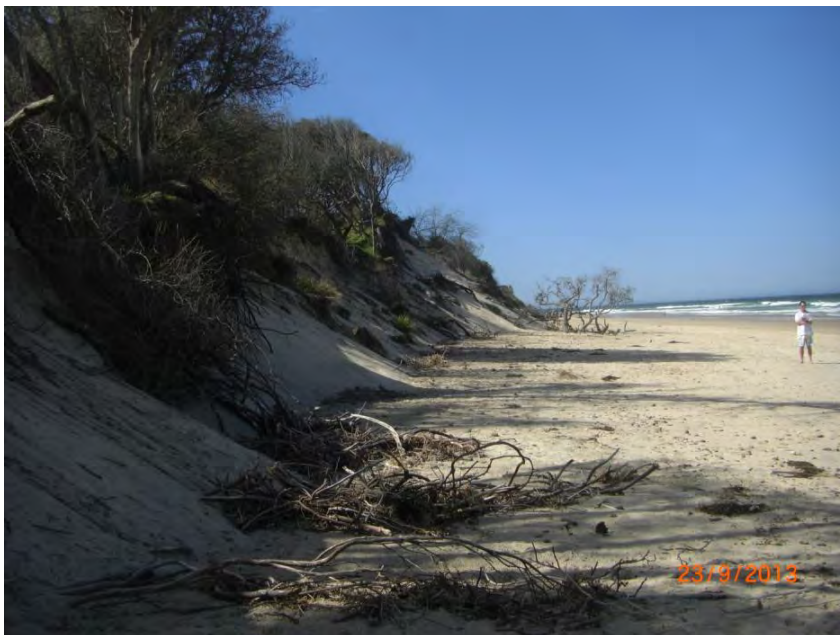
Photo 7 – Eroding dune face

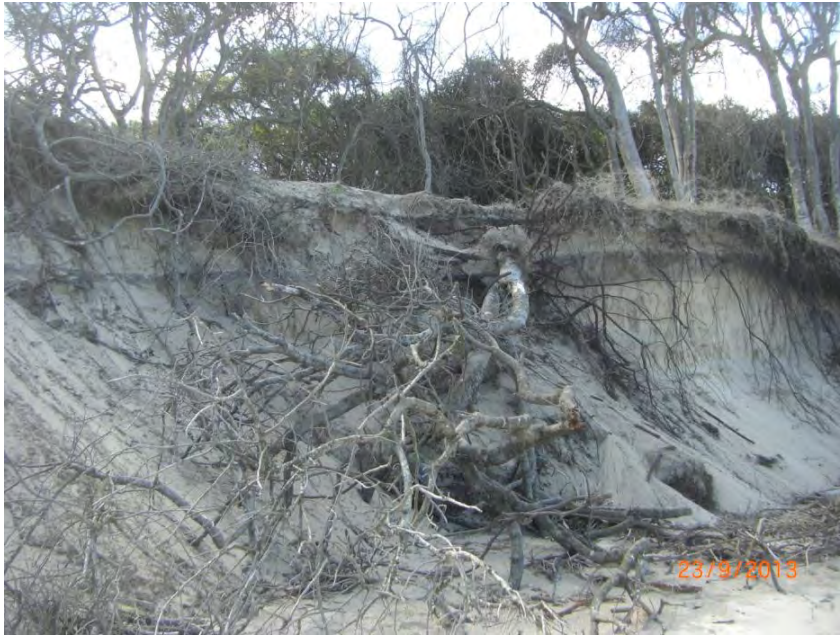
Photo 8 – Trees undermined at dune face

Estimated escarpment crest at this location RL 11. It appeared that the sand which had eroded off the scarp was feeding the beach to create a widened berm low in the swash zone. Water was trapped within this berm.

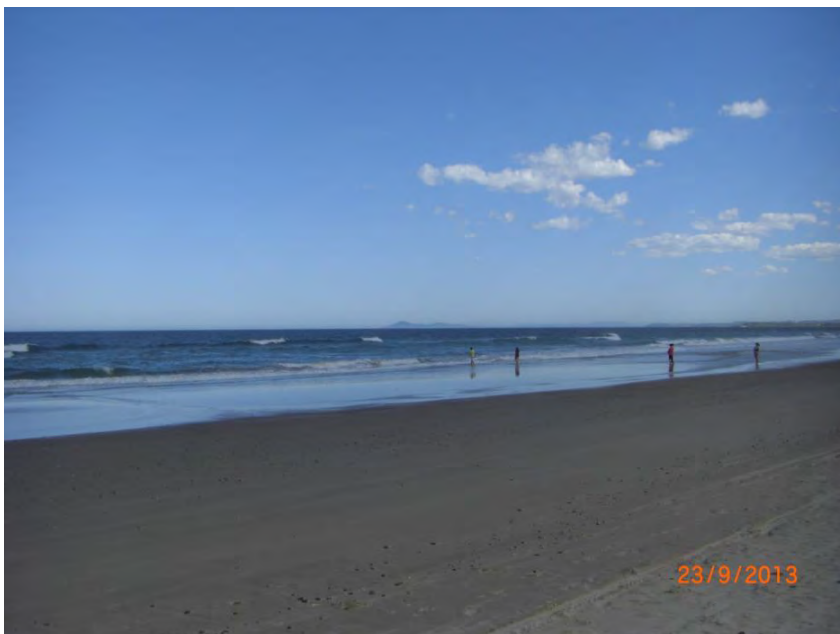
At 2.00 pm the predicted tide was about MSL although the beach had the appearance of a lower tide, i.e. the beach appeared relatively wide, possibly due to the active sand feed from the eroding dune.

Photo 9 – Beach appears relatively widened at about mid tide, possible due to active sand feed from eroding dune

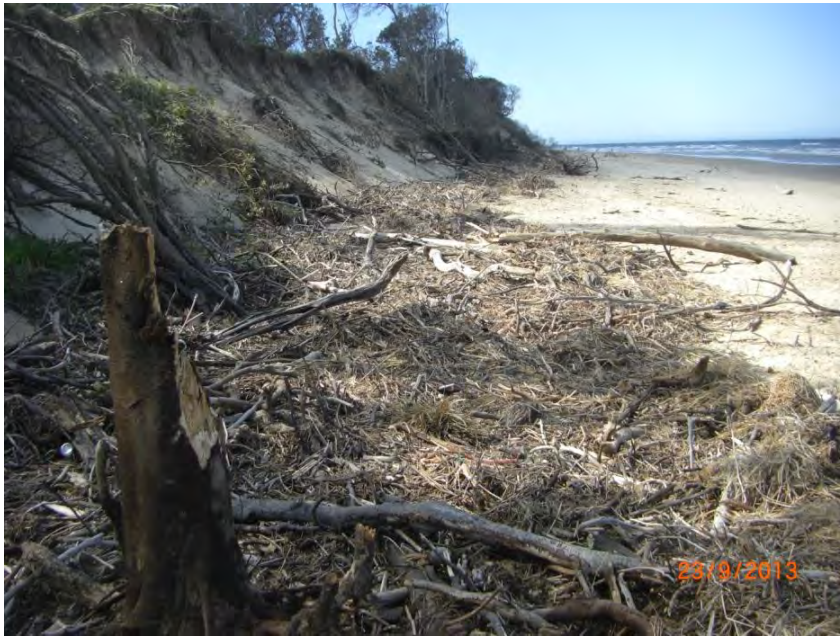
A low point in the dune was observed at S 31° 58' 24.2", E 152° 35' 19.9" at 2.10 pm. The crest of the dune at this location joined an access track linking to the boundary fence of the school estimated at approximately 40 m landward of the dune crest. Wooden debris was littered alongside this dune low point, at the toe of the dune.

Photo 10 – Wooden debris along back of beach

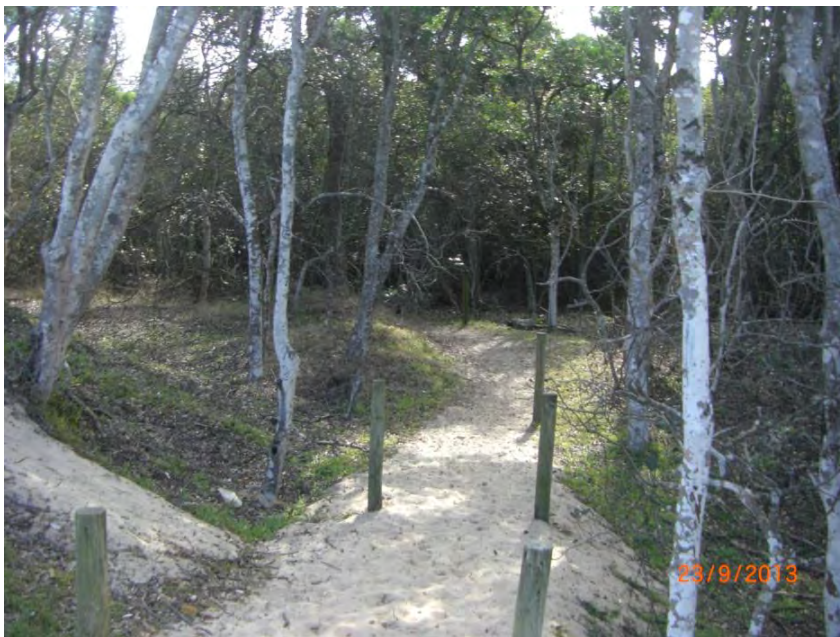
Photo 11 – Access track to school behind dune

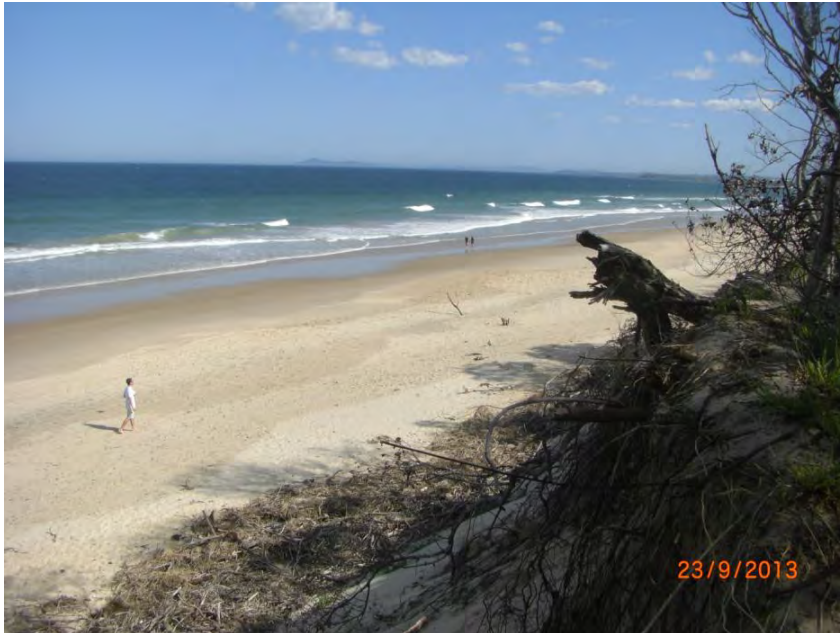
Photo 12 – Vantage to beach from high dune crest, estimated at approximately RL 10

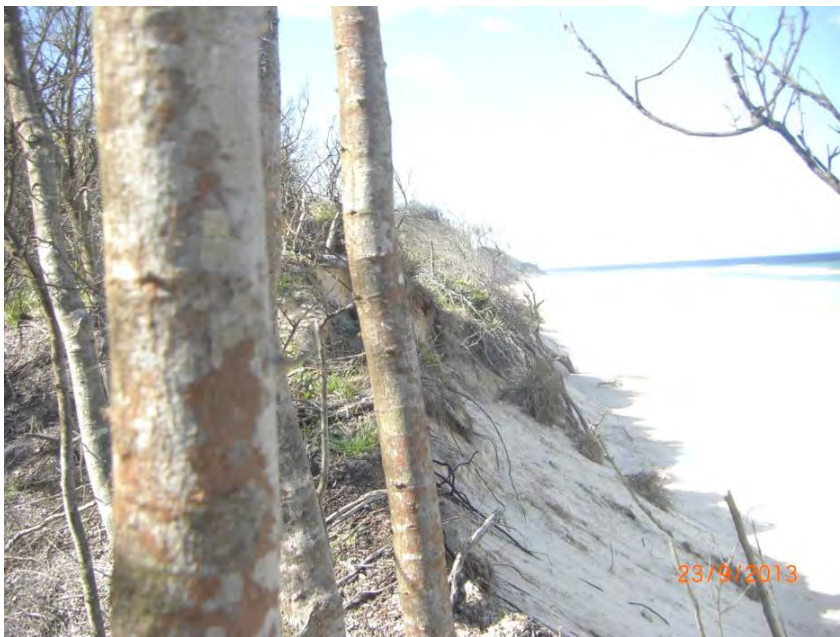
At S 31° 58' 28.4", E 152° 35' 15.1" banksia to 4 m in height were growing behind the dune crest. Teatree and grasses were also observed here. The seaward face of the dune was steep, at the point of slipping (repose slope). This indicated active removal of sand from the toe.

Photo 13 – Steep eroding dune face

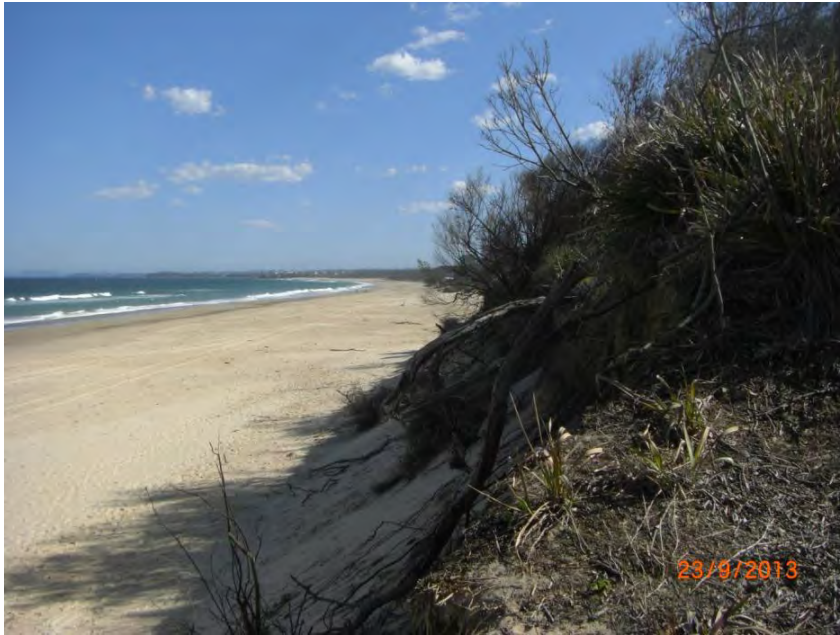
A low point in the dune, with crest level estimated at ~ RL 5, was observed approximately 100 m N of the end of the outer dune adjacent to Racecourse Creek at 2.25 pm (S 31° 58' 30.5", E 152° 35' 12.9"). The dune was steep in this location, and actively slipping at its seaward face. The dune crest and area immediately landward was vegetated. There were small hummocky dunes behind the eroding crest. These appeared to have been built up in the recent past, and now they were eroding. The transient dunal area fronted what appeared to be older and more established dunes further landward.

Photo 14 – Low point in dune crest ~100 m N of end of seaward dune barrier opposite entrance to Racecourse Creek

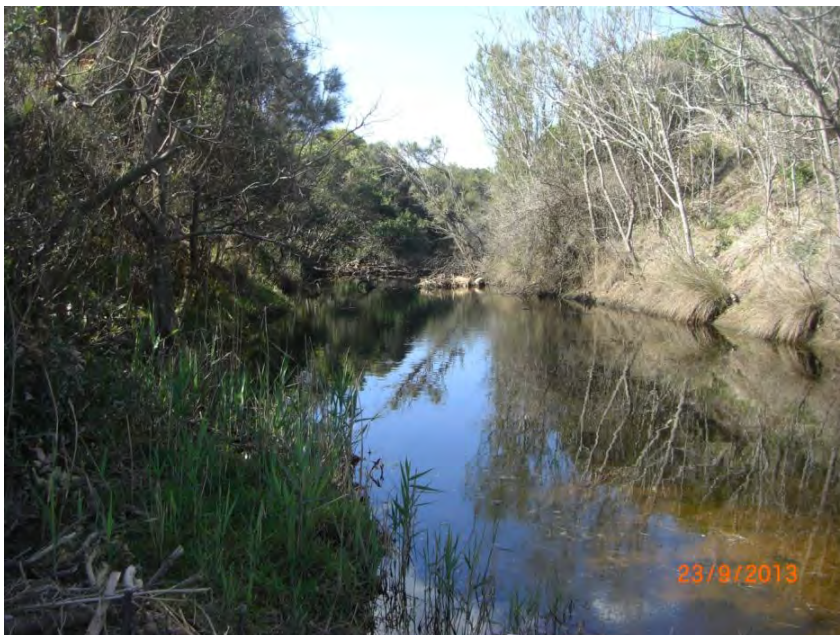
Photo 15 – Entrance to Racecourse Creek

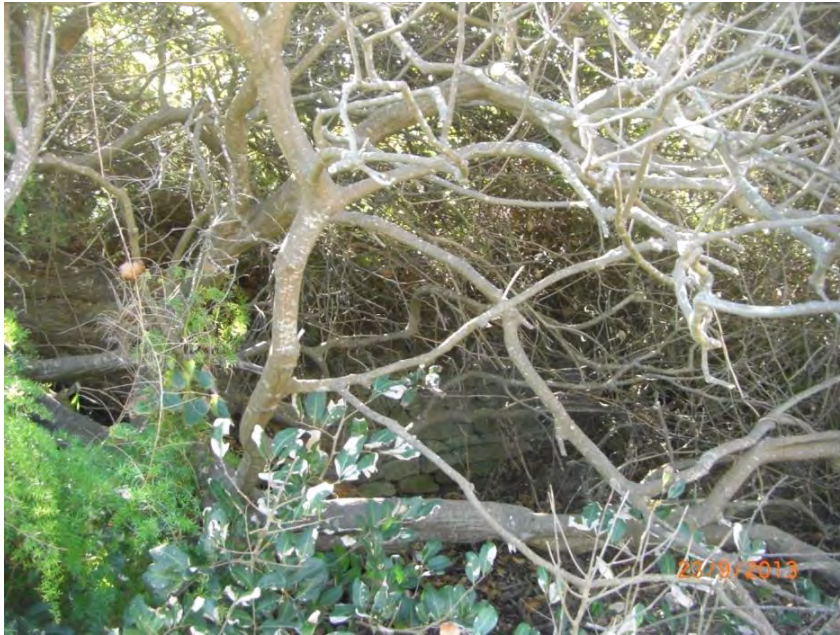
Opposite the ponded water edge at the entrance to the creek old cement bag protection could be seen. Bag sizes were estimated at: 300x200x200, 400x200x200. The cement bags were stacked stretcher-bond in front of the embankment beside Pacific Parade.

Photo 16 – Cement bag wall behind vegetation at entrance to Racecourse Creek

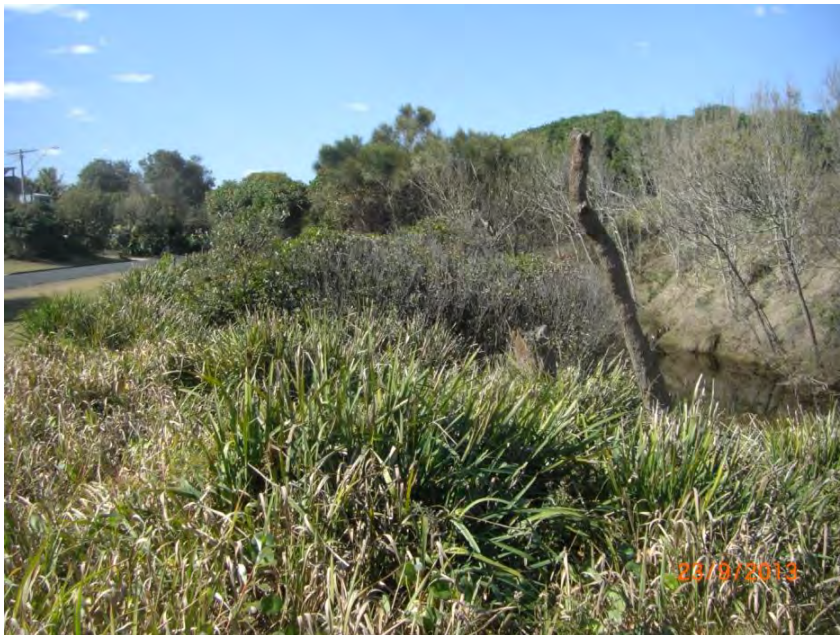
The bank appeared stable here at present. Vegetation observed in the bank included lomandra, sea cabbage, wattle and grasses (S 31° 58' 33.2", E 152° 35' 09.0", 2.35 pm). Although well established, it is likely that these plants could grow over a relatively short period, say 3 to 5 years.

Photo 17 – Well vegetated foreshore between Pacific Parade and entrance to Racecourse Creek

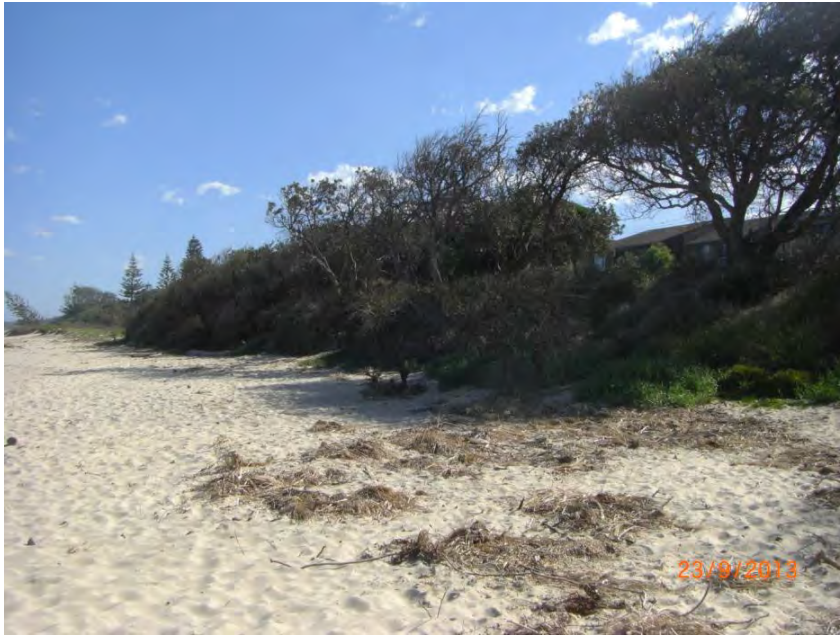
Photo 18 – View to S from foreshore fronting Pacific Parade

If a new structure was to be built to protect the road at this location, it was estimated that the crest of the structure should be approximately 10 m from the edge of bitumen. However, large banksia (height ~6 m, canopy diameter ~8 m) would need to be removed to make way for the embankment protection.

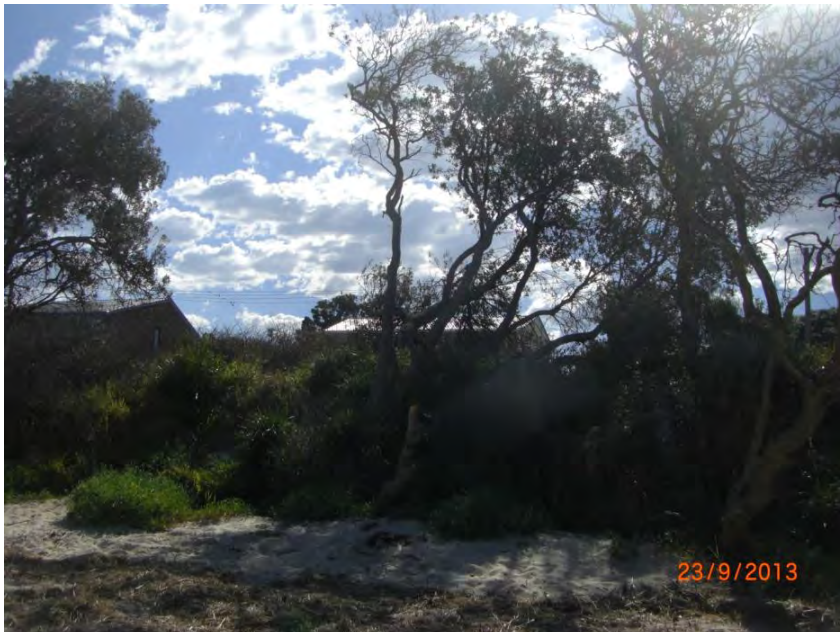
A dune well vegetated with coast wattle and lomandra was observed to extend to the S from S $31^{\circ} 58' 34.4''$, E $152^{\circ} 35' 08.3''$. It was considered important not to disturb this vegetated dune as part of any initial stage to a seawall project.

Photo 19 – Foreshore fronting Pacific Parade

Consider any opportunity to build up the dune at this location, possibly with a terminal wall under the beach at the toe of the built up dune.

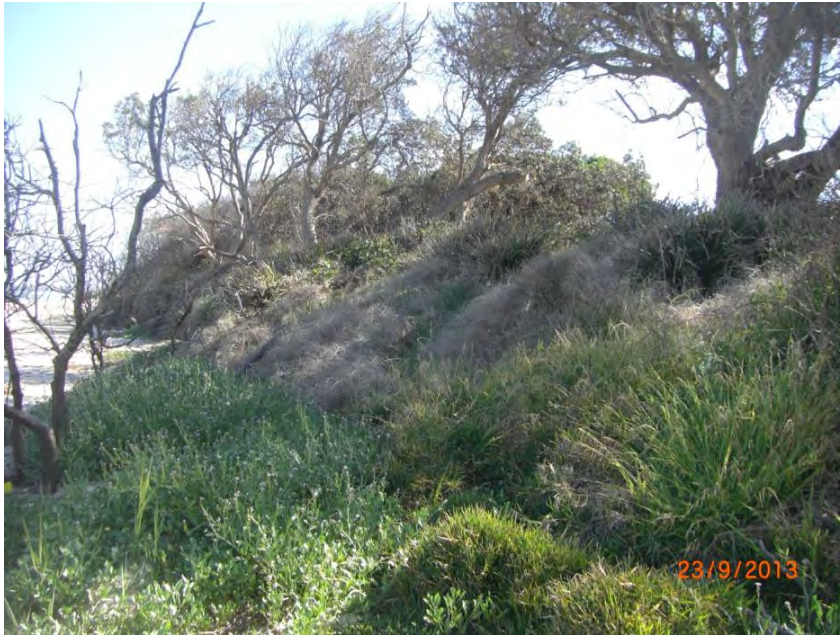
Photo 20 – Well vegetated dune face fronting Pacific Parade near Rose Street

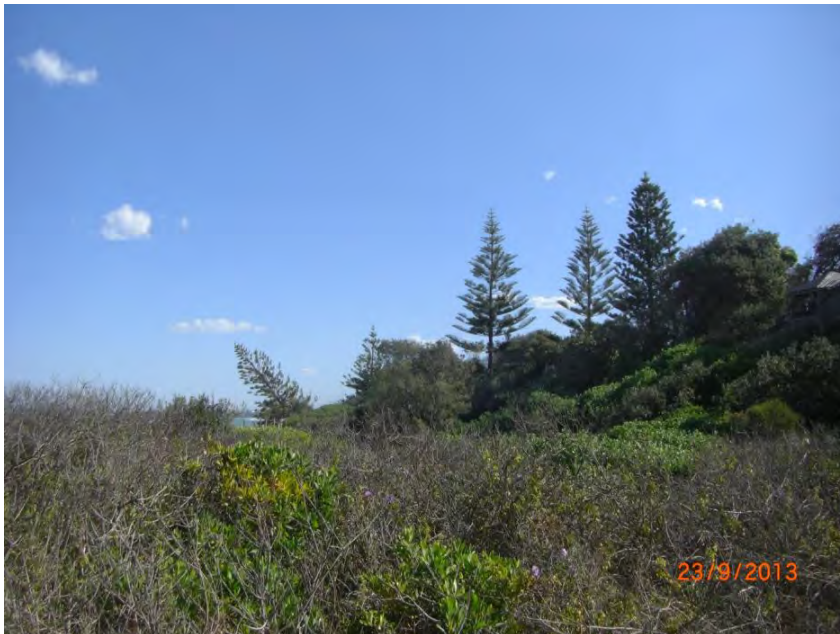
Pig face observed opposite corner of Pacific Parade and Rose Street (2.50 pm). Other vegetation at this location included bitou bush, gazania, sea cabbage, wattle and spinifex. Lot of bitou observed 30 m N of leaning pine tree at S 31° 58' 39.9", E 152° 35' 03.4".

Photo 21 – Bitou amongst native shrubs opposite Rose Street

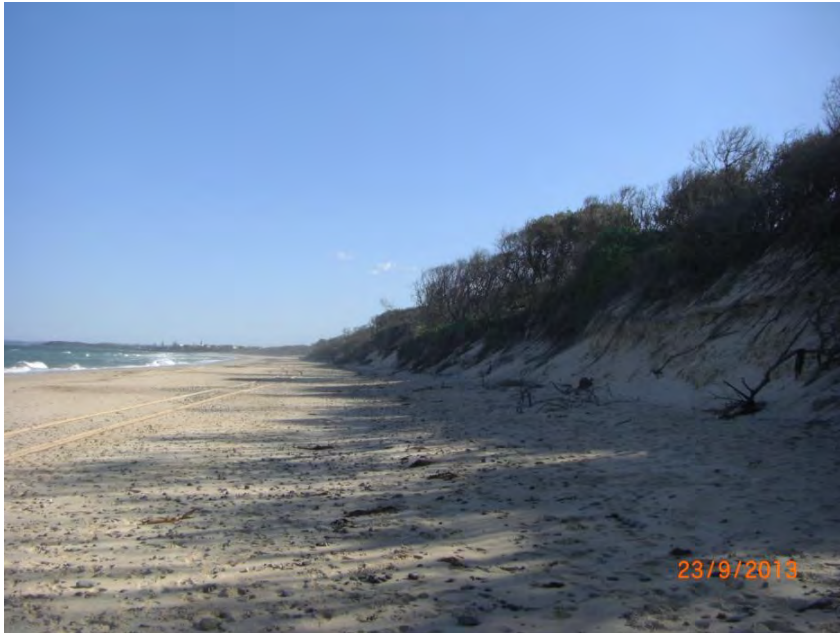
Photo 22 – Beach to the S of the Old Bar subdivision, close to S end of the works area

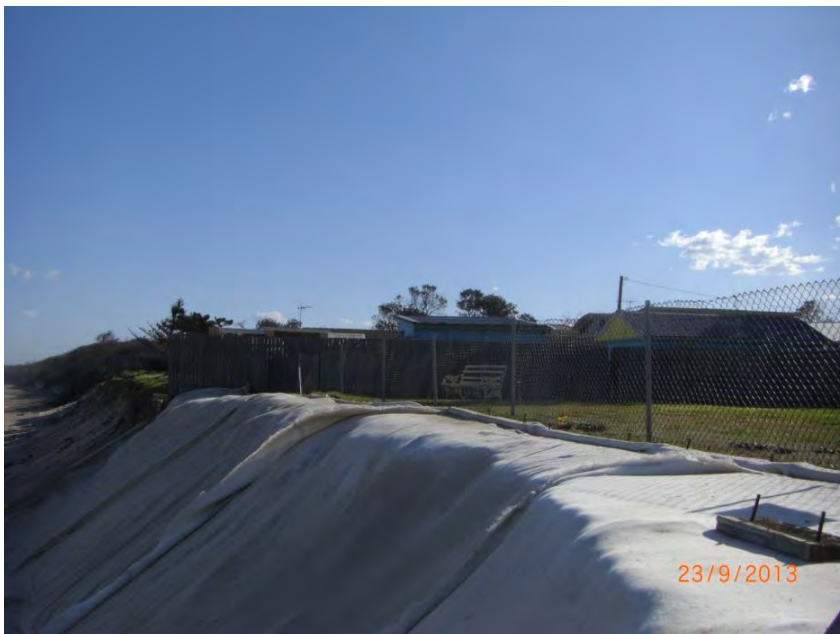
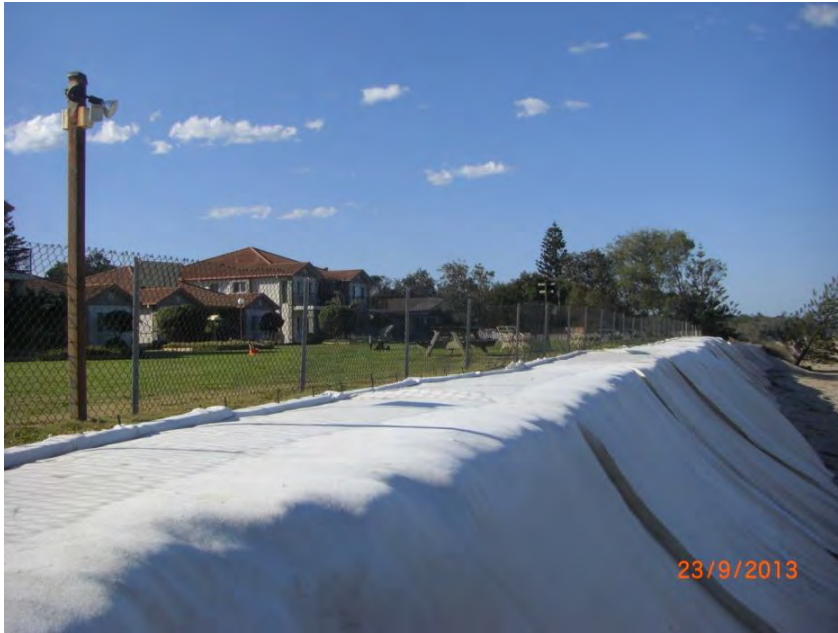
N end of geofabric protection fronting Meridian Resort at S 31° 58' 40.8", E 152° 35' 02.5". S end of geofabric protection fronting Meridian Resort at S 31° 58' 44.4", E 152° 34' 59.2". This fabric identified as TerraStop TS600CAS, supplied as 60 m long by 4 m wide rolls.

Observed 10 m clear back from the crest of the geotextile “wall” at Meridian Resort.

Photo 23 – Geotextile “wall” opposite Meridian Resort

Photo 24 - Geotextile "wall" opposite Meridian Resort

The northern end of any wall protecting the Meridian Resort should (1) return landward to keep it off the beach, (2) be located such as to contain the end effects close to the road head at Rose Street, and (3) be retained in the Pacific Parade road reserve that cuts obliquely onto the beach.

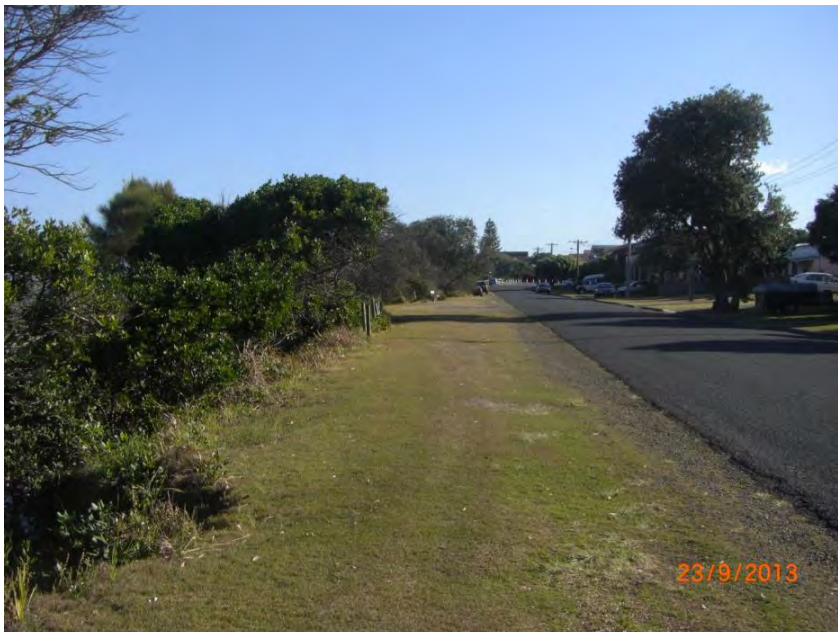
Photo 25 – Road reserve at Pacific Parade, close to possible Stage 2 seawall end point

With Stage 2 extension along Pacific Parade, consider locating the crest of wall:

- ~12 m off edge bitumen opposite 33 Pacific Parade, not closer to the road
- ~8 m off edge bitumen opposite 19 Pacific Parade

Suggest stop Stage 2 wall ~ No 7, and then later extend further to N if required.

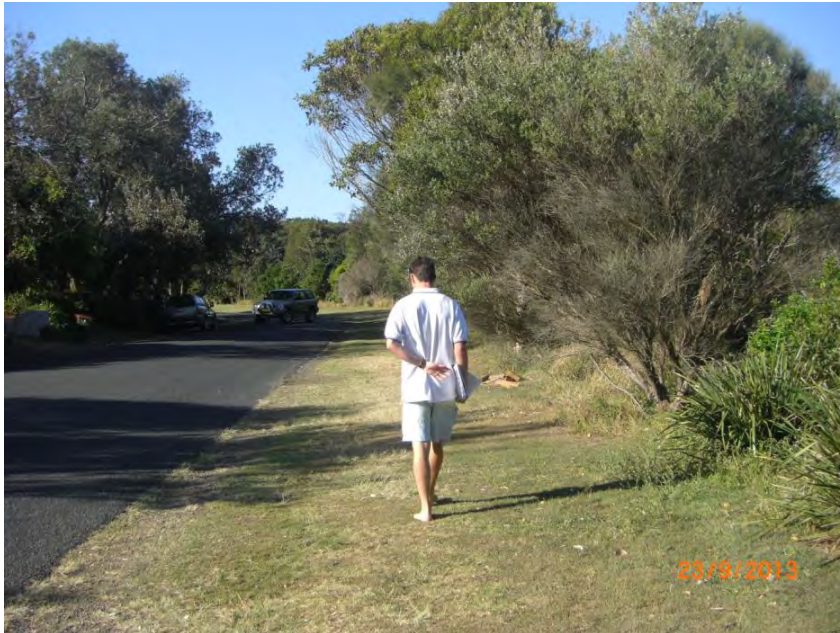
Photo 26 – Road Reserve at Pacific Parade, close to possible Stage 2 seawall end point

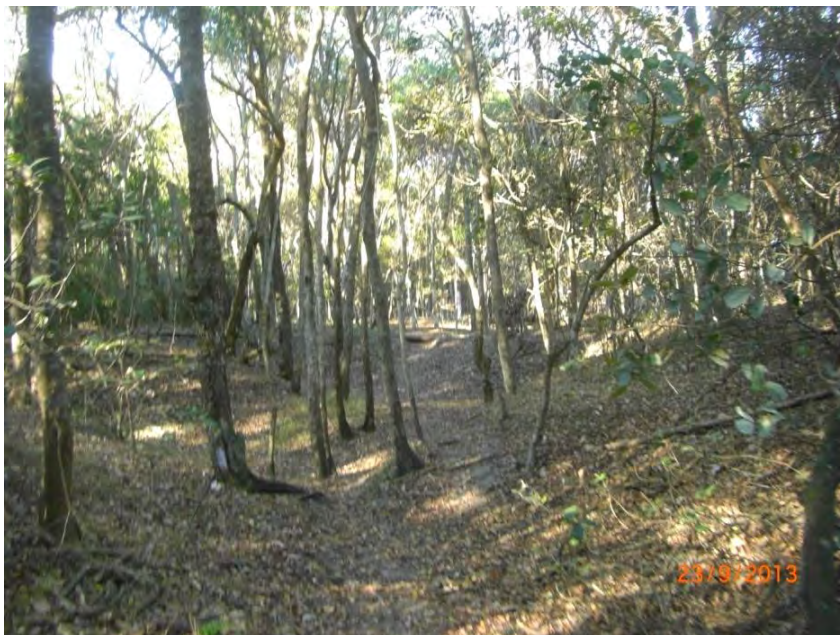
Photo 27 – Tracks in the hind dune between school and Surf Club

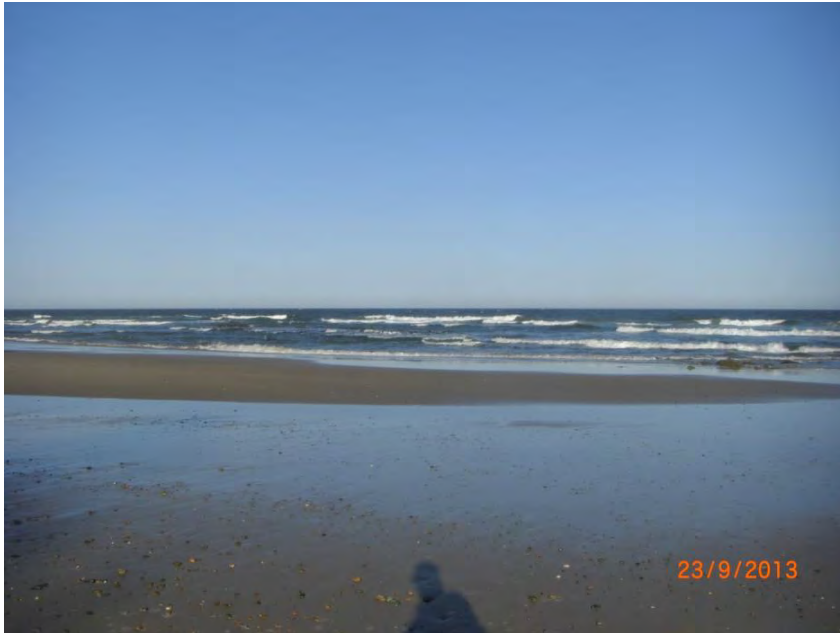
Reef observed at 4.30 pm, protruding 200-300 mm above the water line at S 31° 58' 17.0", E 152° 35' 33.1".

Photo 28 – Rock reef emerging in the beach opposite the Surf Club

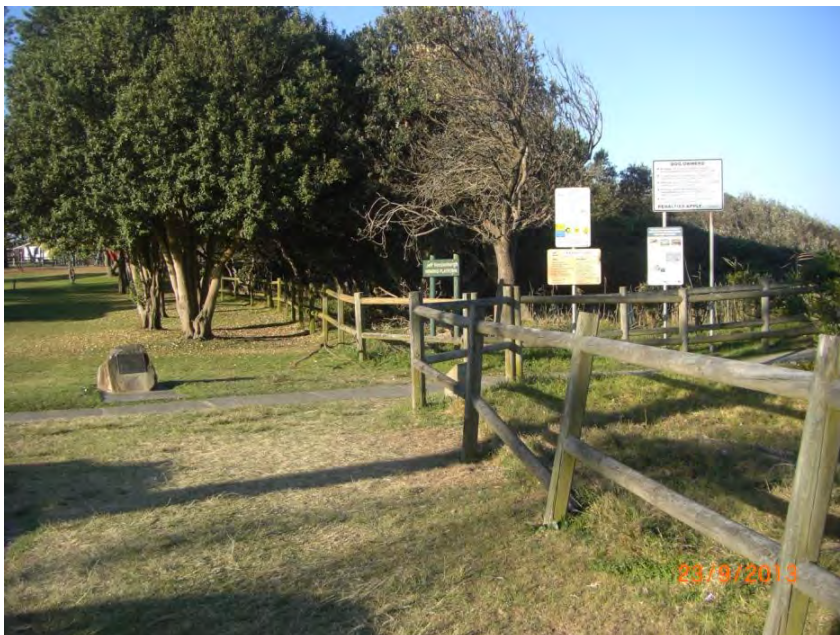
Photo 29 – Foreshore opposite car park to N of Surf Club

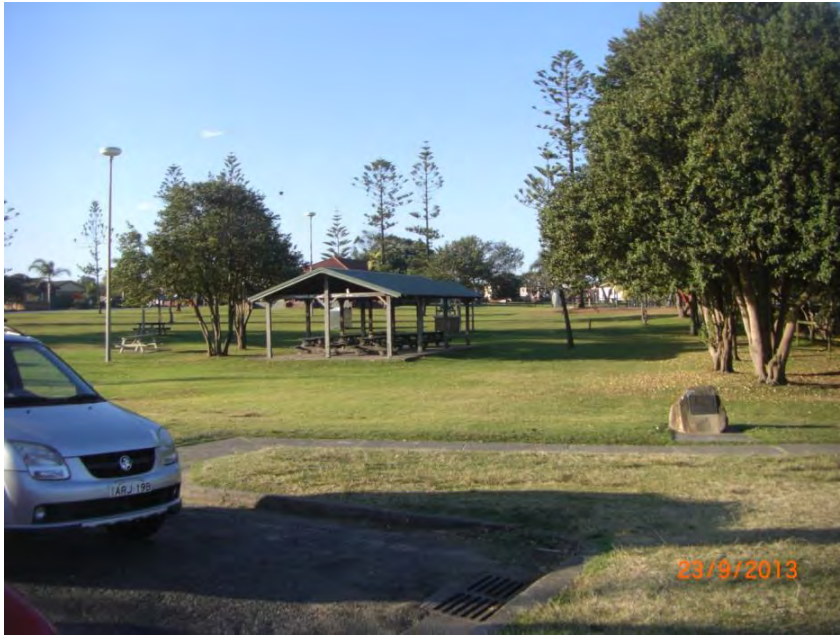
Photo 30 – S end of reserve adjacent to Surf Club carpark. Possible end zone for any Stage 3 wall in this area

There would appear to be ample opportunity for relocation of the Surf Club in the future if required. Any Stage 3 wall fronting the Surf Club should extend to the N of the car park, and finish into the reserve.

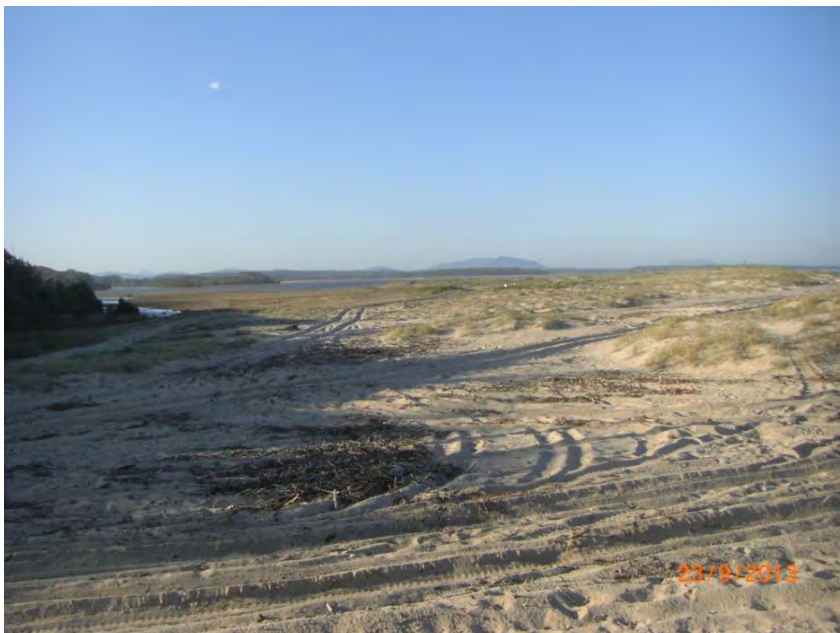
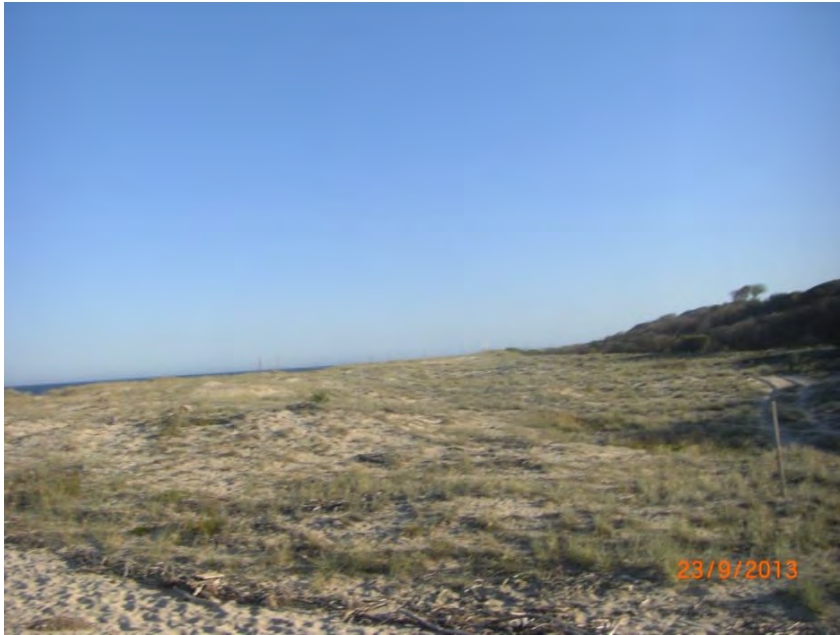
Drove N of caravan park to inspect beach access track, and the beach condition at this location. There was a wide back berm area at this location, close to the entrance to Farquhar Inlet. Spinifex grass was growing in this area.

Photo 31 – Wide back-beach area at S end of Farquhar Inlet

Photo 32 - Wide back-beach area at S end of Farquhar Inlet
