Report on
Preliminary Site Investigation for Contamination

Proposed Rezoning
Sanderling Avenue, Hawks Nest

Prepared for
Lands Advisory Services Pty Ltd

Project 91588.00
July 2019

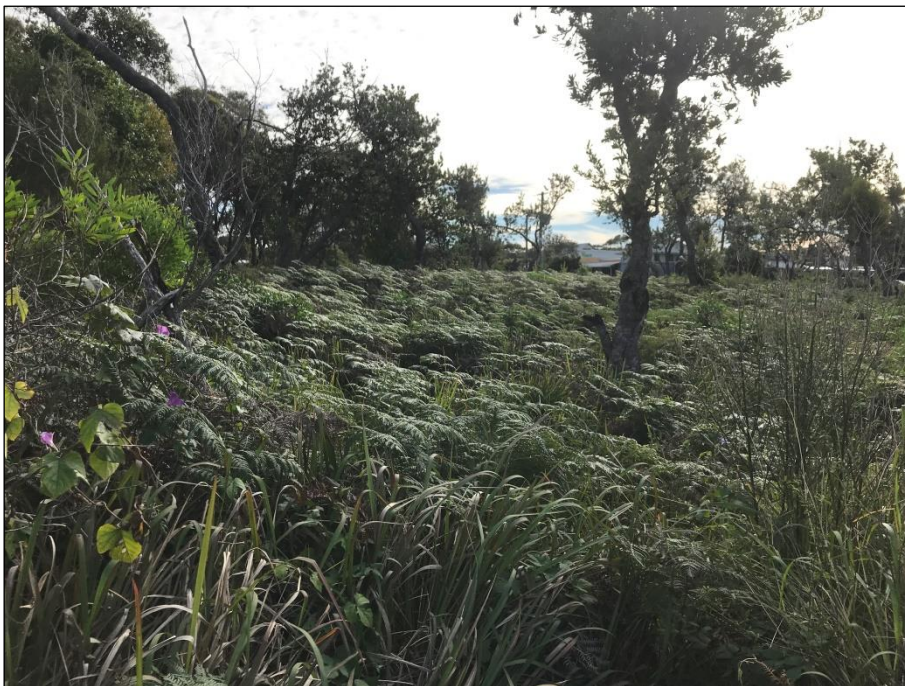
At the time of the inspection, the majority of the site was vacant and vegetated with ground cover (grass and ferns) and scattered mature trees, as shown in Figure 2.

Figure 2: Ground cover at the site, looking north-west from the southern site boundary

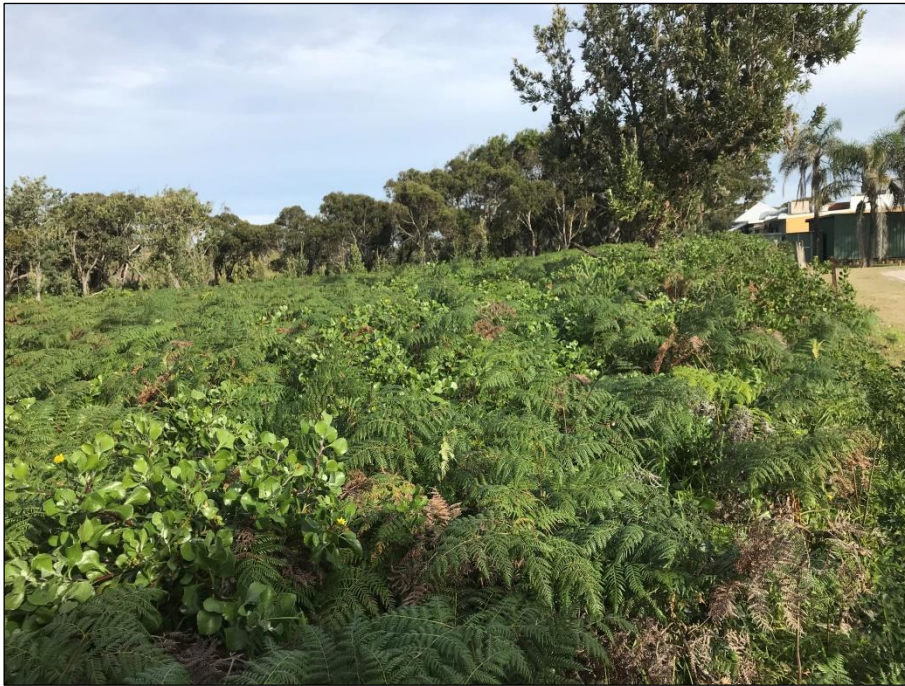
Figure 3: Ground cover and mature trees within the site, looking south from the north-western corner of the site

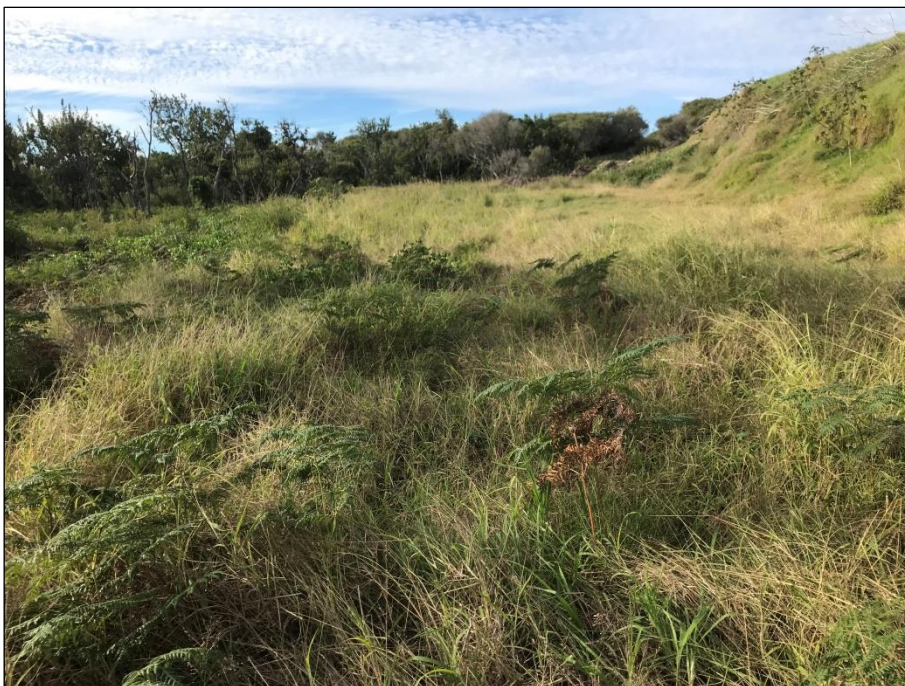
A fill stockpile, approximately 4 m high, was observed immediately east of the site as shown in Figure 4. Based on site observations, possible encroachment of fill onto the subject site may have occurred.

Figure 4: Fill stockpile and possible encroachment of fill on the eastern portion of the site, looking north

- Imported fill materials (source unknown) which may have been placed on the site as part of illegal dumping, adjacent fill placement or as general site filling. It is noted that the site was open to Sanderling Avenue and the Golf Club. Fill materials may be a source of hydrocarbons, pesticides, heavy metals and asbestos, depending on the source;

The potential for gross contamination at the site is considered to be low. Targeted subsurface investigation for soil is recommended to assess the potential contamination sources identified in Sections 6 and 7. It is anticipated that the subsurface investigation could be conducted as part of future planning activities.

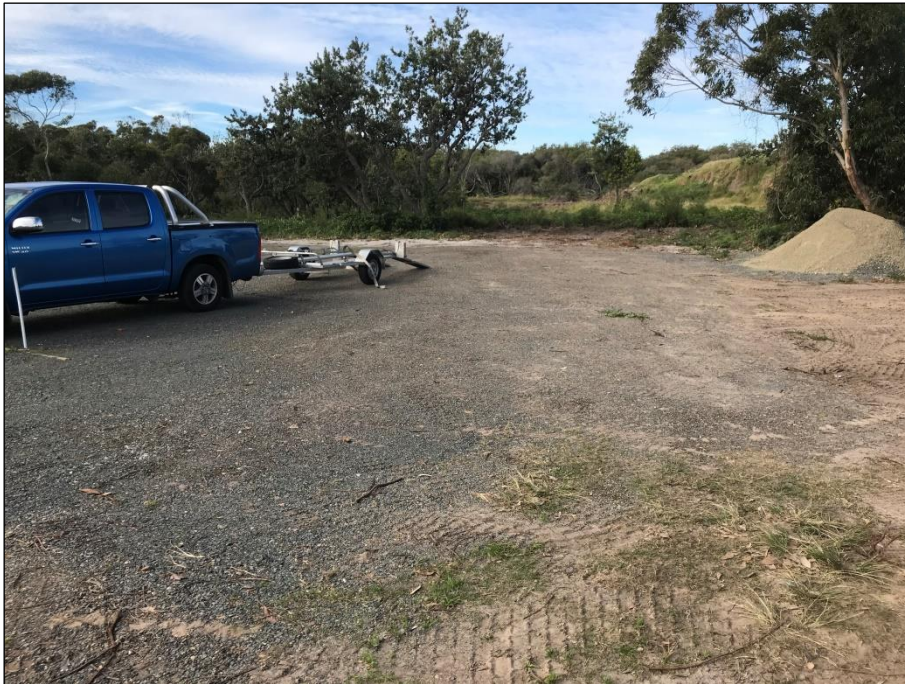
An unpaved car park was observed in the western portion of the site, as shown in Figure 5. The area had been graded with some evidence of recent clearing observed (Figure 6), and placement of quarry gravel at the surface.

Figure 5: Unpaved car park in the western portion of the site, looking east

- Car parking in the western portion of the site. At the time of the assessment the unpaved car park area was in use by the golf club in the western portion of the site. Vehicles may be a source of hydrocarbons and heavy metals;

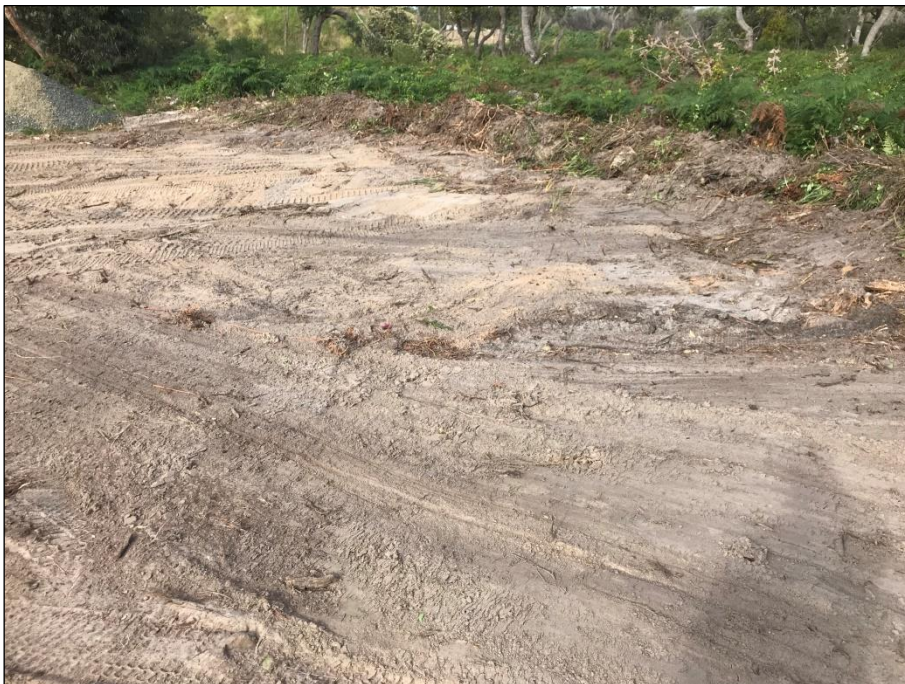
Figure 6: Clearing/grading of the surface in the western portion of the site, looking south

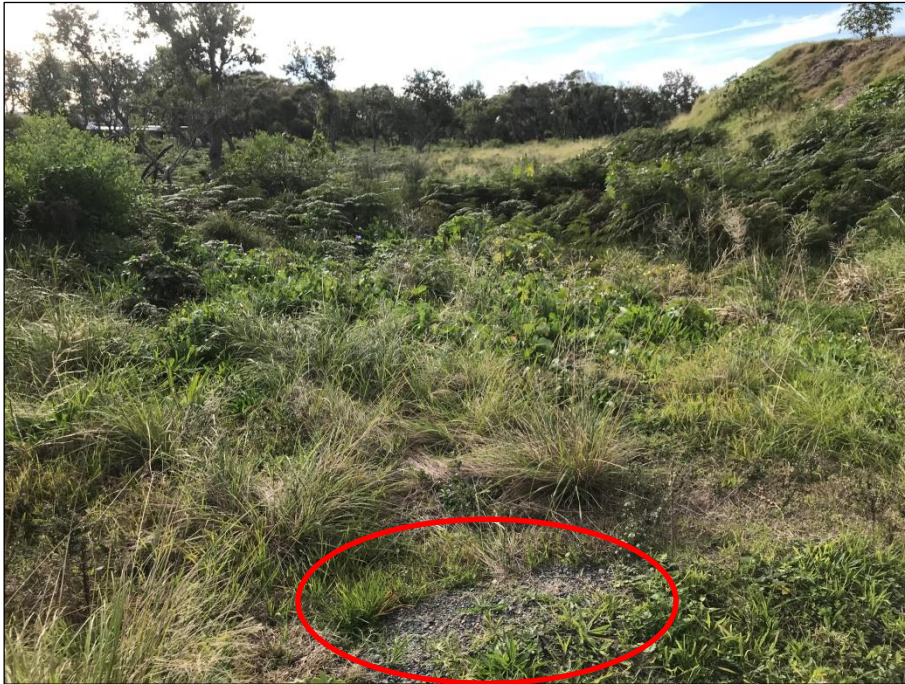
Some localised quarry gravel filling was observed in the south-eastern corner of the site as shown in Figure 7 below.

Figure 7: Exposed quarry gravel (in red) within a localised filled area in the south-eastern corner of the site, looking north

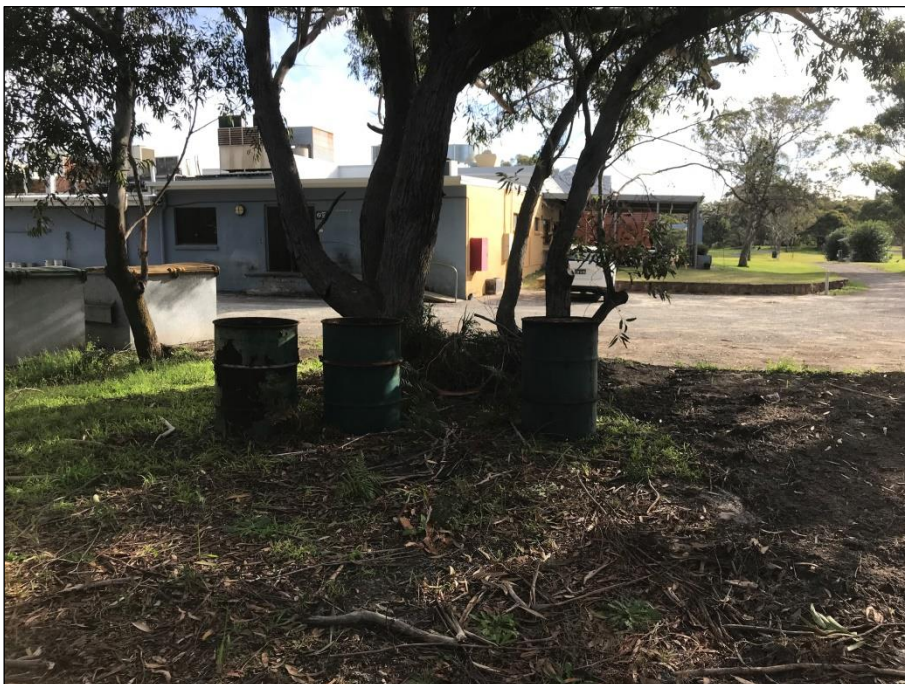
Three 200 litre drums were observed in the western portion of the site, as shown in Figure 8. The drums were labelled as waste cooking oil and were empty at the time of the walkover.

Figure 8: 200 litre drums (possible cooking oil drums) in the western portion of the site

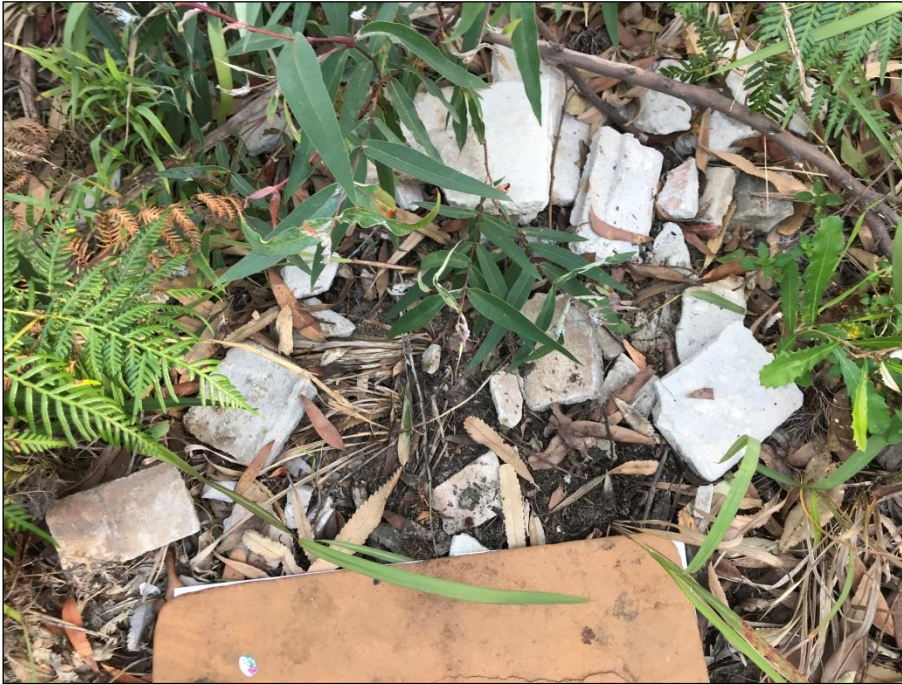
Localised scattered minor building rubble was observed at several locations along the western site boundary as shown in Figures 9 and 10. Concrete and tile fragments, brick fragments, sheet metal and asphalt fragments were observed at the time of the walkover.

Figure 9: Concrete and tile fragments in the north-western corner of the site

Asbestos has not been detected by observation or by laboratory analysis on the surface of the site. Building demolition materials, such as concrete, brick, sheet metal and were, however, located in surface soils, and these are considered as indicative of the possible presence of hazardous building materials (HBM), including asbestos.

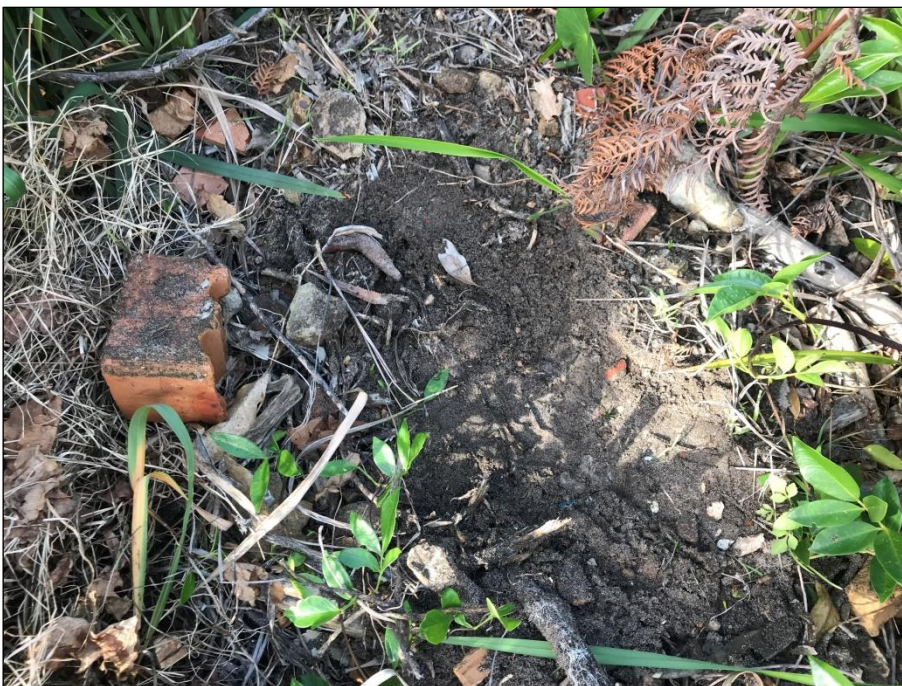
Figure 10: Brick and tile fragments in the western portion of the site
