Wallis
Myall
Karuah

Waterway & Catchment REPORT 2016

MidCoast Council 2016 Waterway and Catchment Report
Prepared by:
MidCoast Council
Natural Systems and Estuaries Section

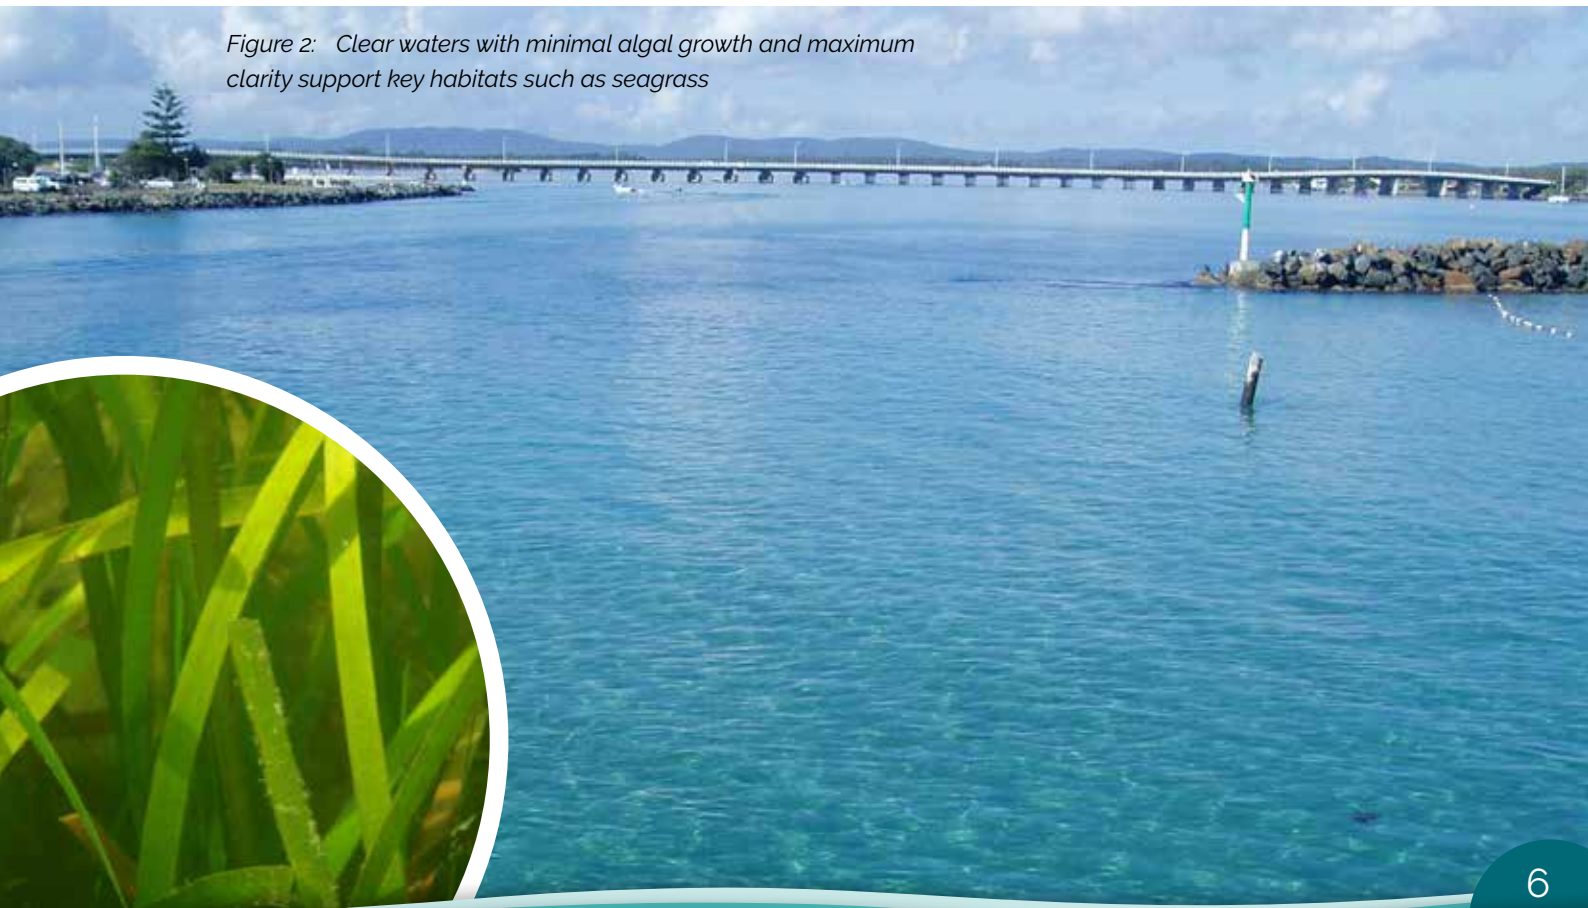
Figure 2: Clear waters with minimal algal growth and maximum clarity support key habitats such as seagrass

1. Minimal algal growth.
2. Minimal sediment inputs and maximum clarity.
3. Intact aquatic habitats like seagrass, macrophyte and riparian vegetation.

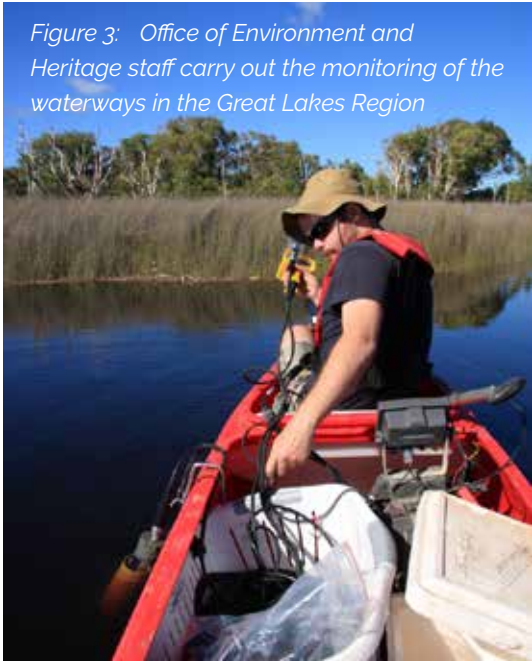
Figure 3: Office of Environment and Heritage staff carry out the monitoring of the waterways in the Great Lakes Region

For the river estuary sites, an 'underway sampler' is used to pass water past the probe whilst the boat travels at a regulated speed along a transect upstream from the middle to the upper part of the estuary. The turbidity is calculated as the mean of logged values for the transect. At two sites along the transect, composite water samples are collected for chlorophyll a analysis.

Chlorophyll a samples are immediately filtered (within one hour) under mild vacuum and the filter frozen until analysis. Chlorophyll a is extracted into acetone and chlorophyll a concentration is determined by spectrometry.

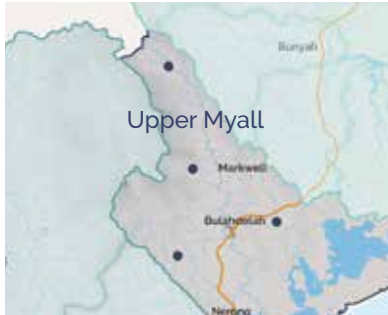
Upper Myall

The condition of vegetation along the upper Myall River is good at three of the four sites in the catchment and fair at one site. In-channel habitat was good to excellent at all sites. Stressors such as nutrients, salinity and turbidity were low resulting in low algal levels. As a result of the good conditions the bugs scores were good, with the exception of one site where a "blackwater" event affected the bug assemblage. "Blackwater" events are caused by breakdown of a large amount of leaf litter in the stream, which depletes the water of oxygen. These occur naturally, usually following a rain event that washes the leaves into the stream.

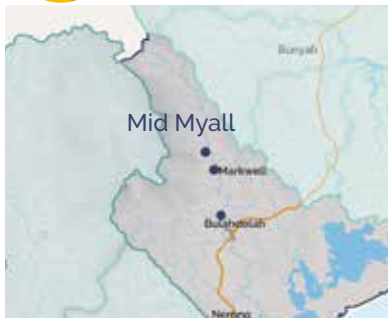
Mid Myall

Ecological health deteriorated markedly in the middle reaches of the Myall where land use intensifies. All three sites in this zone had high levels of nutrients and at one site this has resulted in very high algal levels. Turbidity was a problem at one site, and all sites had declining condition of vegetation along the river. Reach condition was degraded at one site where cattle access has caused severe bank erosion. As a result of the increased pressures the bug scores were only good to fair, however, at this time resilience of the bug communities is still evident.

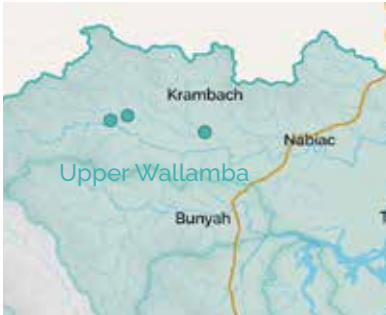
Upper Wallamba

The Wallamba has a long history of agriculture with less intense land use in the steep upper reaches of the catchment. The condition of the riparian zone was good at two of the sites and only fair at the third site. In-channel habitat was good at all three sites. Nutrient and turbidity levels were very good, which meant that the bug community score was good and the levels of algae were low. Salinity was much higher than expected at all three sites; further work is needed to see if this is a result of the local geology or from human activity.

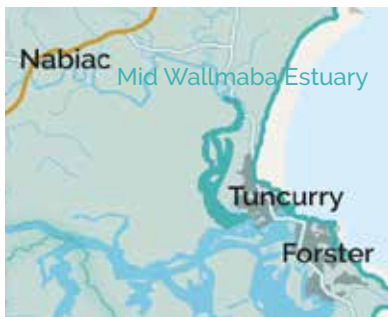
Mid Wallamba Estuary

In the Wallamba Estuary, the overall condition was a 'C' grade, the same as the score recorded in 2015. High levels of algae were recorded, reflecting the large amounts recorded in the Mid Wallamba Catchment. Results show there are still significant problems with nutrients from catchment activities in the Wallamba.

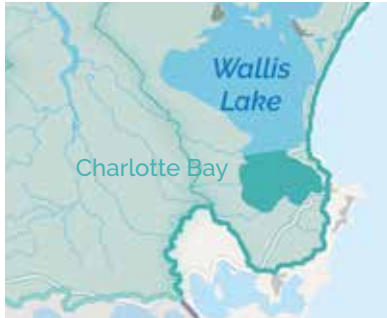
Charlotte Bay

Ecological health remained excellent in Charlotte Bay, despite the above average rainfall. Algal growth was at very low levels, exceeding trigger values in just 15% of samples. Water clarity was excellent with no exceedances.

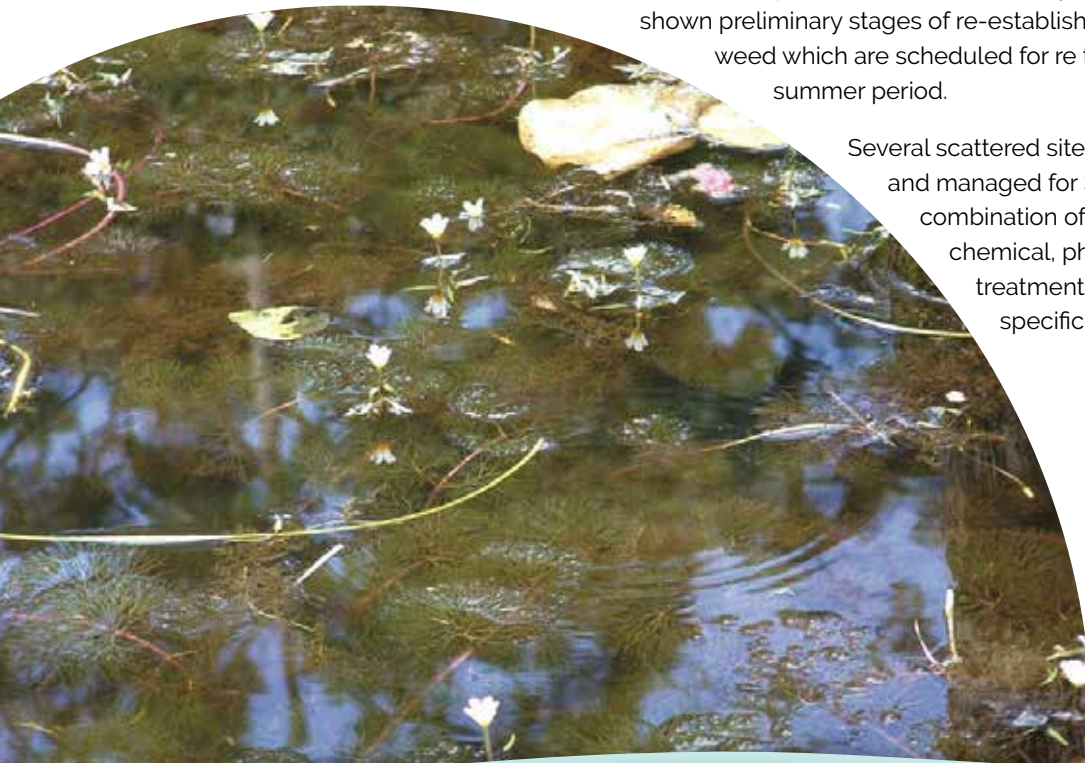
Figure 15: Plants are an excellent indicator of water quality. Aquatic weeds can quickly dominate and clog nutrient rich waters.

All known historic Cabomba infestations targeted for management during a two-year federally funded Cabomba eradication project have been recently assessed. Two areas have shown preliminary stages of re-establishment of the submerged weed which are scheduled for re treatment in the 2016 summer period.

Several scattered sites are being monitored and managed for Salvinia using a combination of controls including chemical, physical and biological treatments governed by site specific conditions.

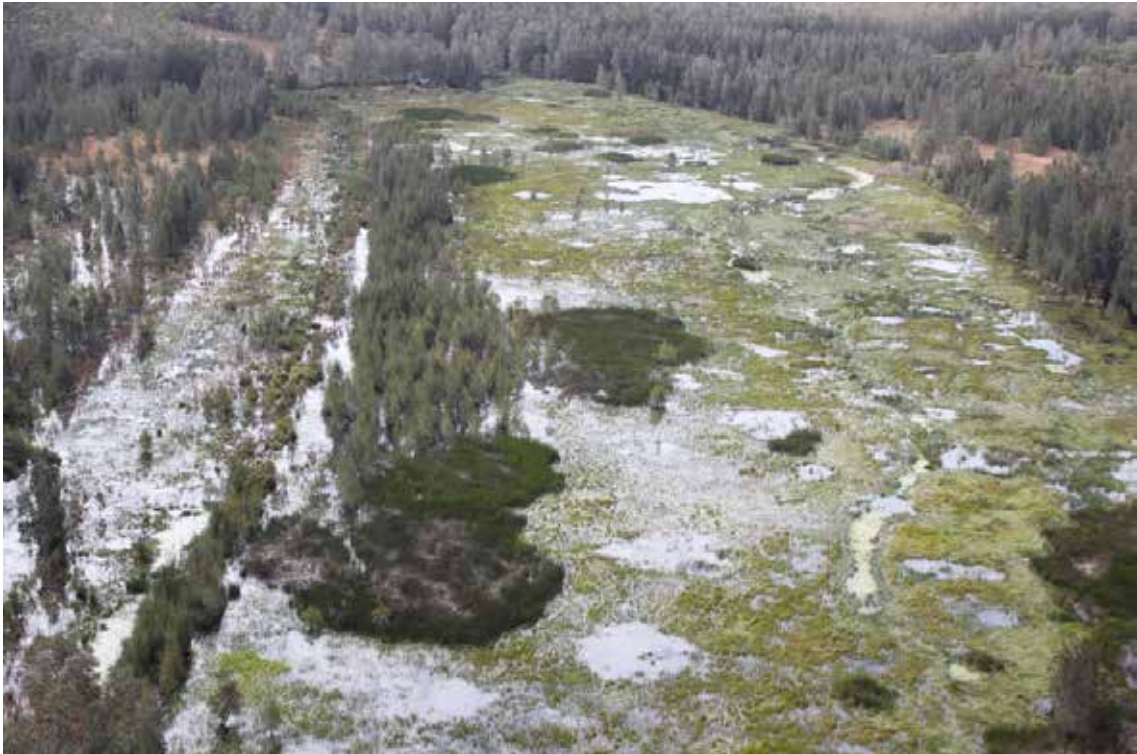
Figure 16: Darawakh Wetland

Council has also restored pre-disturbance hydrology to over 90% of the Darawakh Creek/ Frogalla Swamp through the infilling or decommissioning of 22.2 kilometres of artificial drains and removal of 1.5 kilometres of artificial levees to remediate a significant acid sulfate floodplain wetland system. Monitoring has indicated that the works are having measurable success regarding the protection of the Lower Wallamba River from toxic acid and metal discharges. Further, there has been substantial biodiversity outcomes associated with the program.

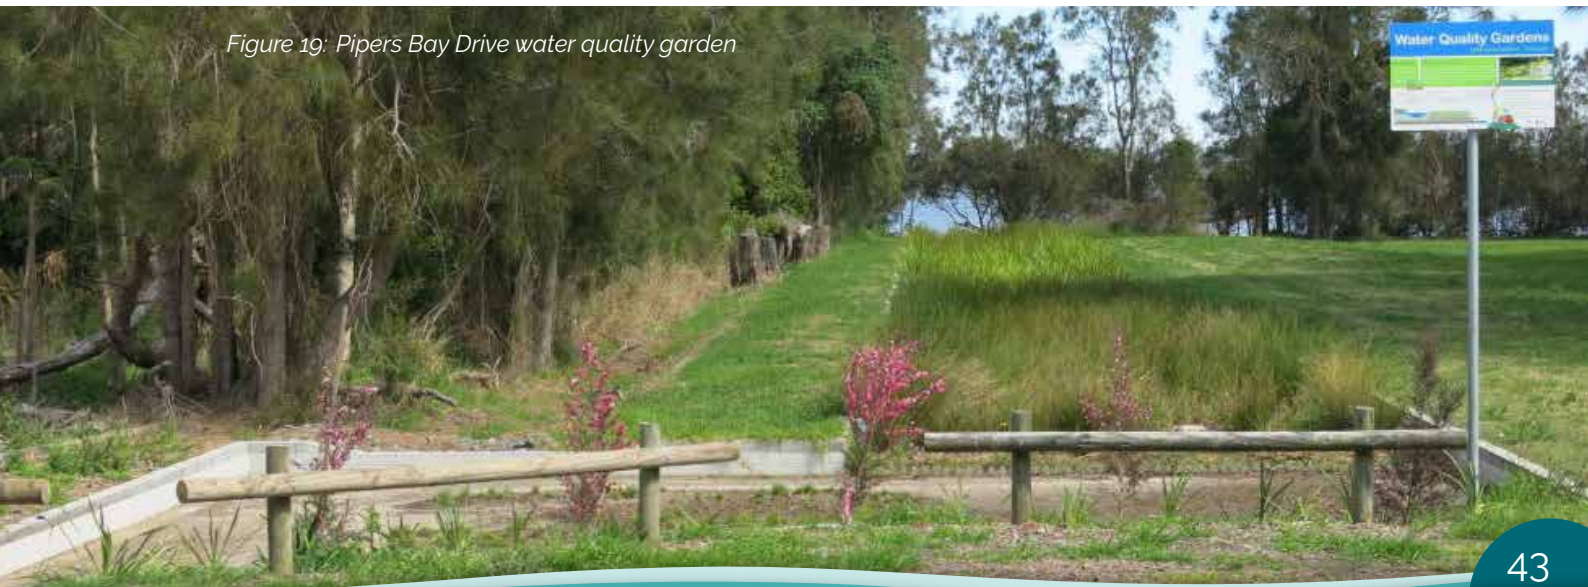
Figure 19: Pipers Bay Drive water quality garden

Over the past five years MidCoast Council have been building water quality gardens in the Pipers Creek Catchment to filter the sediments and nutrients out of the stormwater prior to flowing out into Wallis Lake. Six gardens have been built in the Palms Estate drainage reserve between Kularoo Drive and the Southern Parkway in Forster. An additional garden was built out the front of Council on Breese Parade as a demonstration, filtering water from the road, further protecting Pipers Creek. In 2013, another water quality garden was constructed at the Forster campus of Great Lakes College. The construction of the ninth water quality garden on the corner of Pipers Bay Drive and Tahiti Avenue, Forster was completed in August 2014. The number of gardens constructed now totals nine. The water quality gardens work by slowing down the stormwater so that large particles like soil drop out of suspension. The water then flows over a planted area and the microscopic alga (biofilms) which grow on the plant roots remove the nutrient nitrogen. The sandy loam soil that the plants grow in also acts as an additional filter removing other pollutants like heavy metals, petrochemicals and phosphorus. The water that then flows into the stormwater drain is cleaner prior to flowing into Wallis Lake.

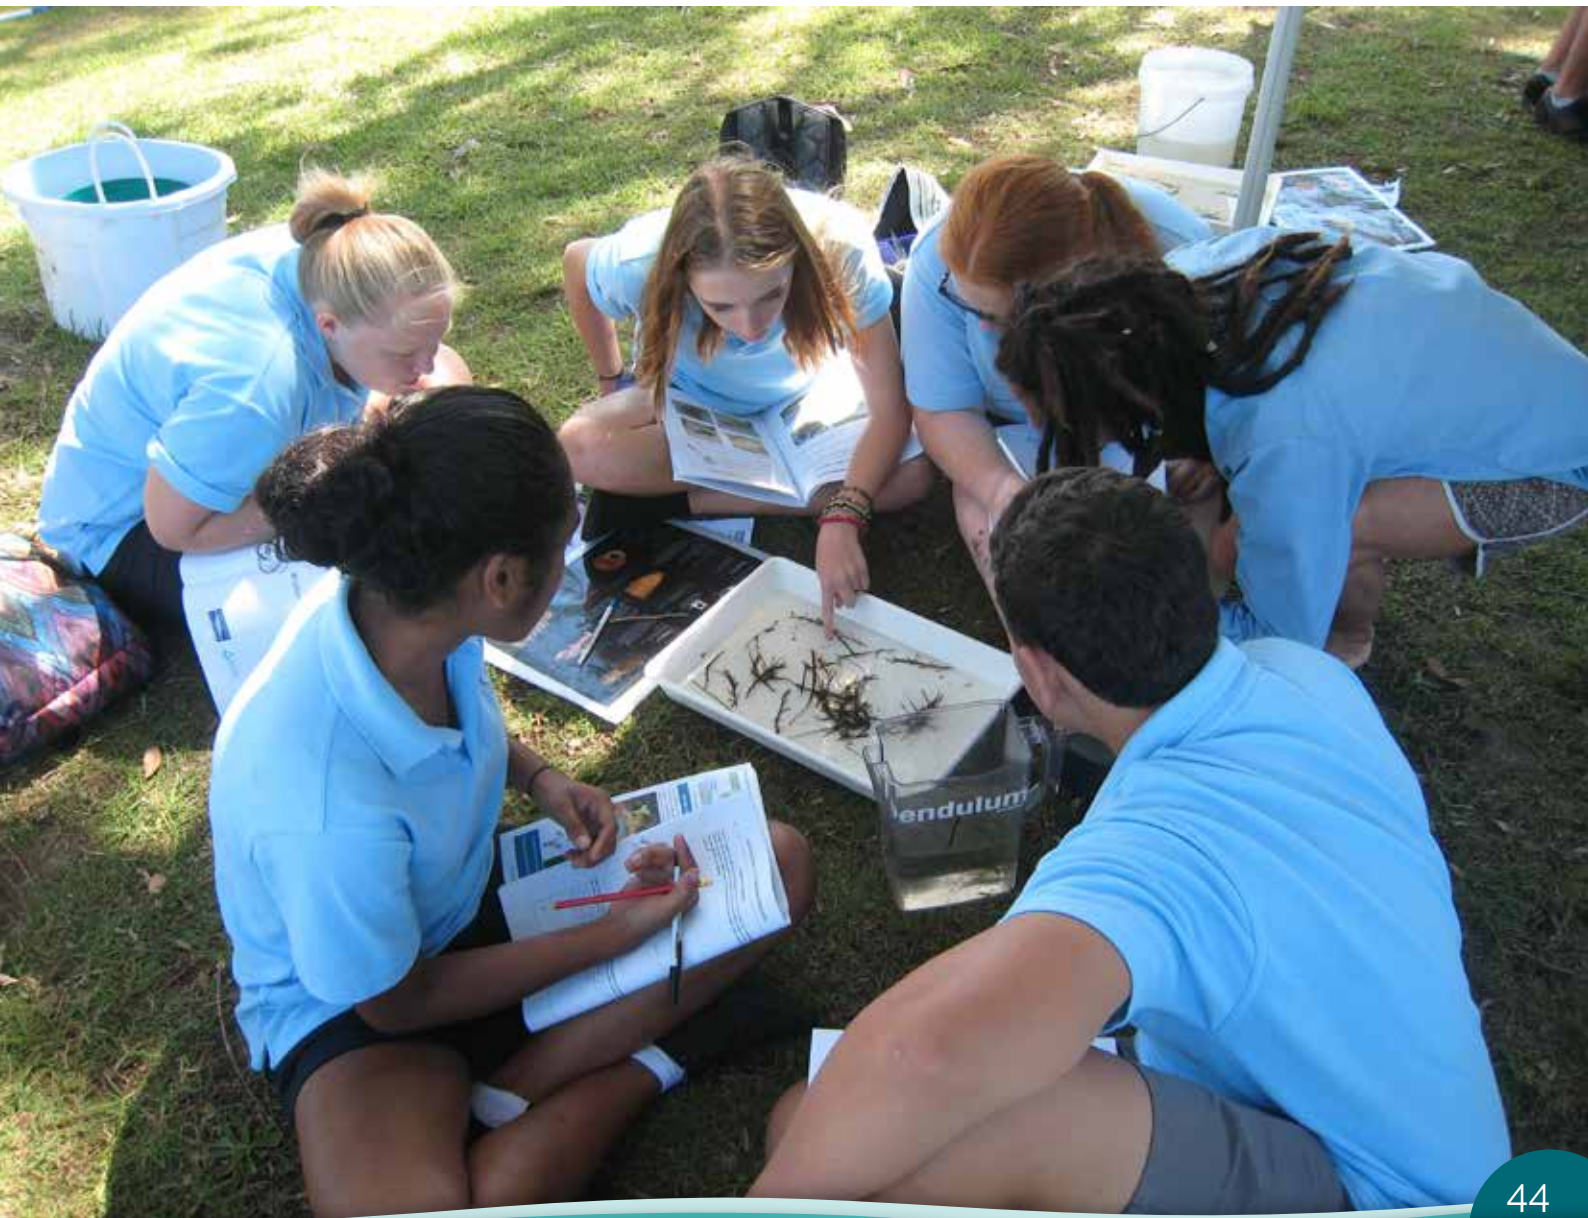
Figure 20: Great Lakes College

Great Lakes College have begun water quality monitoring at their school site with the Waterwatch program, and have also constructed a water quality improvement garden on-campus for water quality outcomes, and as a practical demonstration of the types of actions that can be taken to improve water quality in urban catchments.
