Proposed Residential Development, Lot 612 DP1160096, Blackhead Road, Hallidays Point

Phase 1 Contamination Assessment

Report No. RGS01243.1-AB 25 May 2016

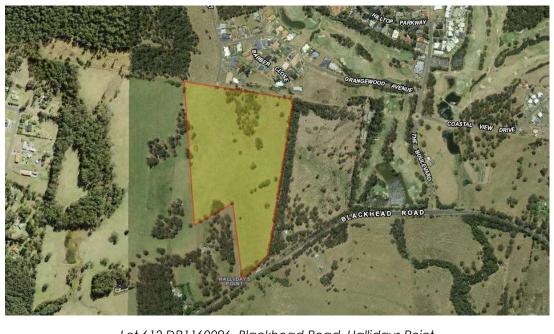
An image of the site taken from the NSW Department of Property Information website is reproduced below.

Lot 612 DP1160096, Blackhead Road, Hallidays Point

The site is bound by other rural properties / grazing land to the east and west, Blackhead Road to the south and by a residential subdivision (Tallwoods Village) to the north.

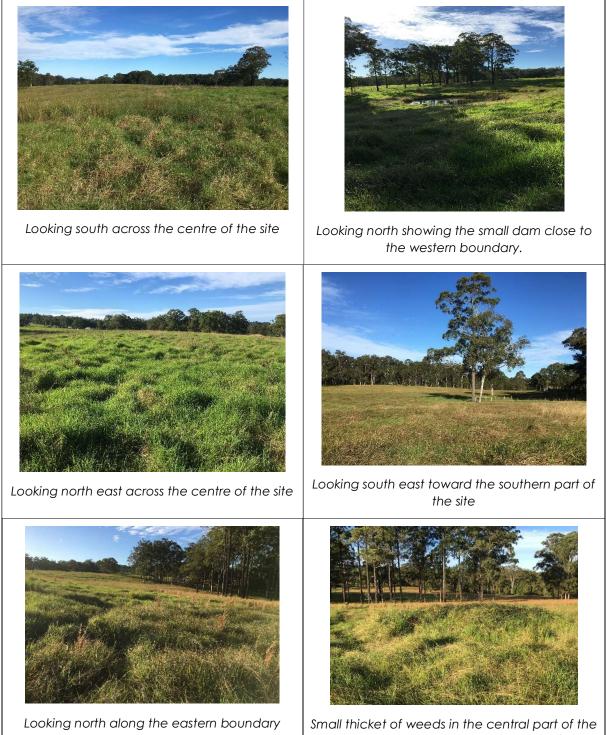
- No structures, or evidence of structures previously in existence, were observed on the site.
- Appears the site has been used primarily for rural grazing land. An old fence was situated toward the southern part of the site which suggests that livestock may have been kept in different sections of the property. Evidence of former livestock yards was observed in the northwest corner.

- One small stockpile of fill was thought to have been encountered in the central part of the site, however upon closer inspection the area was a thicket of weeds which gave the appearance of being a fill stockpile.

- The site was generally comprised of cleared land with thick waist high grass and sparse pockets of large Eucalypt trees up to 25m in height. The trees were predominantly located in the northern part of the site.

- A small dam was located close to the western property boundary approximately halfway along its length.
- The site is located in an area of moderately undulating terrain and sits along a north to south ridgeline which runs through the centre of the site.

A selection of images of the site is presented below.

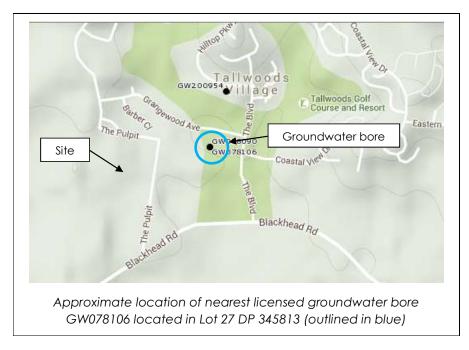
A groundwater bore search on the NSW Office of Water website, <u>http://waterinfo.nsw.gov.au/gw/</u>indicates that there are no licensed groundwater bores present within the site boundary.

Groundwater Bore Map (From NSW Office of Water website)

The nearest licensed groundwater bore GW078106 is present on Lot 27 DP345813, approximately 500m to the east of the site, although its actual location was not visible during fieldwork. The bore records indicate that it was approved for irrigation and recreational use with its current status listed as "converted". It was constructed in 1997 and the profile observed during drilling is recorded as clay soils to 8.5m, broken shale to 20.7m and conglomerate to 67.0m. The water bearing zone was present from 13.7m to 21.3m and from 51.8m to 57.3m.

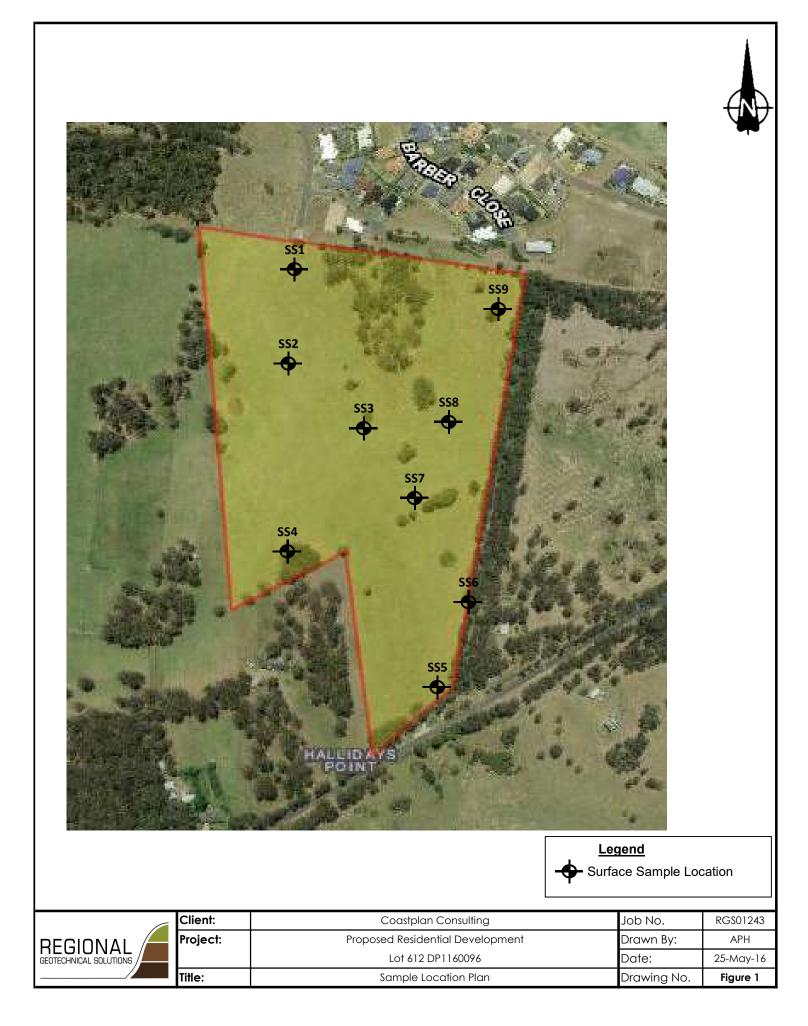
Figure 1 Sample Location Plan

The locations of the surface samples are shown on Figure 1. They were obtained on site by measurement relative to existing site features.
