Water Research Laboratory

Big Swamp Rehabilitation Project Hydrological Study

WRL Technical Report 2012/23
February 2014

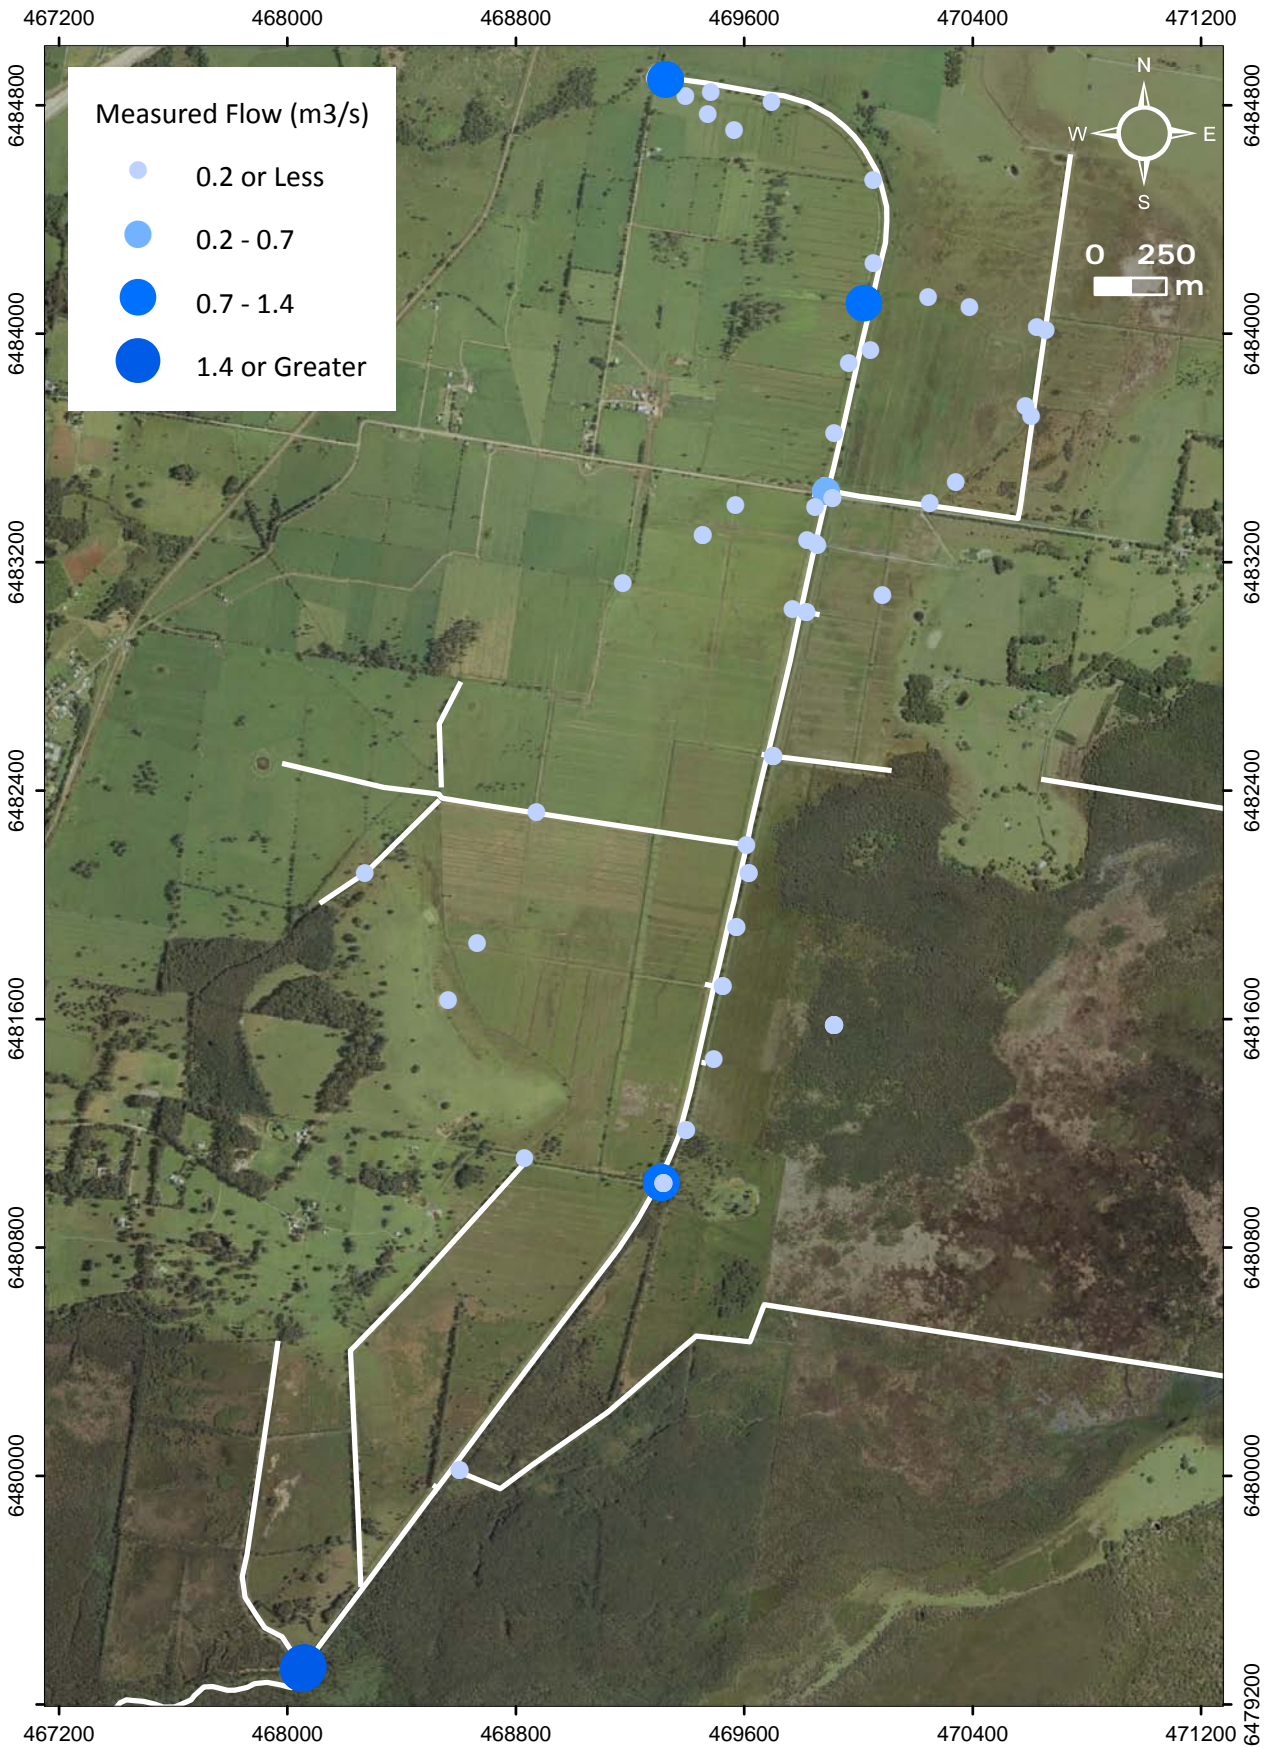
Location of Flow Measurements Taken During the 'Dry Snapshot' on 29th August 2012. Map Projection is MGA-56.

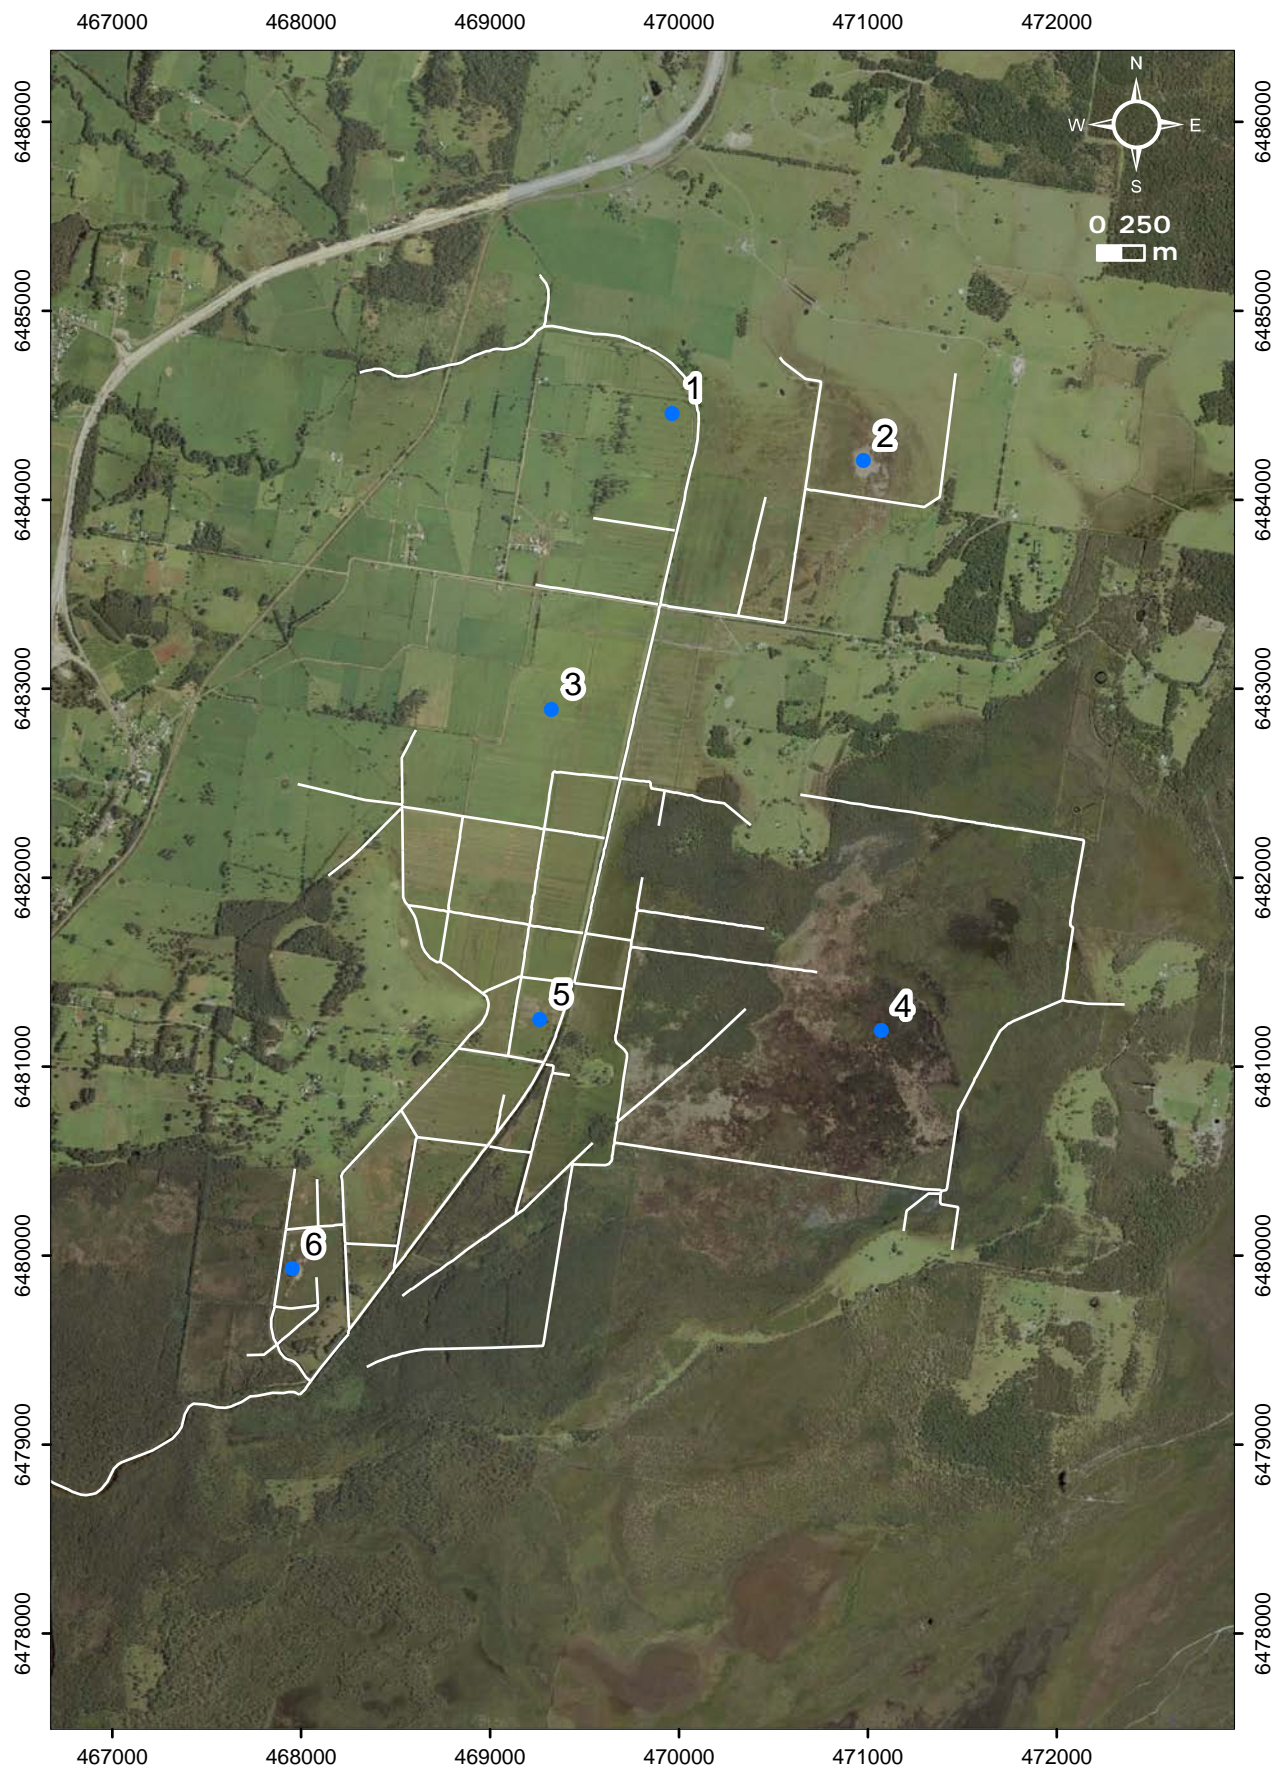
Model Result Timeseries Locations
