Big Swamp Rehabilitation Project: Hydrologic Study

Will Glamore, PhD
Water Research Laboratory,
School of Civil and Environmental Engineering
University of New South Wales

Big Swamp Rehabilitation Project Hydrological Study

WRL Technical Report 2012/23
May 2013

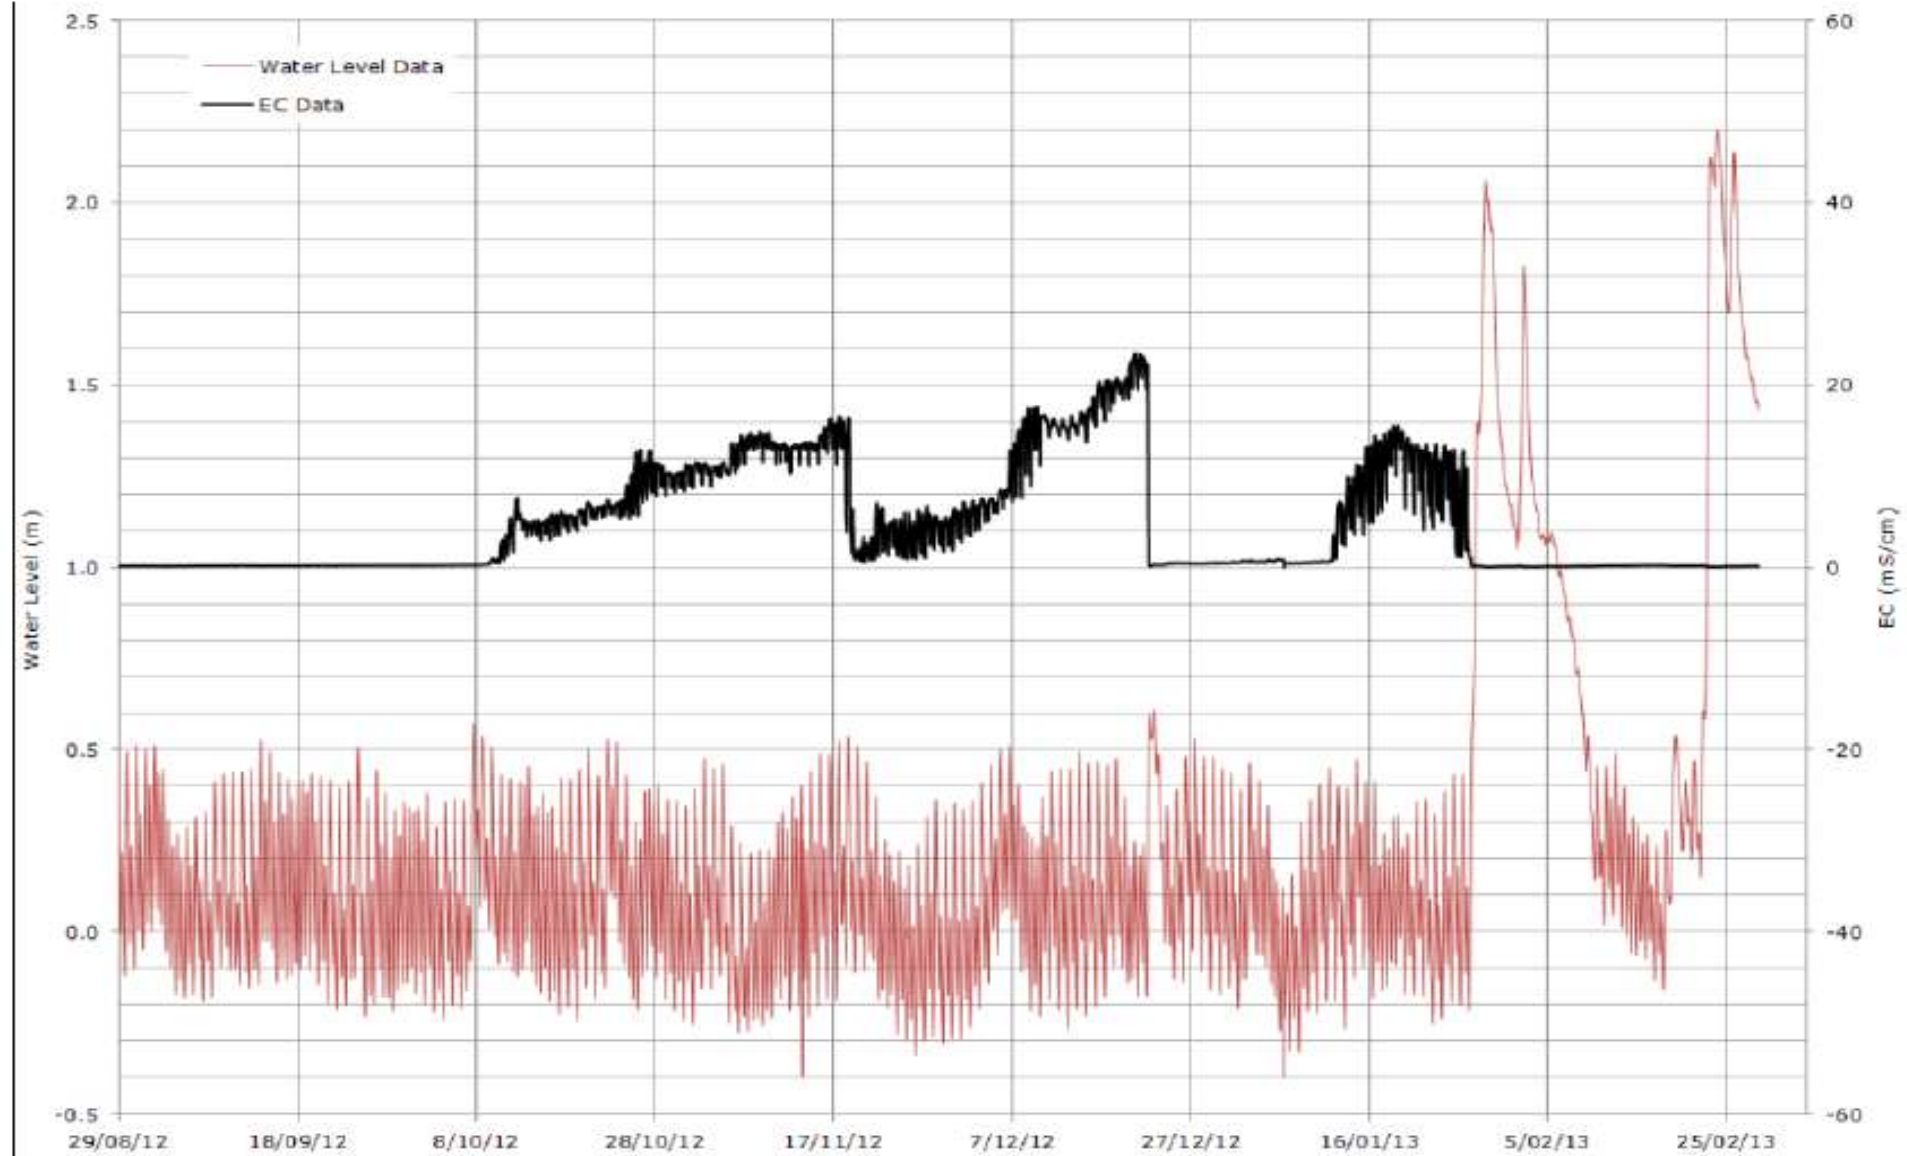
Upper Pipeclay Canal Logger

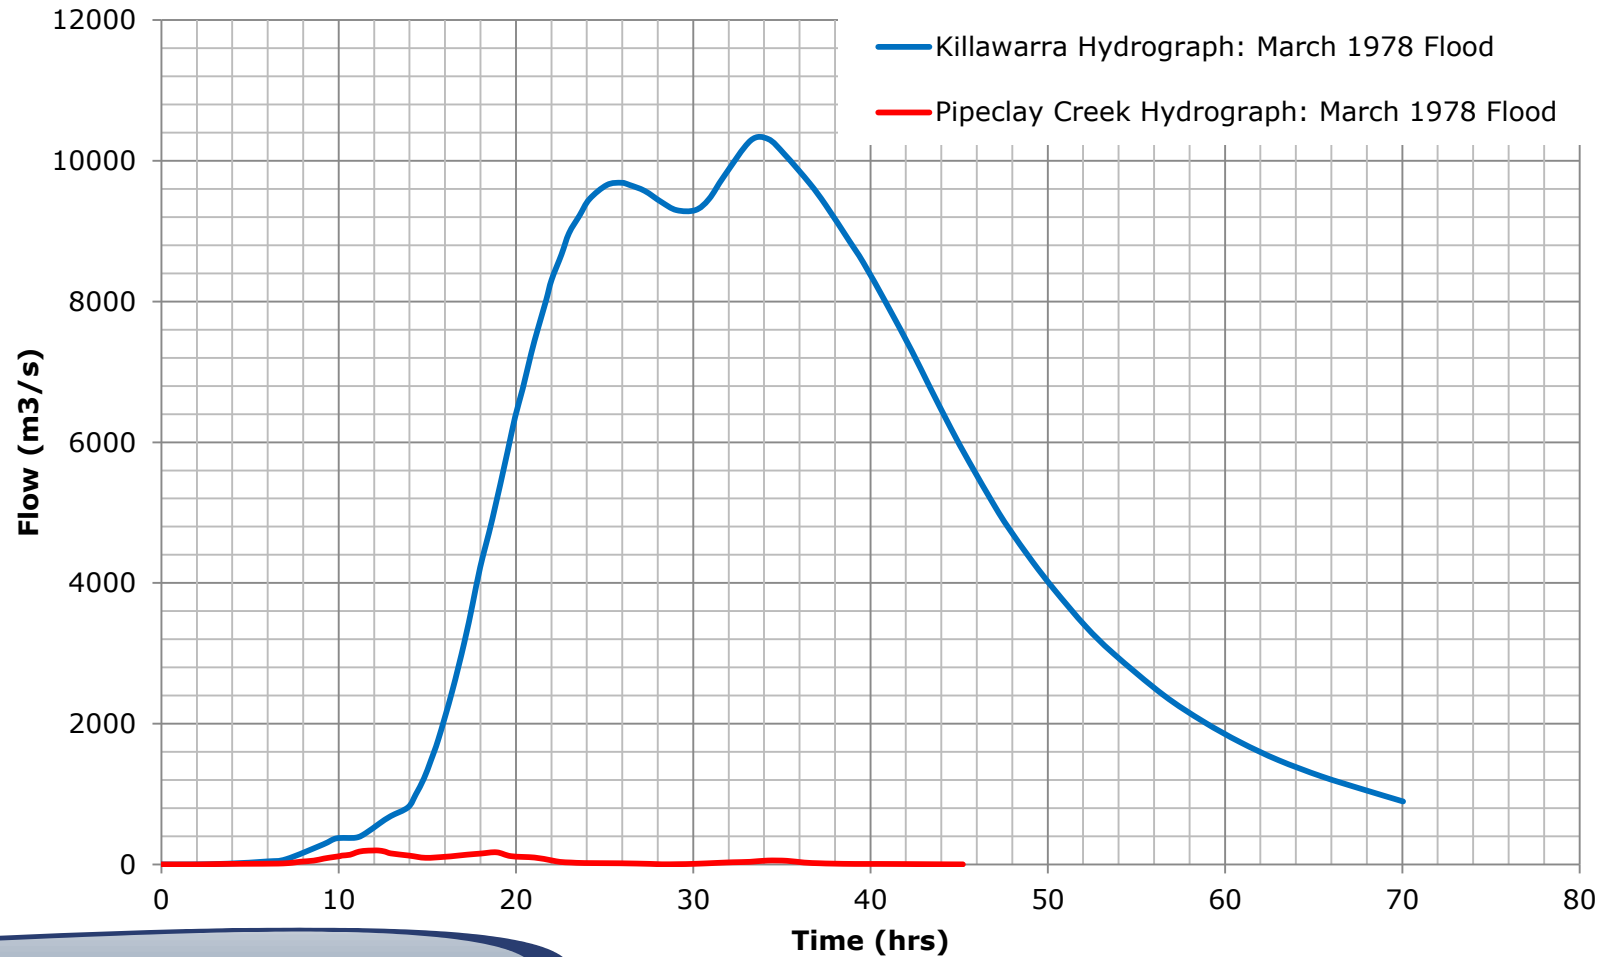
Flood Event: March 1978 (1.3% AEP)

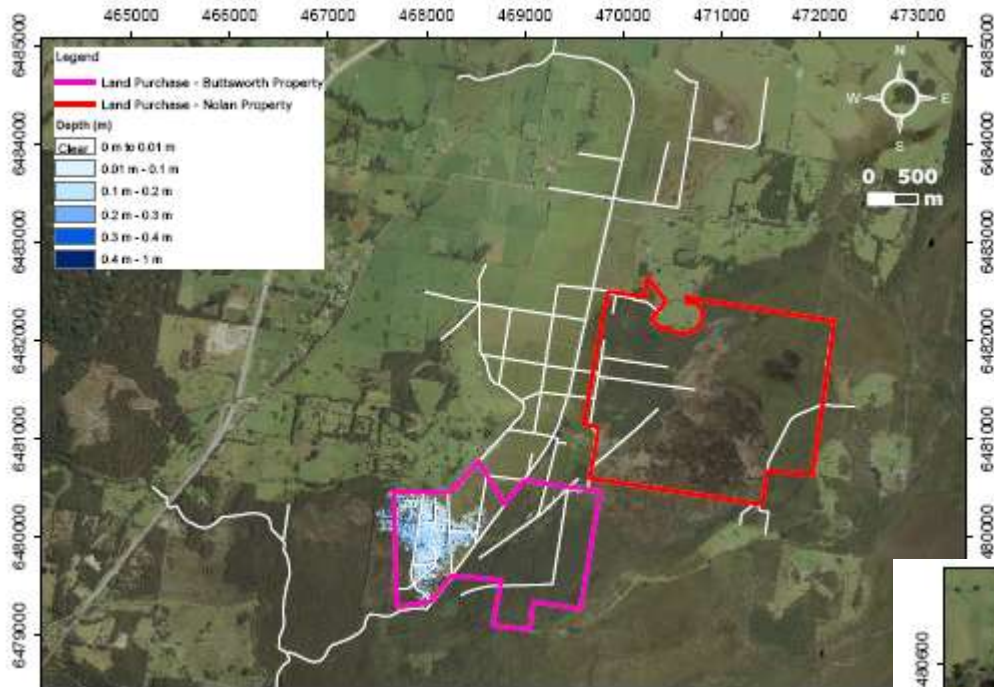
Scenario: No Floodgates
