THE BIGHT CEMETERY, THE BIGHT

Conservation Management Plan

Prepared by
Umwelt (Australia) Pty Limited
on behalf of
MidCoast Council

Project Director: **Tim Adams**
Project Manager: **Karyn Virgin**
Report No. **20100/R01**
Date: **May 2021**

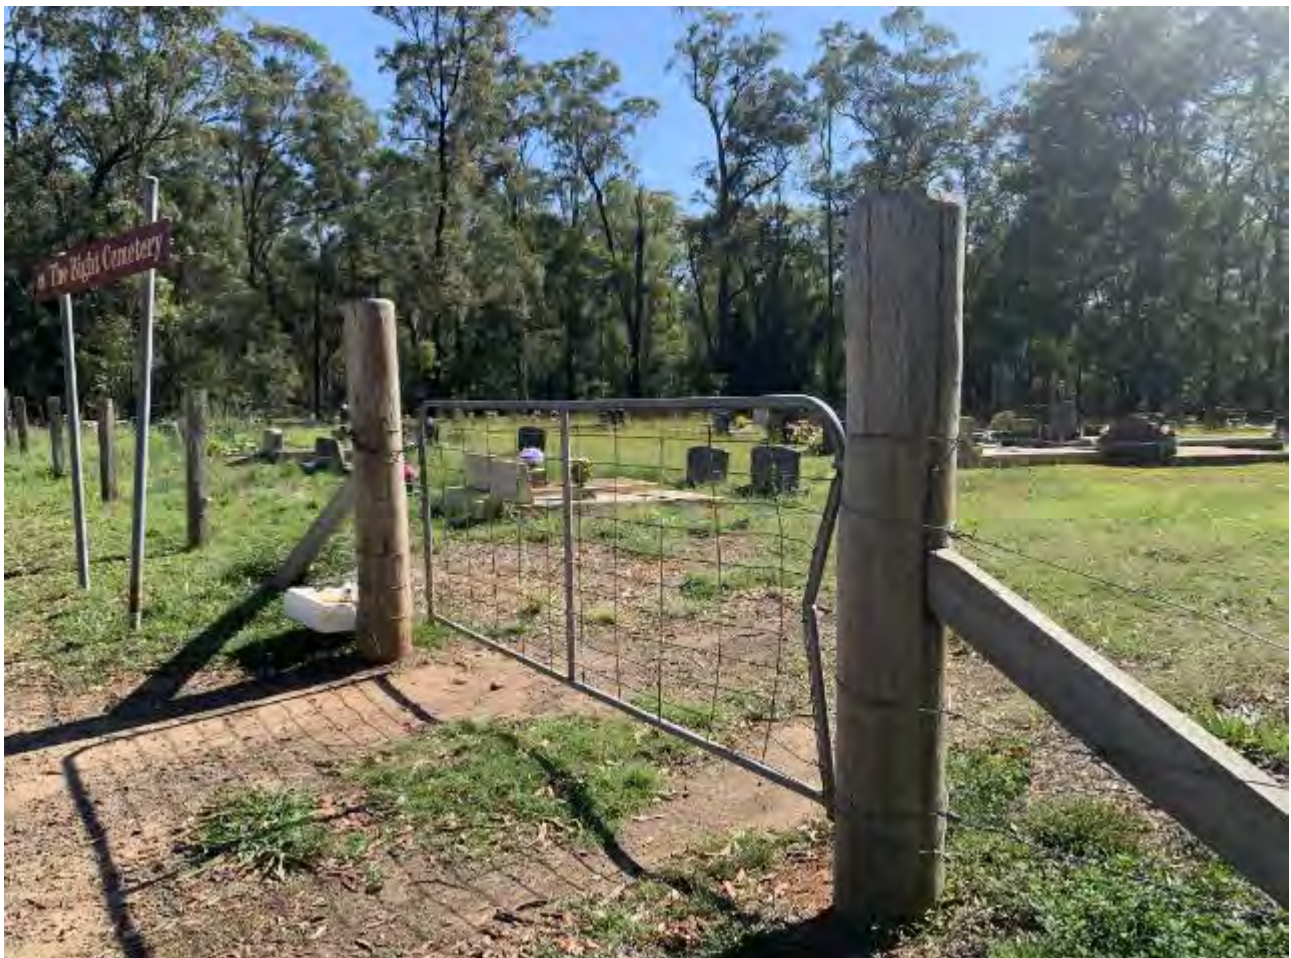
Plate 4.4 View of the front (western) boundary fence of the Cemetery, showing the central stock gate for pedestrian and vehicle access

Signage is also visible

All visible fencing is of a simple post and wire construction, utilising a mixture of timber and star pickets as posts. There is a stock gate for both pedestrian and vehicle access to the centre of the front boundary fence. There is also a metal boom-style gate to the northwestern corner of the 'active portion' of the Cemetery.

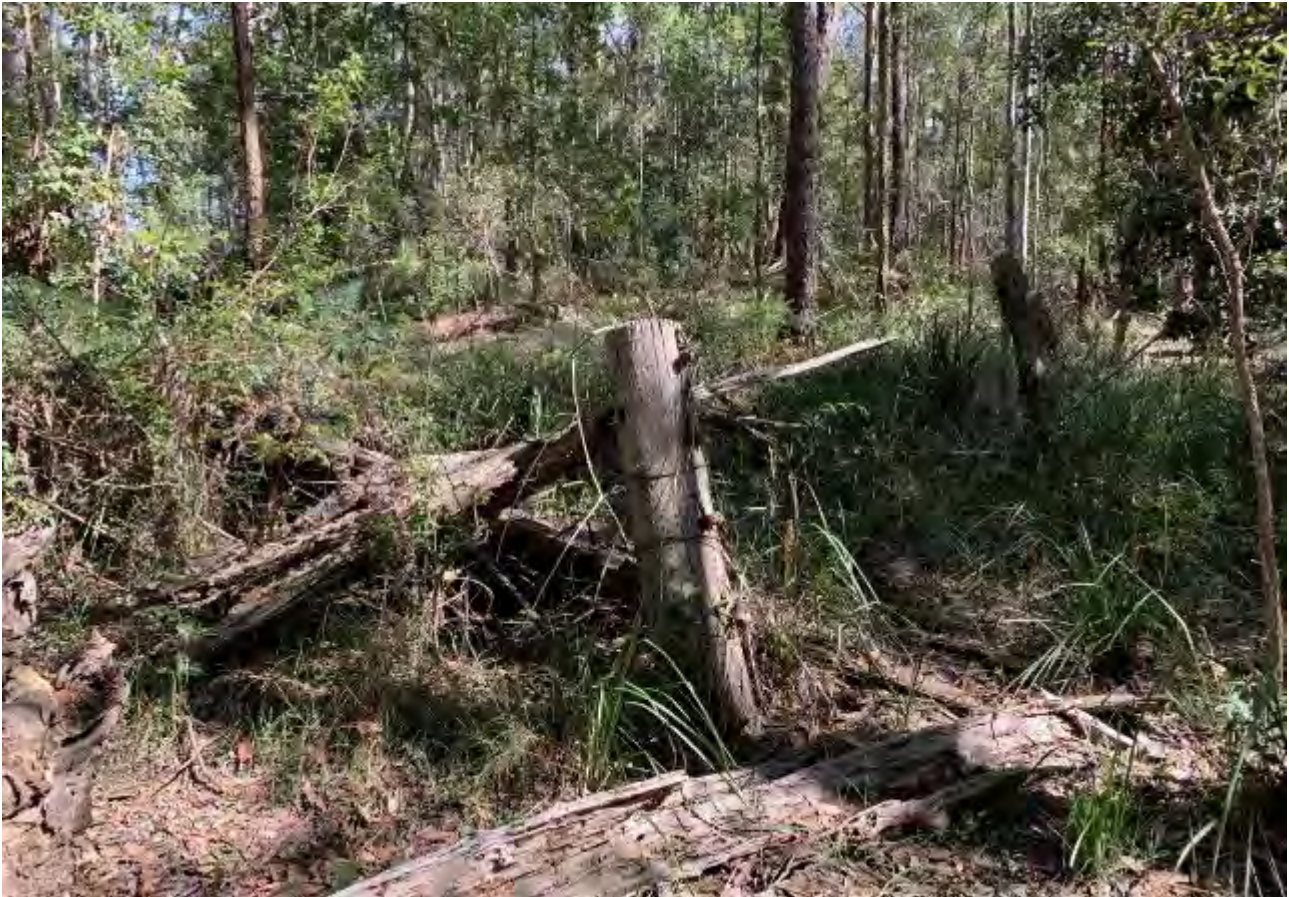
Plate 4.5 View of the southeast corner of remnant boundary fencing, showing the *in situ* corner post

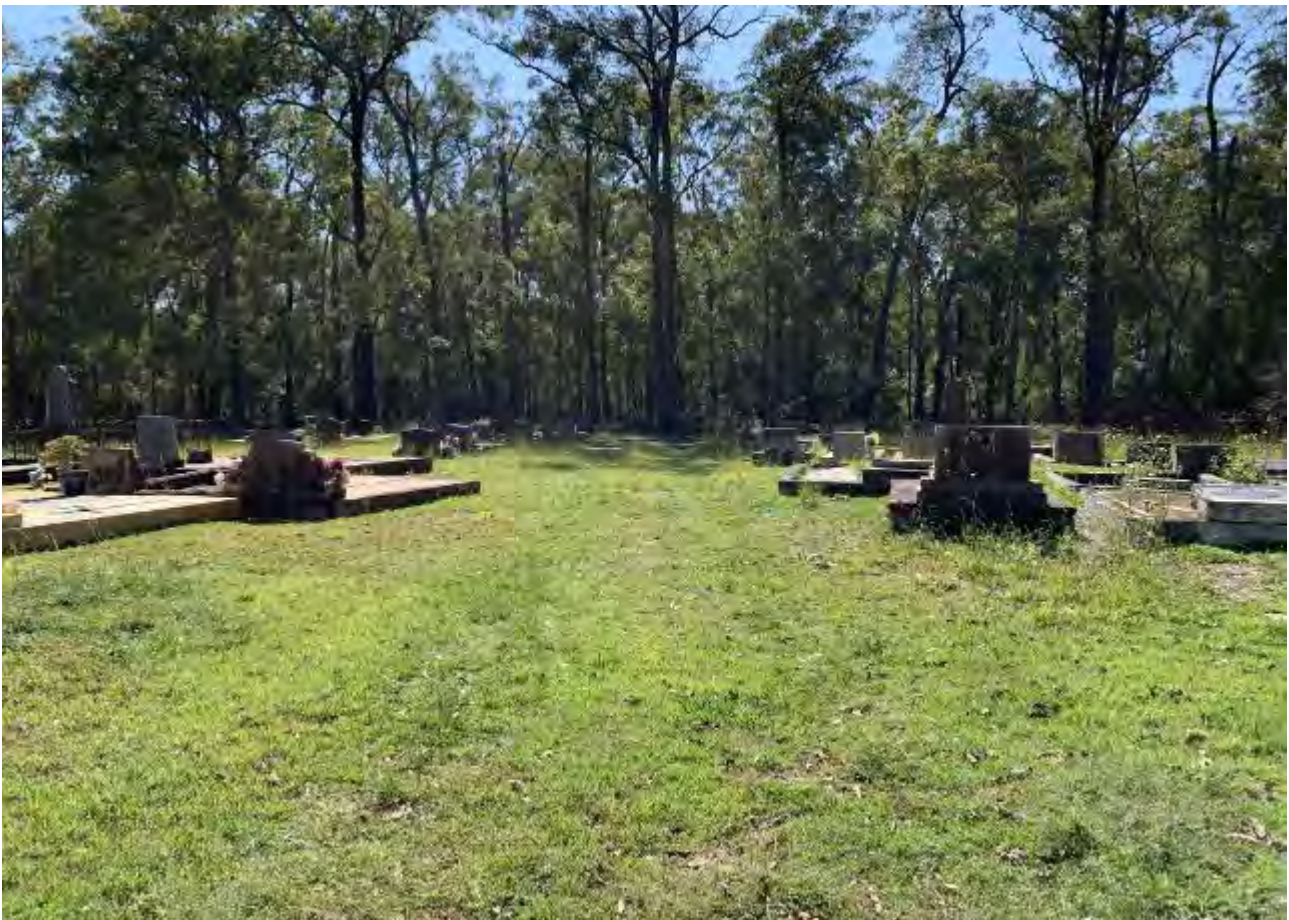
Plate 4.7 View of the informal east-west access track through the centre of the ‘active portion’ of the Cemetery, facing east

As noted above, a stock gate located to the front (western) fence line of the Cemetery provides both pedestrian and vehicle access. The gate is located roughly in the centre of the front fence line, in relation to the ‘active portion’ of the Cemetery. An informal and unsealed (dirt) vehicle track extends from this gate to the east, where it meets a perpendicular track that runs in a north-south orientation in proximity to the eastern (rear) extent of the ‘active portion’ of the Cemetery. A gently curved track (also informal and unsealed) is also located in proximity to the northern extent of the ‘active portion’ of the Cemetery. The layout of the ‘active portion’ of the Cemetery, including these tracks, is shown in **Figure 4.1** for reference.

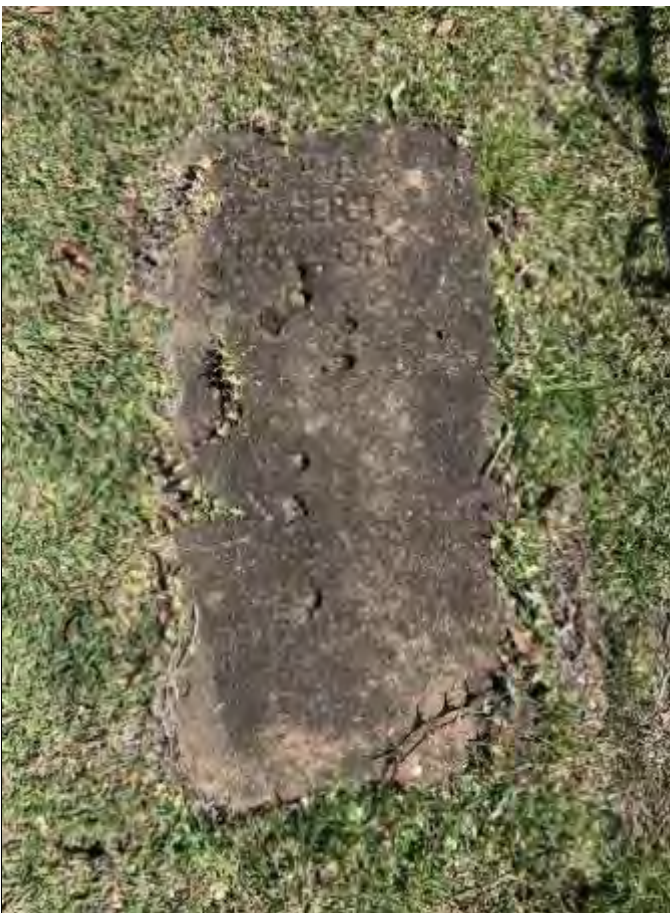
Plate 4.13 Ledger grave marker (Sydney Robert Taylor), 1879 (ID144)

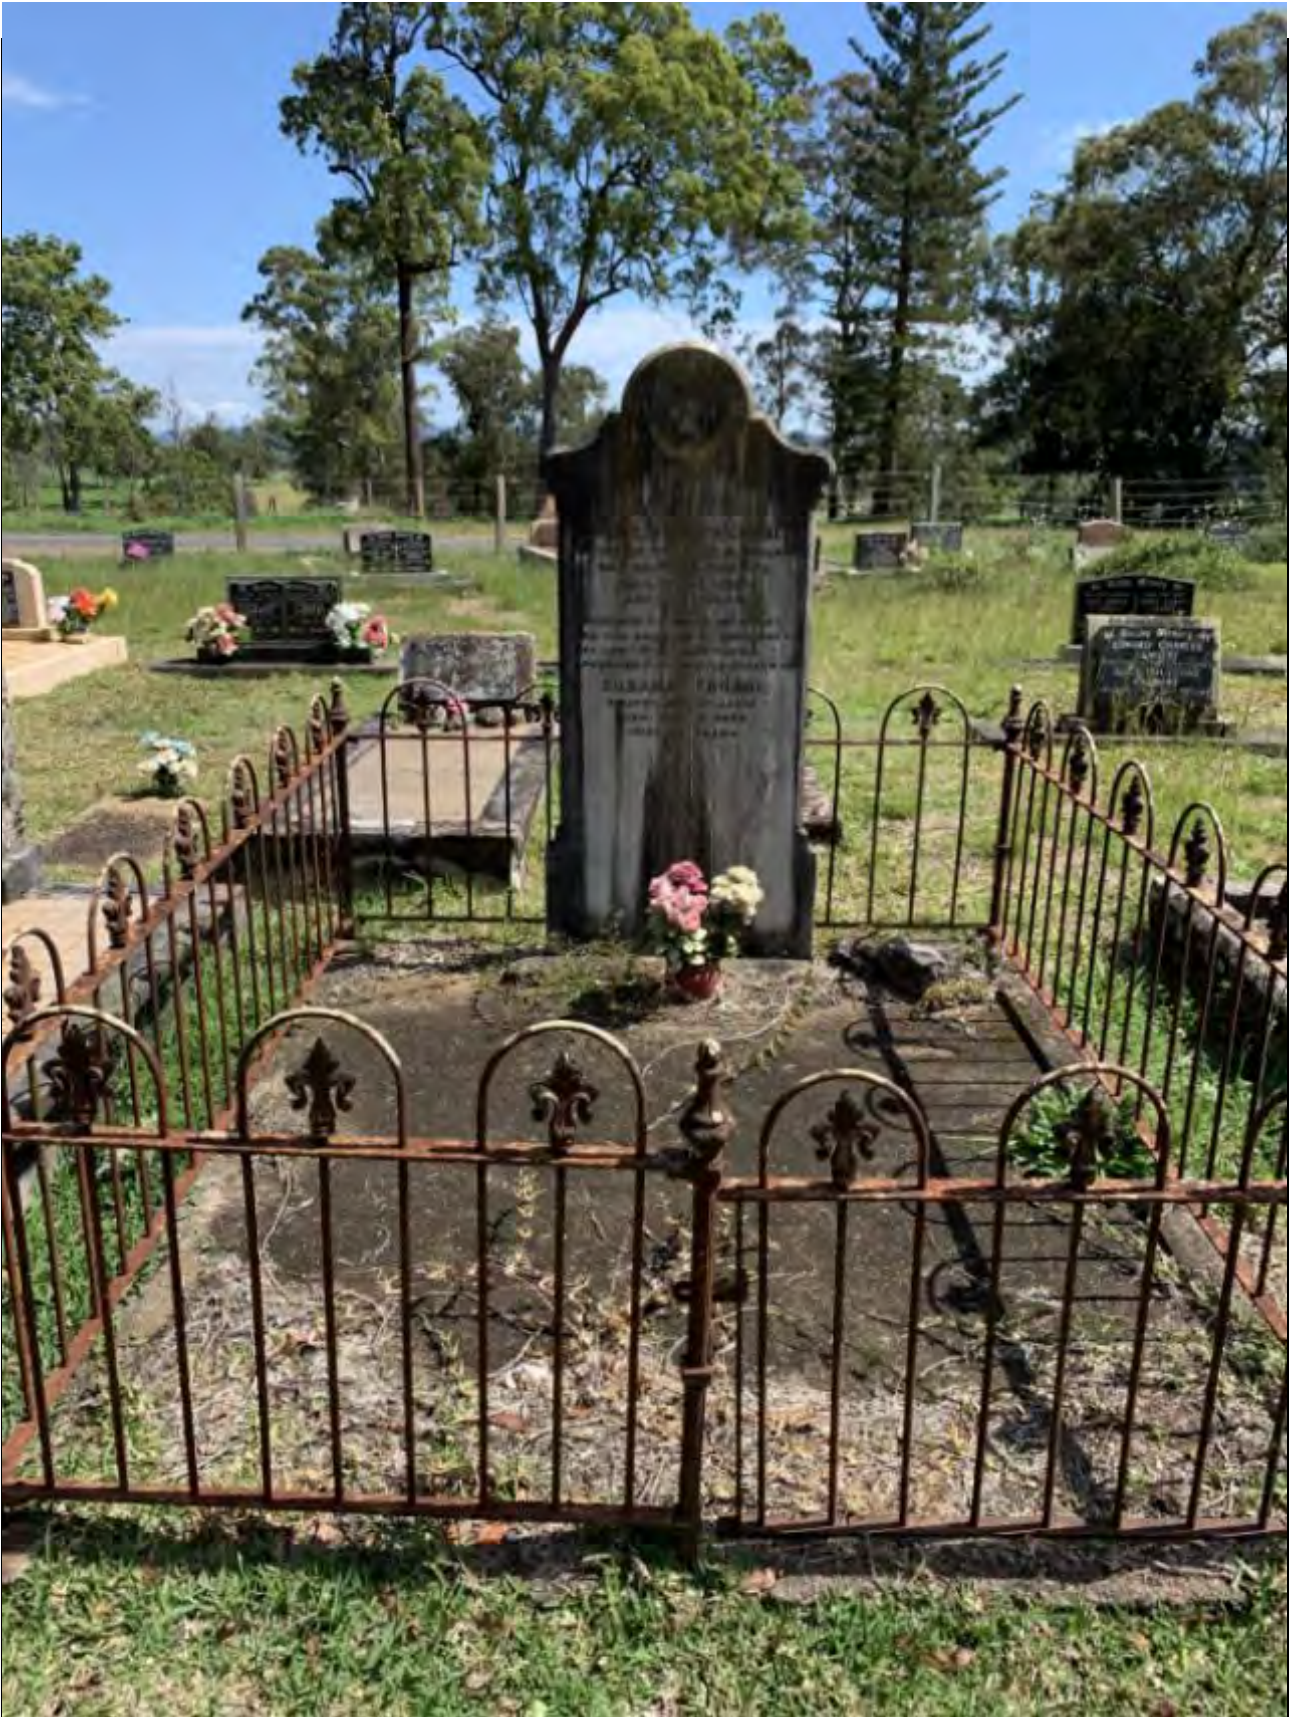
Plate 4.14 Marble stela grave marker (William and Susana Froude) with a low-set tomb surrounded by a cast-iron surround (ID120)

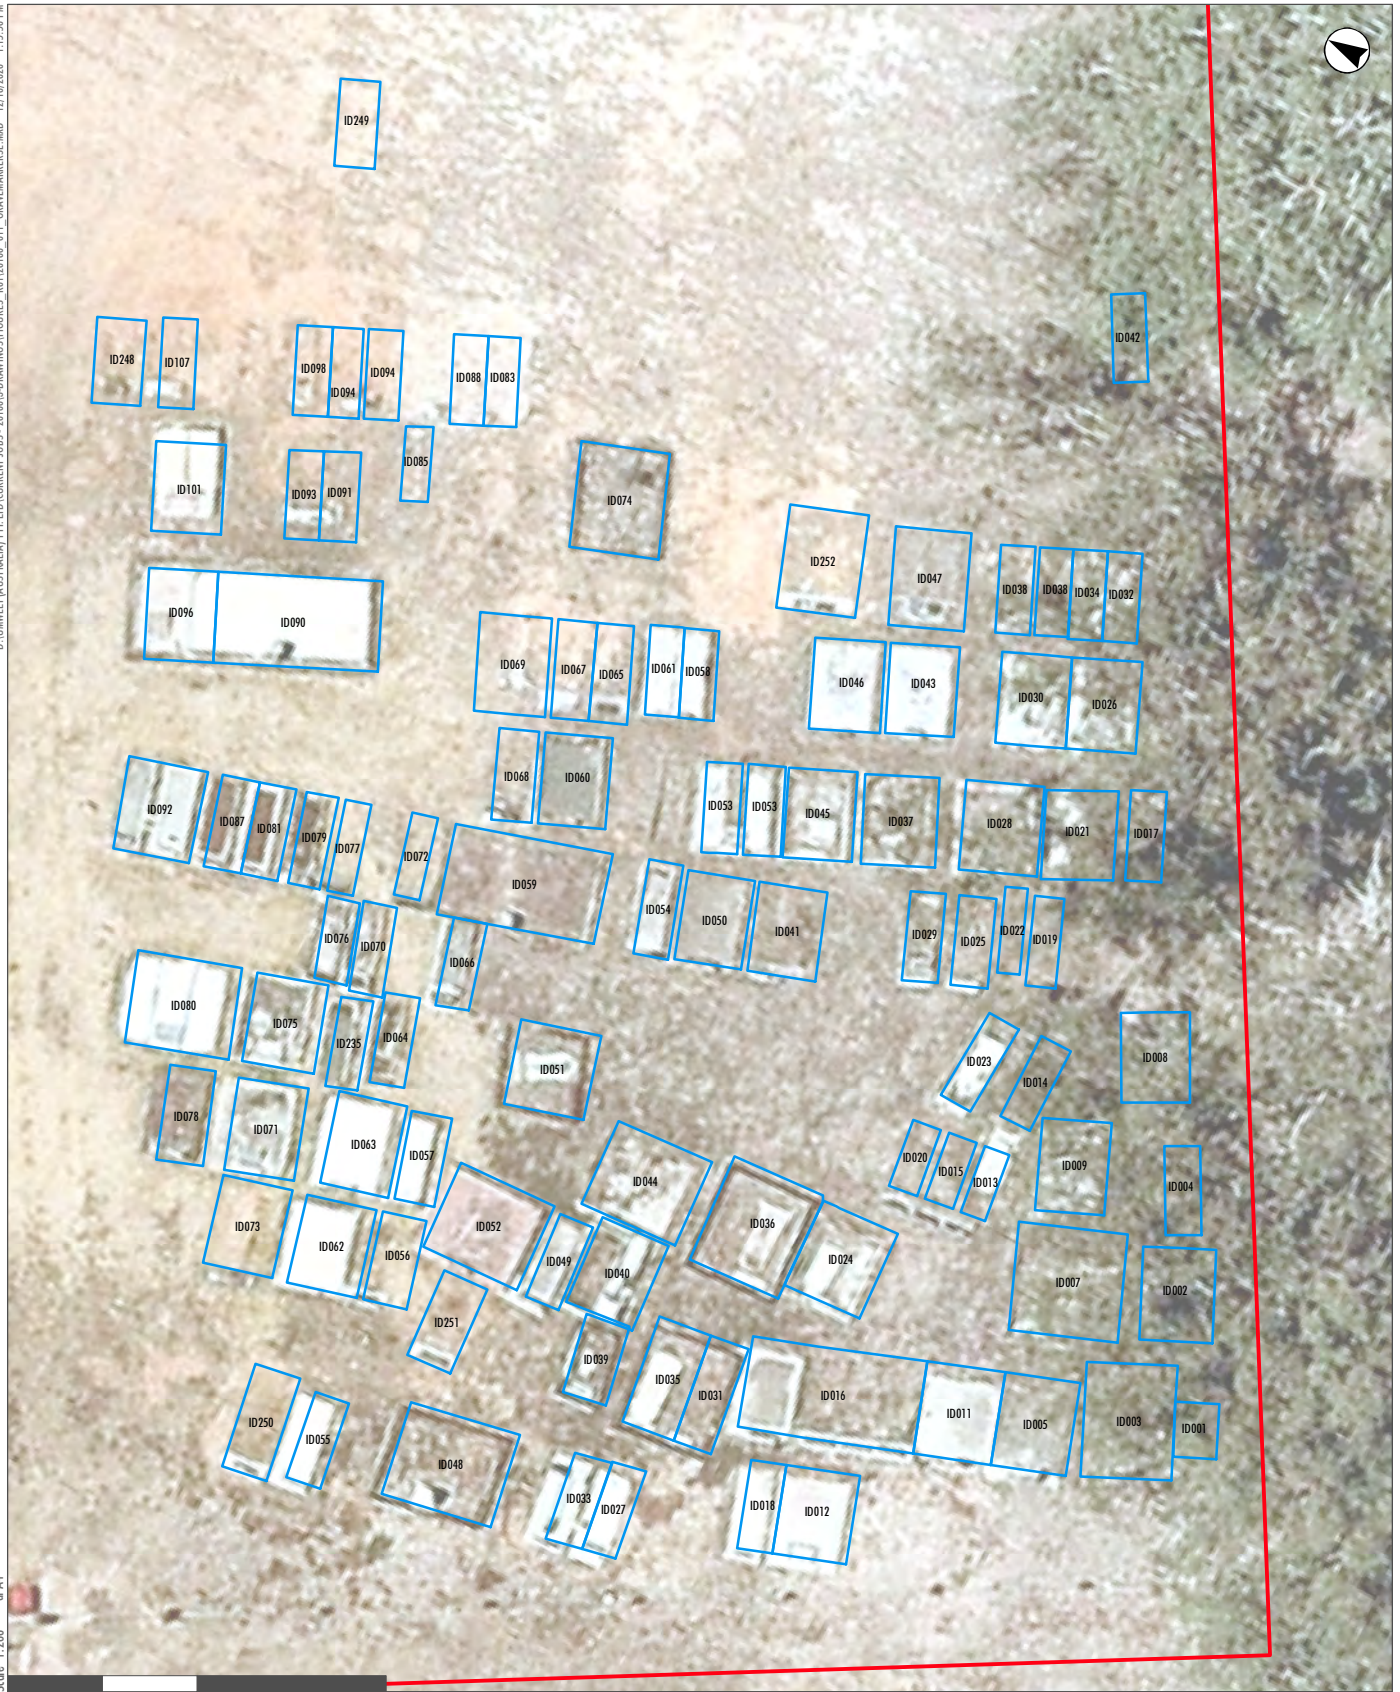
FIGURE 4.2B
Grave Markers within The Bight Cemetery

All of the graves are generally oriented to the east, noting that the placement of graves is not entirely consistent, as demonstrated in **Figure 4.2**. Graves are generally arranged in denominational sections, and older graves are more concentrated in the south-west corner of the Cemetery (which is shown on a 1916 Parish Map to have been originally demarcated as the Presbyterian section, refer to **Section 4.6**). Grave markers present at the Cemetery span 1863 to the present day.

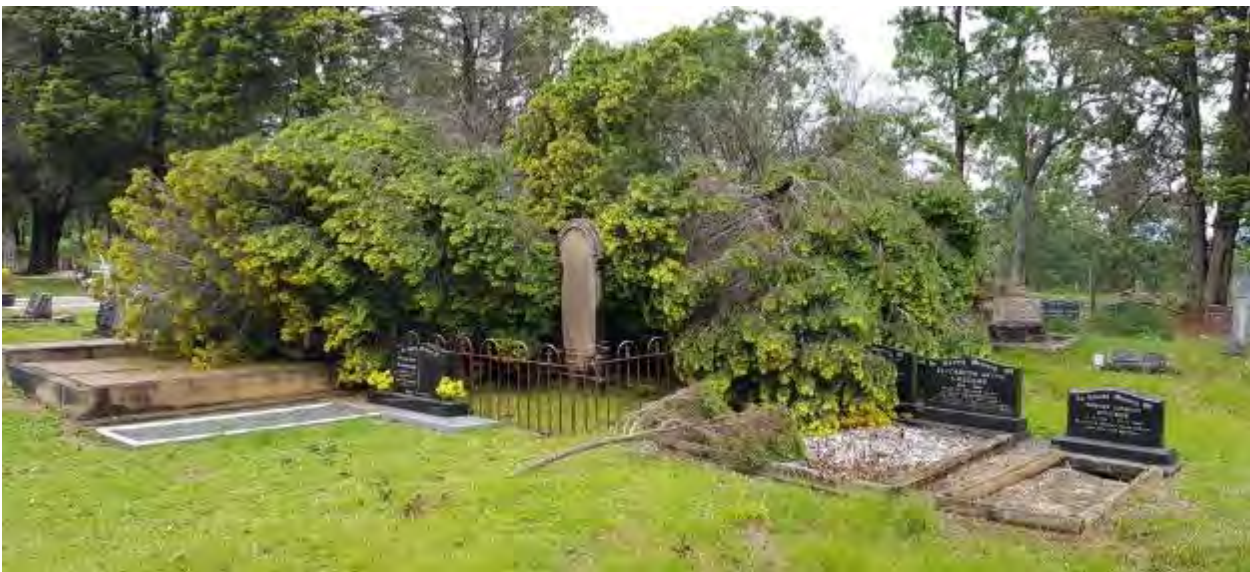
Plate 4.15 View of fallen Golden cypress trees in December 2018

Until 2018, the front (western) fenceline of the Cemetery, which fronts Tinonee Road, was marked by a row of Golden cypress trees (*Cupressus macrocarpa*). In December 2018, two of these trees were impacted by a severe storm. The two trees were blown over and into the Cemetery, with their fall causing damage to several graves. Following this and to avoid further impacts of this nature, the remaining Golden cypress trees were removed from the front boundary of the Cemetery; an arborist report undertaken at the time showed that structural failures were evident even those trees that remained standing after the storm (MCC pers. comm.). Following the removal of the row of trees, MidCoast Council committed to planting a new row of trees more suited to the conditions as part of a wider beautification program.⁴ These planting works have not yet been undertaken, but are scheduled to occur following the repair of damaged grave markers.

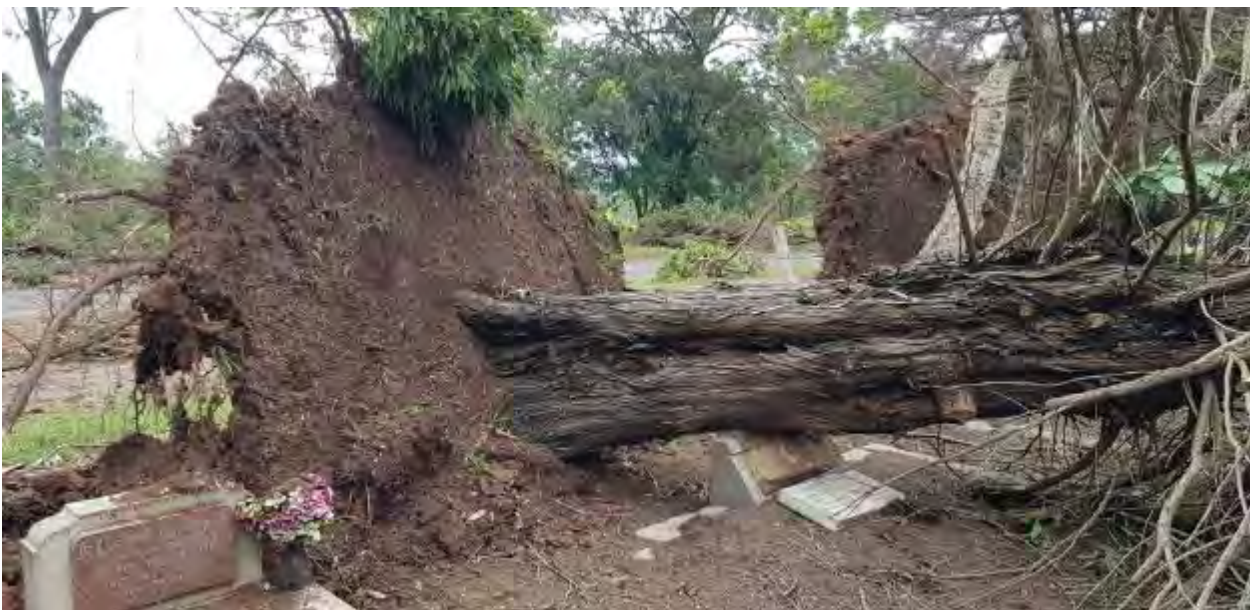
Plate 4.16 Detailed view of damage to grave markers as a result of fallen trees, December 2018

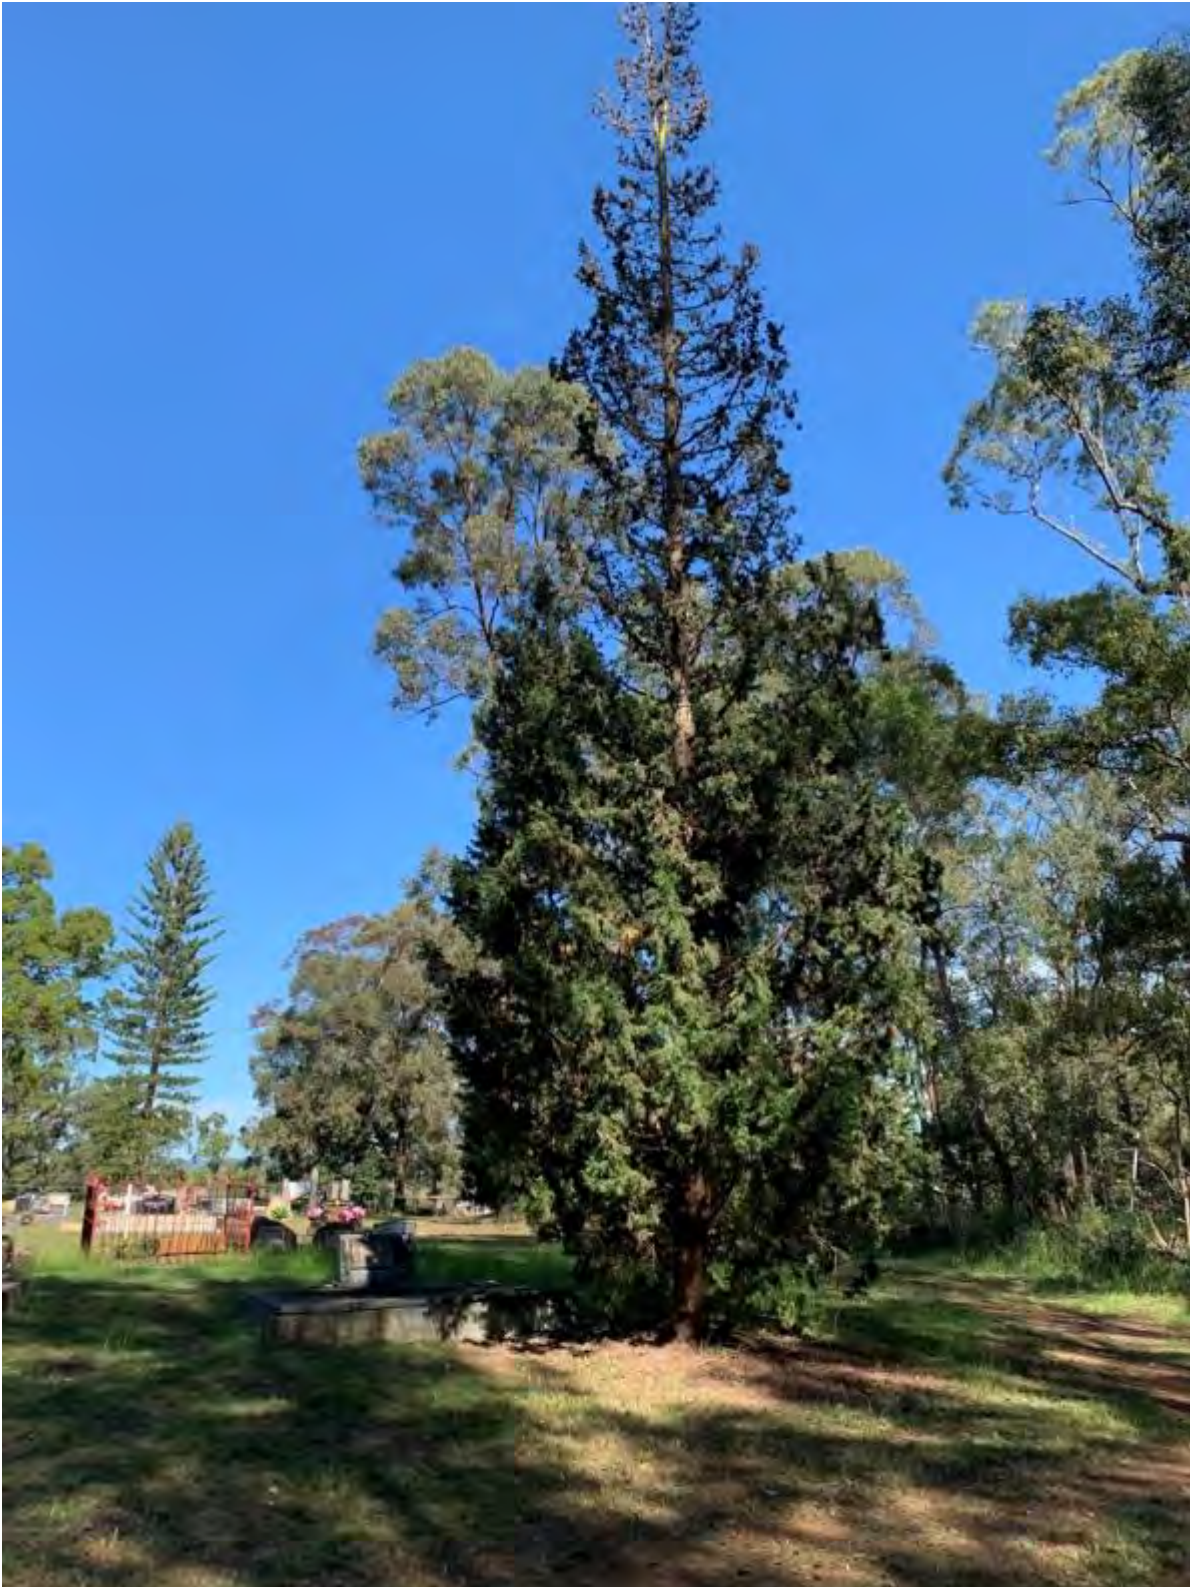
Within the remainder of the Cemetery, there is only one planting that appears to be deliberate/cultural. This is a single Radiata pine tree planted near the Poole family grave (ID244). This tree is shown below for reference. The tree is causing damage to the grave enclosure, as the roots of the tree are lifting the northeastern corner of the enclosure.

Plate 4.17 Radiata pine tree planted in immediate proximity to the Poole family grave (ID244)

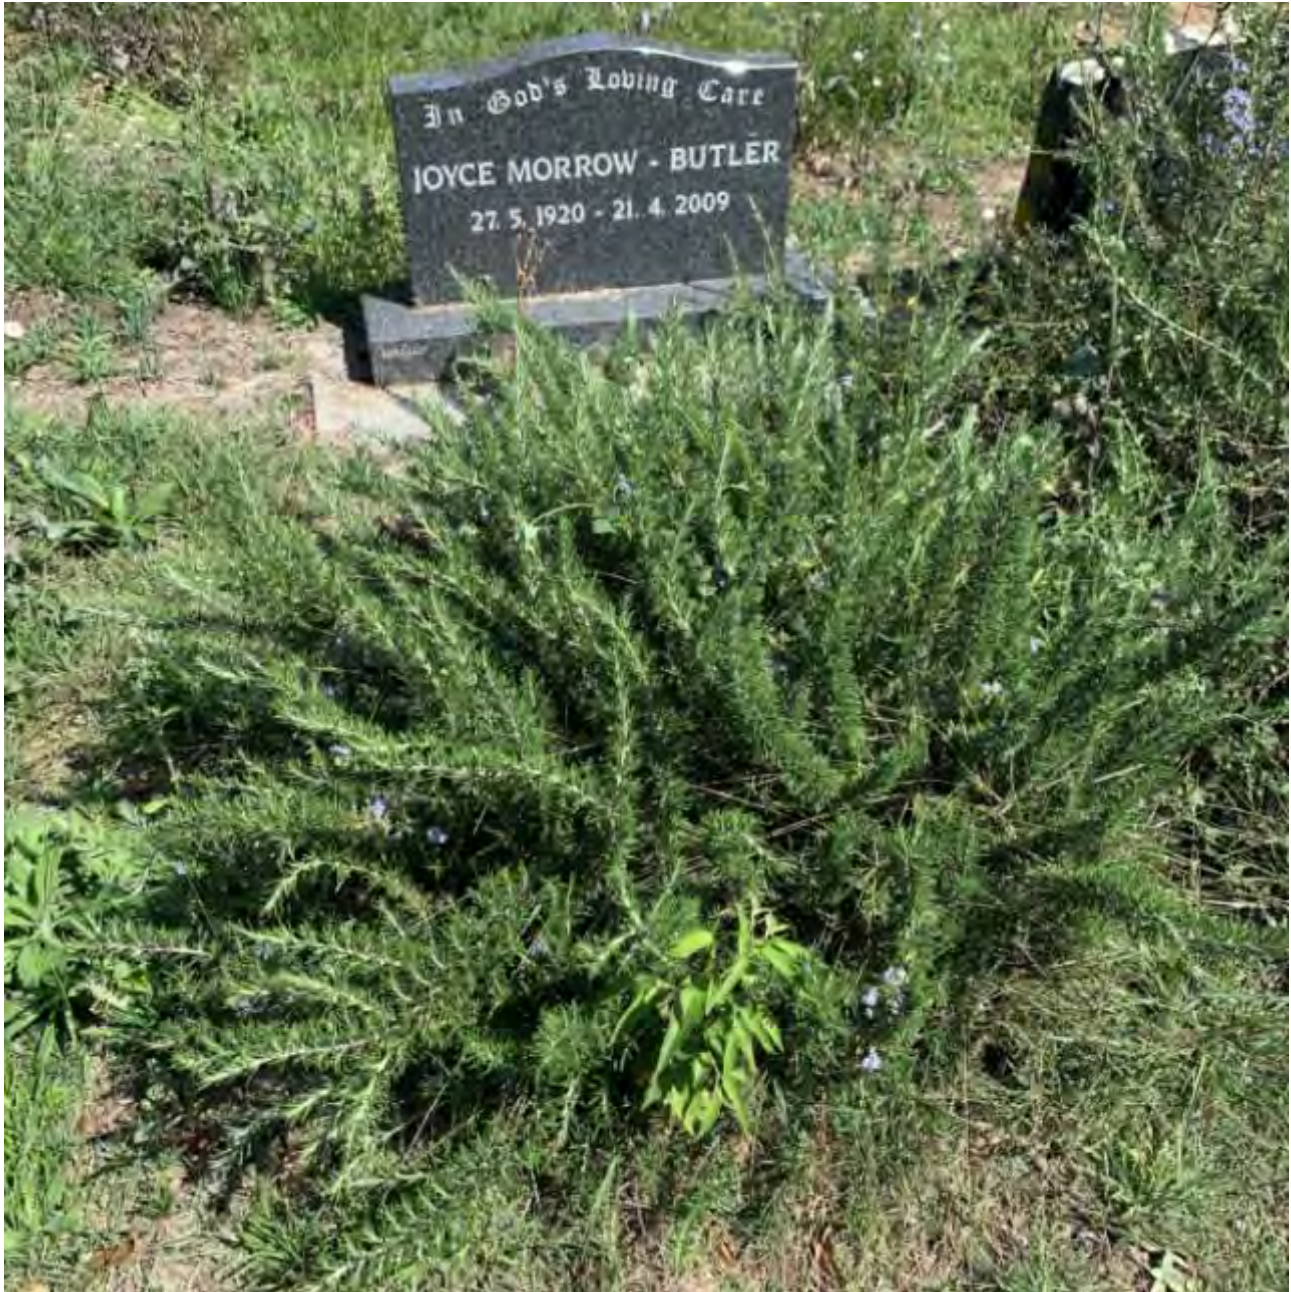
A number of graves also feature plantings within the footprint of the grave. The 2009 National Trust guideline identifies these kinds of plantings as ‘controlled overgrowth’, rather than deliberate cultural planting associated with the wider Cemetery (**Plate 4.18**). It is generally recommended that controlled overgrowth be maintained, as it contributes to the character of the place. Weeds, by contrast, are generally recommended for management/removal (**Plate 4.19**).

Plate 4.18 Controlled overgrowth within The Bight Cemetery associated with grave of Joyce Morrow Butler (ID146)

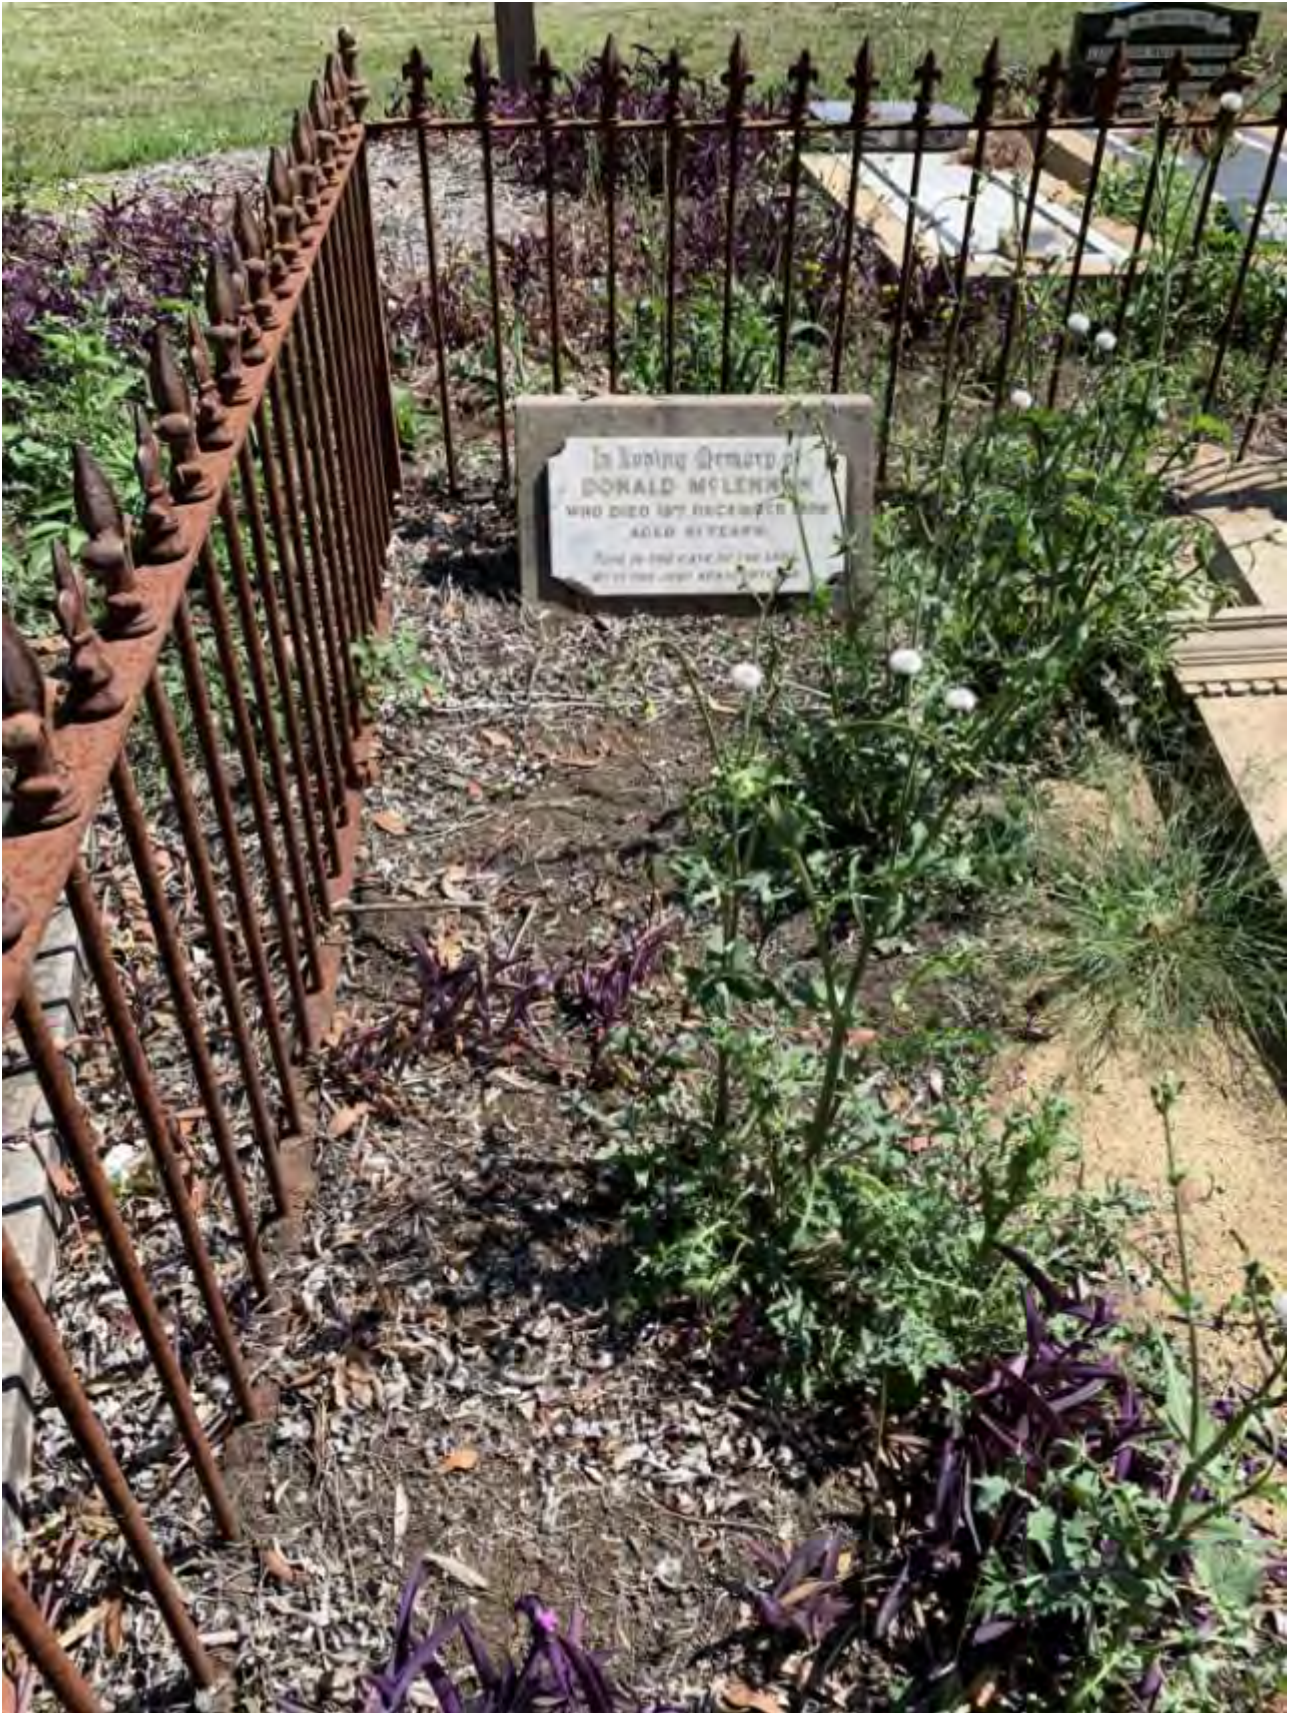
Plate 4.19 Weeds evident in association with a grave site (Donald McLennan) at The Bight Cemetery (ID031)

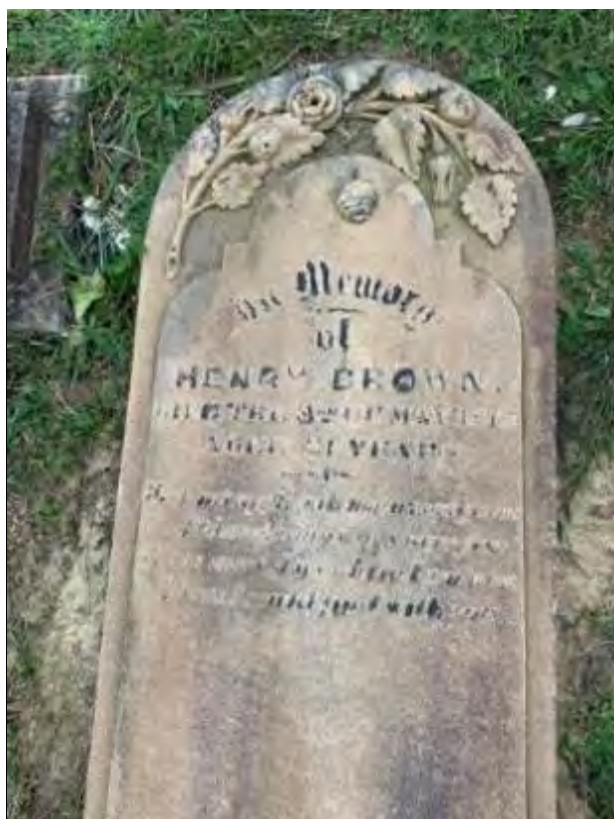
Plate 5.10 Example of a hand carved sandstone grave marker, marking the grave Henry Brown and dated 1867

The grave markers at The Bight Cemetery span over 150 years, with interments continuing today. As expected, there is a large variety in designs, trends and materials used in the grave markers. The older graves are predominantly sandstone or marble with hand carved designs and lead lettering, while the more recent headstones tend to be granite with machined designs. This is evidenced in the photographs below (refer also to **Section 4.4**).

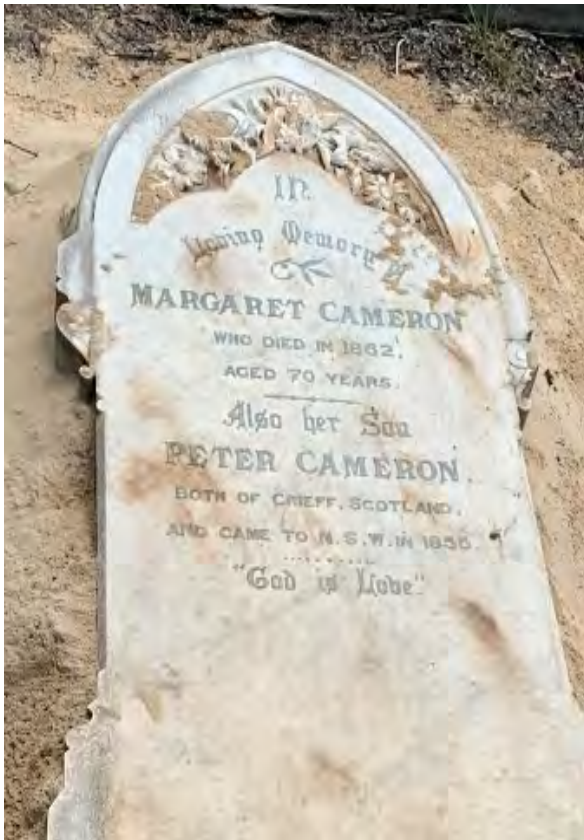
Plate 5.11 Example of a marble headstone with lead lettering, marking the grave of Margaret Cameron and her son, dated 1862

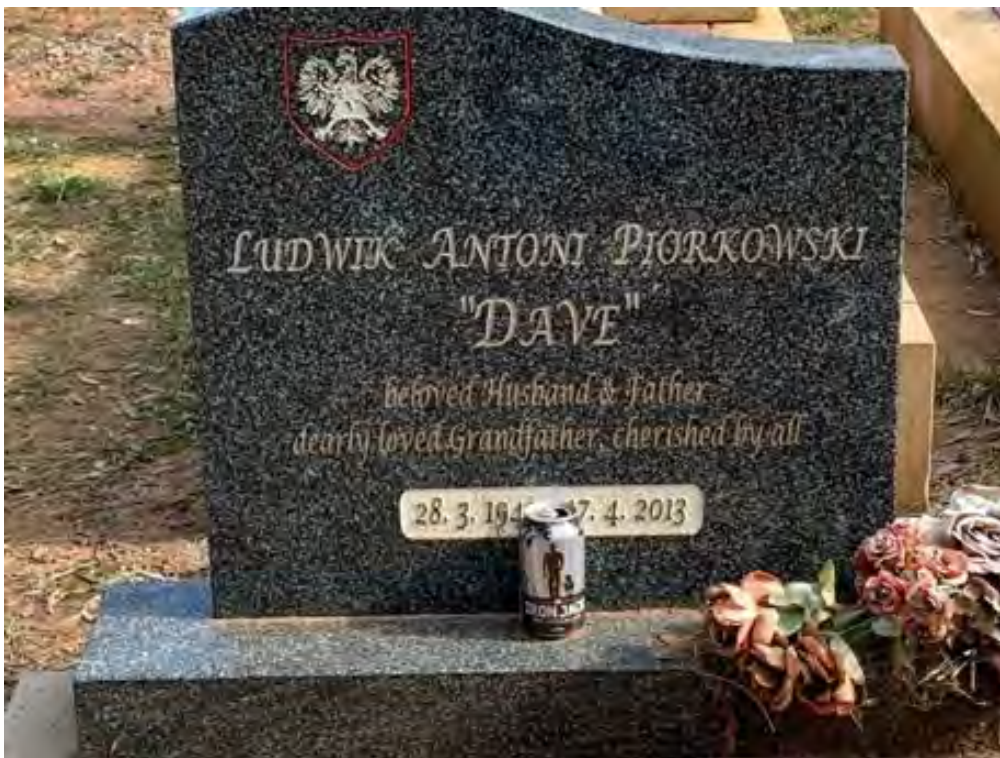
Plate 5.12 Example of a machined granite grave marker, marking the grave of Ludwik Antoni Piorkowski, and dated 2013

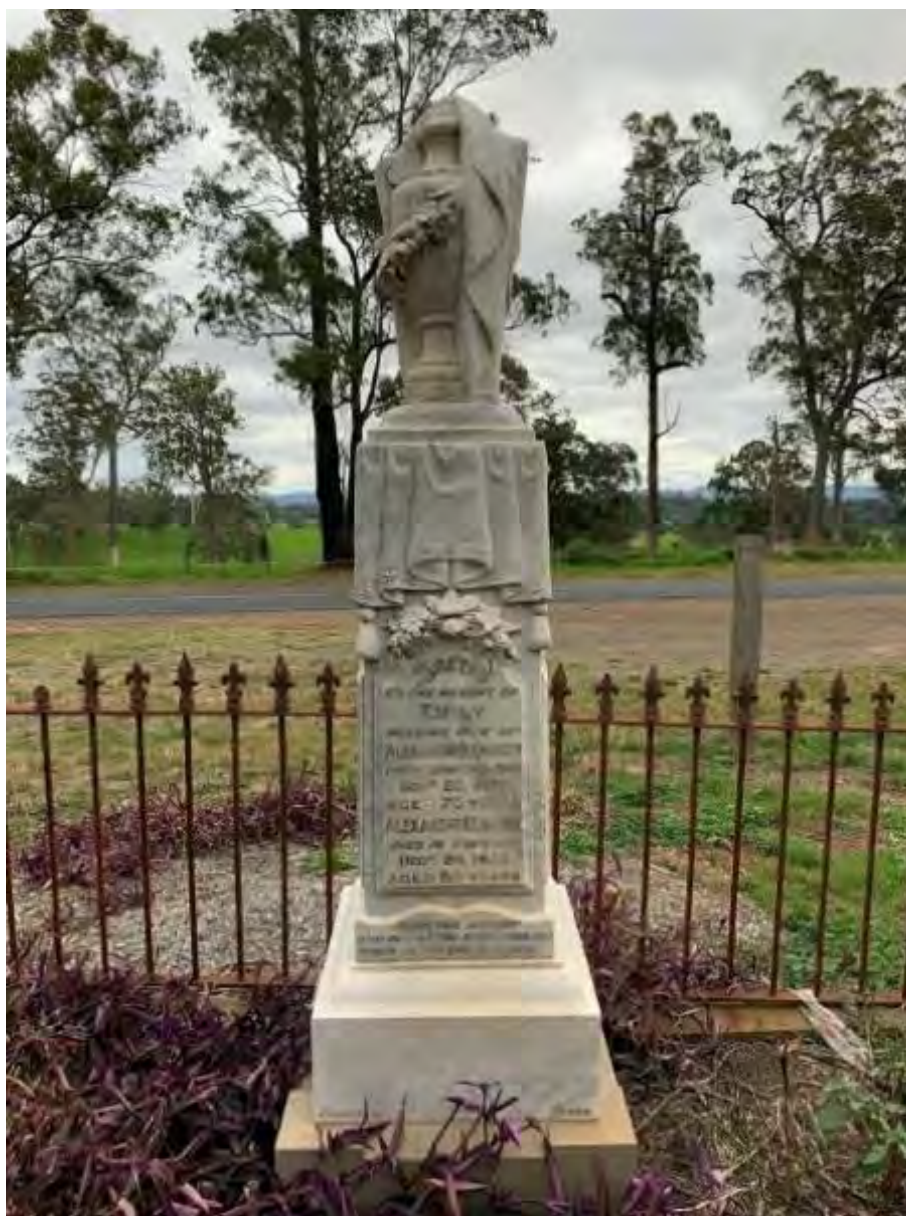
Plate 5.13 Example of the use of an urn in a grave marker at The Bight Cemetery

In Victorian times, the urn symbolised death and the returning of the body to ashes. Grave marker pictured is that of Alexander and Emily Kennedy, dated 1893

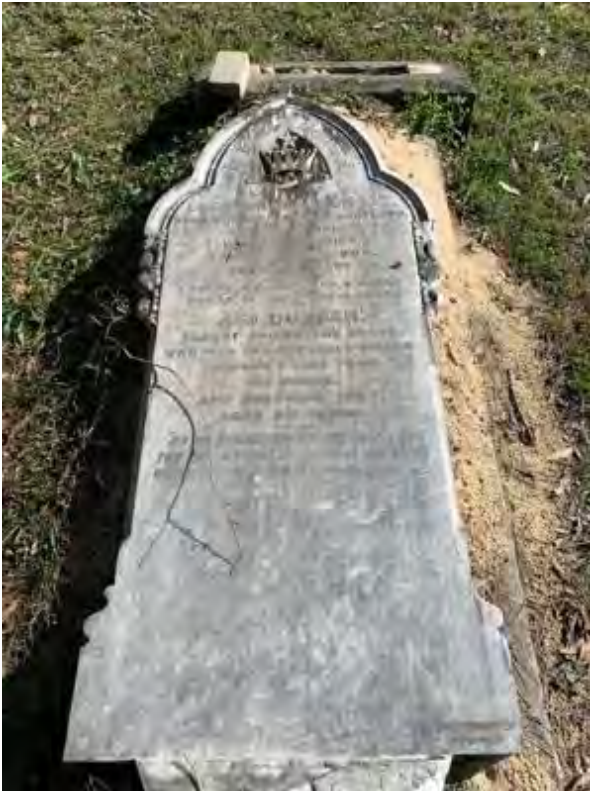
Plate 5.15 Grave marker of Lachlan (1892) and Duncan MacDonald (1863), crafted by Sydney monumental mason James Cunningham (ID023)

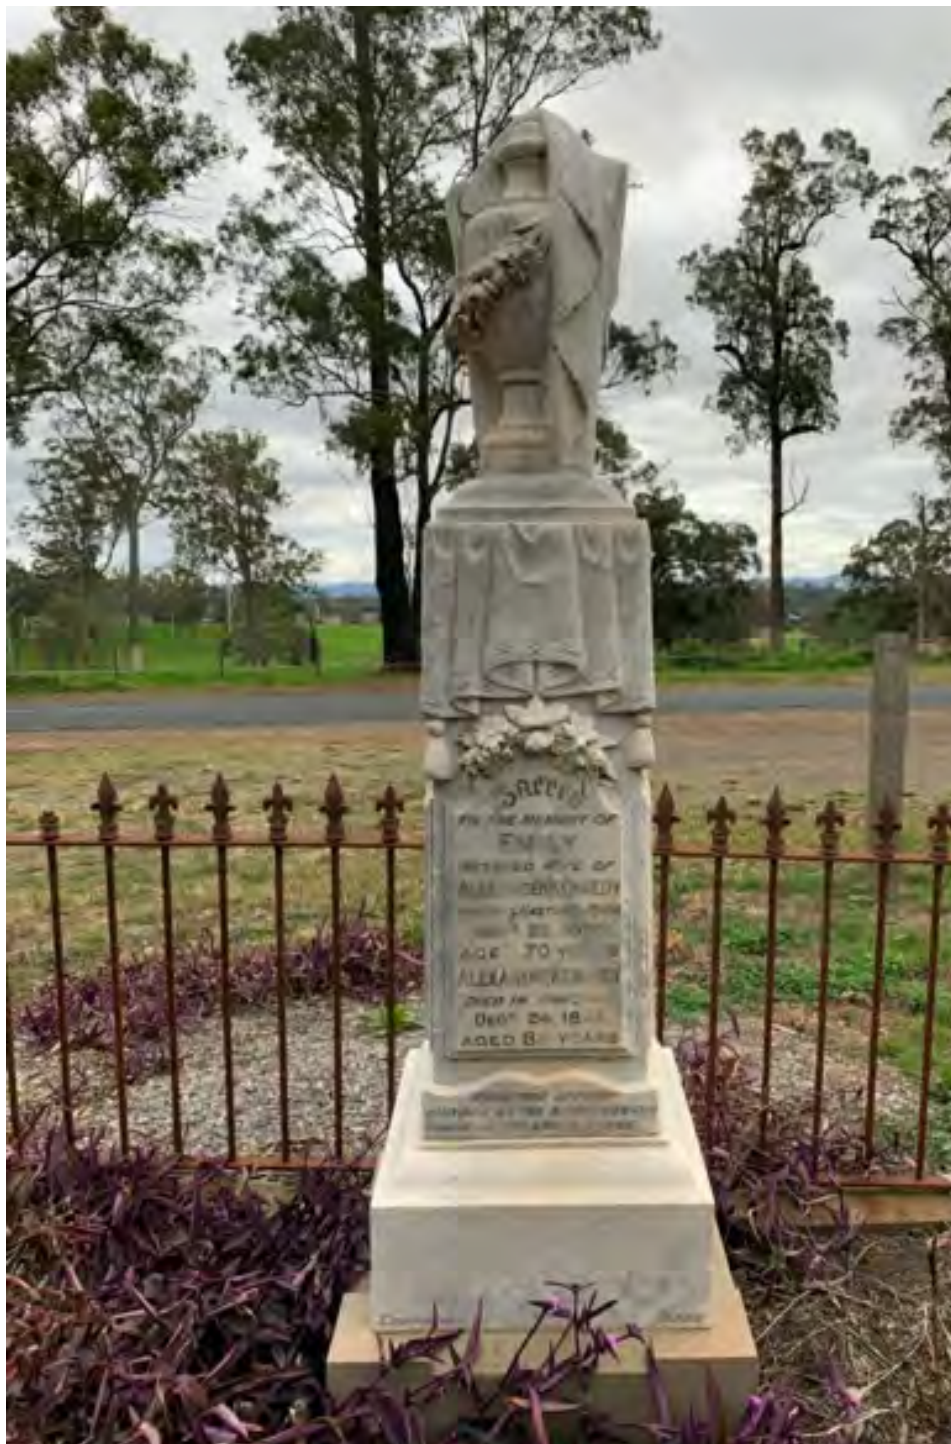
Plate 5.25 The grave marker of the Kennedy's and George Fowler (ID048)

Alexander and Emily Kennedy came to Australia as assisted immigrants from Scotland in 1848 and settled on the Hastings River.¹¹⁷ They passed away in 1893 and 1877, respectively. Their white marble grave marker featuring a draped urn is one of the more ornate at The Bight Cemetery.
