THE BIGHT CEMETERY, THE BIGHT

Conservation Management Plan

Prepared by
Umwelt (Australia) Pty Limited
on behalf of
MidCoast Council

Project Director: **Tim Adams**
Project Manager: **Karyn Virgin**
Report No. **20100/R01**
Date: **May 2021**

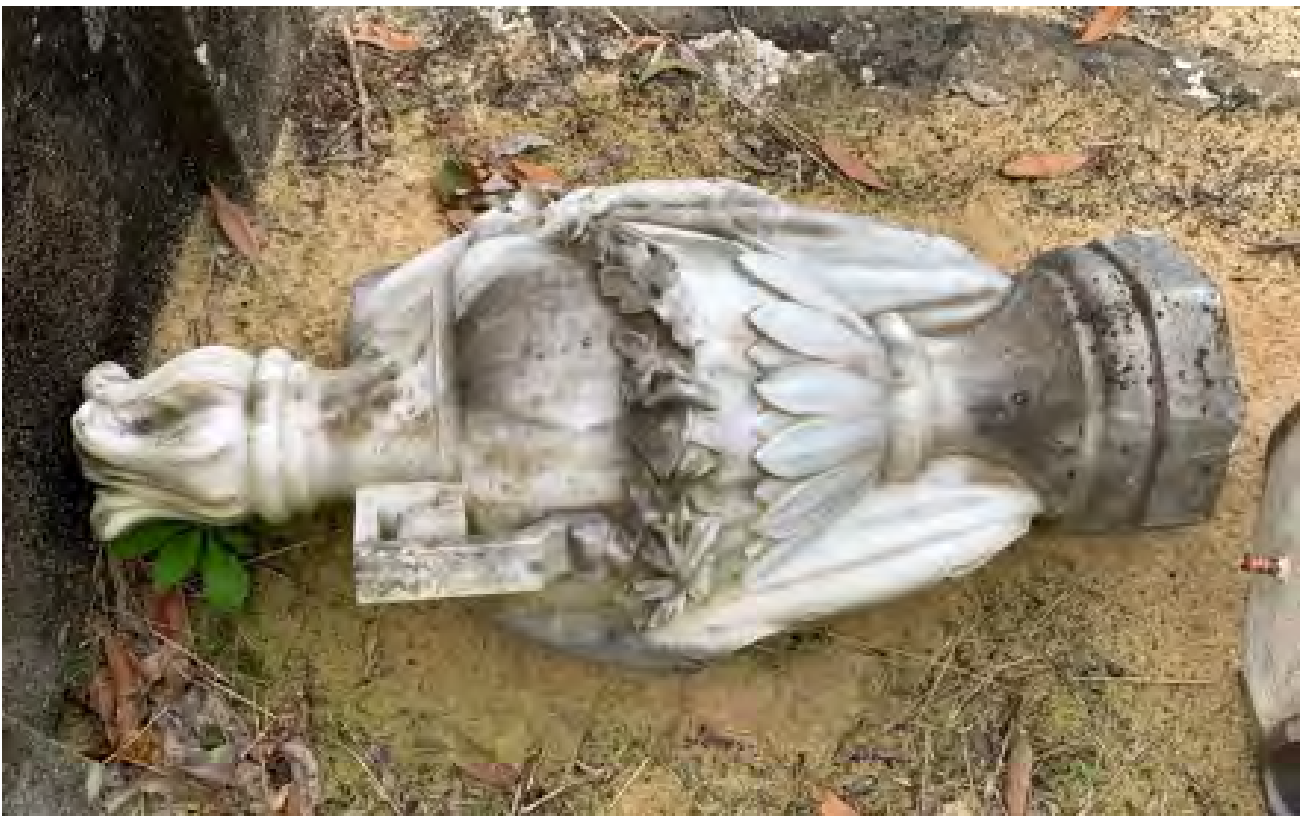
Plate 5.26 The marble urn that forms part of James Hodgins' grave marker (ID040)

James William Hodgins passed away at the age of 47 on 25 March 1907. James was in charge of the Nationally heritage listed Post and Telegraph Office at Wingham for 27 years. His funeral was one of the largest ever seen in Wingham.¹²³ His grave marker, pictured below, is ornate, featuring a marble draped urn atop a pedestal.

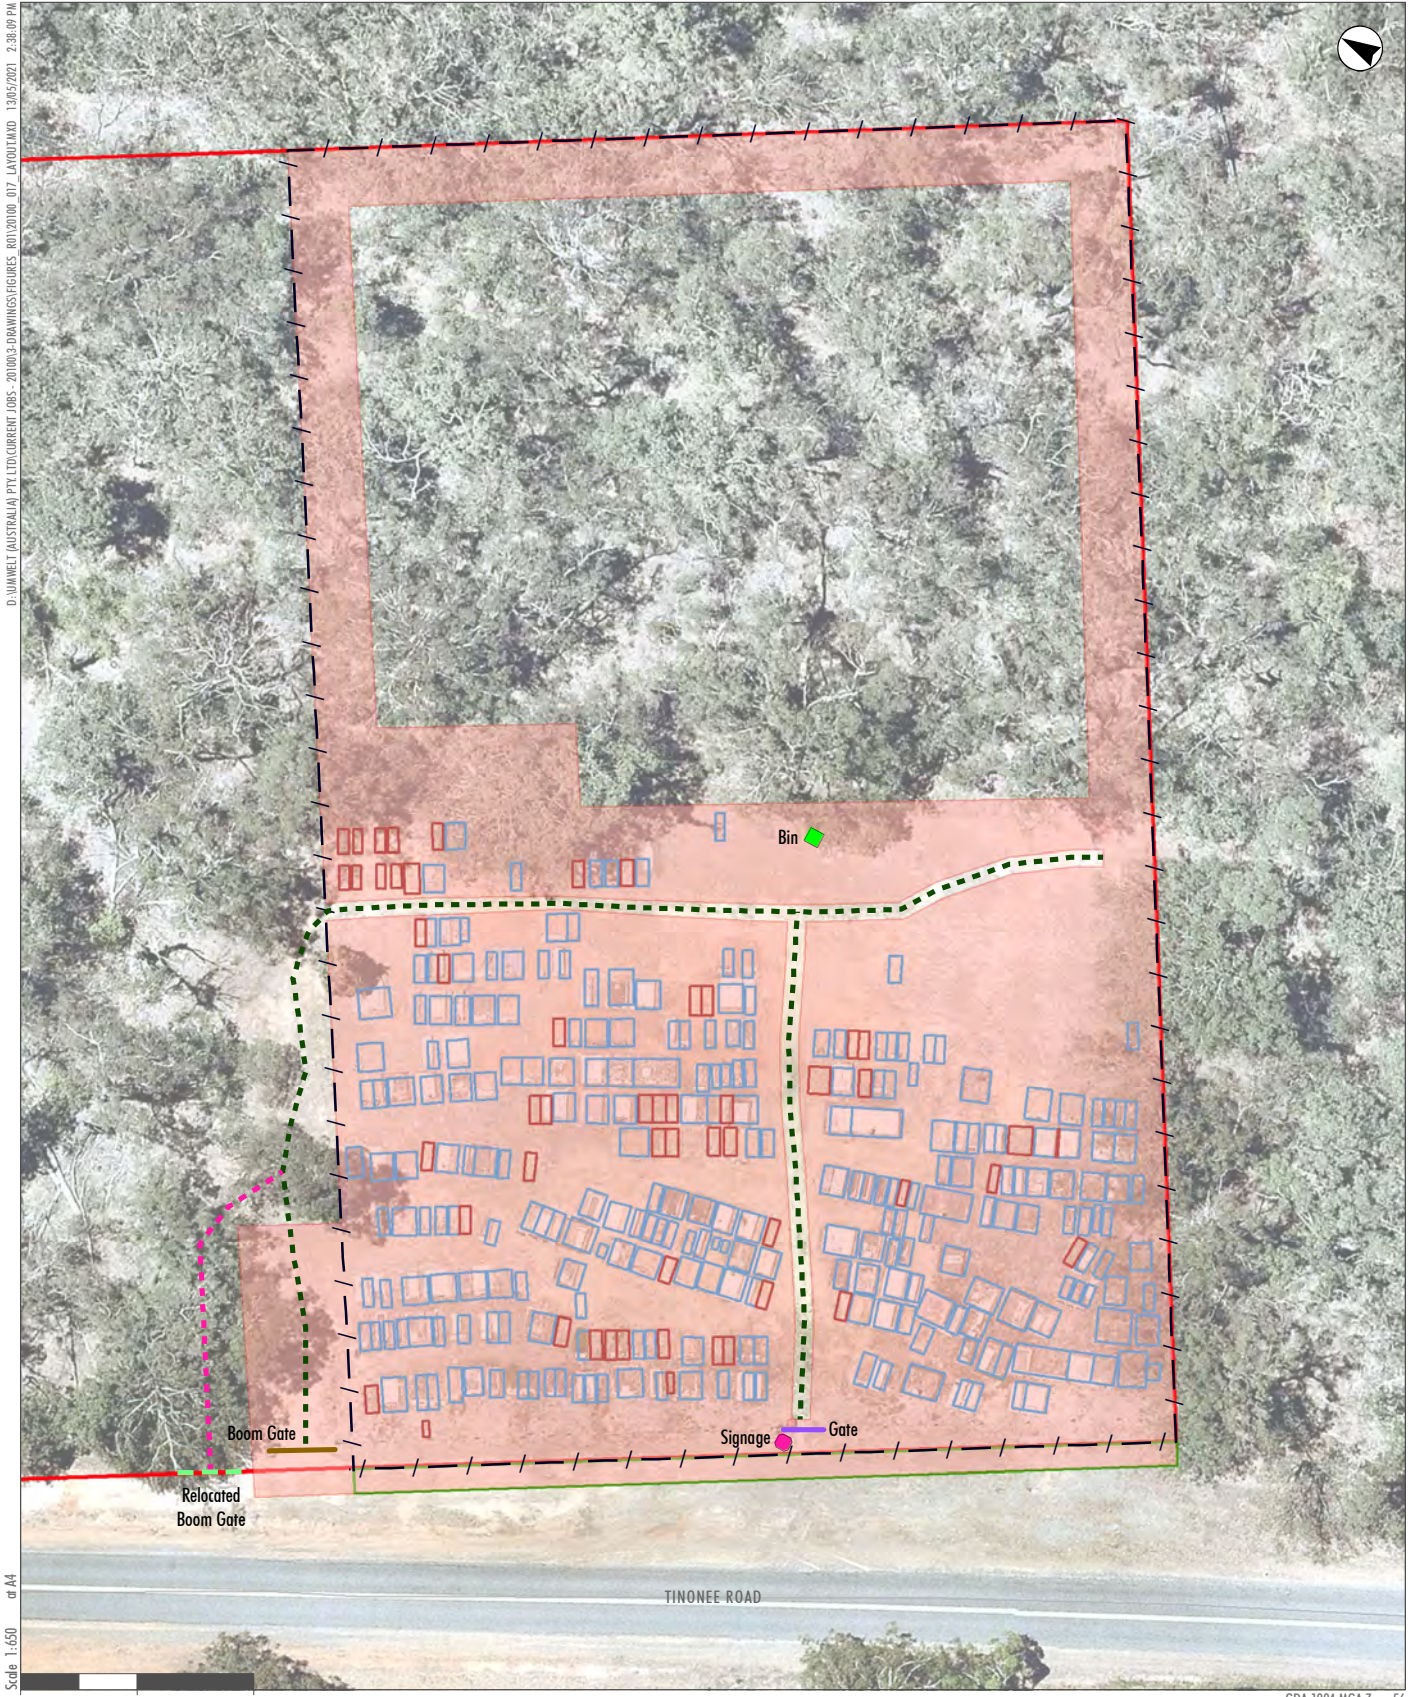
FIGURE 7.1

Buffer zones to be considered when planning or undertaking works within the Cemetery are shown in **Figure 7.1**. These buffer zones have been applied around all known (marked and unmarked) grave sites to ensure that work in the vicinity of the grave sites is undertaken with caution and an acknowledgement of the potential for human remains in the vicinity of known grave sites.

To further assist with this, buffer zones to be considered when planning or undertaking works within the Cemetery are shown in **Figure 7.1**. These buffer zones have been applied around all known (marked and unmarked) grave sites to ensure that work in the vicinity of the grave sites is undertaken with caution and an acknowledgement of the potential for human remains in the vicinity of known grave sites. A buffer zone has also been applied around the fence line of the Cemetery in association with land that is managed by Council, to ensure that works outside but in the immediate vicinity of the Cemetery also proceed with caution.

Guideline 58. Unless approved and appropriate alternatives are developed in the future, vehicle movement must adhere to the existing pathways shown in **Figure 4.1** and **Figure 7.1** so as to avoid inadvertent impacts to grave sites (marked and unmarked).

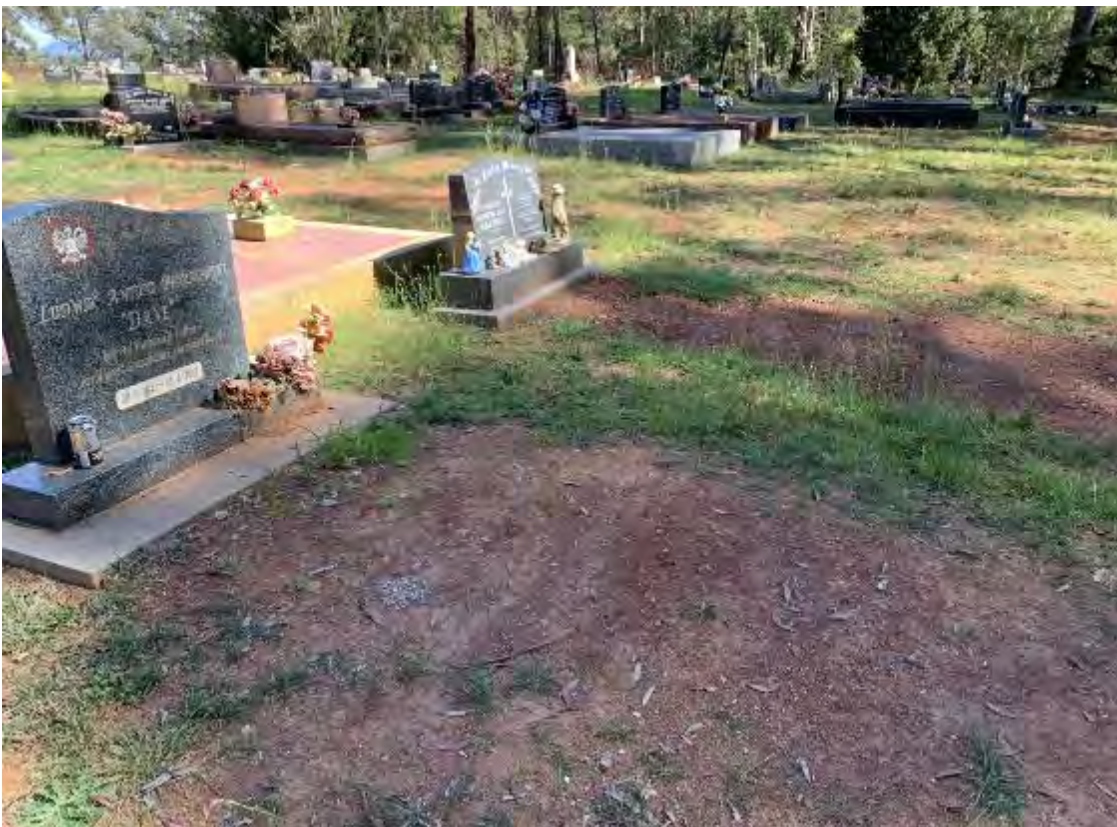
Plate 7.2 Tyre marks visible on graves to the rear (eastern) side of the ‘active portion’ of the Cemetery

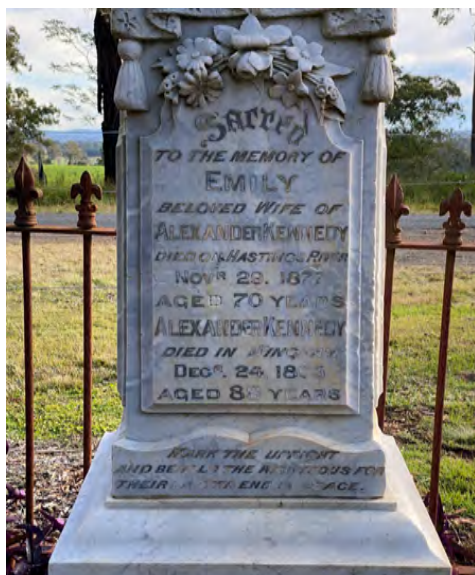
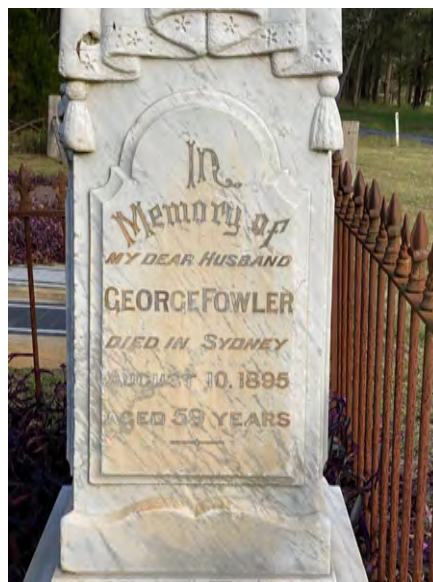
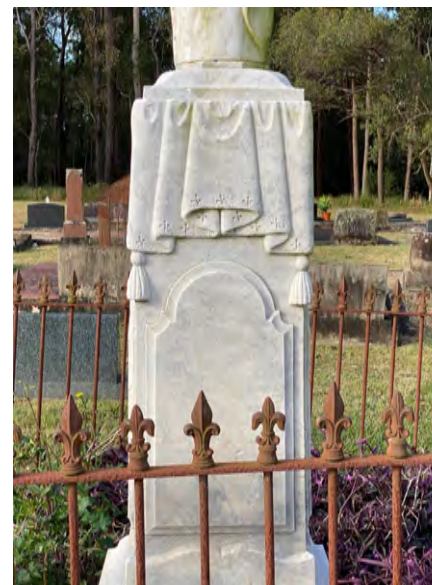
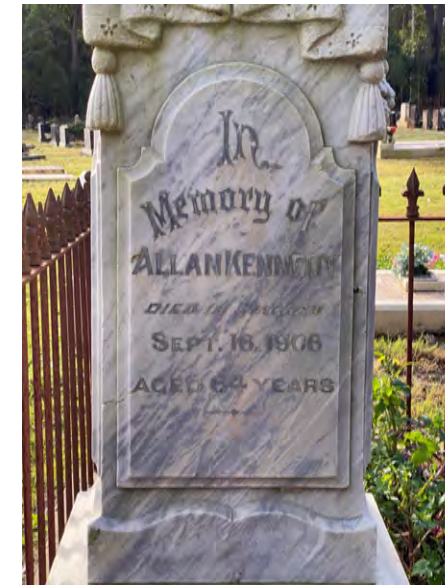
ID No	Date of Death	Name	Description	Inscription	Condition
048	10 August 1895 24 December 1893 29 November 1877 16 September 1906	George Fowler Emily Kennedy Alexander Kennedy Allan Kennedy	Four face ornate marble obelisk with carvings and lead lettering on three sides.	<p><i>"To the memory of Emily, beloved wife of Alexander Kennedy died on Hastings River, Nov 29 1877. Aged 70 years. Alexander Kennedy died in Wingham Dec 24 1893. Aged 88 years.</i></p> <p><i>In memory of Allan Kennedy, died in Wingham Sept 16 1906. Aged 64 years.</i></p> <p><i>In memory of My Dear Husband George Fowler, died in Sydney. August 10 1895. Aged 59 years."</i></p>	Monument was not laid down, however has possible strap marks on corners.

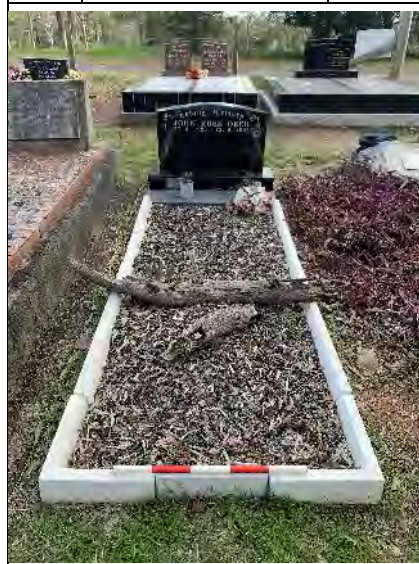
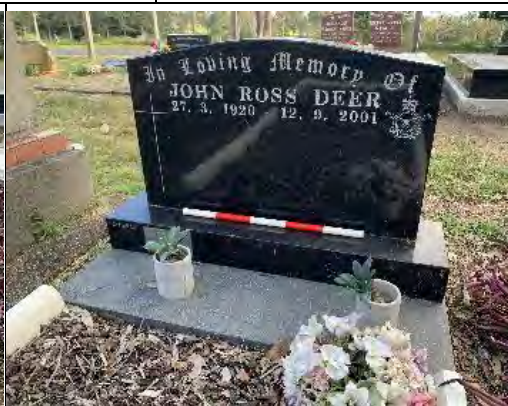
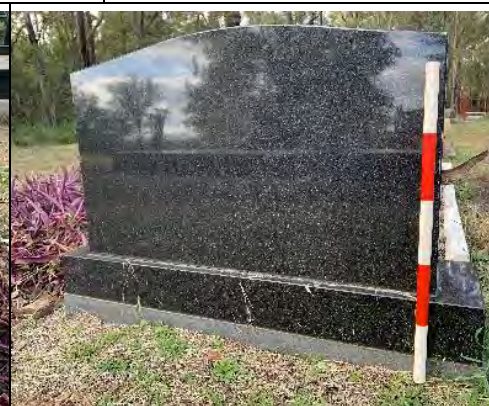
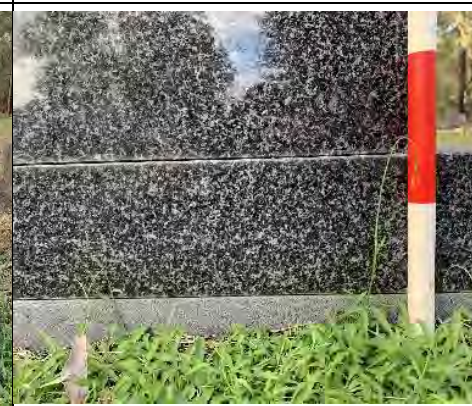
ID No.	Date of Death	Name	Description	Inscription	Condition
198	12 September 2001	John Ross Deer	Die on stand black granite marker and plinth, with a serpentine arch style. The marker has a thin engraved cross to one side, and a military badge on the other. The grave is framed with a white wooden border, infilled with mulch and natural materials. 'EDSTEIN' is engraved on the front of the plinth, with a metal plaque to the side.	<i>"In Loving memory of John Ross Deer 27.3.1920 – 12.9.2001"</i>	The grave marker is in good condition, with no damage or cracking evident. The grave marker is in its original positioning. It appears that the headstone was removed from the plinth, but has since been re-instated and re-adhered.

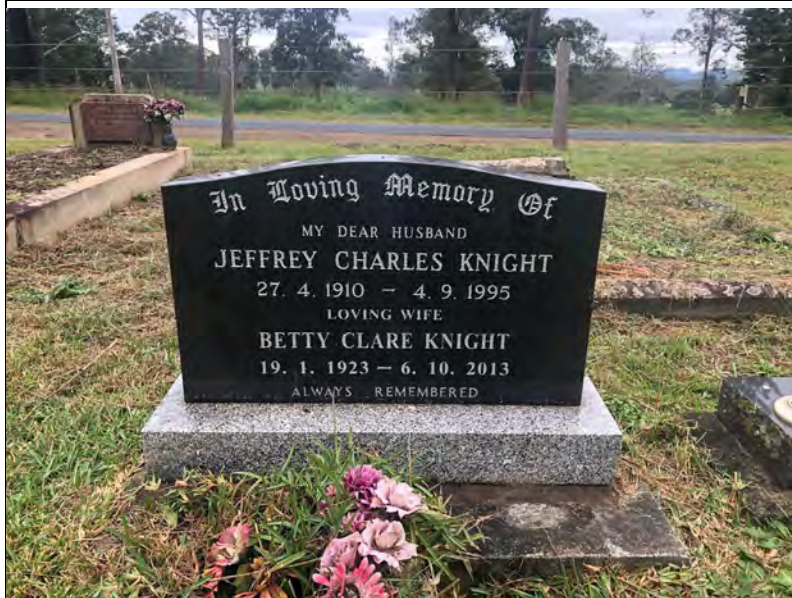
ID No.	Date of Death	Name	Description	Inscription	Condition
012	14 June 1961 20 August 1963	John Hugh Cameron Eliza Cameron	Block black/grey granite headstone removed from the plinth, lying a top of a double enclosure featuring a stone border and pink tiles slab top. No ornate carving.	<i>"In Loving Memory of our dear parents John Hugh Cameron died June 14. 1961 aged 90 years Eliza Cameron died Aug. 20 1963 aged 88 years The lord is my shepherd"</i>	Headstone has been forcibly removed, exposing the underlying cement. Minimal structural damage to the stone plinth. No visible damage on the grave marker or enclosure.

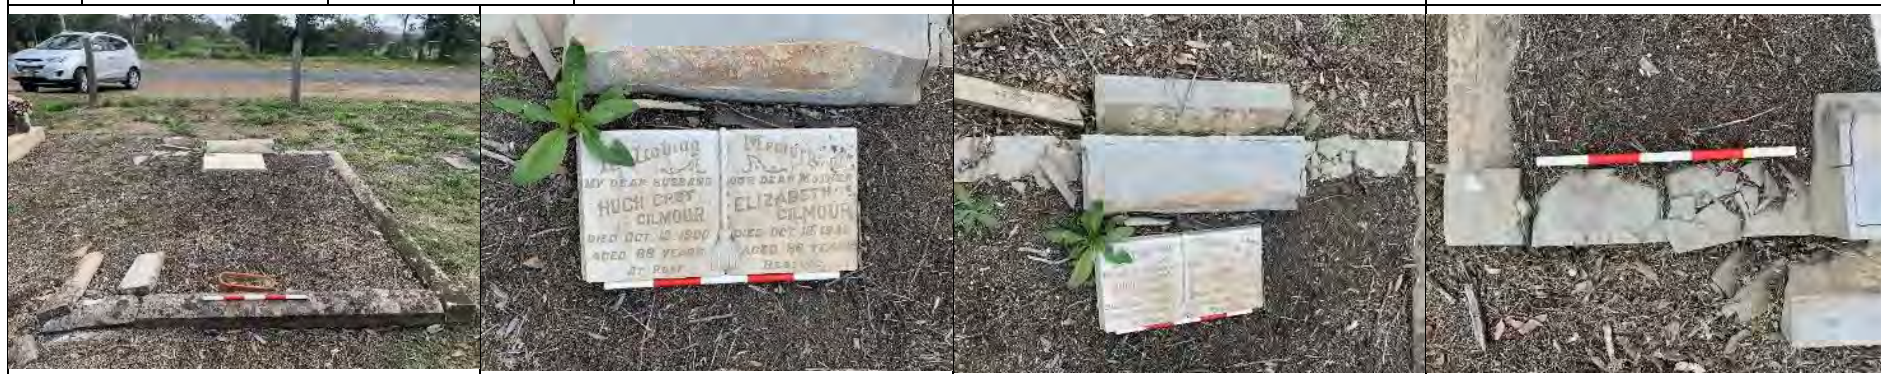
ID No.	Date of Death	Name	Description	Inscription	Condition
035	17 October 1880	Mary McLennan	Die in socket grave marker is of an open book style and ornate stone ledger. The grave is located within an iron gothic style fencing. The open book heading is inscribed, however it is faded beyond comprehension. The grave marker has been removed from its original upright position, and is lain upon a bed of sand.	<p><i>“Sacred in the Memory of Mary The beloved wife of Donald Mc Lennan. Who departed this life at Damaresque Island Manning River on the 17th October 1880 aged 51 years. My flesh and my heart failed but God is the strength of my heath and my portion forever. Pslam 78 and 26.”</i></p>	The grave marker has been laid down at the base of the original anchor point. The marker is in fair condition, with some minor cracking at the base and a small area of damage atop the upper arch. Damage is further evident on the base, with stone missing.

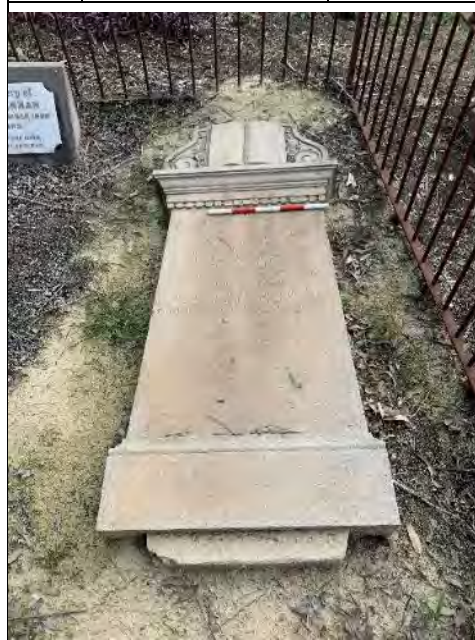
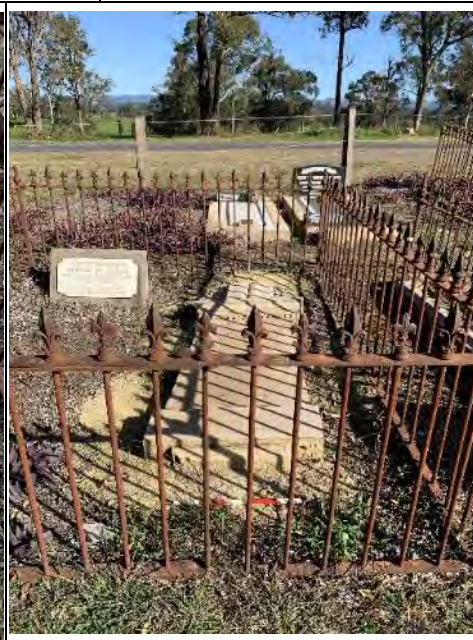
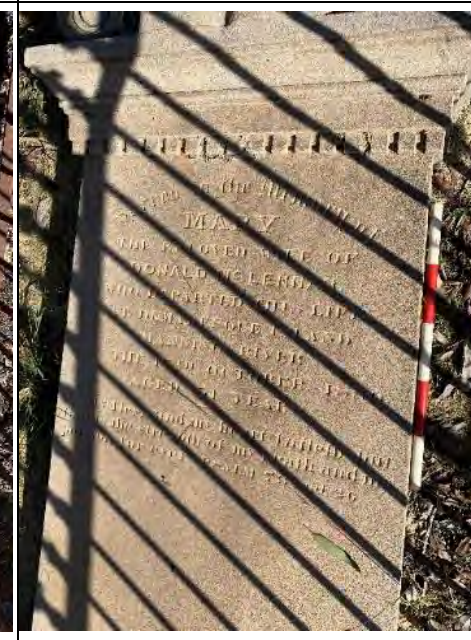
ID No.	Date of Death	Name	Description	Inscription	Condition
036	30 January 1876	Alexander Lobban	Stone pulpit grave marker with inscribed open book header. Ornate floral carved scrolls frame the open book header. The headstone has been removed from its original positioning and lays on the ground within the confines of a wrought iron gothic styled fence. The headstone is lain in front of the plinth it was removed from.	<p style="text-align: center;"><i>“In Loving memory of Alexander Lobban. Native of Banffshire Scotland who departed this life at Park----- 30 January 1876 Aged 76 years.</i></p> <p style="text-align: center;"><i>‘--- who for 26 years was a resident of the Manning district . The interests of w--- -- ---- strive to promote and for most of that time as an elder of the Presbyterian church of Eastern Australia. He performed the duties of that office with a zeal guided by intelligence and sanctified by divine grace, strong in faith he was called to ----- an example worthy of emulation as a loving husband, a tender father, a wise counsellor, a faithful friends, a sincere Christian and in all the transactions of life an honourable man”</i></p>	The grave marker is in moderate condition. A large crack runs through the width of the headstone, likely caused by the removal process. Minor damage is also evident along the base of the headstone, with small pieces of stone missing. Cracking is evident along the stone surround. The iron fencing is rusted but generally stable.

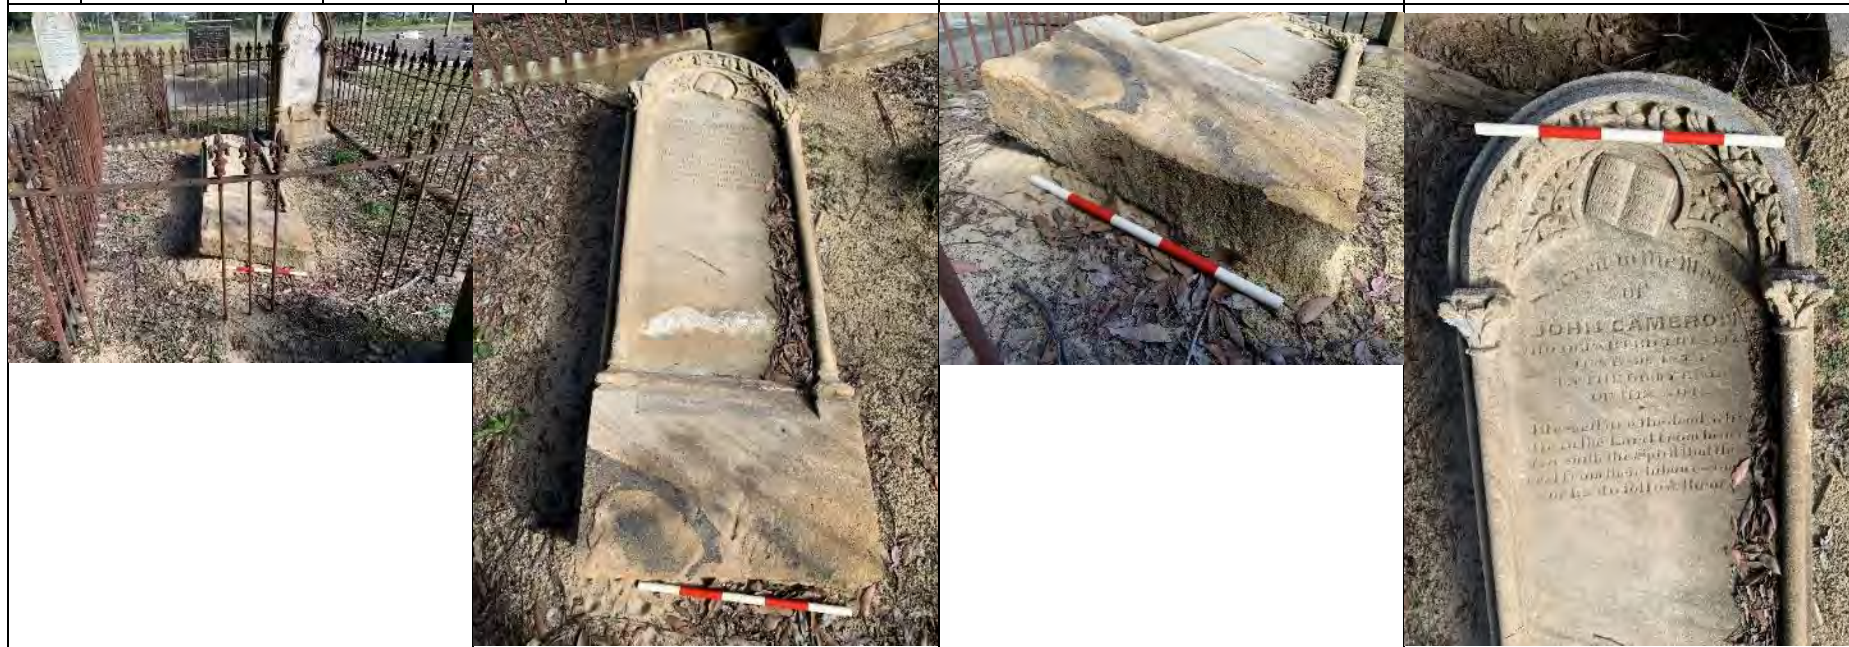
ID No.	Date of Death	Name	Description	Inscription	Condition
024	6 June 1879 21 September 1919	Isabella McLean Hector McLean	Gothic styled marble tablet headstone removed from its original position, lain in front of the plinth. The grave is enclosed by a concrete framed square, outlining the extend of the site. The side of the headstone is engraved with ornately carved flowers and leaves.	<p><i>“Sacred to the memory of Isabella The beloved wife of Hector McLean who died at Copebella Manning River on the 6th June 1879 in the 39th year of her age. “Blessed are the dead which die in the lord” ALSO Hector McLean died Sept 21st 1919 aged 90 years.</i></p>	<p>The headstone is generally in good condition, with no damage or cracks evident.</p> <p>There is some dark discolouration/dirt on the top third of the stone. The stone border encasing the grave has cracking evident.</p> <p>The grave marker has been damaged as a result of being removed from the plinth and laid down.</p> <p>Some cracking is evident to the stone surround.</p>

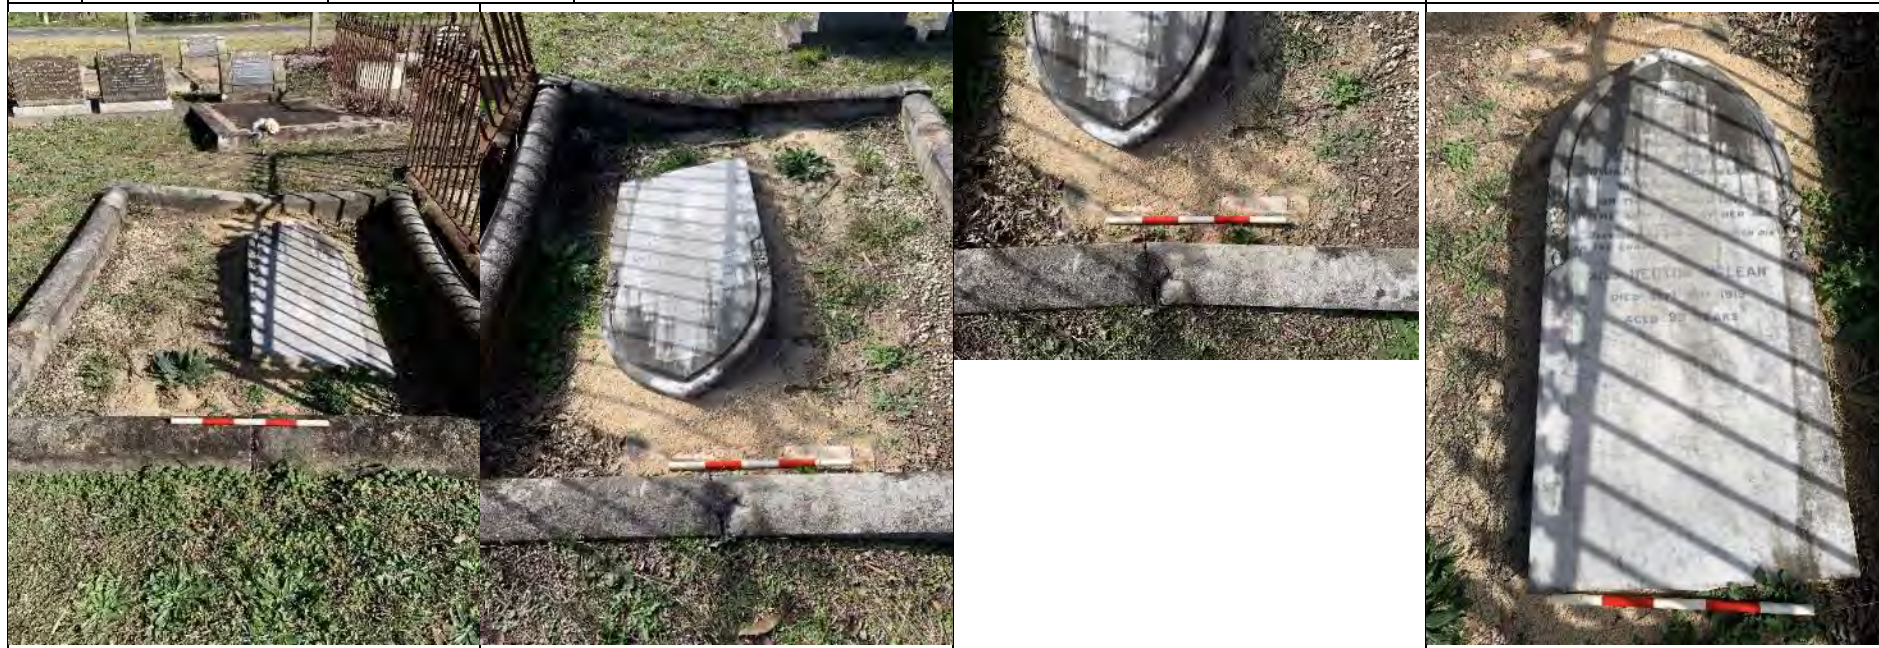
ID No.	Date of Death	Name	Description	Inscription	Condition
167	5 June 2017	Trudy Vrielink	<p>A small die on base grave marker with a stone plaque. The marker is in a peon styled arch, with pillars on either side and scrolls framing the stone.</p> <p>Both the headstone and plinth are sandstone. The grave is not bordered or framed.</p>	<p><i>"In Loving Memory Trudy Vrielink 8th.7.1923 – 5th. 6. 2017 Rest in Peace"</i></p>	<p>The grave marker is in good condition, with no evident damage or cracking to the headstone or plinth.</p> <p>It appears that the headstone has been re-instated and re-adhered to the plinth.</p>

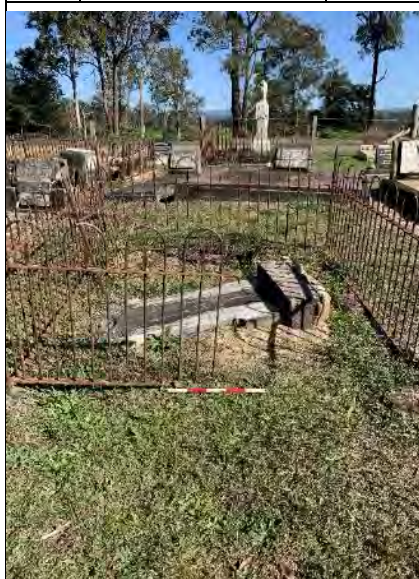
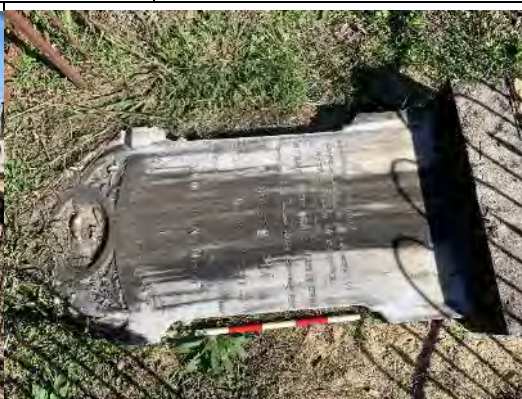
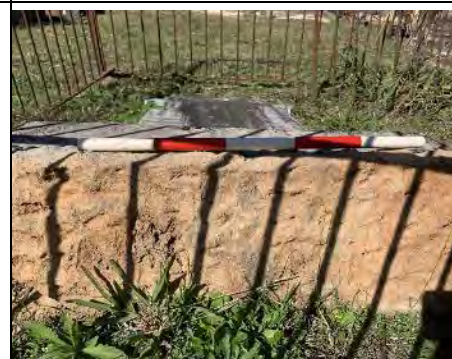
ID No.	Date of Death	Name	Description	Inscription	Condition
051	13 October 1910 13 March 1896	John McIntosh Barbara McIntosh	A die in socket marble grave marker with a sandstone plinth. The arch is of a gothic style with ornate flowers and natural motifs and clasped hands in the centre, symbolic of the reuniting of the couple interred. The grave is enclosed within a wrought iron fence with modern dome posts with forged arrows between. The fence is in disrepair with sections out of place but present on the site. The headstone is lying a top of the plinth, on an angle.	<p><i>“Sacred to the Memory of John McIntosh native of Caithness Scotland Died Oct. 13. 1910. Aged 81 years Also Barbara His beloved wife native of same place Died March 13. 1896. Aged 78 years Erected by Hector Gollan in memory of a couple of good Christian pioneers”</i></p>	<p>The grave marker is in good condition, with no cracks or damaged evident. Some inscriptions have been discoloured, as well as the upper portion of the marble. Possible that the inscription was originally infilled to increase visibility.</p> <p>The headstone has been removed from its footing, which remains <i>in situ</i>.</p> <p>The iron fence surround is rusted, with the entrance gate displaced an stored within the surround,</p>

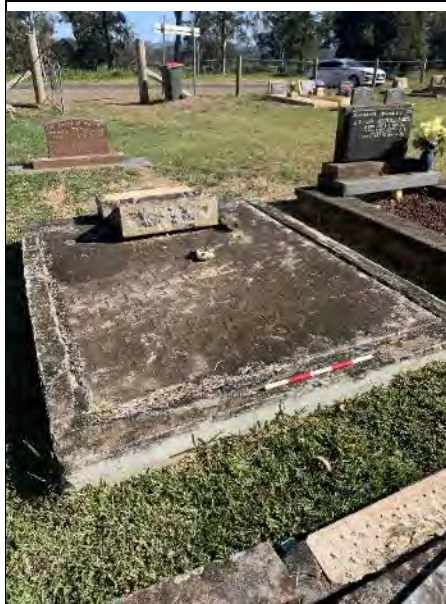
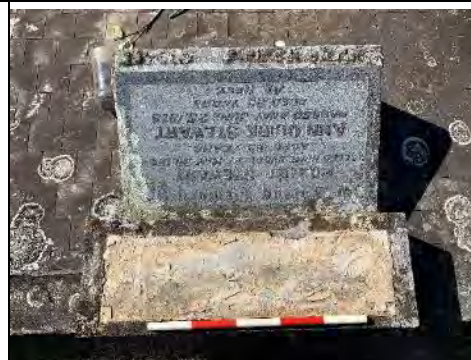
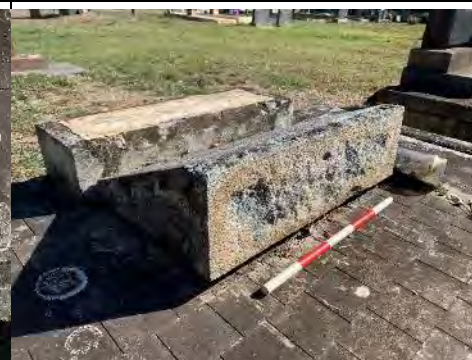
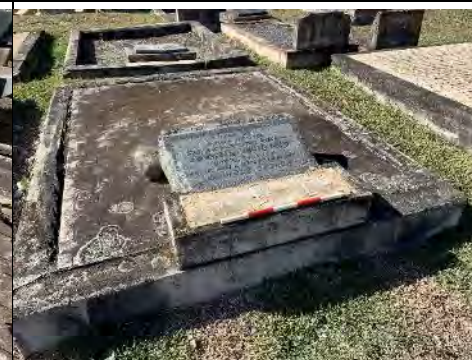
ID No.	Date of Death	Name	Description	Inscription	Condition
071	30 May 1944 25 June 1975	Robert Stewart Ann Quirk Stewart	A blue/grey granite headstone with plinth, with no decorative engravings. The headstone is laying in front of the plinth. The grave enclosure features a stone border and tiled slab. The headstone is divided into two devotions.	<p><i>"In Loving Memory Of Robert Stewart Called home suddenly May 30. 1944 aged 69 years."</i></p> <p><i>"Ann Quirk Stewart Passed away June 25. 1975 aged 95 years AT Rest."</i></p>	The headstone is in fair condition, with no cracking evident. The contact site is visible, but undamaged. The plinth shows damage along the front border, with debris visible. Likely caused during the headstone removal. The base of the marker shows damage with fragments missing, also likely caused by removal. There is significant lichen growth over the stone slab, plinth and headstone. The stone surround to the grave enclosure has some cracking.

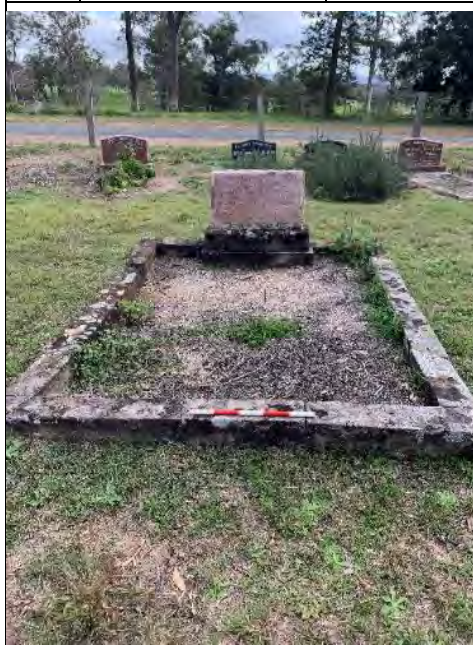
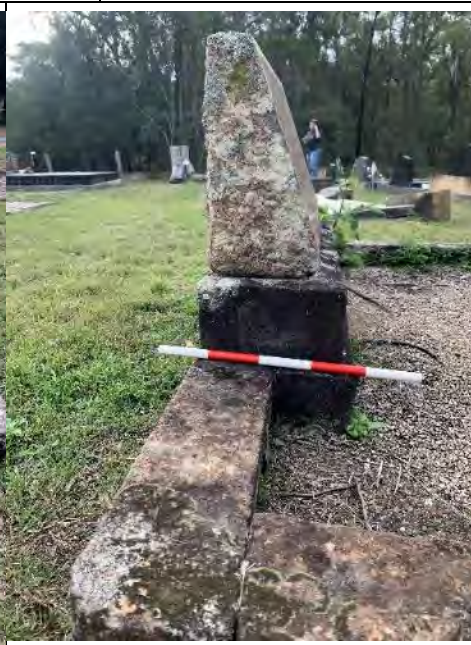
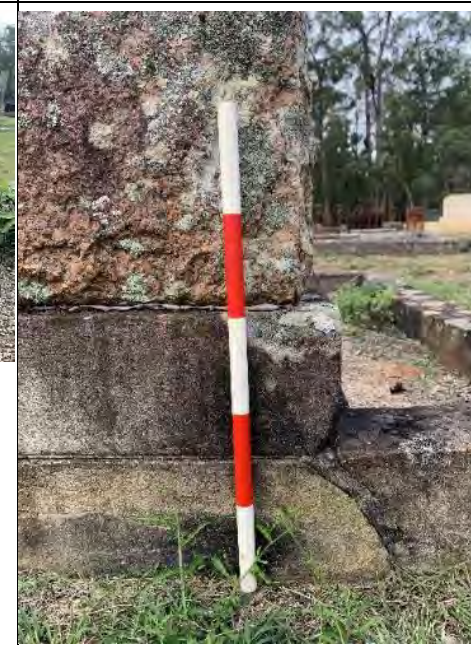
ID No.	Date of Death	Name	Description	Inscription	Condition
161	19 February 1909	William Somerville	A marble die on base marker with a sandstone plinth. The headstone has a gothic arch with shoulders, with an engraved border and flower/natural motifs carved into the shoulders and central arch. The headstone is lying a top the original anchor position.	<i>“Sacred to the Memory of William Somerville Died Feb 19 1909 Aged 84 years. At Rest”</i>	The grave marker is in fair condition, with no cracking or damage evident on the headstone. The devotion is not inscribed, with portions of the writing fallen off or damaged, with the legibility dependant on the imprint of letters and numbers. The marble has discoloured in areas. Some minor damage to the plinth, evident along the base edge and likely caused by the headstone’s removal.

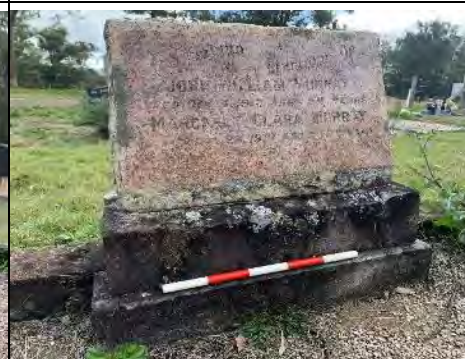
ID No.	Date of Death	Name	Description	Inscription	Condition
151	4 December 1917 29 October 1941	John William Murray Margaret Clara Murray	A slant headstone in pink granite, with a stone plinth. The headstone has no ornate engravings. The grave enclosure framed by a stone border, with a stone slab and small white rocks infilling. The headstone is a double devotion.	<p><i>"In Loving Memory To John William Murray Died Dec 4. 1917, aged 54 years Margaret Clara Murray Died Oct 29. 1941, aged 72 years At Rest"</i></p>	<p>The grave marker is in moderate condition, with no cracking or damage evident on the headstone. The plinth has damage to the corners and edges. The stone surround has cracking and some damage evident, with concentrated damaged underneath the headstone.</p> <p>It appears that the headstone has been re-instated and re-adhered to the plinth.</p>

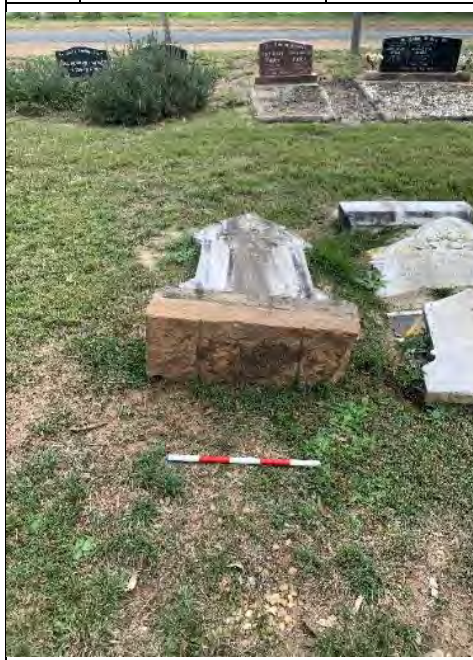
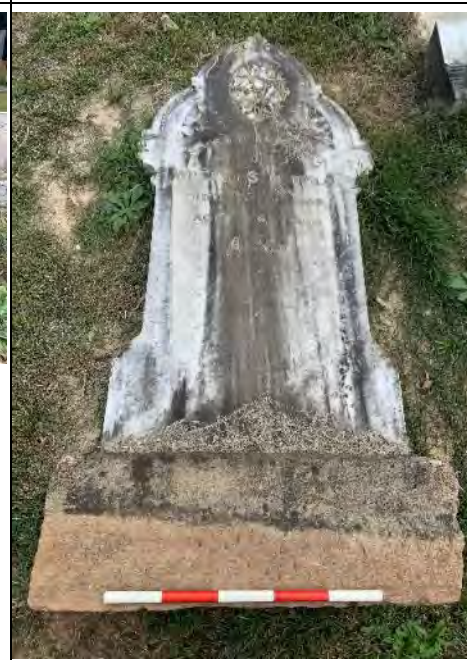
ID No.	Date of Death	Name	Description	Inscription	Condition
168	20 October 1903	Barbara Ann Sommerville	A white marble die on base marker. The headstone has a gothic arch with shoulders, with an engraved border and flower/natural motifs carved into the shoulders and central arch. The shoulders have further columnar features. The headstone is lying in front of the plinth.	<p><i>"Sacred to the Memory Barbara Ann Sommerville Died 20 Oct. 1903 Aged 68 years. At Rest"</i></p>	The grave marker is in poor condition, with the headstone cracked into two distinct pieces. The headstone is detached from the plinth with fine cracking also evident. The marble plinth appears undamaged.

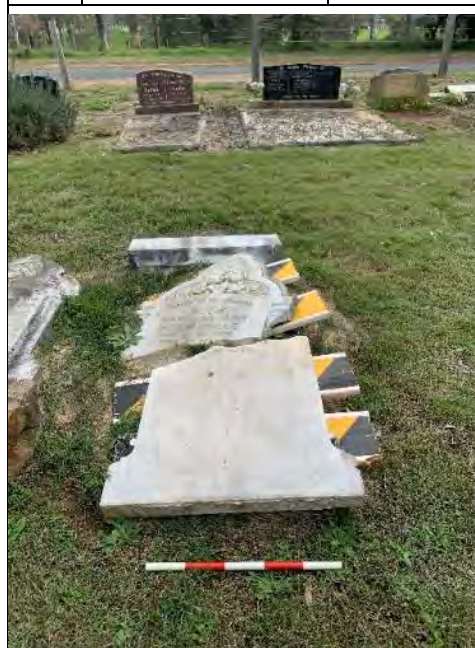
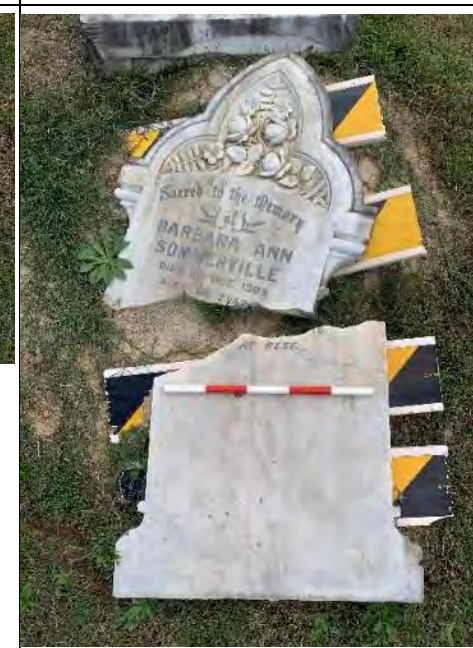
ID No.	Date of Death	Name	Description	Inscription	Condition
176	5 September 1895 3 September 1895 20 September 1889	Barbara Annie (Somerville) Longworth Victoria Armstrong (Somerville) William Somerville	Grave marker is a die on base white structure, with a pedestal attached to the headstone and disconnected plinth. Gothic styled arch with natural motifs follow the shape of the arch and frame the upper portion of the stone. An engraving is visible on the base of the marker, stating “ – forever with the Lord”	<p><i>“Barbara Annie Beloved wife of John Longworth who died 5th Sep 1895 aged 25 years</i></p> <p><i>Also Victoria Armstrong died 3rd Sep 1895, and William died 20th Sep 1889 beloved children of William and Barbara Somerville Forever with the Lord J Cunningham Sydney”</i></p>	The grave marker is in good condition, with no evident cracking or damage. The headstone is rested upon a sand bank at the foot of the plinth. The metal supports are jutting from the plinth. Some discolouration to the border of the headstone.

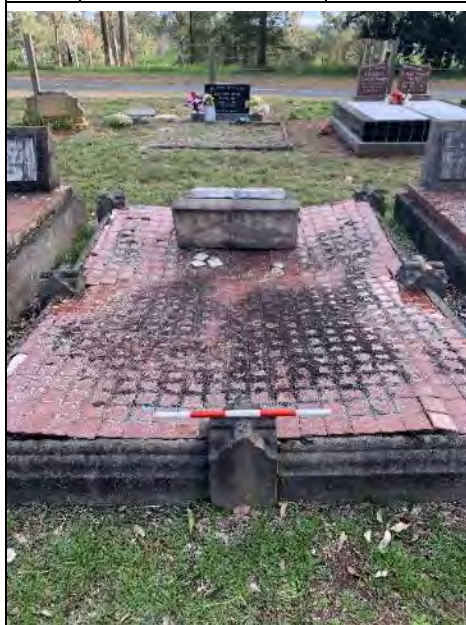
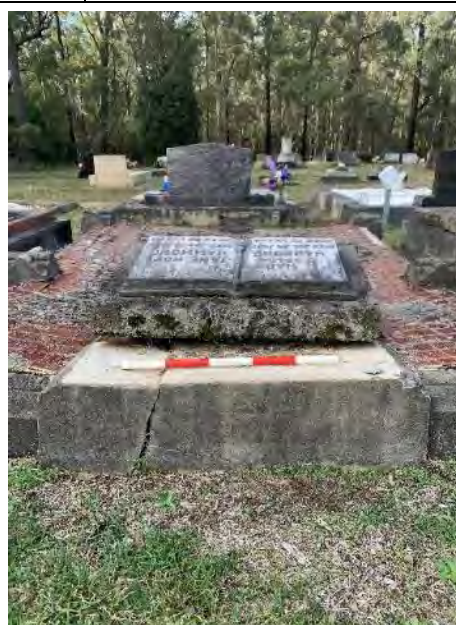
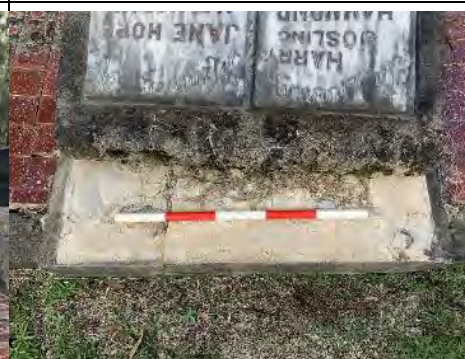
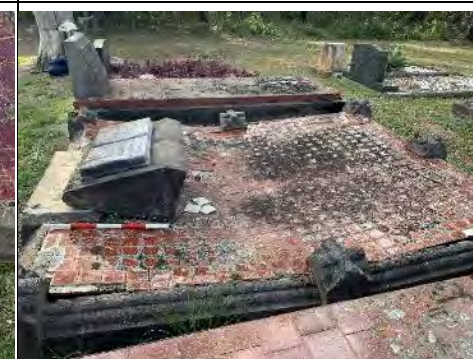
ID No.	Date of Death	Name	Description	Inscription	Condition
191	28 December 1927 14 January 1939	Harry Josling Hammond Jane Hope Hammond	A granite headstone with a white marble plaque/tablet inscribed. The grave enclosure is framed by a stone border and a red tile slab top. The headstone lies in front of the plinth. Six stone pillars frame the grave site.	<i>"In Loving Memory Of Harry Josling Hammond died Dec. 28. 1927 aged 73 years Jane Hope Hammond died Jan. 14.1939 aged 80 years"</i>	The grave marker is in poor condition, with cracking and damage evident to the stone border, tile topping slab and plinth. The centre of the box tomb has begun to depress and sink into the ground. Lichen growth has discoloured the majority of the red tile slab. Multiple red tiles have been broken/displaced possibly due to the headstone removal.

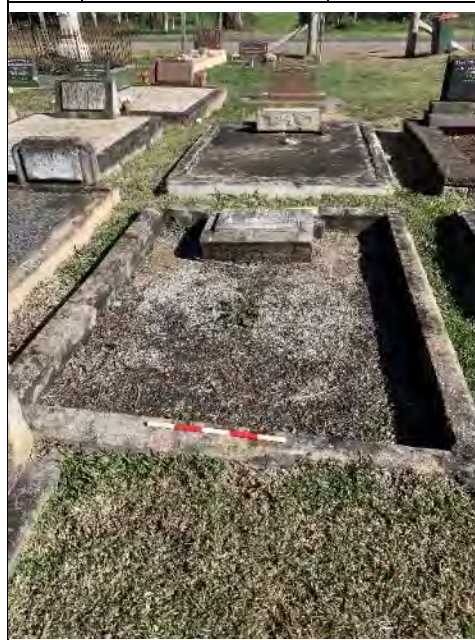
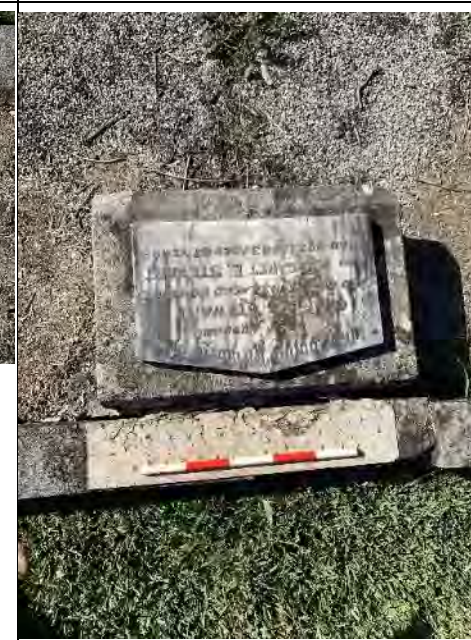
ID No.	Date of Death	Name	Description	Inscription	Condition
080	2 October 1942 11 April 1963 31 July 1943	Allan McIntyre Stewart Sarah Ann Stewart Mary Isabel Stewart	A grey granite slant headstone with engraving on a stone plinth. The headstone is in the tudor style and is resting upon its original stone plinth. The removal site is visible. The triple grave features an enclosure with a stone border. The marker is divided into three devotions.	<p><i>"In Loving Memory Of Allan McIntyre Stewart Died 2nd Oct 1942 aged 65 years"</i></p> <p><i>"Sarah Ann Stewart Died 11th April 1963 Aged 81 years"</i></p> <p><i>"Mary Isabel Stewart Died 31st July 1943 Aged 18 years"</i></p>	<p>The headstone is in fair condition with no cracking. Cracking and chipping is visible to the plinth.</p> <p>The box tombs have sunken and are slanted, with cracking evident to the stone surround.</p>

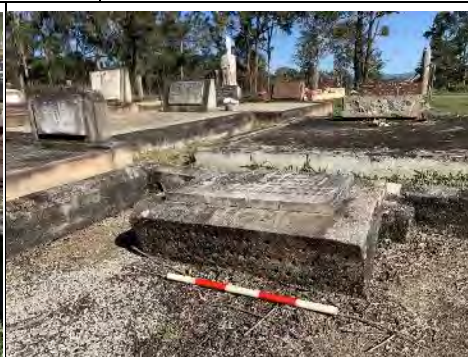
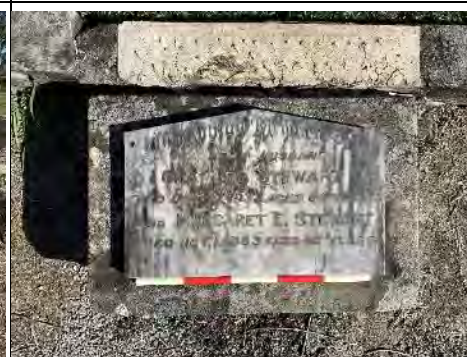
ID No.	Date of Death	Name	Description	Inscription	Condition
075	14 October 1937 1 October 1953	Charles Stewart Margaret Stewart	Slant headstone with marble plaque/tablet. The plaque is in the tudor style with no decorative engravings. The grave site is bordered with stone and the remains of white pebbles on top of a pebbled stone (concrete) enclosure.	<p><i>"In Loving Memory Of My Dear Husband Charles Stewart Died Oct 14 1937 aged 64 years And Margaret E. Stewart Died Oct 1.1953 aged 87 years"</i></p>	The grave marker is in poor condition. The marble plaque has cracking along the bottom and is discoloured/stained. The marker itself is cracked and has damage evident along its surface and especially along the base due to its removal. The connection site with the stone border is visible, cracked and unsightly. The enclosure surround is cracked, sunken and the stone slab is crack and sunken.

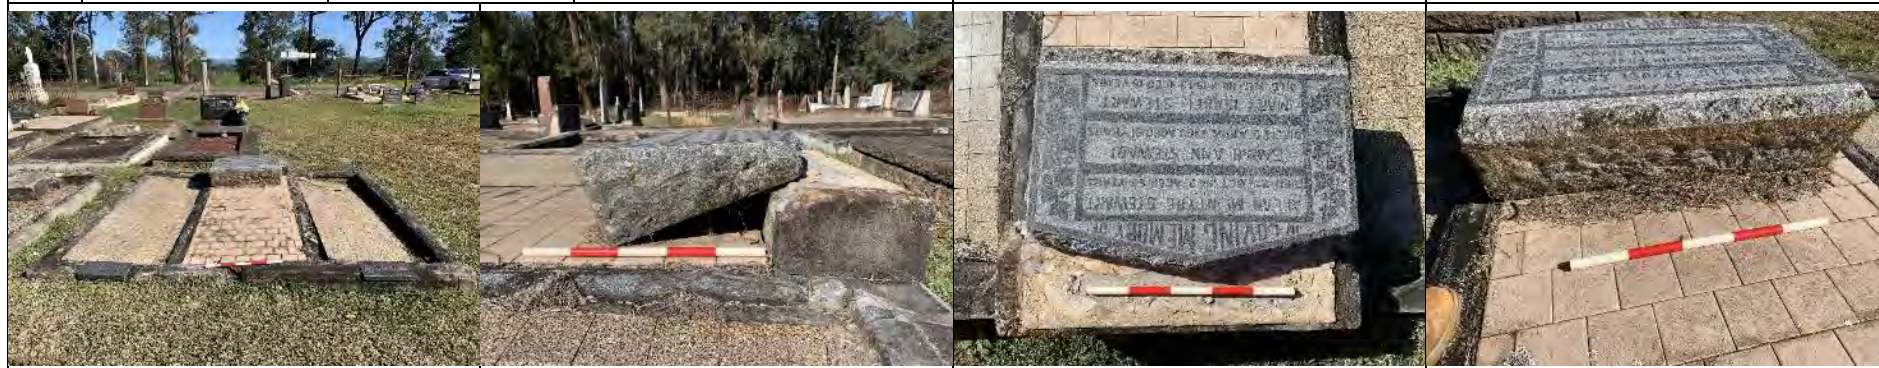
ID No.	Date of Death	Name	Description	Inscription	Condition
139	7 November 1909	Sarah Pollock John Ernest Pollock	Grey stone die in socket grave marker. The headstone is framed by Corinthian styled pillars engraved into the sides, with a flower motif engraved into the top centre. The headstone has a shouldered gothic styled arch. The headstone is lying in front of the original anchor point. The grave is framed by a stone surround. The base of the headstone has "EDSTEIN" engraved.	<p><i>"In Loving memory Of Sarah Beloved wife of Thomas Pollock Died November 7 1909 Aged 48 years 'Time has passed and still we miss her. Words would fail our love to tell, but in heaven we hope to meet her. Jesus doeth all things well.' Also her infant son John Ernest Safe in the arms of Jesus'"</i></p>	The grave marker is in very poor condition, with the headstone cracked into two pieces, with the upper third at a small distance from the remaining monument. The plinth and socket are both fractured and severely damaged, with debris visible. The stone surround has cracking and substantial damage at the location of the anchor point, with a large chunk of stone fractured off the structure. All the damage has been caused by the removal of the marker, including the subsequent 'laying down' of the headstone.
