THE BIGHT CEMETERY, THE BIGHT

Conservation Management Plan

Prepared by
Umwelt (Australia) Pty Limited
on behalf of
MidCoast Council

Project Director: **Tim Adams**
Project Manager: **Karyn Virgin**
Report No. **20100/R01**
Date: **May 2021**

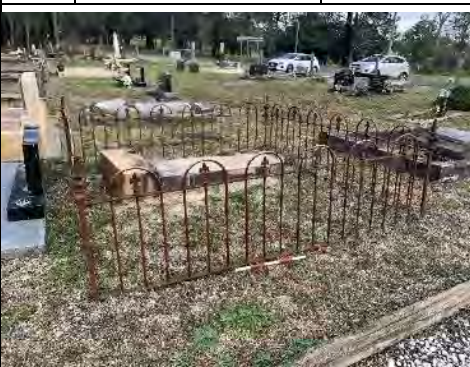
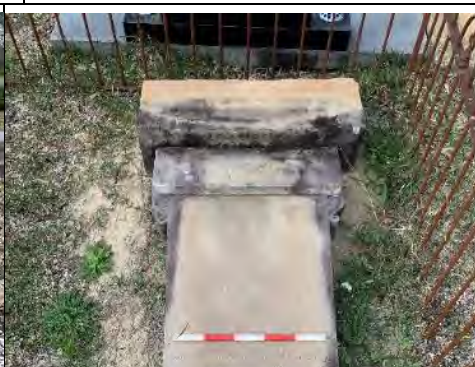
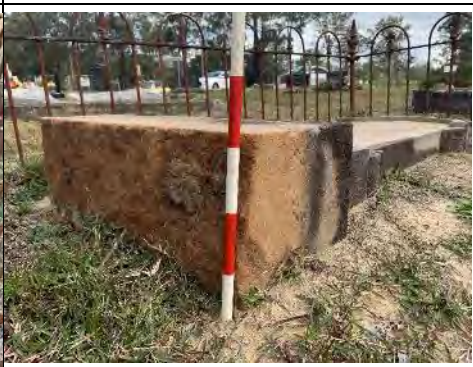
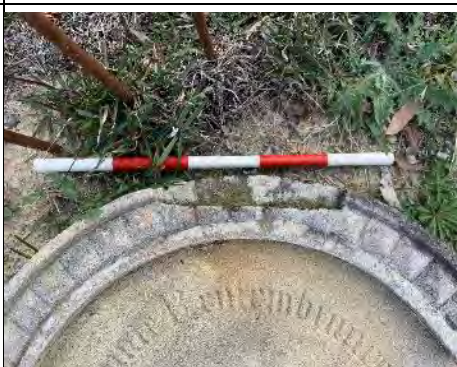
ID No.	Date of Death	Name	Description	Inscription	Condition
154	12 March 1888	Isabella Pollock	Die on base grave marker, with pedestal and plinth. The headstone is made of sandstone and has a rounded arch. The grave site is a double sized plot, but only one devotion. The headstone arch is framed with a geometric square pattern, and a scroll flower motif on either side. A gothic style iron fence surrounds the site. The headstone is lying on the ground, over the original anchor point with pedestal and plinth attached.	<p><i>“(Latin inscription) of Isabella The beloved wife of John Pollock. Who died 12th March 1888 aged 69 years. ‘weep not for me as we pass bye. As you are now so once was i. As I am now so you will be. Prepare for death to follow me’”</i></p>	The grave marker is in moderate condition. The arch of the headstone is damaged at the apex, with sections of stone missing. The stone is discoloured in places. The pedestal and plinth are both damaged, with cracking and flaking of the stone evident. The iron fencing is in moderate condition, with substantial rust and some bending of the pikes.

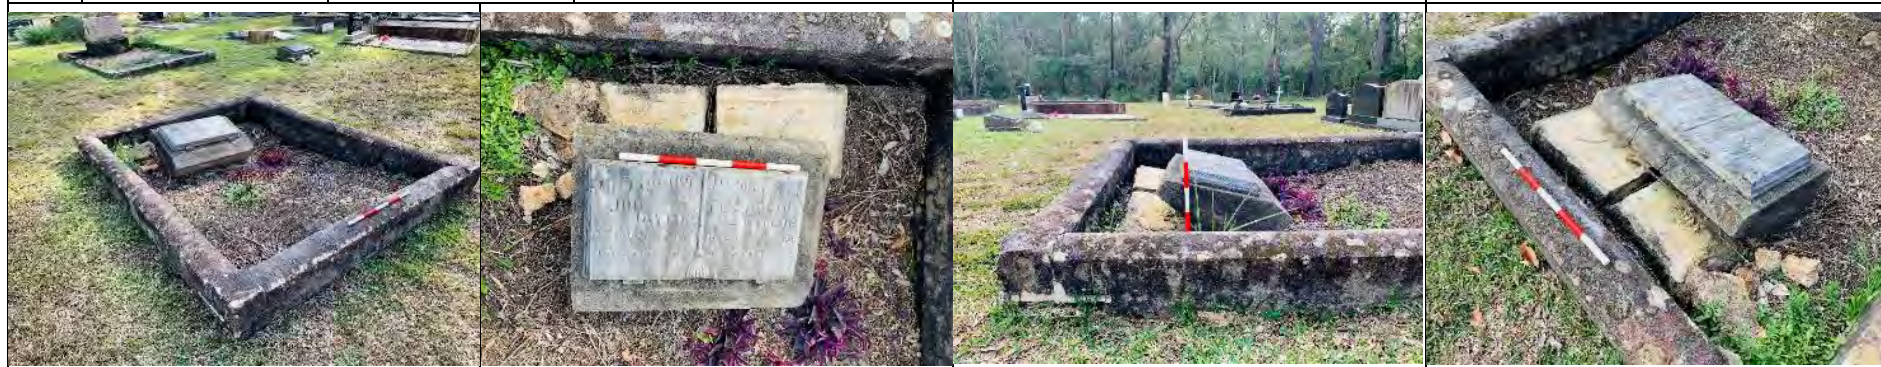
ID No.	Date of Death	Name	Description	Inscription	Condition
186	19 May 1919	Elizabeth Jane Bryan	Slant headstone with a pink granite plaque/tablet. The grave enclosure is bordered with stone with a stone slab covering the grave. The headstone is placed upright in front of the plinth	<i>“Sacred to the Memory of Elizabeth Jane Bryan Died May 19th 1919 Aged 10 years”</i>	The grave site is in poor condition. The plaque inscriptions are difficult to read due to weathering and lichen growth. Plinth shows damage occurring during the removal process. The surround has extensive cracking and damage, with debris inside and outside. The headstone has cracking and damage evident, likely due to weathering. The granite plaque is in good condition, with no damage or cracking. The stone slab covering the grave is damaged, with areas destroyed or cracking off.

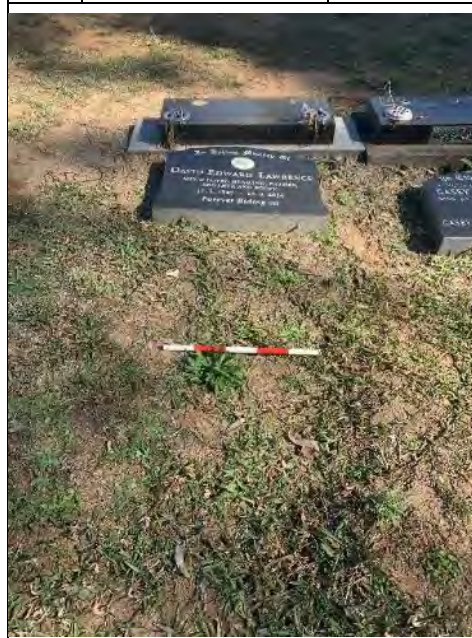
ID No.	Date of Death	Name	Description	Inscription	Condition
200	27 March 1994	Casey David Lawrence	Die on base grey granite marker, with granite pedestal and plinth. The headstone has a square topped scotia shoulder styled arch. The pedestal has a pink rose engraved, with green leaves, carved into the front. Flower holders are on either side of the pedestal. The headstone lies in front of the original anchor point. The grave site has no border or fencing.	<p><i>"In Loving Memory of A much loved son and brother Casey David Lawrence Died as a result of a car accident 27.3.1994 Aged 20 years 'he ain't heavy, he's my brother' Casey Bradley".</i></p>	The grave site is in good condition, with no cracking or damage evident on the headstone. The pedestal has minor damage at the original anchor site, caused during the removal of the headstone. The plinth has minor corner damage.

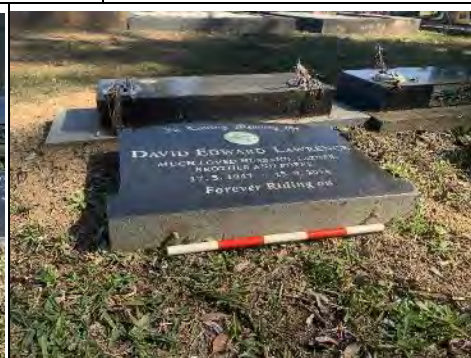
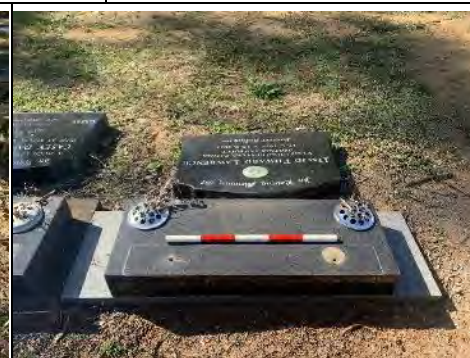
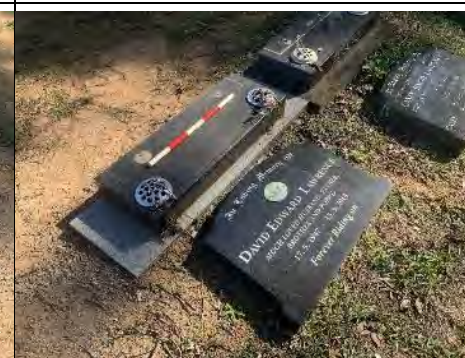
ID No.	Date of Death	Name	Description	Inscription	Condition
199	15 September 2014	David Edward Lawrence	Die on base grey granite marker, with a granite pedestal and plinth. The headstone has a square topped scotia shoulder styled arch. Flower holders are on either side of the pedestal. The headstone lies in front of the pedestal/plinth. The grave site has no border or fencing. A circular photo of the deceased on a motorbike is at the top centre of the headstone.	<p><i>"In Loving Memory Of David Edward Lawrence Much loved husband, father, brother and poppy. 17.5.1947 – 15.9.2014 Forever Riding on"</i></p>	The grave site is in good condition, with no cracking or damage evident on the headstone. The pedestal has minor damage at the original anchor site, caused during the removal of the headstone.

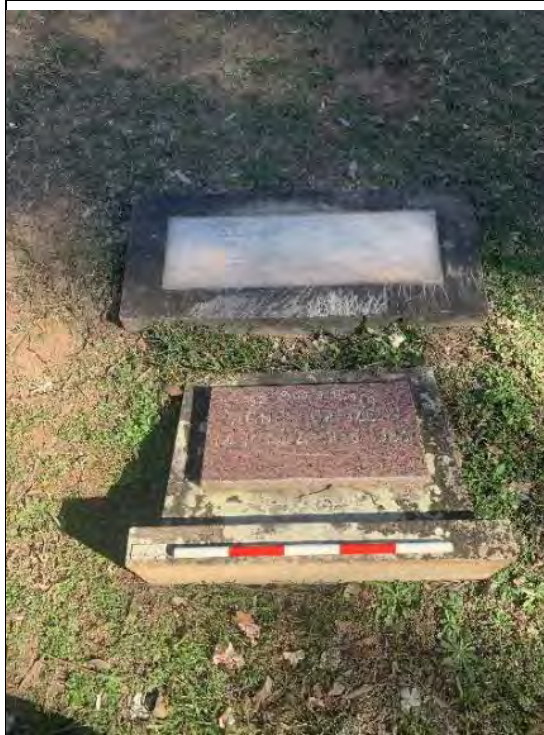
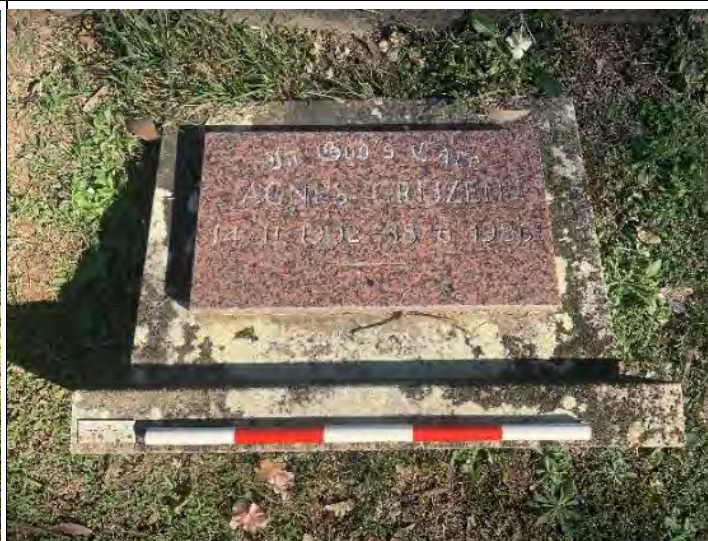
ID No.	Date of Death	Name	Description	Inscription	Condition
025	1 March 1909 14 August 1933	Donald McLeod Elizabeth McLeod	A dark slant marker upon a pedestal and plinth. Material is possibly a black granite. No ornate carving. The headstone is lying on the ground, at a small distance from its plinth. Lettering is hand carved.	<i>"Donald McLeod died 1st March 1909 'hear the voice that bids me come'"</i> <i>"Elizabeth McLeod died 14th August 1933 ' the lords may shepherd'"</i>	The grave marker is in good condition, however lichen growth has covered the top portion of the headstone making it difficult to read any underlying inscriptions. Some minor damage to the pedestal and plinth.

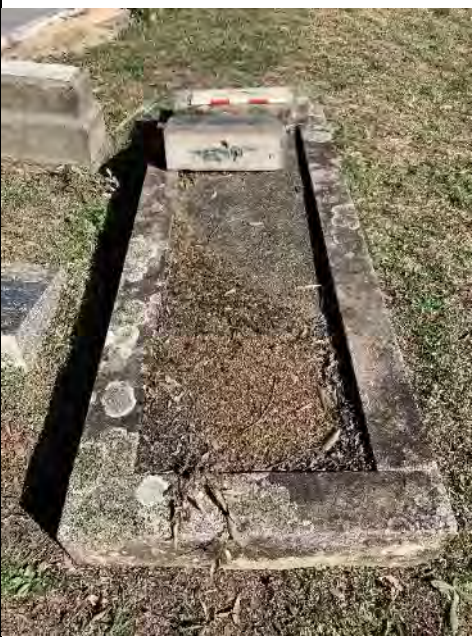
ID No.	Date of Death	Name	Description	Inscription	Condition
066	24 April 1938 18 June 1997	Reginald Claude Harris Christina Mitchell	A dark granite die in socket headstone with sandstone pedestal and plinth. The grave enclosure has a stone border and slab, topped with small white pebbles. The headstone is of a straight style with no arching or ornate carving. The headstone has been removed but remains on top of its plinth	<p><i>"In Loving Memory Of Reginald Claude Harris Died April 24. 1938. Aged 34 years Also his dear wife Christina Mitchell (formerly Harris) Died June 18. 1997 aged 87 years"</i></p>	<p>The headstone is in good condition, with no evident cracking or damage. The plinth is damaged along its border, with fragments of broken stone visible. This is recent damage and likely caused during the removal of the headstone. More aged damaged is evident on the underlying bed feature, with the corners being most affected.</p> <p>The headstone has been re-instated but not re-adhered to the plinth.</p>

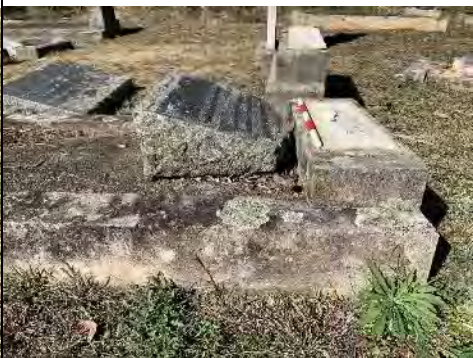
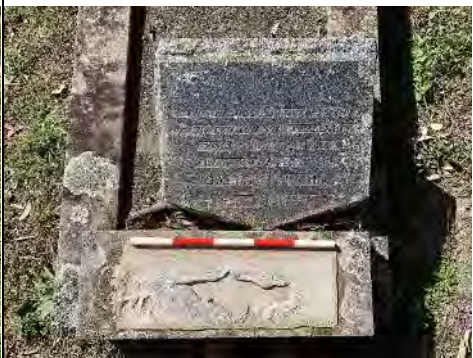
ID No.	Date of Death	Name	Description	Inscription	Condition
029	2 June 1962	William McLeod	A granite headstone in the tudor arch style with plinth. Headstone lies at the foot of the plinth. There is no ornate or decorative carving on the headstone. Grave enclosed in stone with a sunken slab.	<p style="text-align: center;"><i>“At Rest William McLeod Born 11th April 1870, died 2nd June 1962 ‘Love that will not let me rest my weary soul in thee.’”</i></p>	The headstone is in good condition, with no evident damage of cracking. Lichen is growing on the sandstone features of the grave. The grave enclosure has some cracking and moss growth.

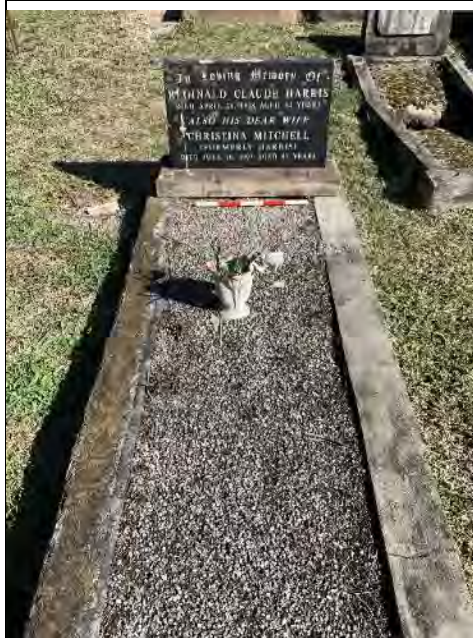
ID No.	Date of Death	Name	Description	Inscription	Condition						
070	19 August 1947	Charlotte Harris	A slant headstone of a straight style with dark granite plaque/tablet. The headstone is sandstone with the tablet is granite. The grave is enclosure features a stone surround and a slab top covered in small white pebbles. The headstone has been lain across the anchor point	<p><i>"In Loving Memory Of My dear wife & our mother Charlotte Harris Died Aug. 19. 1947 Aged 66 years"</i></p>	The grave marker is in fair condition, with small cracking but no damage evident. Some cracks are evident on the top corner portion of the stone and along the stone surround. Lichen is growing across both the stone and granite.

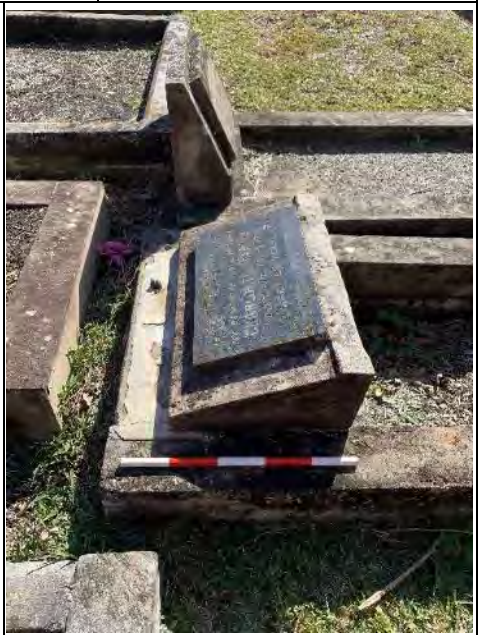
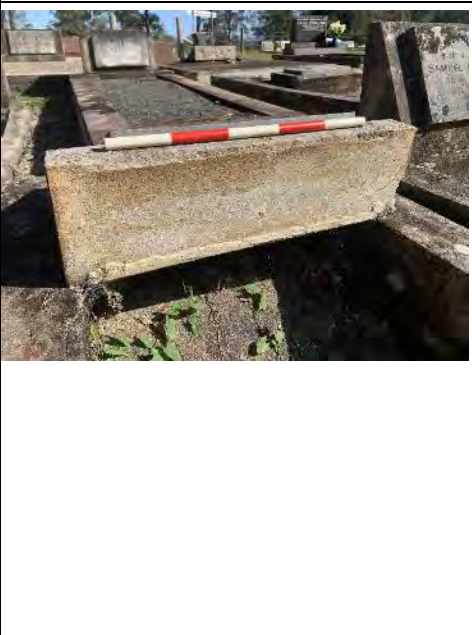
ID No.	Date of Death	Name	Description	Inscription	Condition
079	15 February 1952 10 November 1986	Madeline Blanche McDermid Archibald McDermid	A sandstone slant headstone with white marble plaque/tablet in the shape of an open book. A secondary metal plaque is found underneath the marble. The grave enclosure is framed by stone. "B. WELLS" is engraved into the sandstone base.	<p><i>"In Loving Memory Of My dear wife and our mother Madeline Blanche McDermid Died 15th Feb. 1952 aged 48 years"</i></p> <p><i>"60261 Private Archibald McDermid 1 BN A.I.E Died 10-11-1986 Aged 86 – Husband of Madeline"</i></p>	<p>The condition of the grave is fair, with some damage evident to the base/plinth of the headstone. The damage includes flaking and chipping of stone during the removal of the headstone. The detached stone is visible in the grass below. Some damaged has also occurred to the headstone itself, with some minor chipping on the back corner edge. The tablet and plaque do not appear damaged.</p> <p>The headstone has been removed from its original position, but has been placed back atop the anchor point.</p>

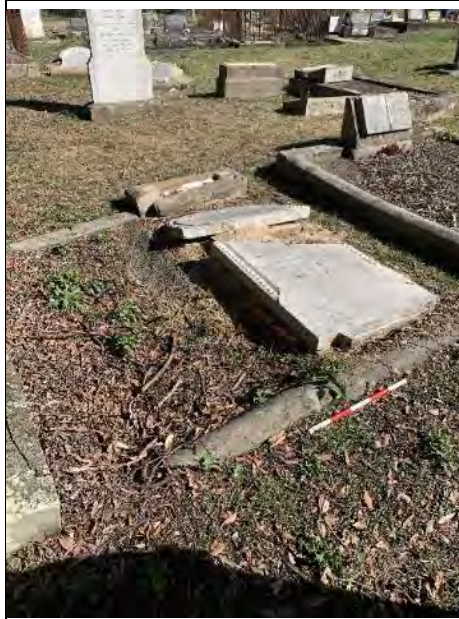
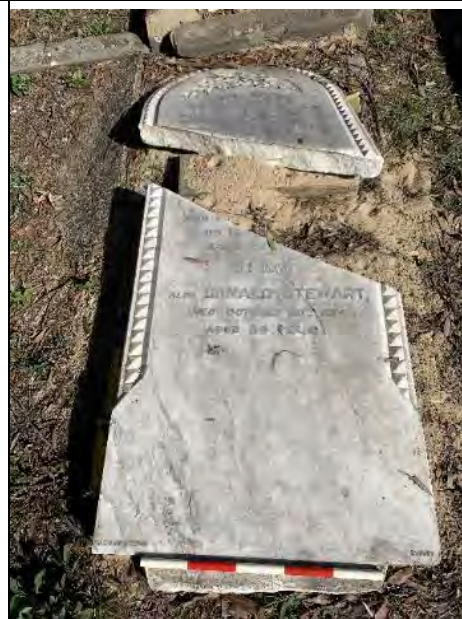
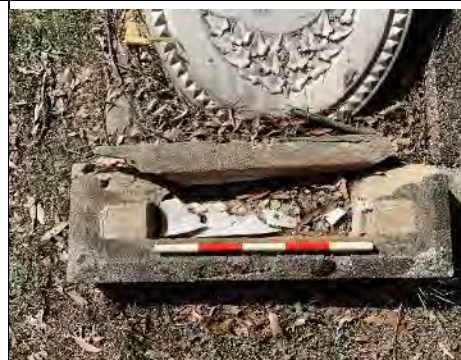
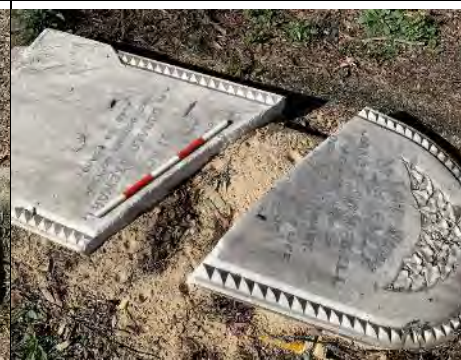
ID No.	Date of Death	Name	Description	Inscription	Condition
021	18 December 1900 30 October 1914	Janet Campbell Stewart Donald Stewart	Marble die in socket headstone enclosed within a frame. The headstone arch is basket style, with a black and white pattern found along the edges on the top 2/3 of the stone. A floral motif is carved beneath the arch. Plinth has inscribed "J. CUMMINGHAM – SYDNEY", being the stonemason.	<p><i>"In Loving memory of Janet Campbell Beloved wife of Donald Stewart who departed this life on 18th Dec. 1900 aged 64 years At rest Also Donald Stewart Died October 30th 1914 aged 89 years"</i></p>	The headstone is in poor condition, being cracked and broken at a diagonal angle through the middle. The cleanness of the cut suggests this occurred during or after the headstone was removed from its base. The plinth is also damaged, with the front portion detached from the remaining. Remnants of marble are found in the base cavity, highlighting the recent damage inflicted to the stone.

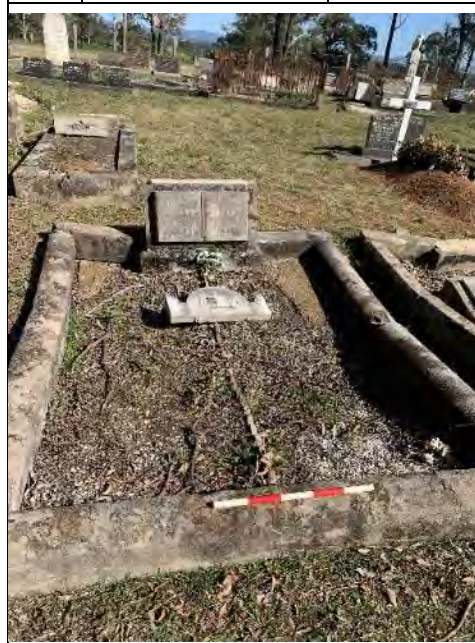
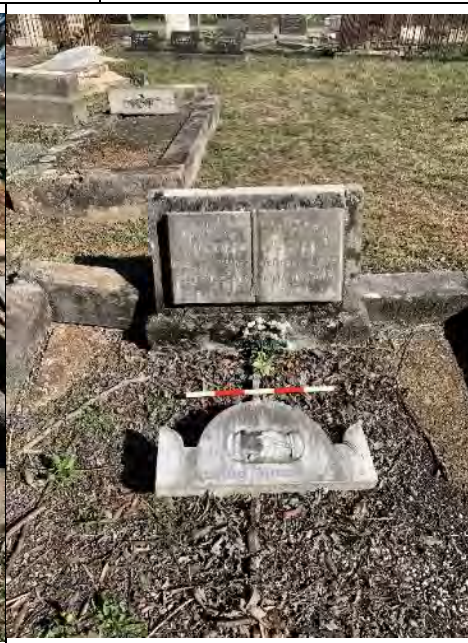
ID No.	Date of Death	Name	Description	Inscription	Condition
045	18 August 1932 7 April 1946	Donald Stewart Eliza Ann Stewart	Marble plaque/tablet in the tudor style mounted on a sandstone slant headstone and plinth. The headstone is lying at the foot of the plinth, facing into the grave. The grave site is framed in a concrete rectangular surround with a stone slab top.	<p><i>"In Loving Memory of My dear husband & our dear father Donald Stewart Died Aug. 18. 1932 aged 71 years Eliza Ann Stewart His beloved wife Died April 7. 1946 aged 84 years Thy will be done."</i></p>	The grave is in poor condition. The marble plaque/tablet is complete with no cracking or damage evident. The headstone supporting the plaque/tablet is damaged considerably, with extensive cracking across its entirety and broken pieces in the top corners. This damage has occurred after the headstone's removal from its plinth given the pattern of debris. The marble plaque/tablet is also tilted on an angle and no longer sits square in its original position. The concrete surround of the grave site is in further disrepair with extensive cracking

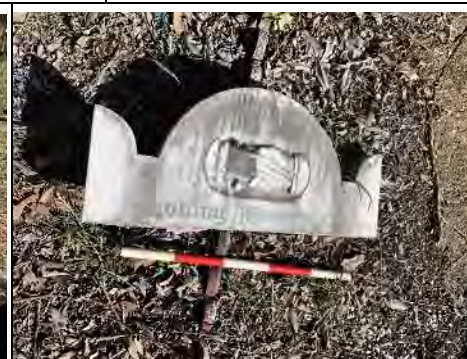
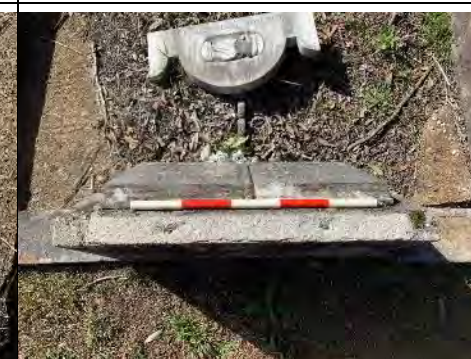
ID No.	Date of Death	Name	Description	Inscription	Condition
037	2 June 1927 23 February 1929	Janet Harman Joseph Harman	Marble plaque/tablet on a slant headstone with plinth, an ornate marble open book plaque and convex arch. The arch has been removed and lays at the base of the headstone. Two hands shaking in a formal manner is carved into the centre of the arch. The grave is encased within a concrete surround and divided into two plots by a discrete stone border.	Removed arch: <i>"In Loving Memory Of"</i> <i>"Janet Harman"</i> <i>Died June 2nd 1927 aged 70 years. At rest.</i> <i>Joseph Harman died Feb. 23 1929 aged 70 years"</i>	The grave is in poor condition. The headstone is worn, discoloured and has lichen growing over the plinth. The plinth further has cracking and damaged to the corners. The removed marble arch is complete without any evident cracking or damage aside from the point of contact where it was removed. The remaining grave plot has sunken, has cracking along the concrete surround and filled with debris and weeds.

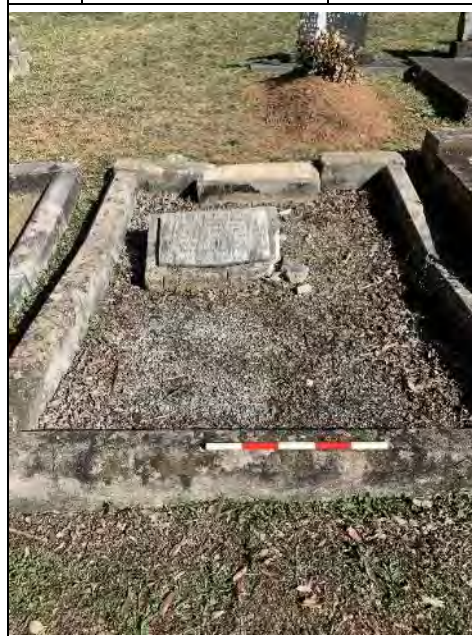
ID No.	Date of Death	Name	Description	Inscription	Condition
053	10 February 1976 31 August 1994	Joseph Albert Harman Jessie Harman	A double plot in a double enclosure, grave site decorated with white tiles. One is tiled with plain white square tiles, the other being a more ornate curved pattern with an internal darker pattern. The headstone is a flat die on base design with a sandstone backing and dark granite plaque. The gravestone is lying in front of the plinth. "EDSTEIN" is engraved in the plinth, being the name of the maker.	<p><i>"In Loving Memory of Joseph Albert Harman passed away Feb. 10th 1976 aged 76 years</i></p> <p><i>A faithful preacher of the gospel of Jesus Christ.</i></p> <p><i>Jessie Harman passed away Aug. 31st 1994 aged 95 years</i></p> <p><i>Live a life of love just as Christ loved us. EPH 5:2"</i></p>	The grave is in fair condition, with no substantial cracking or damage evident. The stone is discoloured and lichen is growing over large portions of the stone. The granite plaque/tablet is complete with no signs of damage.

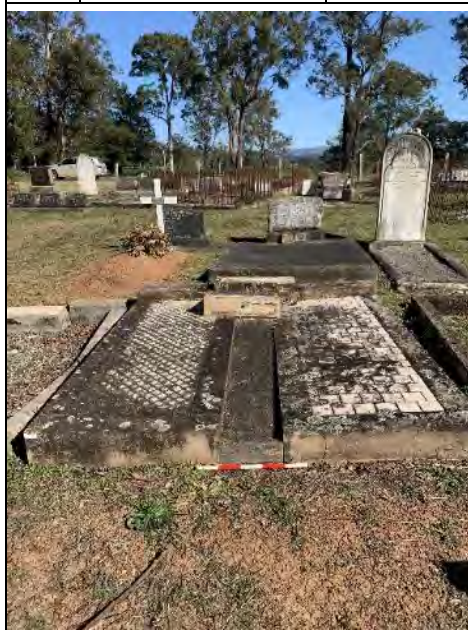
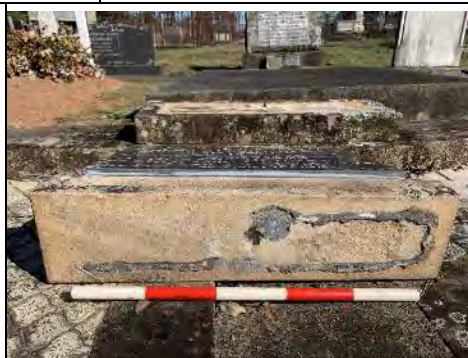
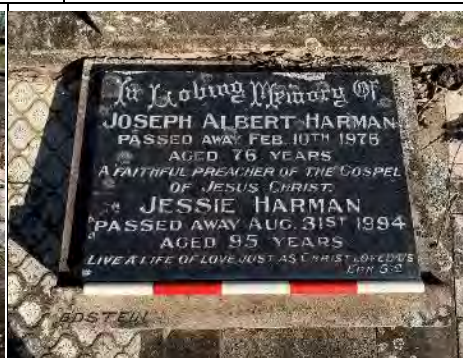
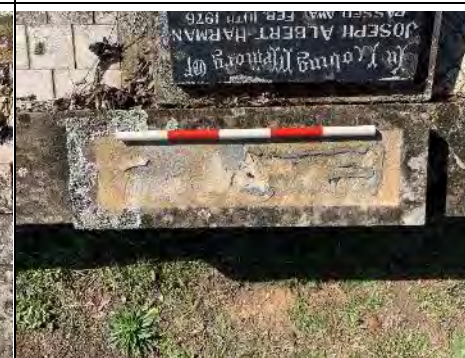
ID No.	Date of Death	Name	Description	Inscription	Condition
047	8 March 2008	Mary Jeanette Bringolf	A double plot with a dark granite die on base headstone with a serpentine arch style. The grave site has a timber surround, with a division between plots. The headstone sits upon a granite pedestal and plinth. The headstone has an engraved rose in the centre. The plinth has "EDSTEIN" engraved, being the maker.	<p><i>"In Loving Memory of Bringolf Mary Jeanette 28-5-1939 – 8-3-2008 Aged 68 years Loved wife, mother & grandmother Loved and Remembered Always"</i></p>	The headstone is in good condition. No damaged or cracks are evident. The removal from the base is smooth.

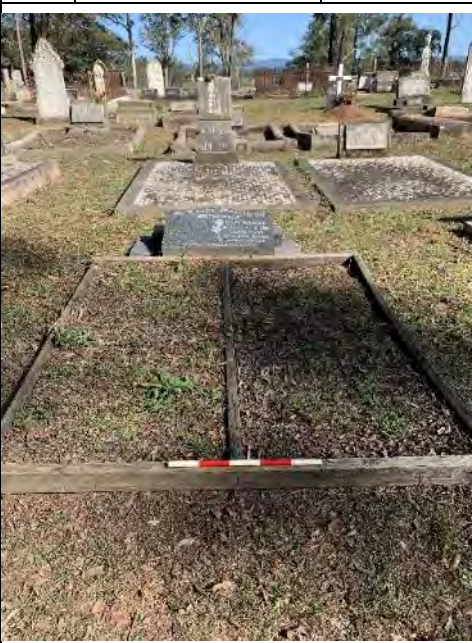
ID No.	Date of Death	Name	Description	Inscription	Condition
096	24 December 1960 8 June 1951	Archie Duncan Dennes Cecil Dennes	A pink granite headstone atop a grave enclosure. The plinth is sandstone, with the enclosure featuring a stone border with pink/orange stone tiles adorning the top. The headstone is lying in front of the plinth, with no decorative engravings.	<p style="text-align: center;"><i>"In Loving memory Of Archie Duncan Dennes Died Dec 24. 1960 aged 86 years And Cecil Dennes Died June 8. 1951 aged (8)3 years At Rest"</i></p>	The grave site is in fair condition, with no damage or cracking evident on the headstone. Significant lichen growth has made the inscriptions near unreadable. The headstone removal was smooth, leaving an even and near undamaged surface. The plinth shows no signs of damage. The stone surround has some minor cracking, as does the tile top.

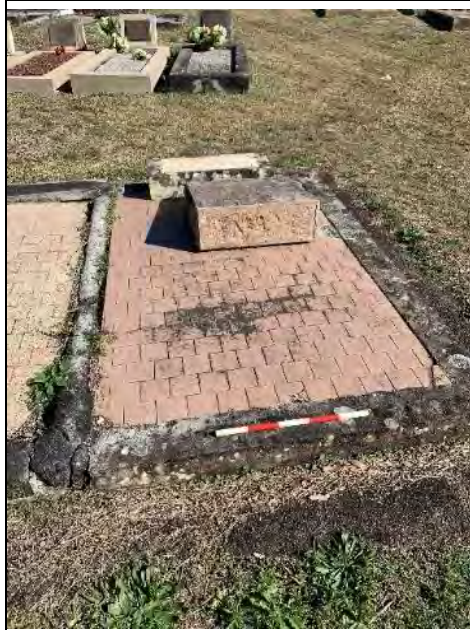
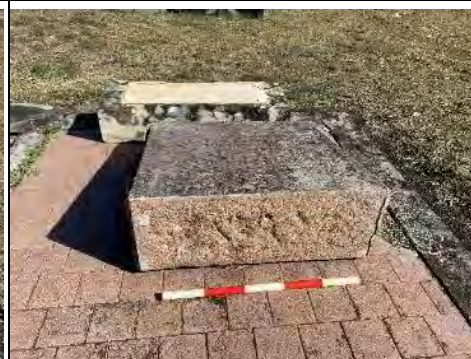
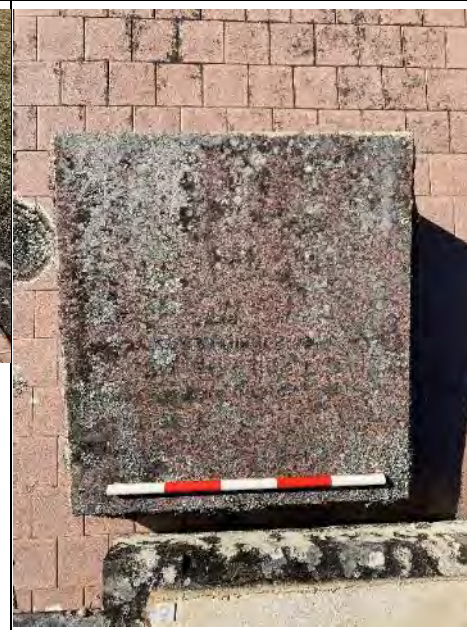
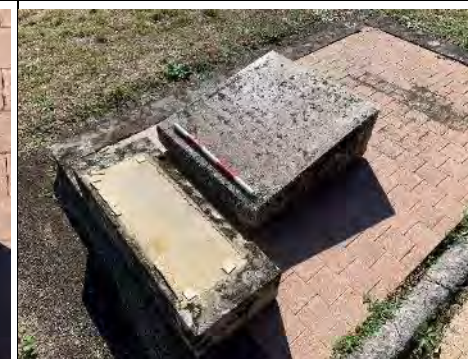
ID No.	Date of Death	Name	Description	Inscription	Condition
101	17 October 1991 28 July 2010	Reginald Charles Parbery Cecilia Mary Parbery	A double grave site with an enclosure featuring a stone surround and tiled surface. The grave marker is a die on base, with sandstone plinth and a red granite engraved headstone in a serpentine style. The headstone has two devotions and has two red roses engraved into either side of the inscriptions. A small metal plaque rests in front of the headstone.	<p style="text-align: center;"><i>“In Loving Memory Of A dear husband, father and grandfather Reginald Charles Parbery Passed away 17.10.1991 aged 75 years. A dear wife, mother and grandmother Cecilia Mary Parbery Passed away 28.7.2010 aged 90 years In Gods Care” “N- 160495- R.C Parbery S/S AUS R INR---- LEST WE FORGET”</i></p>	The grave is in good condition with no prominent cracking or signs of damage. The plinth is still attached to the headstone is laying over its original anchor point. The box tomb is in good condition, with no evident damage and minimal cracking.

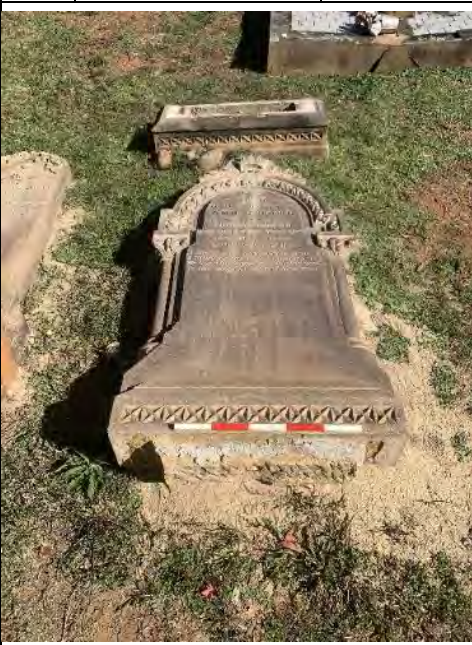
ID No.	Date of Death	Name	Description	Inscription	Condition
145	12 March 1998 7 March 2001 29 April 1995	Gwendoline Dorothy Thompson Gilbert Fulton Gulliver Thompson Florence Norris	A die on base sandstone headstone with a square top ogee shoulders arch style and plinth. The headstone has a black granite plaque/tablet with two devotions. The grave site is a double grave, with the enclosure framed by stone and featuring a white square tiled stone top. A square sandstone cube sits on top, with a vase holder for flowers. One of the graves has a small metal plaque atop its base (Norris).	<p style="text-align: center;"><i>"In Loving memory of Gwendoline Dorothy Thompson Passed away 12th March, 1998 aged 73 years. Beloved wife of Gil, loved mother of Kerry and Jennifer, grandmother and great grandmother of their children. Gilbert Fulton Gulliver Thompson 27.9.1920 – 7.3.2001 2nd/1st battalion NX9864 Beloved and loving husband of Gwendoline, caring step-parent to Kerry and Jennifer and their families."</i></p> <p style="text-align: center;">Metal Plaque reads <i>"Final resting place in God's care Florence Norris 11.12.1899 - 29.4.1995 Dearly loved"</i></p>	The headstone and base are in good condition with no evident cracking or damage. The sandstone bed is in fair condition, with some discolouration and minor damage at the top corner. A large complete crack is found at the head of the bed, likely caused by the removal of the headstone. Debris is also evident along the edge and underneath of the headstone, also likely caused by the removal. The grave has sunken into the middle division line.

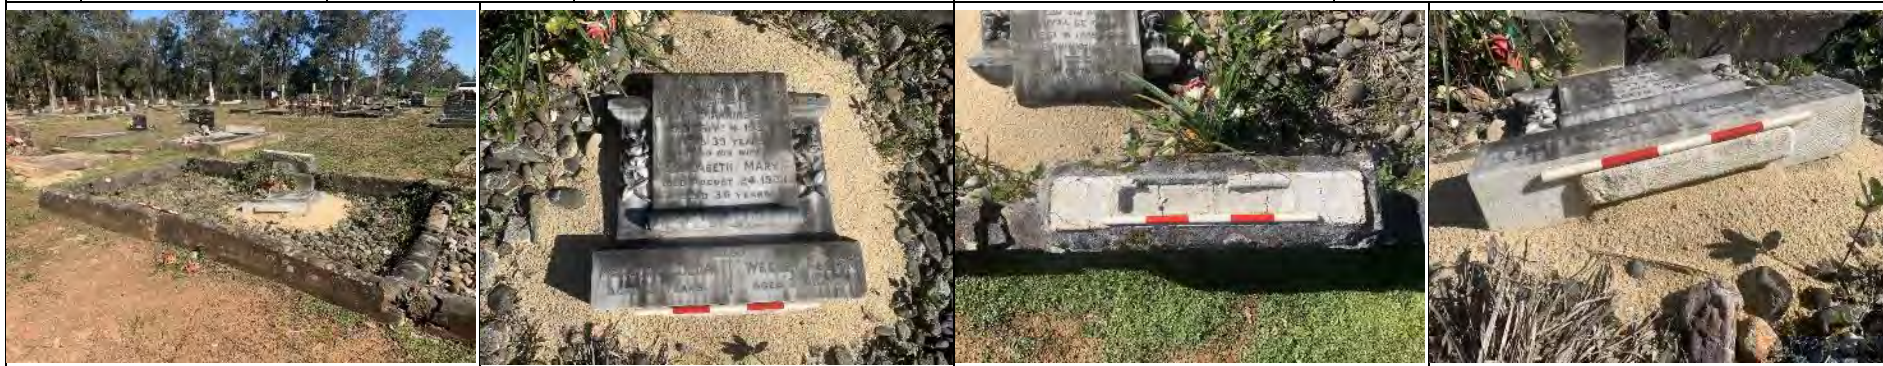
ID No.	Date of Death	Name	Description	Inscription	Condition
170	27 December 1939 14 May 1936	Edward Brown Sarah Susannah Brown	A slant grey granite headstone with a sandstone plinth. The granite is engraved into an open book, with two devotions. The grave is framed by a stone surround and infilled with river pebbles. The plinth has "RESTING" engraved at the front.	<p><i>"In Loving Memory Of Edward Brown Died Dec. 27. 1939 aged 92 years.</i></p> <p><i>And Sarah Susannah Beloved wife of Edward Brown Departed with life May 14th 1936 aged 79 years."</i></p>	The grave is in moderate condition, with cracking and damage evident along the length of the stone surround. The grave has sunken into the middle. The underside of the headstone shows damaged inflicted during the removal process, with a rough uneven surface and pieces of missing granite. The headstone is in fair condition, with no cracking or damage evident. Lichen is growing across the inscriptions. The plinth has damage on top due to the removal, with an uneven and rough surface.

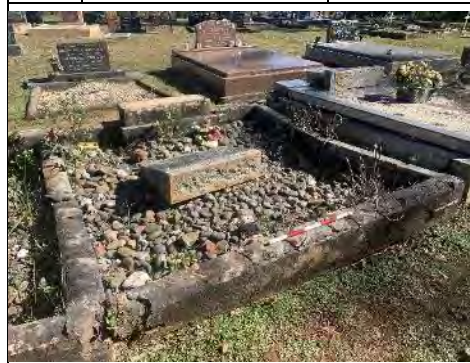
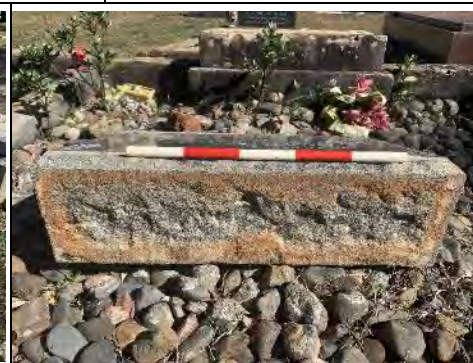
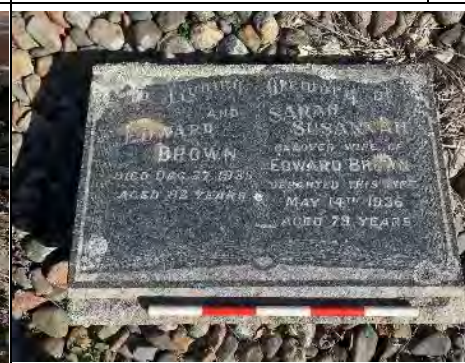
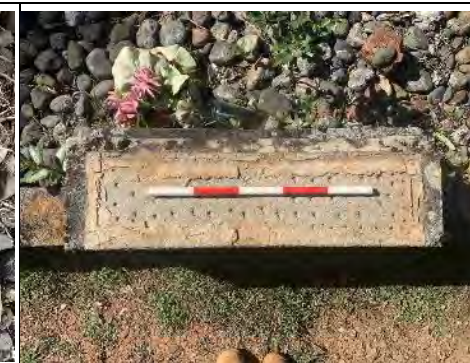
ID No.	Date of Death	Name	Description	Inscription	Condition
181	7 November 1966 24 March 1969	James Vernon Brown Myrtle May Brown	A die on base marker with a black granite headstone on a grey/blue tiled base. The headstone has a tudor styled arch. The grave site is a double grave, with a double devotion on the headstone. The inscriptions "MUM" and "DAD" are at the foot of the individual graves. A grey/blue tiled vase holder sits on the top middle of the graves. The headstone is laying upon the original anchor point.	<p><i>"Cherished Memories Of James Vernon Brown Beloved husband of Myrtle & loving father of Phyllis, Rita, Edward and Hugh. Departed this life 7th Nov. 1966 aged 70 years. Also loved wife & mother Myrtle May Departed this life 24-3-69 aged 71 years. "Thy will be done"</i></p>	The headstone is in good condition, with no cracking or damage evident. The grave site is in fair condition, with cracking and damage evident on the bottom front corners of the plinth. Minor cracking is evident on the tiled top of grave enclosure. Lichen and moss grows across much of the grave.

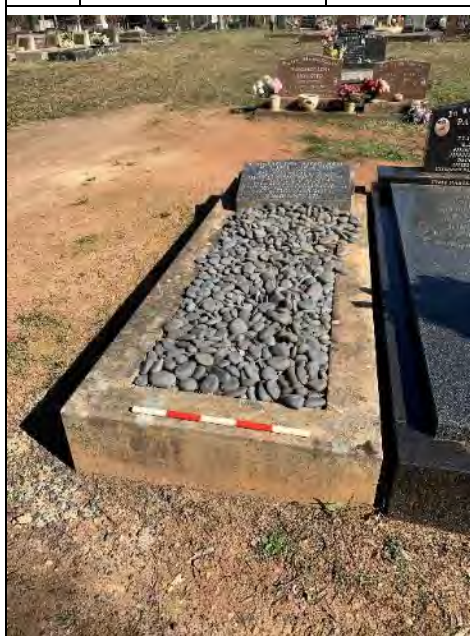
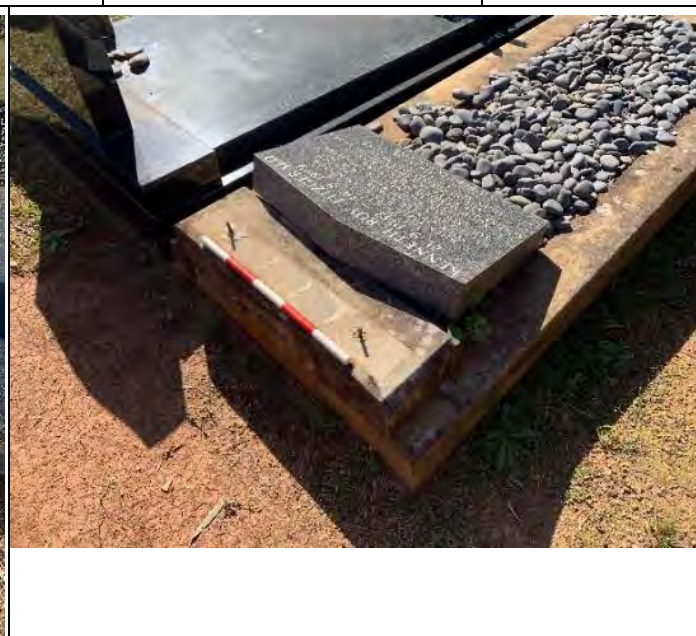
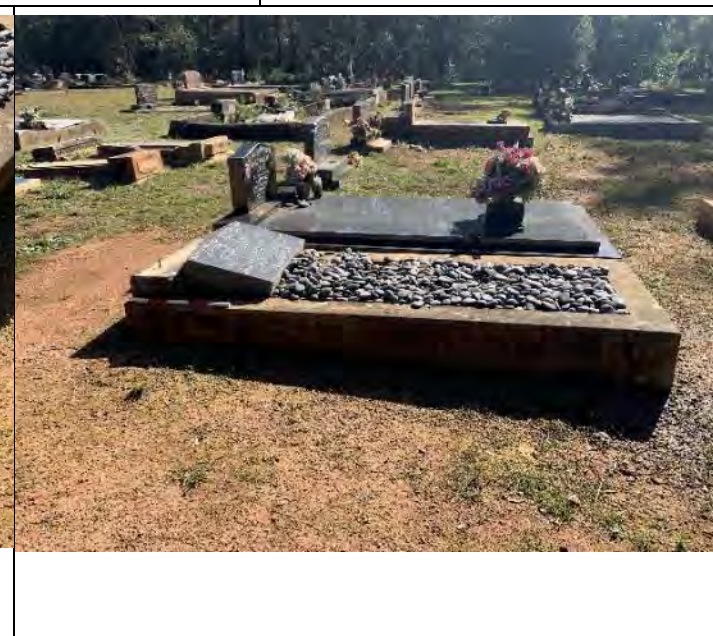
ID No.	Date of Death	Name	Description	Inscription	Condition
140	15 October 1999	Kevin John Jones	Die on base pink granite headstone with a serpentine styled arch. The headstone is upright in front the original anchor point, with the plinth attached. The grave enclosure is made of sandstone with a pink stone square tile covering. A single sandstone flower holder sits in the middle of the enclosure.	<p><i>"In Loving Memory Of Kevin John Jones 6.3.1949 – 15.10.1999 Father of Paul and Laura, Kate Sadly missed by all who loved him"</i></p>	The headstone is in good condition with no evident cracking or damage. The anchor point has visible solvent. The sandstone border has some minor cracking.

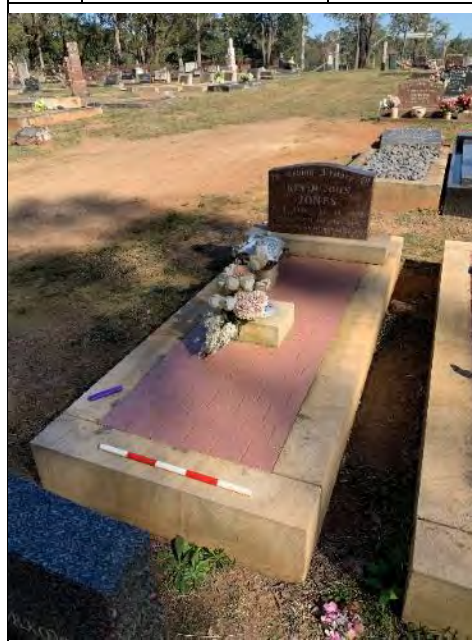
ID No.	Date of Death	Name	Description	Inscription	Condition
148	23 November 1999 7 July 2004	Robert Francis Jones Olive Mary Jones	Die on base pink granite headstone with serpentine arch style and attached plinth. The grave enclosure is made of sandstone with a pink stone square tile covering. The site is a double grave with two sandstone flower holders on either side of the enclosure. The headstone has two devotions. The gravestone is lying a top the original anchor point.	<p><i>"In Loving Memory Of Robert Francis Jones 12.3.1918 – 23.11.1999 A dear husband, father and grandpa Olive Mary Jones 3.12.1921 – 7.7.2004 A dear wife, special mother & nan Always in our hearts, always remembered"</i></p>	The grave site is in good condition, with no evident cracking or damage. The underside of the headstone has residual solvent used to adhere the plinth to the underlying enclosure.

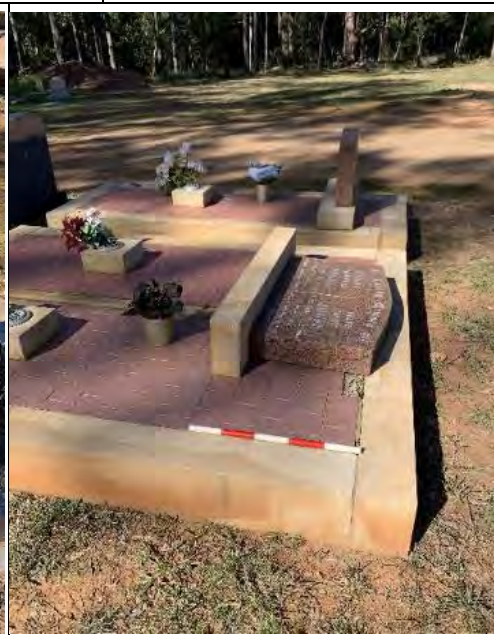
ID No.	Date of Death	Name	Description	Inscription	Condition
243	5 December 1956 22 February 1951	Margaret Lyall Parsons Frederick W. Parsons	Die on base headstone in black granite. The marker is divided into two devotions. The headstone is laying in front a granite pedestal and plinth, with the metal supports jutting from the pedestal. The headstone is in a tudor style. There is no framing or bordering of the grave site. The plinth is inscribed "CAITES".	<p style="text-align: center;"><i>"Parsons In Loving Memory Of Our dear parents Margaret Lyall Died Dec. 5 1956 aged 60 years Frederick W. Died Feb 22 1951 Aged 62 years.</i></p>	The grave marker is in good condition, with no evident cracking or damage. There is some yellow/brown discolouration of the plinth. This is likely caused by adhesive used to secure the gravestone to the plinth. Minor damage to the front corners of the plinth.

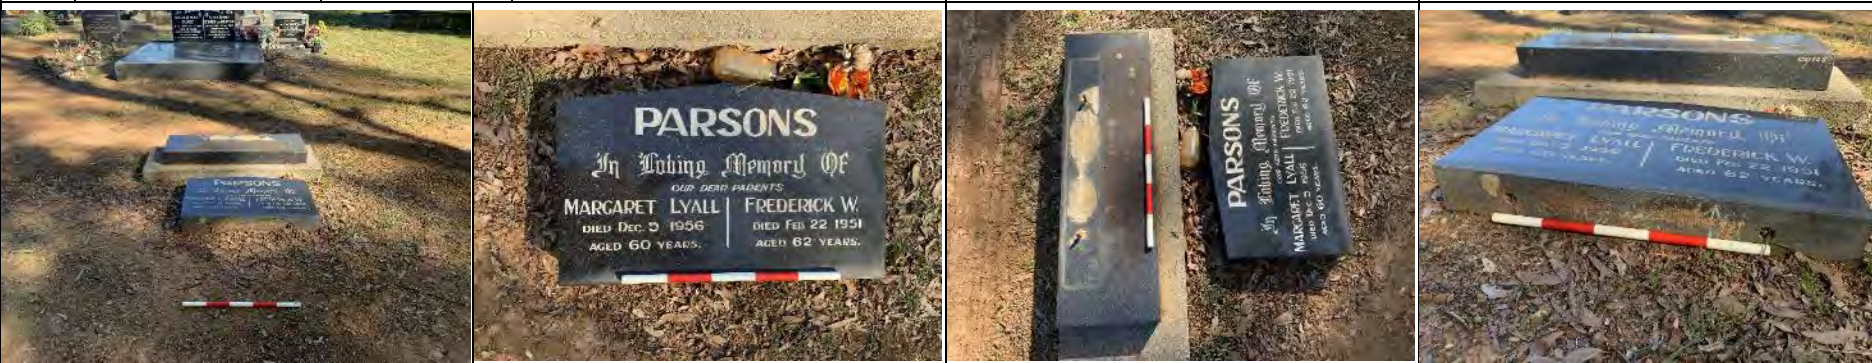
ID No.	Date of Death	Name	Description	Inscription	Condition
030	1 October 1991 25 June 1978	Jeanie Cameron Kirton Harry Heywood Kirton	A double plot with a raised enclosure, each side decorated with small white and black square tiles. The headstone is a die on base design in dark granite with a carved open book motif. The headstone is in its original position, but has been removed from the enclosure.	<p style="text-align: center;"><i>"In Loving Memory Of Jeanie Cameron Kirton passed away Oct. 1. 1991 aged 87 years Harry Heywood Kirton passed away June. 25. 1978 aged 74 years In Gods Care"</i></p>	<p>The headstone is in good condition, with no cracks or damaged evident. Lichen is growing over much of the gravestone and its base.</p> <p>The headstone has been removed from the enclosure, and is not longer adhered to the stone below.</p>

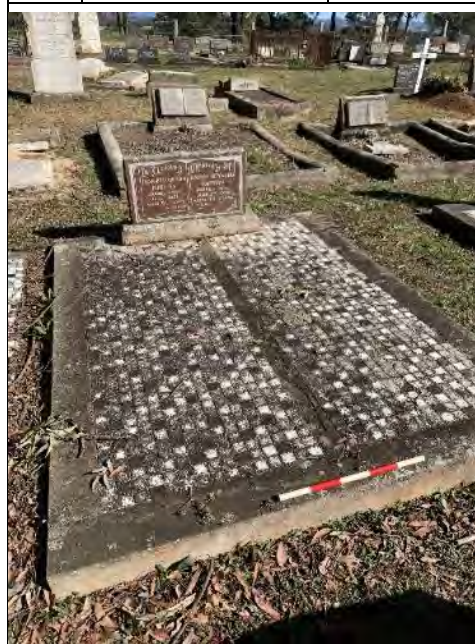
ID No.	Date of Death	Name	Description	Inscription	Condition
098	19 January 1992	John L. Brown	Upright headstone on a plinth, with two empty vase slots on either side of the headstone. A metal plaque is fixed to the angled surface of the headstone. The headstone has been removed from its original anchor point, however remains upright. The grave is bordered by a rounded stone surround.	<p style="text-align: center;"><i>“John L. Brown 10.10.1920 – 19.1.1992 Loved By All”</i></p>	The grave is in moderate condition, with the stone surround cracked and broken in multiple locations. The grave has sunken into the earth and lichen is growing both on the headstone and the stone border. There is no cracking or damaged evident on the headstone or plinth.

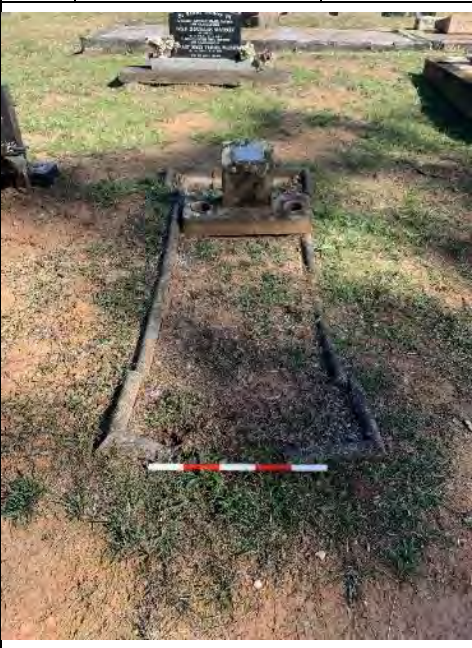
ID No.	Date of Death	Name	Description	Inscription	Condition
160	2 June 1992	Wylie Richard Anderson	Die on stand pink granite headstone with a curved oval arch style. The headstone has ornate flower motifs engraved into either side of the inscription. A photo within a small oval frame is visible on the front centre of the plinth. The marker is upon a two-tiered enclosure, with the upper tier consisting of pink granite topped with yellow stone tile. The bottom tier is made of stone. A granite plaque is found at the bottom of the bed with stone carved pink flowers. The headstone is laying upon the original anchor point.	<p><i>"A Tribute of Love To a dear son and brother Wylie Richard Anderson 1.6.1983 – 2.6.1992 Aged 9 years Long days and nights he bore with pain to seek for rest all in vain till god himself who thought it best to end his suffering gave him rest"</i></p>	The grave site is in fair condition, with no damage or cracking evident on the headstone. Some damage is evident at the corner of the bed slab. The bottom stone tier of the enclosure has further cracking and damage at the corners and along the edges. Solvent is visible on the underside of the headstone. Lichen is growing upon the headstone and bed slab.

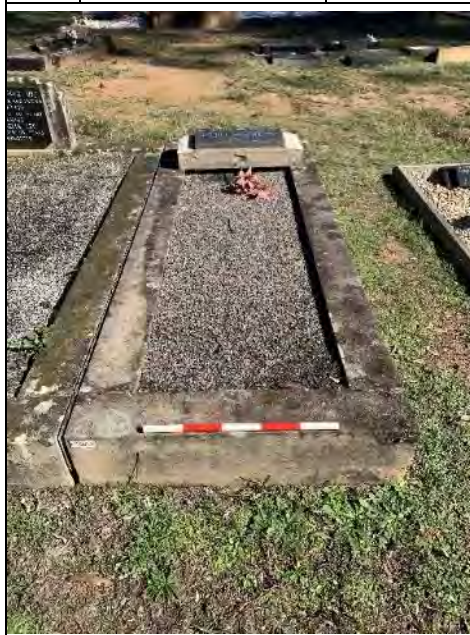
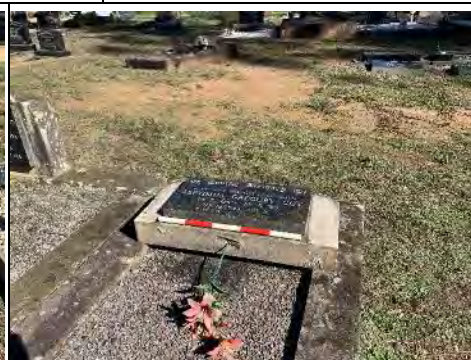
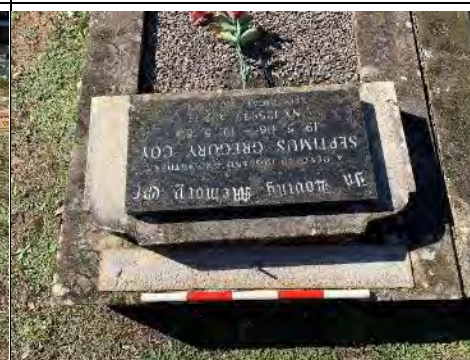
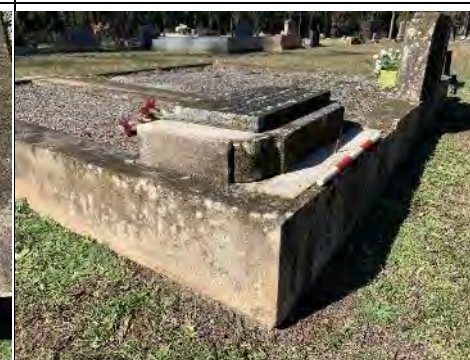
ID No.	Date of Death	Name	Description	Inscription	Condition
201	19 May 1980	Septimus Gregory Coy	A stone oval top scotia shoulders styled headstone with no base, supporting a and black granite plaque/tablet. The grave enclosure has a stone border and is topped with a slab and small pebbles. The headstone is laying on top of the original anchor point, metal supports exposed.	<p style="text-align: center;"><i>"In Loving Memory Of A devoted husband and father Septimus Gregory Coy 19.5.06-19.5.80 NX 125933 A.I.F Reo----cat -- -----"</i></p>	The grave site is in fair condition, with no evident cracking or damage. There is, however, evidence of general wear and age. The stone border of the enclosure and the granite plaque/tablet has lichen growth, covering some of the inscriptions. The headstone has some damage on the underside due to the removal process.

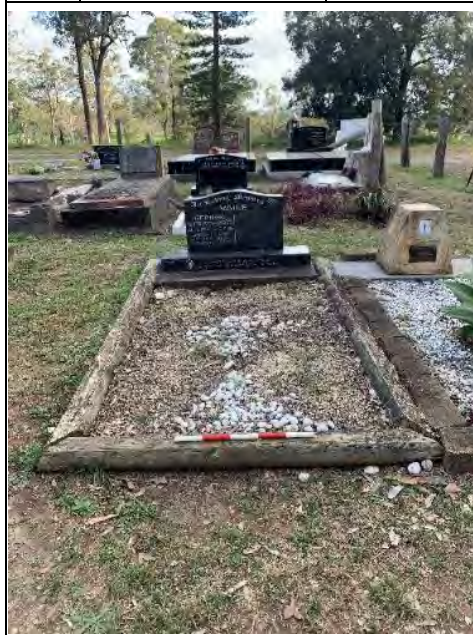
ID No.	Date of Death	Name	Description	Inscription	Condition
087	1 February 1997	Betty Colina Berriman Derry and Desiree (infants)	A slant sandstone headstone with a metal plaque/tablet centred. The grave enclosure is framed by sandstone and infilled with red stones.	<p><i>"In Loving memory Of Our mother, grandmother, great-grandmother and friend Betty Colina Berriman Wide of Ron Sadly missed Born 16.2.1924-Died 1.2.1997 And in memory of their twin babies Derry and Desiree Born 3.1944"</i></p>	The grave site is in good condition, with minor cracks to the headstone. The headstone has been detached from its anchor point, but remains a top it. It does not appear to have been re-adhered to the anchor point.

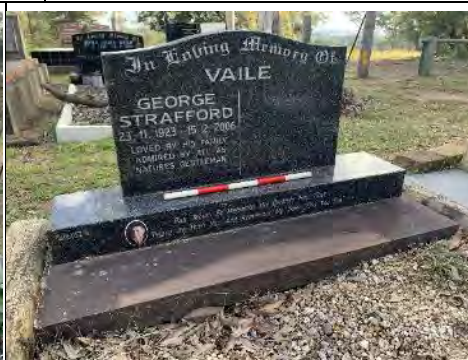
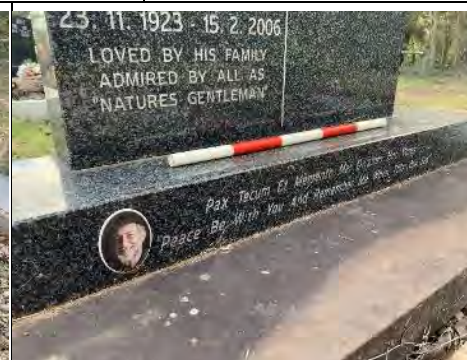
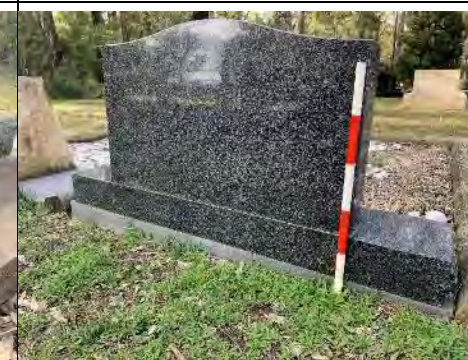
ID No.	Date of Death	Name	Description	Inscription	Condition
205	15 February 2006	George Strafford Vaile	<p>A die on base headstone in black granite, with a pedestal and plinth base and no decorative engraving. The headstone has an ogee styled arch. The site is a double grave. The grave is framed by a timber surround, infilled with pebbles and natural material. A small portrait of the individual is visible at the front of the pedestal.</p> <p>The pedestal is inscribed <i>"Pax tecum et memento mei quando hoo vices"</i> <i>"Peace by with you and remember me when this you see"</i></p>	<p><i>"In Loving Memory Of Vaile George Strafford 23.11.1923 – 15.2.2006 Loved by his family, admired by all as natures gentleman"</i></p>	<p>The grave is in good condition, with no evident cracking or damage. Some weed growth has began growing in the cavity of the grave, and the timber surround has begun to discolour.</p> <p>The headstone appears to be in its original location. It is unclear if the headstone has been re-instated or re-adhered.</p>
