THE BIGHT CEMETERY, THE BIGHT

Conservation Management Plan

Prepared by
Umwelt (Australia) Pty Limited
on behalf of
MidCoast Council

Project Director: **Tim Adams**
Project Manager: **Karyn Virgin**
Report No. **20100/R01**
Date: **May 2021**

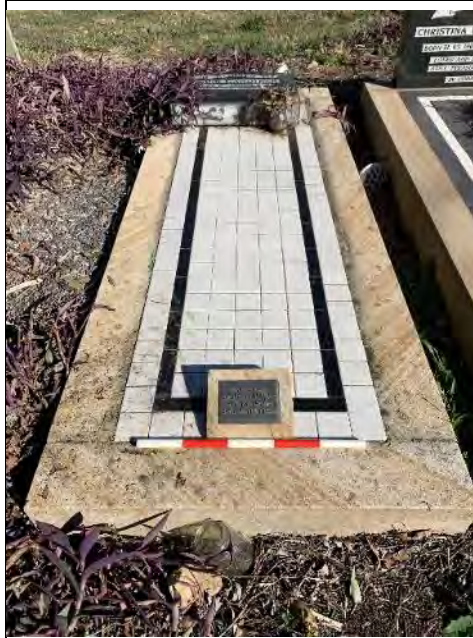
ID No.	Date of Death	Name	Description	Inscription	Condition
103	27 April 1988 24 September 1992	Elise Isabel Young Hepburn Young	A double grave site with double devotion. A die in base headstone, with a pink plaque/tablet. The headstone has a square topped ogee arch. The grave enclosure features a stone borders with yellow square tiles atop each grave. The headstone is on its original anchor point.	<p><i>"In Loving memory Of Elise Isabel Young Passed away April 27th 1988 Aged 82 years Hepburn Young Passed away Sept 24 1992 Aged 89 years"</i></p>	<p>The grave site is in fair condition, with no cracking or damage on the enclosure. There is no cracking or damage evident on the headstone or plaque/tablet. Lichen is growing along the border and gravestone. General discolouration of the stone and tiles.</p> <p>It is not clear as to whether or not the headstone has been re-adhered to its anchor point.</p>

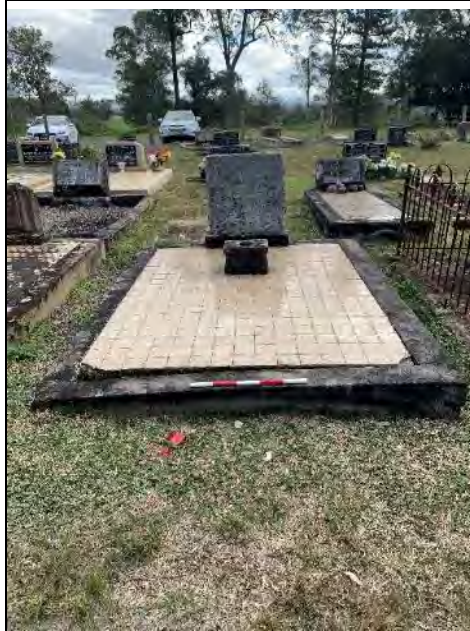
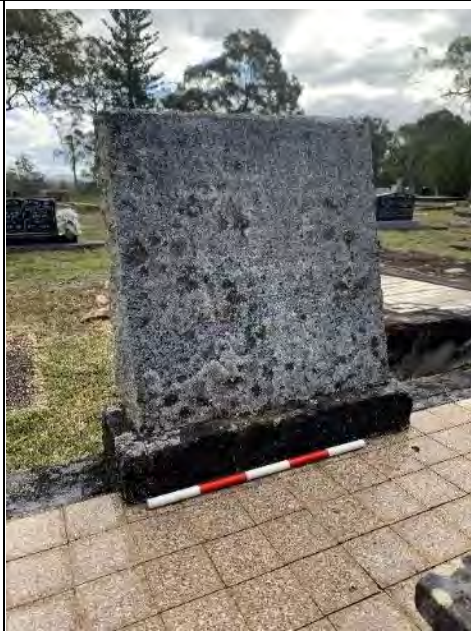
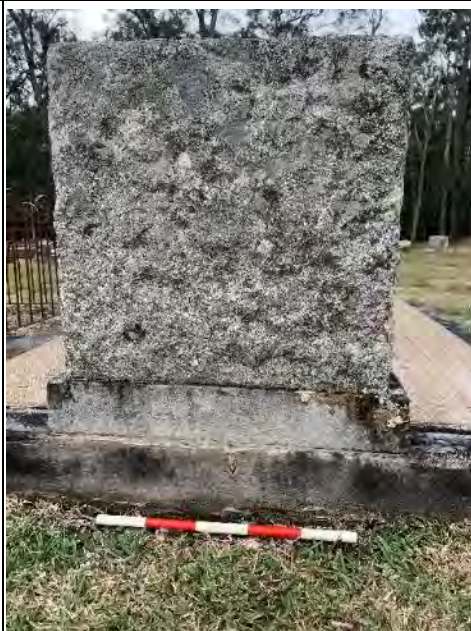
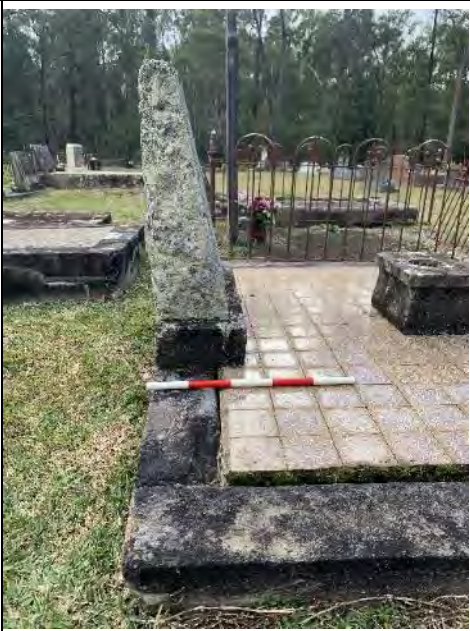
ID No.	Date of Death	Name	Description	Inscription	Condition
110	1906 1914 1945	Thomas Henry Lambert Mary Ann Lambert James Lambert	A grey granite slant headstone with plinth. The grave enclosure features a stone border and yellow square stone tiled top. A stone cubed vase holder is centre top of the slab. The site is likely a double plot. The headstone is in its original anchor position.	Illegible	The grave is in moderate condition. There is minor cracking/damaged evident along the stone enclosure frame. The headstone is extremely weathered/impacted by lichen. The inscriptions are illegible. The headstone does not appear to have been re-adhered to its anchor point.

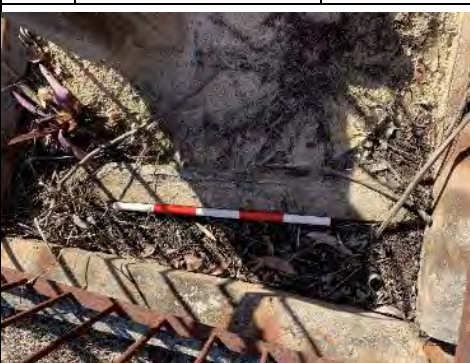
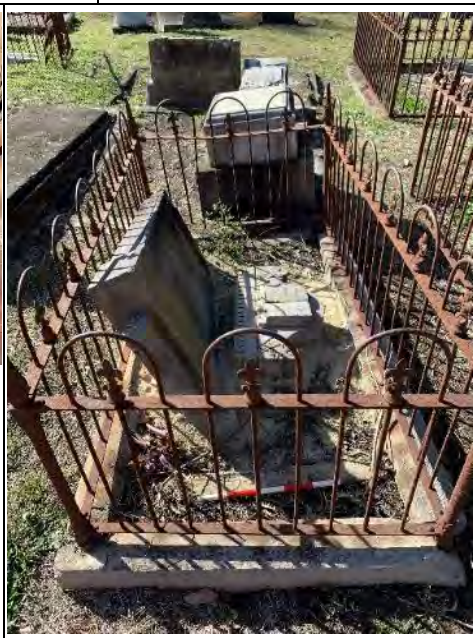
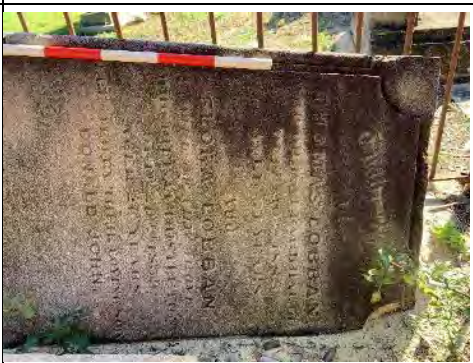
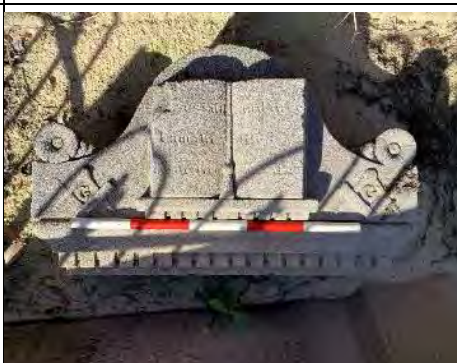
ID No.	Date of Death	Name	Description	Inscription	Condition
039	30 December 1883 20 October 1859	Thomas Lobban Flora Lobban	Sandstone headstone with an open book style header (removed) of an ornate serpentine curved style. The grave has an iron fence surround. The headstone is lying perpendicular on the ground. The book header is inscribed.	<p><i>“To the memory of Thomas Lobban, who died at Tarkhaugh Dec 30th 1883 aged 54 years</i></p> <p><i>And Flora Lobban wife of the above, who died at Thistleton, October 20th 1859 aged 26 years</i></p> <p><i>Erected by their loving son Donald John”</i></p>	The headstone is in fair condition, however it has been removed from its original position with the plinth exposed. Some small structural damage to the headstone below the inscription and to the corner of the book header, destroying a portion of inscription. Inscription of book header is not comprehensible. Removal of the header has caused some minor damage to the top of the headstone and base of the header.

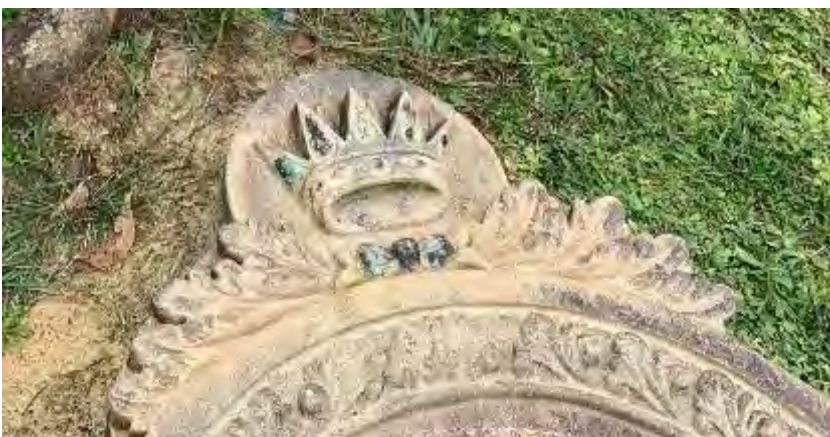
Similarly, the five pointed crown represents Christ and his wounds. Grave of Ann Brown (1879).

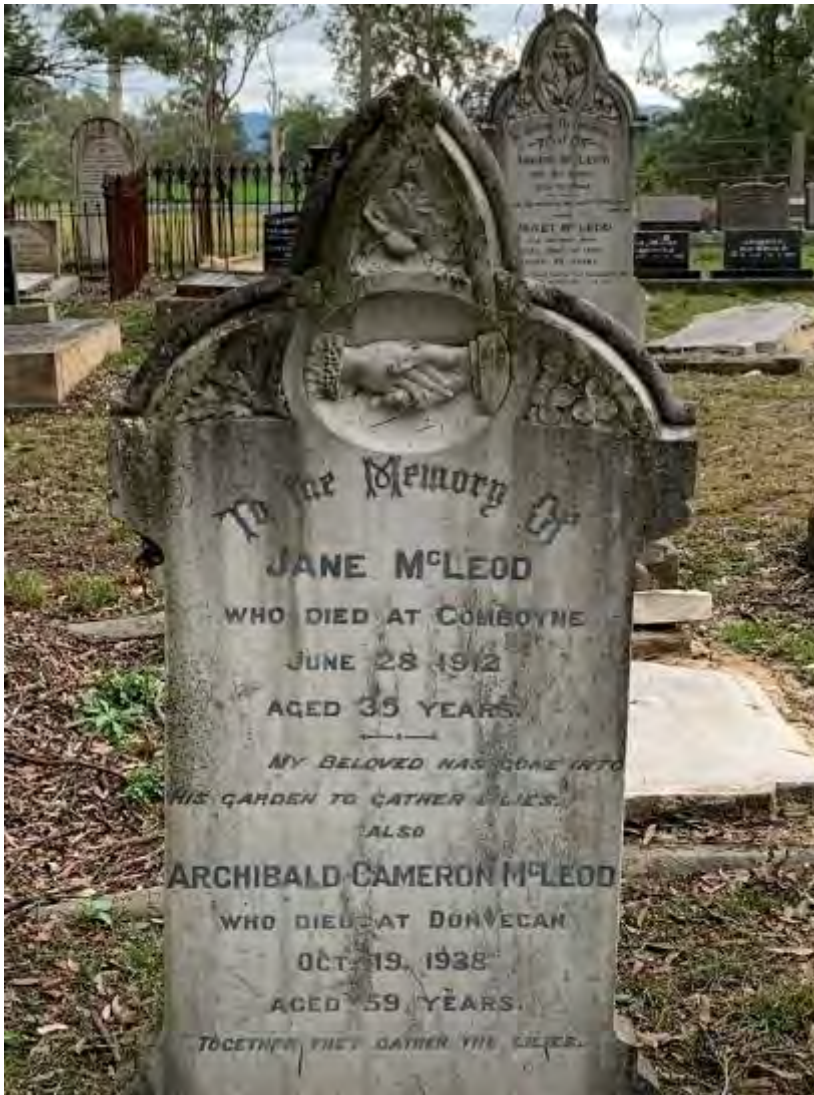
Common Victorian grave symbol of clutched hands used for husband and wife representing meeting again in heaven. Grave of Jane (1912) and Archibald Cameron McLeod (1938).

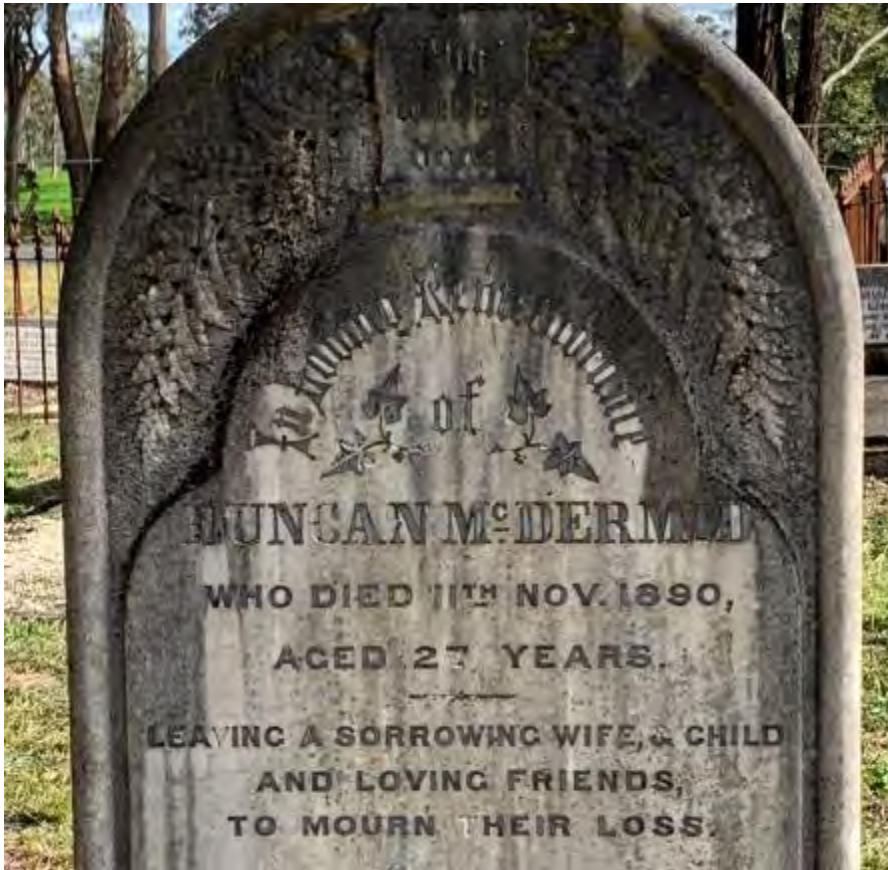
Many graves in the Cemetery have fern and ivy motifs. Ferns represent sincerity and solitude, while ivy promises faithfulness and eternal love.

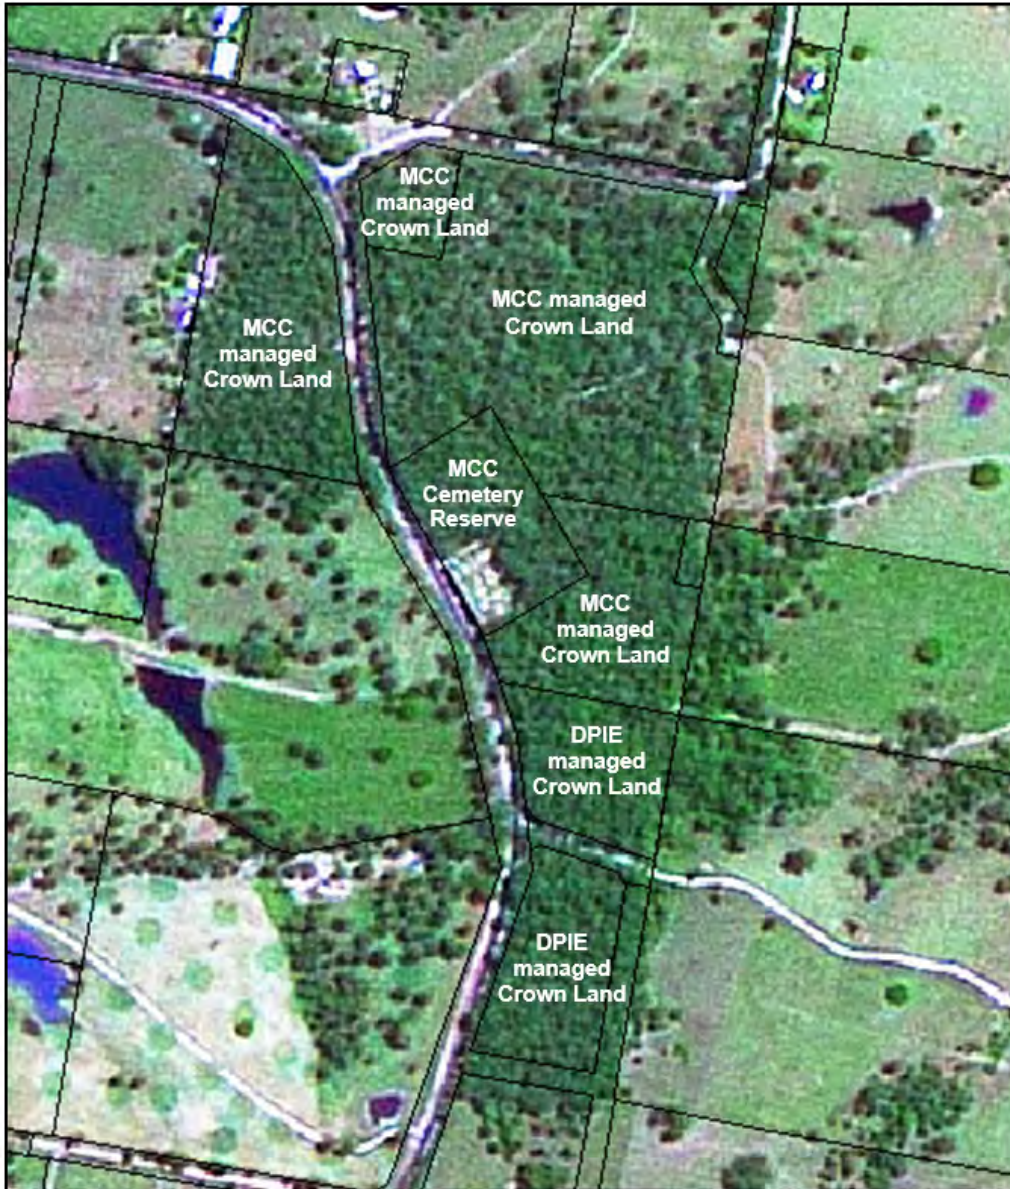
Figure 1 Wingham Bight Cemetery and surrounding Crown Lands

The proposed works would be undertaken on Lot 1 DP 1155351, Lot 7015 DP 1001487, Lot 269 DP 753202, Lot 7001 DP 10011488, Lot 7002 DP1027058, Lot 7003 DP 1027058, Lot 7004 DP 1001486, Lot 7301 DP 1156555, at Wingham Bight Cemetery in Mid Coast Local Government Area. Approximately 0.5 ha will be affected by the actions in the Management Plan (Figure 1).
