THE BIGHT CEMETERY, THE BIGHT

Conservation Management Plan

Prepared by Umwelt (Australia) Pty Limited on behalf of MidCoast Council

Project Director: Tim Adams Project Manager: Karyn Virgin Report No. 20100/R01 Date:

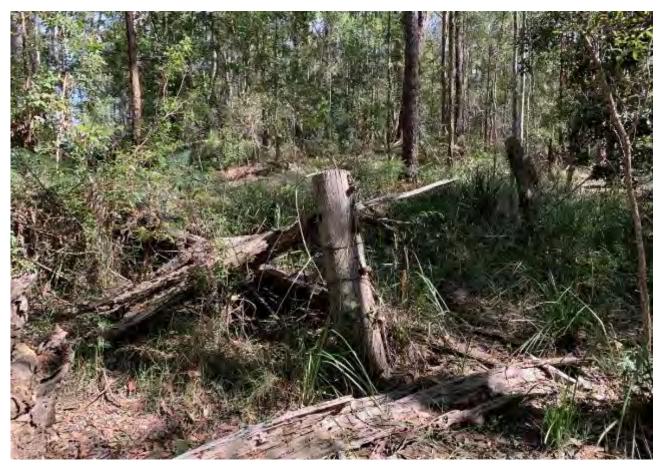
Plate 4.5 View of the southeast corner of remnant boundary fencing, showing the *in situ* corner post © Umwelt, 2020

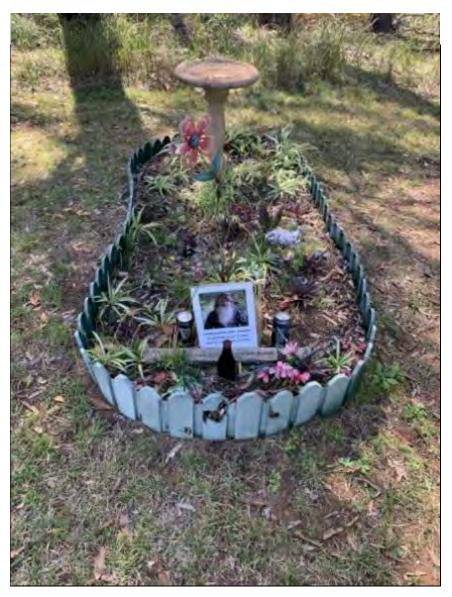
Plate 4.11 Example of a grave (Christopher Hannan) with no formal grave marker present (ID209) © Umwelt, 2020

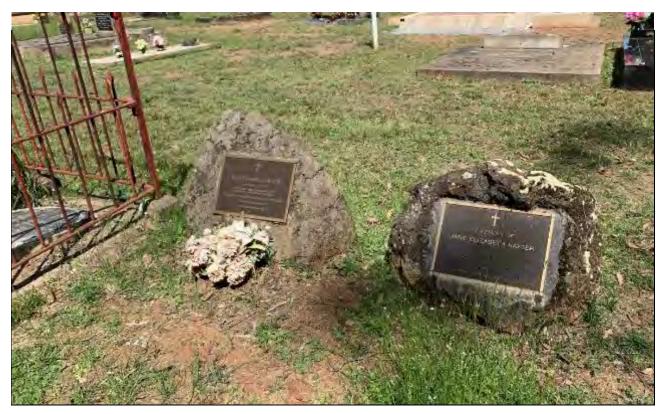
Plate 4.12 Stone grave markers (Dr. Ross and Jane Hayter) at the Cemetery (ID234 and ID237) © Umwelt, 2020

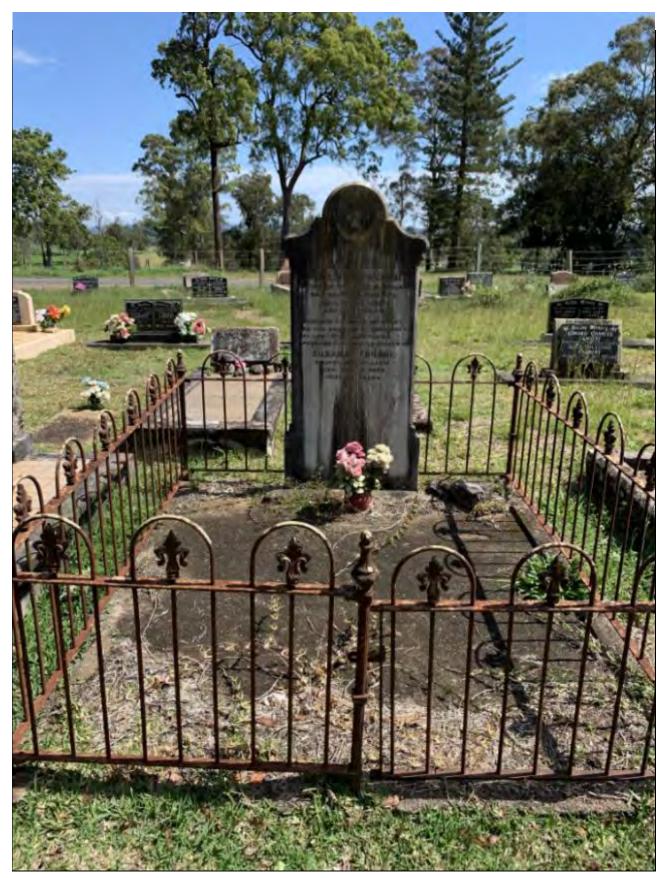
Plate 4.14 Marble stelae grave marker (William and Susana Froude) with a low-set tomb surrounded by a cast-iron surround (ID120)

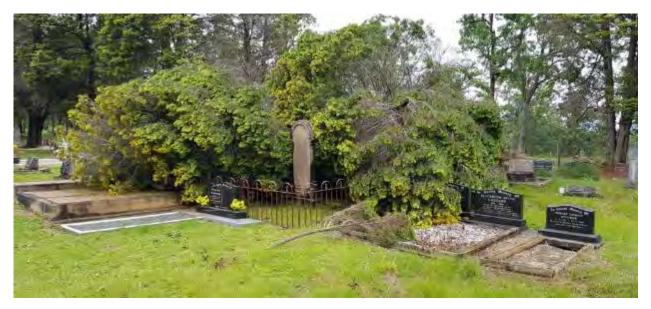
Until 2018, the front (western) fenceline of the Cemetery, which fronts Tinonee Road, was marked by a row of Golden cypress trees (*Cupressus macrocarpa*). In December 2018, two of these trees were impacted by a severe storm. The two trees were blown over and into the Cemetery, with their fall causing damage to several graves. Following this and to avoid further impacts of this nature, the remaining Golden cypress trees were removed from the front boundary of the Cemetery; an arborist report undertaken at the time showed that structural failures were evident even those trees that remained standing after the storm (MCC pers. comm.). Following the removal of the row of trees, MidCoast Council committed to planting a new row of trees more suited to the conditions as part of a wider beautification program.⁴ These planting works have not yet been undertaken, but are scheduled to occur following the repair of damaged grave markers.

Plate 4.15 View of fallen Golden cypress trees in December 2018

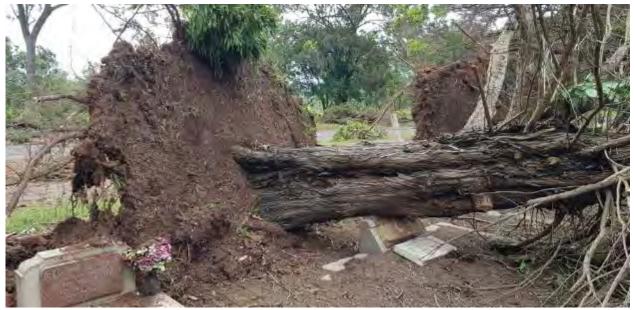
Plate 4.16 Detailed view of damage to grave markers as a result of fallen trees, December 2018 © Courtesy of Peter Langdown

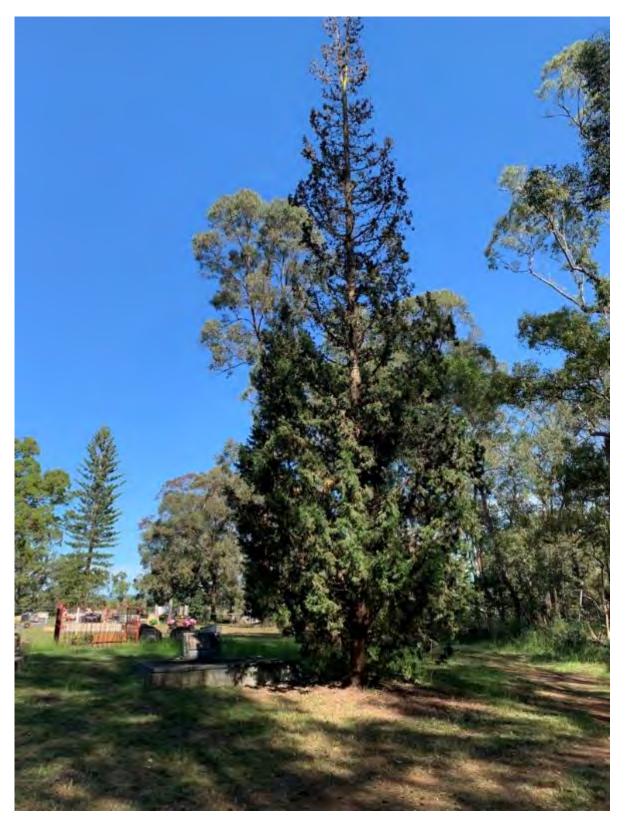
Within the remainder of the Cemetery, there is only one planting that appears to be deliberate/cultural. This is a single Radiata pine tree planted near the Poole family grave (ID244). This tree is shown below for reference. The tree is causing damage to the grave enclosure, as the roots of the tree are lifting the northeastern corner of the enclosure.

Plate 4.17 Radiata pine tree planted in immediate proximity to the Poole family grave (ID244) © Umwelt, 2020

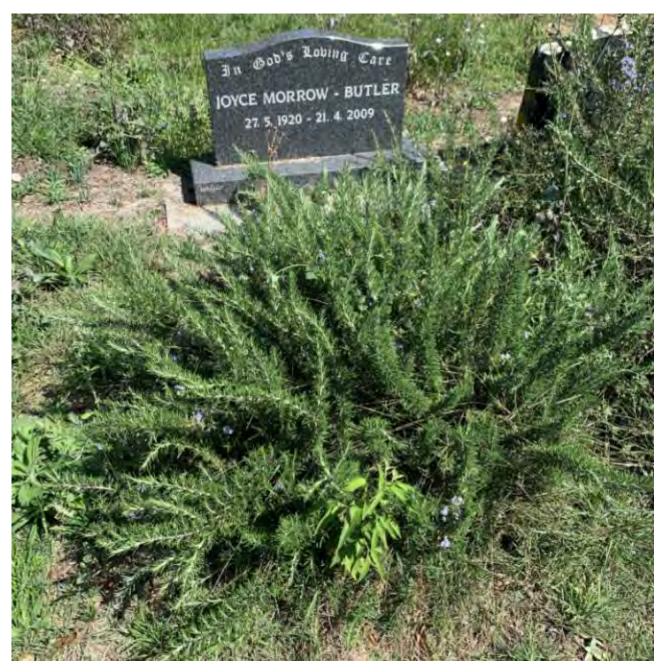
A number of graves also feature plantings within the footprint of the grave. The 2009 National Trust guideline identifies these kinds of plantings as 'controlled overgrowth', rather than deliberate cultural planting associated with the wider Cemetery (**Plate 4.18**). It is generally recommended that controlled overgrowth be maintained, as it contributes to the character of the place. Weeds, by contrast, are generally recommended for management/removal (**Plate 4.19**).

Plate 4.18 Controlled overgrowth within The Bight Cemetery associated with grave of Joyce Morrow Butler (ID146) © Umwelt, 2020

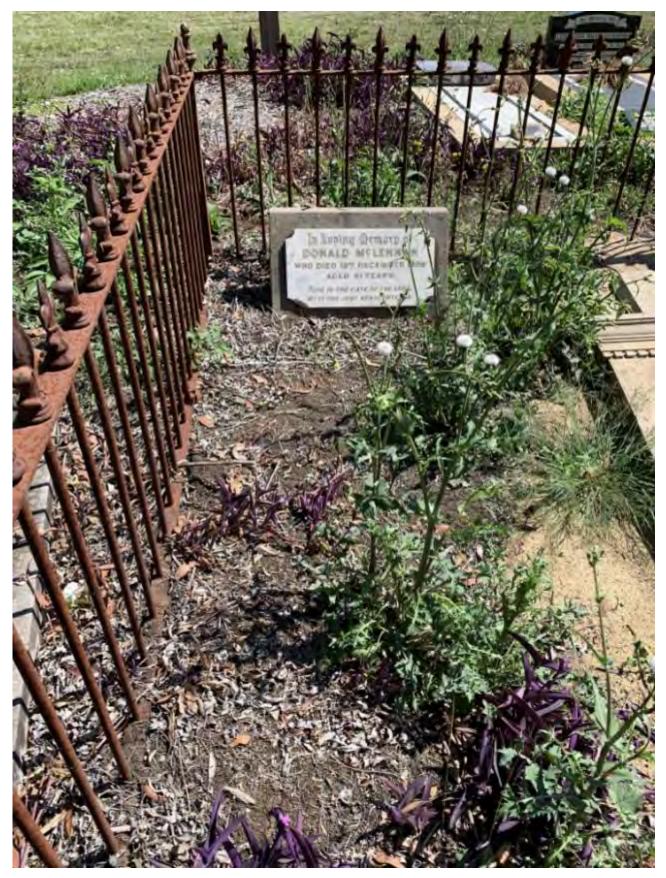
Plate 4.19 Weeds evident in association with a grave site (Donald McLennan) at The Bight Cemetery (ID031) © Umwelt, 2020

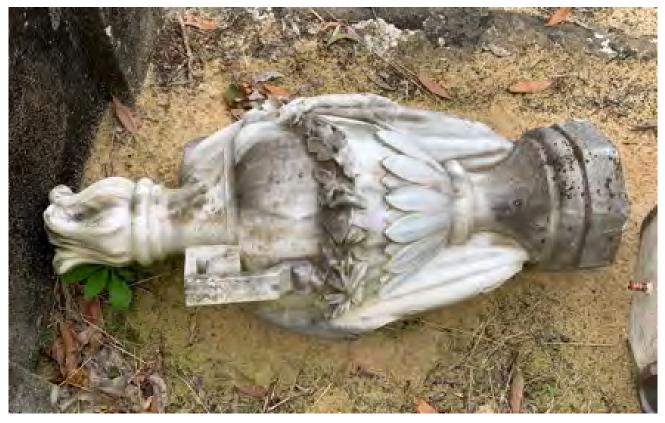
James William Hodgins passed away at the age of 47 on 25 March 1907. James was in charge of the Nationally heritage listed Post and Telegraph Office at Wingham for 27 years. His funeral was one of the largest ever seen in Wingham.¹²³ His grave marker, pictured below, is ornate, featuring a marble draped urn atop a pedestal.

Plate 5.26 The marble urn that forms part of James Hodgins' grave marker (ID040) © Courtesy of Janine Roberts, 2020

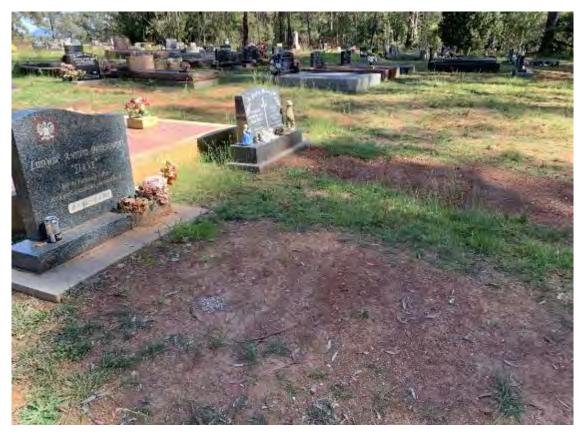
It is understood that lawnmowers, trucks and other machinery utilised for the purposes of excavating graves use all of the informal tracks shown on **Figure 4.1**. It is also noted that the visual inspections undertaken to inform this CMP identified relatively fresh vehicle tracks on the location of known, marked graves. Guidelines relating to the movement of vehicles within the Cemetery have therefore been developed, and are provided at **Section 8.10**.

Plate 7.2 Tyre marks visible on graves to the rear (eastern) side of the 'active portion' of the Cemetery © Umwelt, 2020
