MIDCOAST
council

WATERWAY AND CATCHMENT REPORT

Reporting on data
November 2019 to March 2020

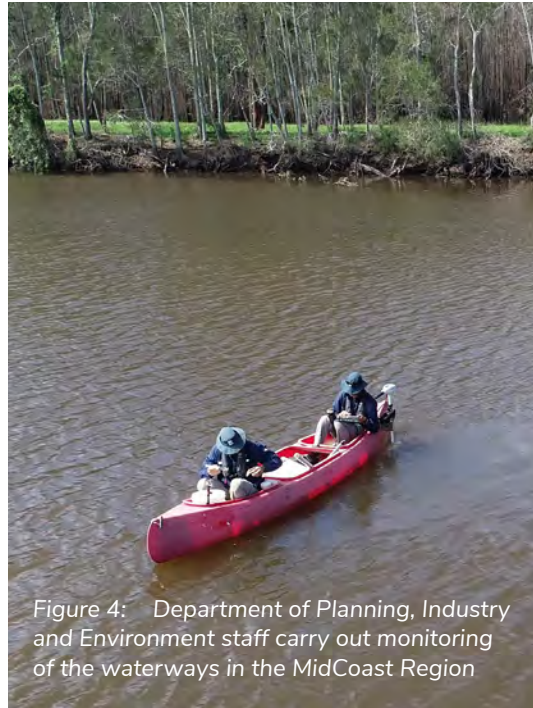
Figure 4: Department of Planning, Industry and Environment staff carry out monitoring of the waterways in the MidCoast Region

At each of the selected sites, samples were taken in accordance with the New South Wales Monitoring, Evaluation and Reporting protocols which are described in full in Roper et al. (2011). At each of the 'Lake' sites, turbidity was measured using a calibrated probe suspended at a depth of 0.5 metres for five minutes as the boat drifted or was motored (generally covering a distance of at least 300 metres), logging data every 15 seconds. The final value for the 'site' sampled was the average of all the logged data. During the drift, at least five samples of the top 1 metre of the water column were collected and combined in a bucket. At the end of the drift, a single 200 millilitre sample for chlorophyll a analysis was taken from the composite in the bucket.

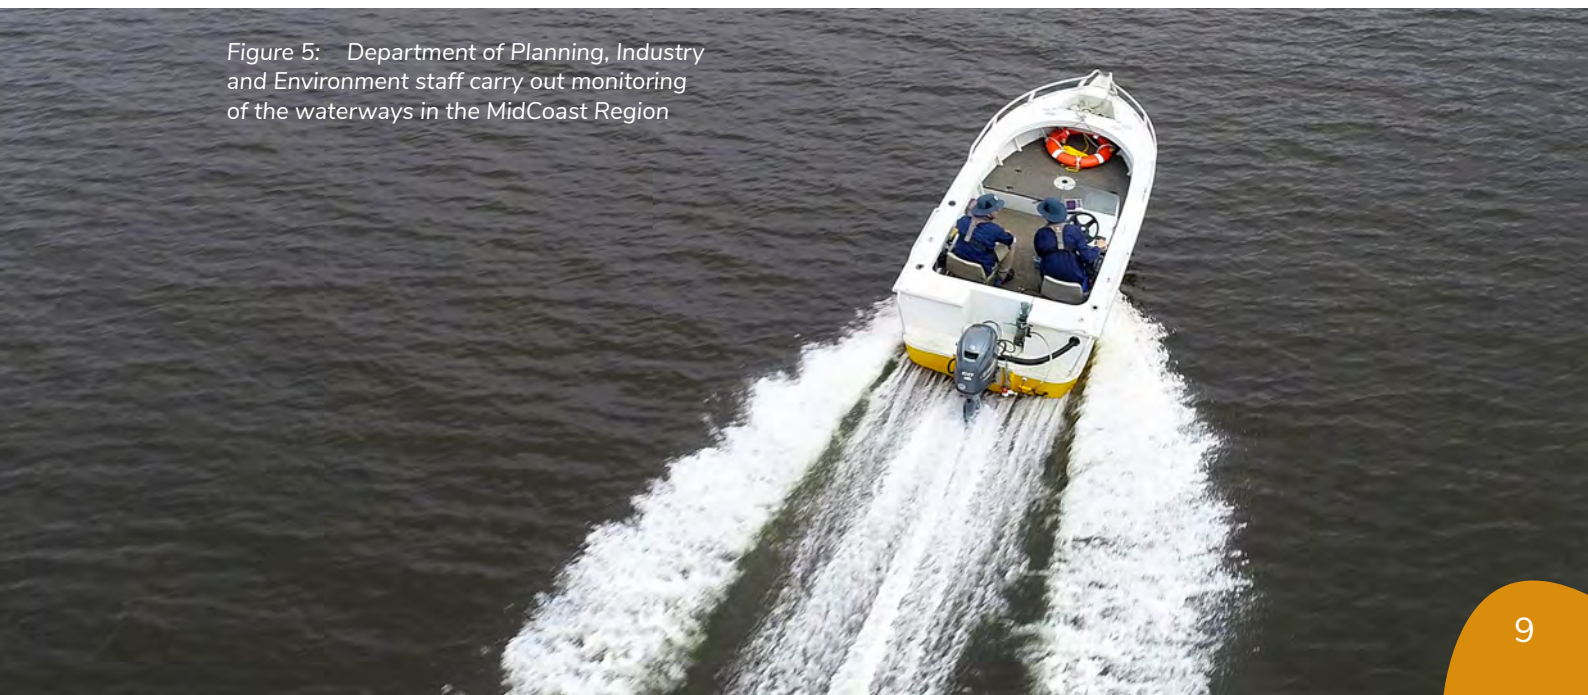
Figure 5: Department of Planning, Industry and Environment staff carry out monitoring of the waterways in the MidCoast Region

Chlorophyll a samples are immediately filtered (within one hour) under mild vacuum and the filter frozen until analysis. Chlorophyll a is extracted into acetone and chlorophyll a concentration is determined by spectrometry.

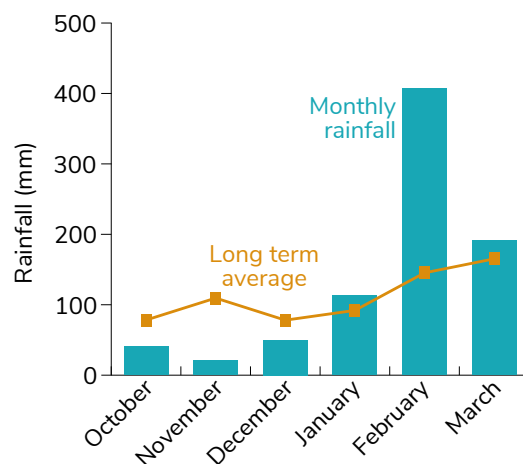
Figure 11: Monthly observed and long term average rainfall during the 2019-20 monitoring program at Taree Airport (bom.gov.au)

The sampling period for 2019/20 saw a variety of climatic conditions with drought conditions and little rainfall during the first three months followed by moderate rains and then flooding conditions in January, February and March.

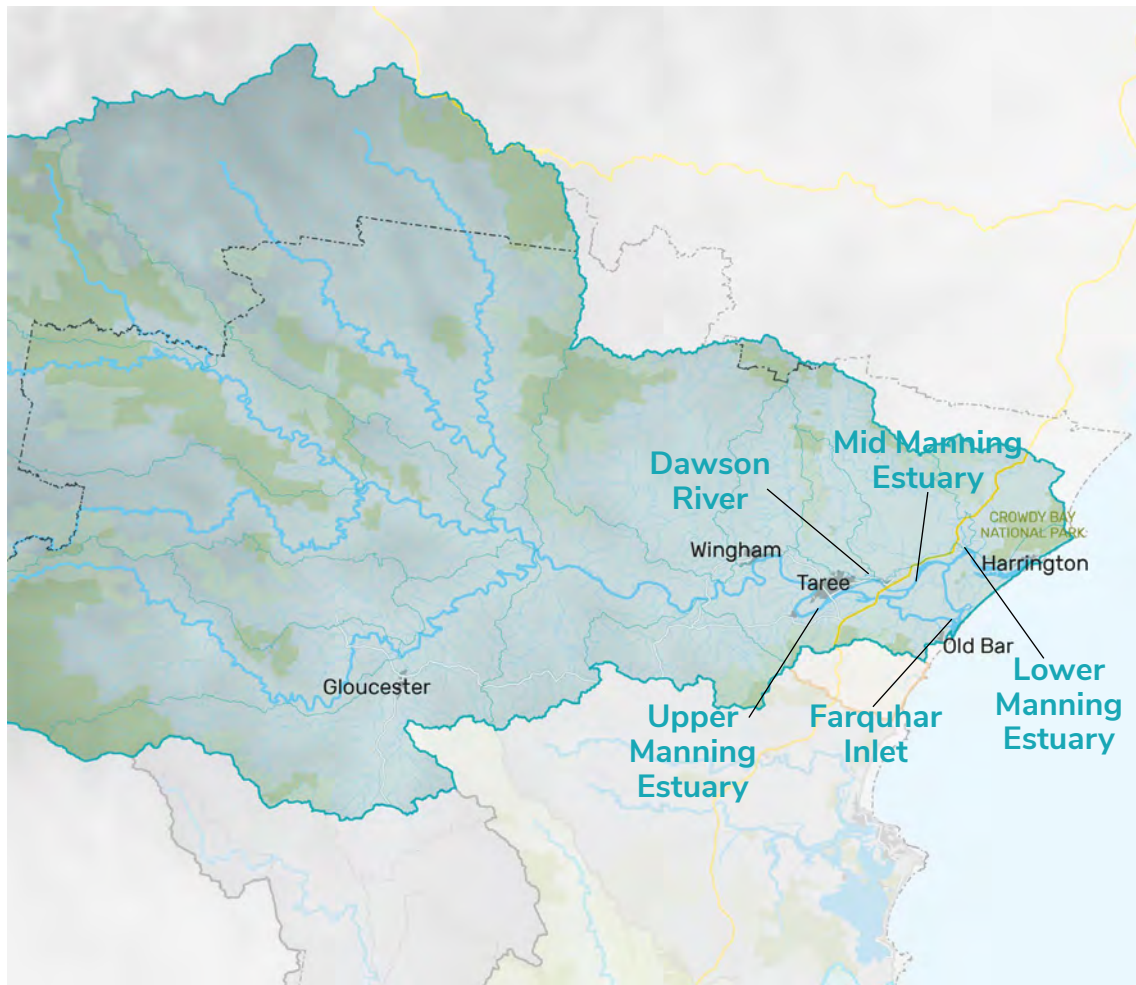
Figure 13: Manning River

The Manning River has a catchment area of 8,420 square kilometers, which makes it the sixth largest on the coast of NSW. The Manning River is unique on the NSW coast because it is a double delta with two river entrances at Harrington and Old Bar. The main land uses within the catchment are urban development, beef cattle grazing, dairying, oyster growing and forestry. Significant areas of the catchment are also conserved within National Parks and Nature Reserves. The majority of the catchment's population live in the estuarine zone around the town centres of Taree, Wingham, Cundletown, Harrington and Old Bar.

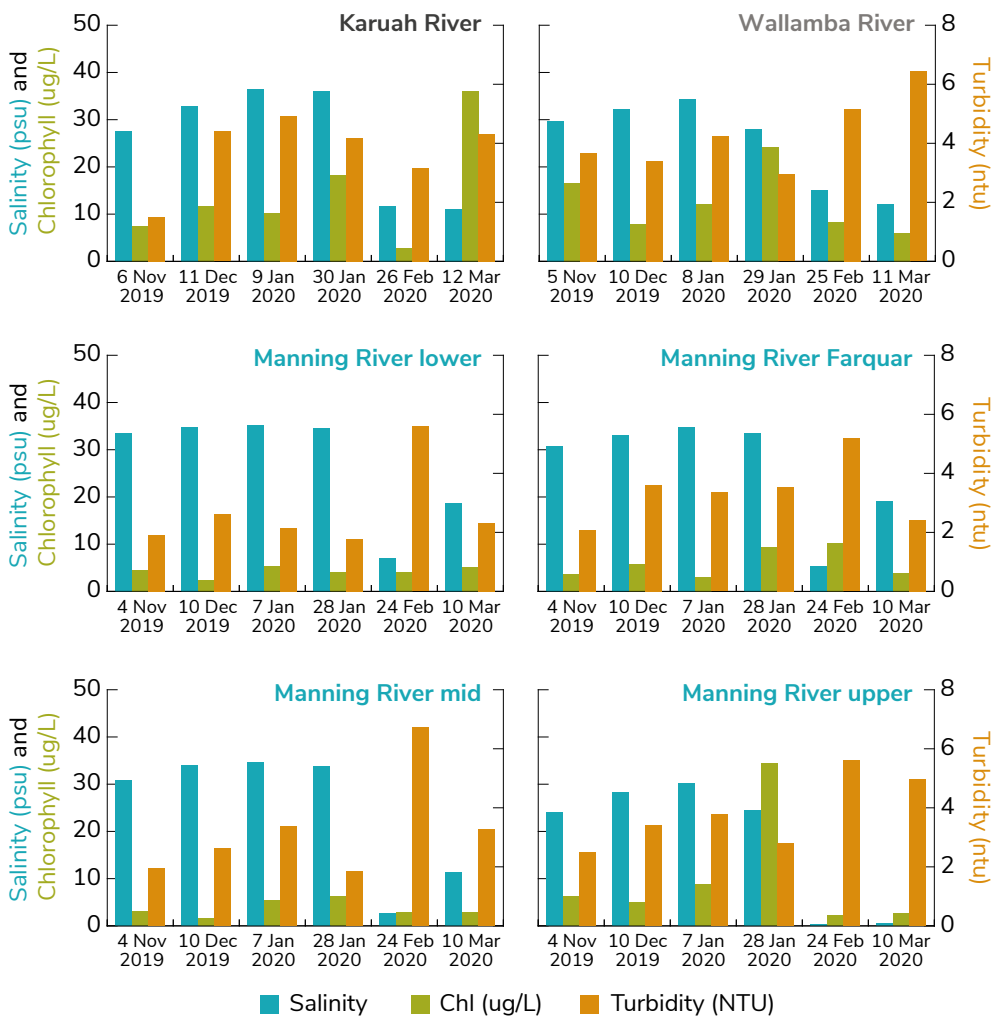
Figure 21: Salinity, chlorophyll and turbidity in the rivers

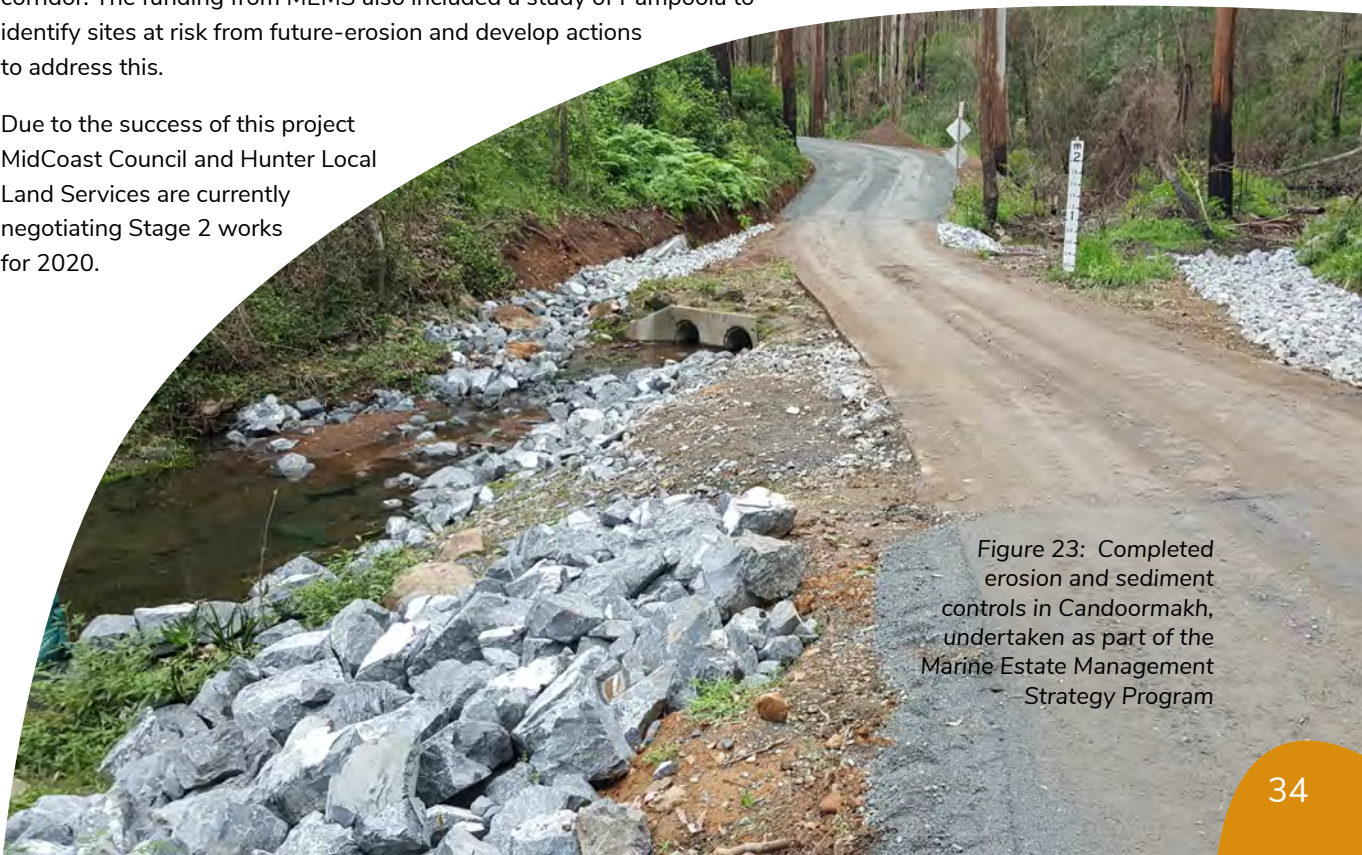
Figure 23: Completed erosion and sediment controls in Candoormakh, undertaken as part of the Marine Estate Management Strategy Program

The Marine Estate Management Strategy also provided funding to address eroding riverbanks through this program, which contribute significant sediment and nutrients to the waterway. \$305,000 was provided through MEMS which in turn was matched by \$82,000 from MidCoast Council. Over 1150 metres of riverbank were rehabilitated in two key locations: Lower Wallamba River and the Lansdowne River. Not only will these projects reduce sediment from eroding river banks entering the waterways, they will also provide additional fish habitat and increase mangrove growth, while re-establishing the adjacent riparian corridor. The funding from MEMS also included a study of Pampoola to identify sites at risk from future-erosion and develop actions to address this.

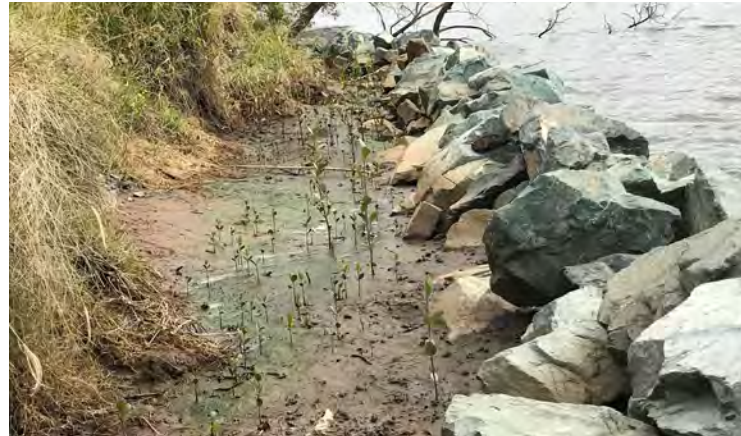
Figure 30: Mangroves regenerating behind rock fillets to protect the bank from erosion on Dumaresq Island

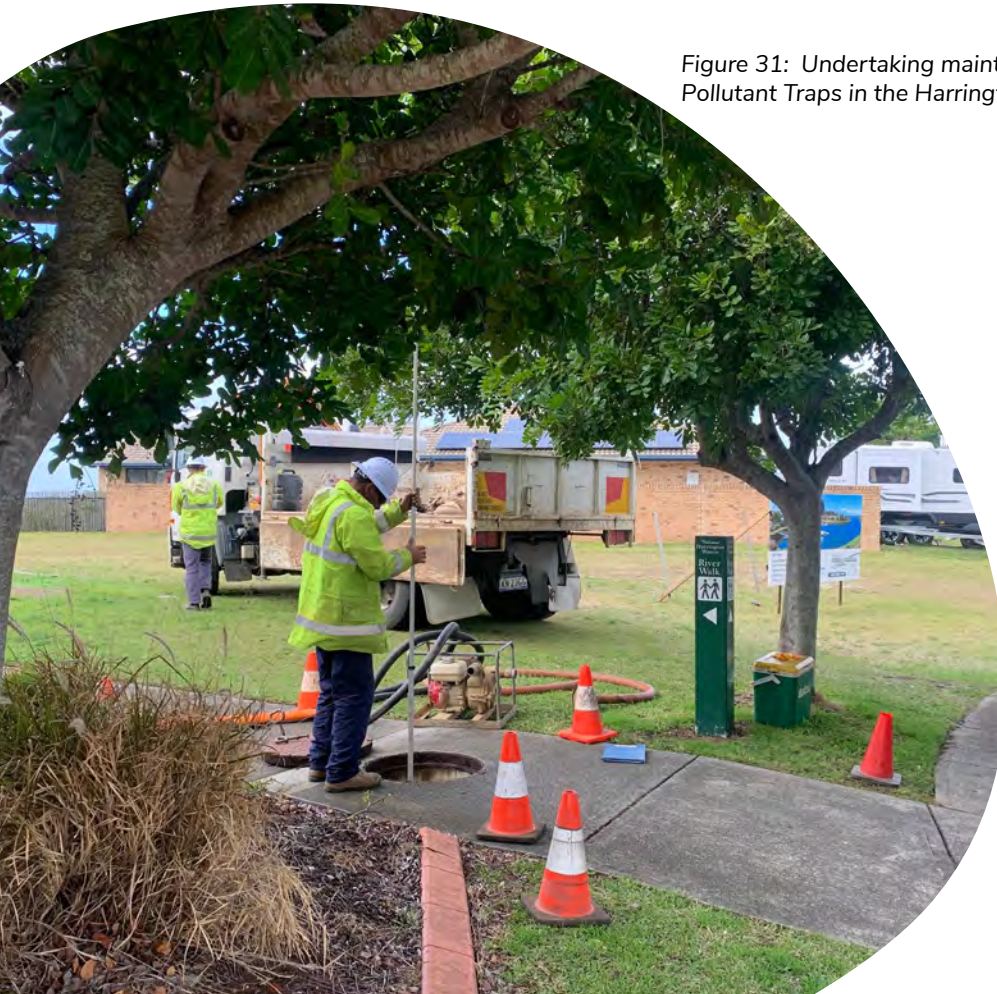
Figure 31: Undertaking maintenance on Gross Pollutant Traps in the Harrington area

GPTs filter stormwater runoff and catch stormwater pollution before it has a chance to enter waterways. Council has recently completed an audit all the GPTs in the Manning to assess how well they are functioning and ensure that they are all in working order. Following the audit a comprehensive clean of each device is being undertaken and rectification works are underway on several devices that had started to deteriorate with age.

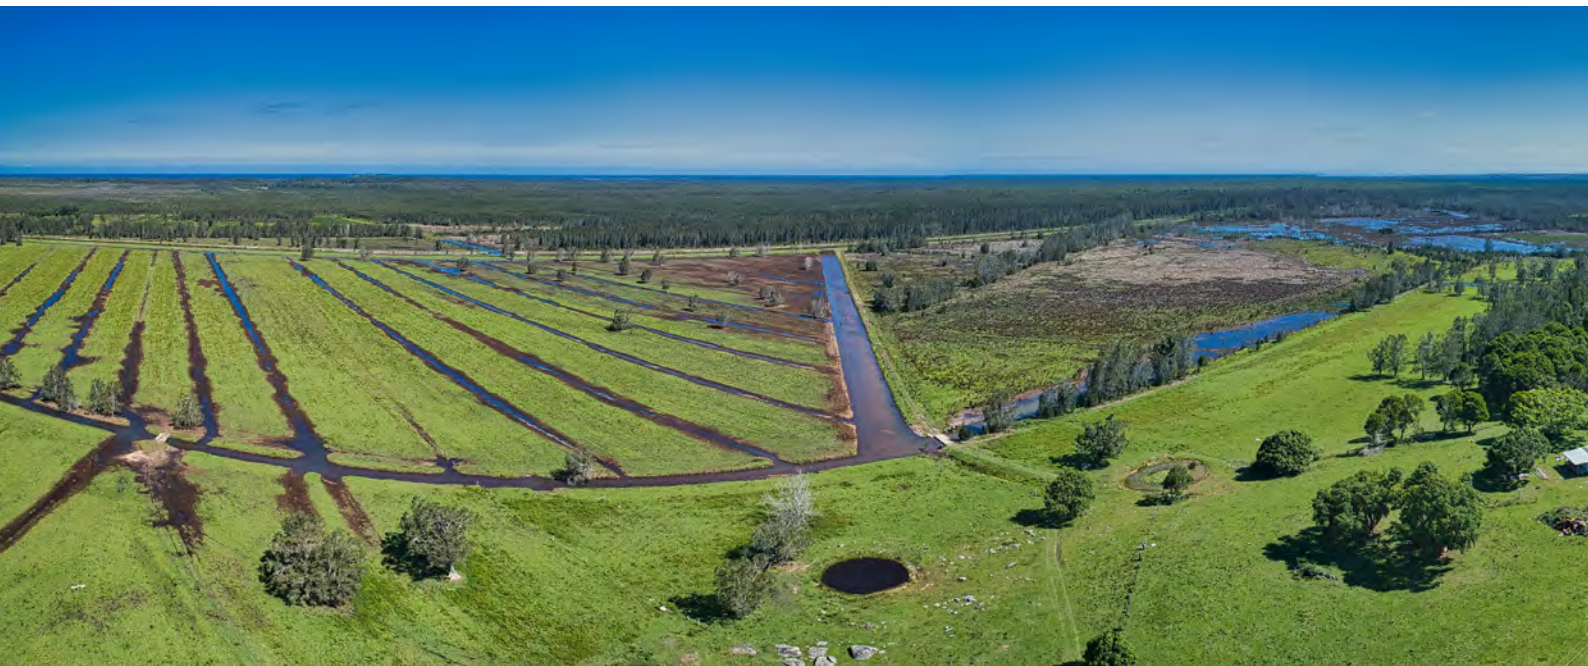
Figure 32: Big Swamp project area

Through this monitoring it has been shown that provided substantial rain falls in the Big Swamp catchment, acid sulfate discharges can continue to impact water quality in Pipeclay Canal, Cattai Creek and the Manning River Estuary. Long term monitoring has also indicated that water quality in the Big Swamp area has been improving since on-ground works in the lower end of the project area to restore the natural hydrology have been implemented.

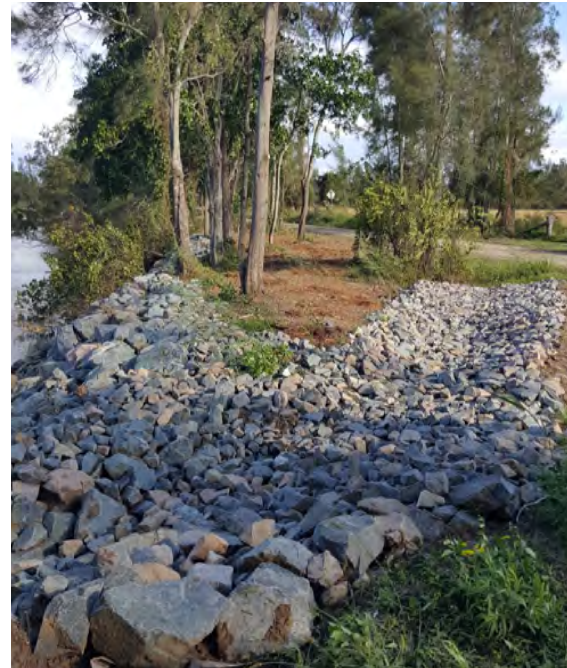
Figure 33: Completed erosion and sediment controls on North Moto Road undertaken as part of the Marine Estate Management Strategy Program

Over 1150 metres of riverbank were rehabilitated in two key locations: Lower Wallamba River and the Lansdowne River. Not only will these projects reduce sediment from eroding river banks entering the waterways, they will also provide additional fish habitat and increase mangrove growth, while re-establishing the adjacent riparian corridor. The funding from MEMS also included a study of Pampoola to identify sites at risk from future-erosion and develop actions to address this.

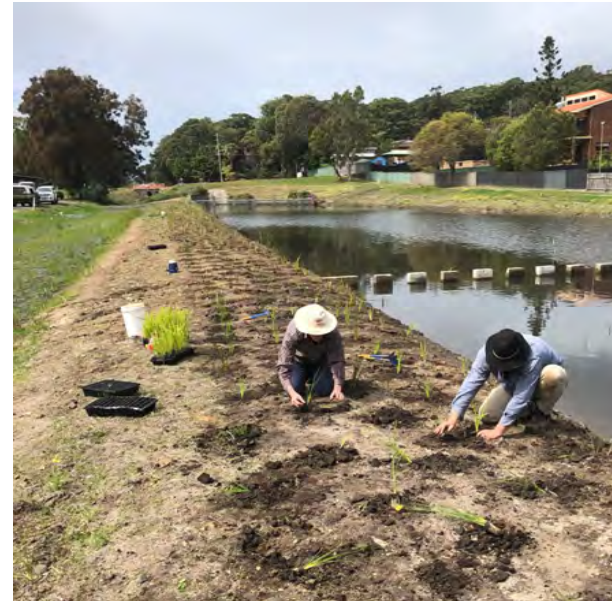
Figure 37: Planting underway at the newly refurbished Townsend Wetland

The wetland receives stormwater inflow from 90 hectares of the surrounding urban area that prior to the original construction, would have drained untreated directly into Wallis Lake. The refurbishment works involved the removal of existing vegetation and excavation of accumulated sediments captured during the previous 17 years. A total of 985 tonnes of material was removed from the wetland basin. The trash racks that capture large pieces of litter were replaced, the wetland outlet drain was reconstructed and the high flow by-pass channel was cleaned out and lined with rock to reduce sedimentation and assist with on-going site maintenance.

Following the completion of the construction works, the wetland basin was planted with native macrophytes, which are aquatic plants that grow in or on the edge of saline and fresh water bodies. Macrophytes are an important component in both natural and constructed wetlands as they provide food and shelter for fish, aquatic invertebrates and water birds. Once established, these Macrophytes are very good at removing nutrients from stormwater runoff.

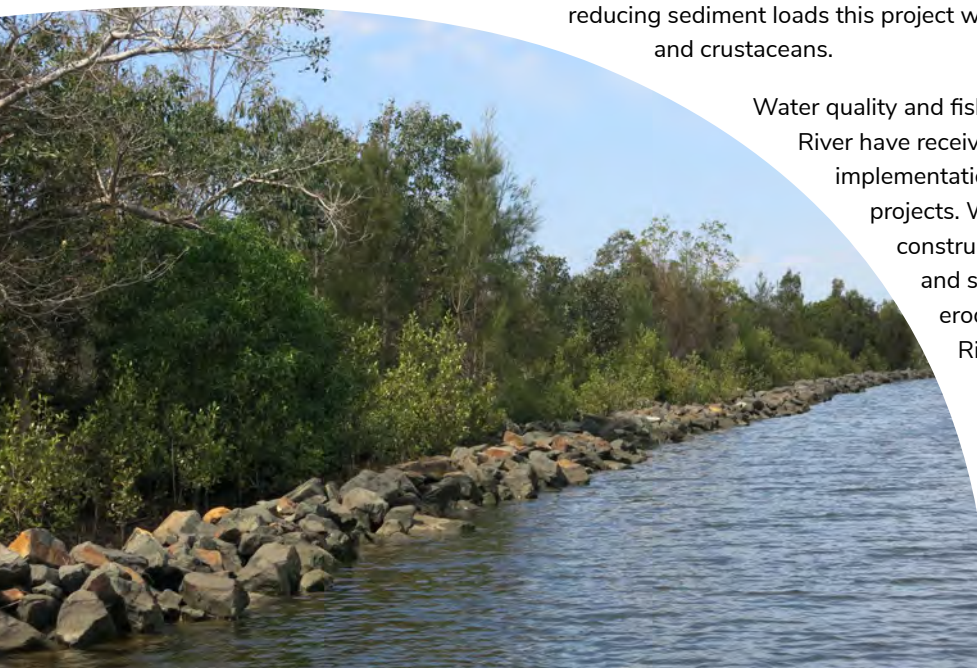
Figure 38: Bank stabilisation works in the Wallamba River

Water quality and fish habitat in the lower Wallamba River have received a recent boost following the implementation of 2 on-ground restoration projects. Works have involved the construction of rock fillets, revegetation and stock exclusion fencing on severely eroded riverbanks along the Wallamba River at Darawank and Nabiac.

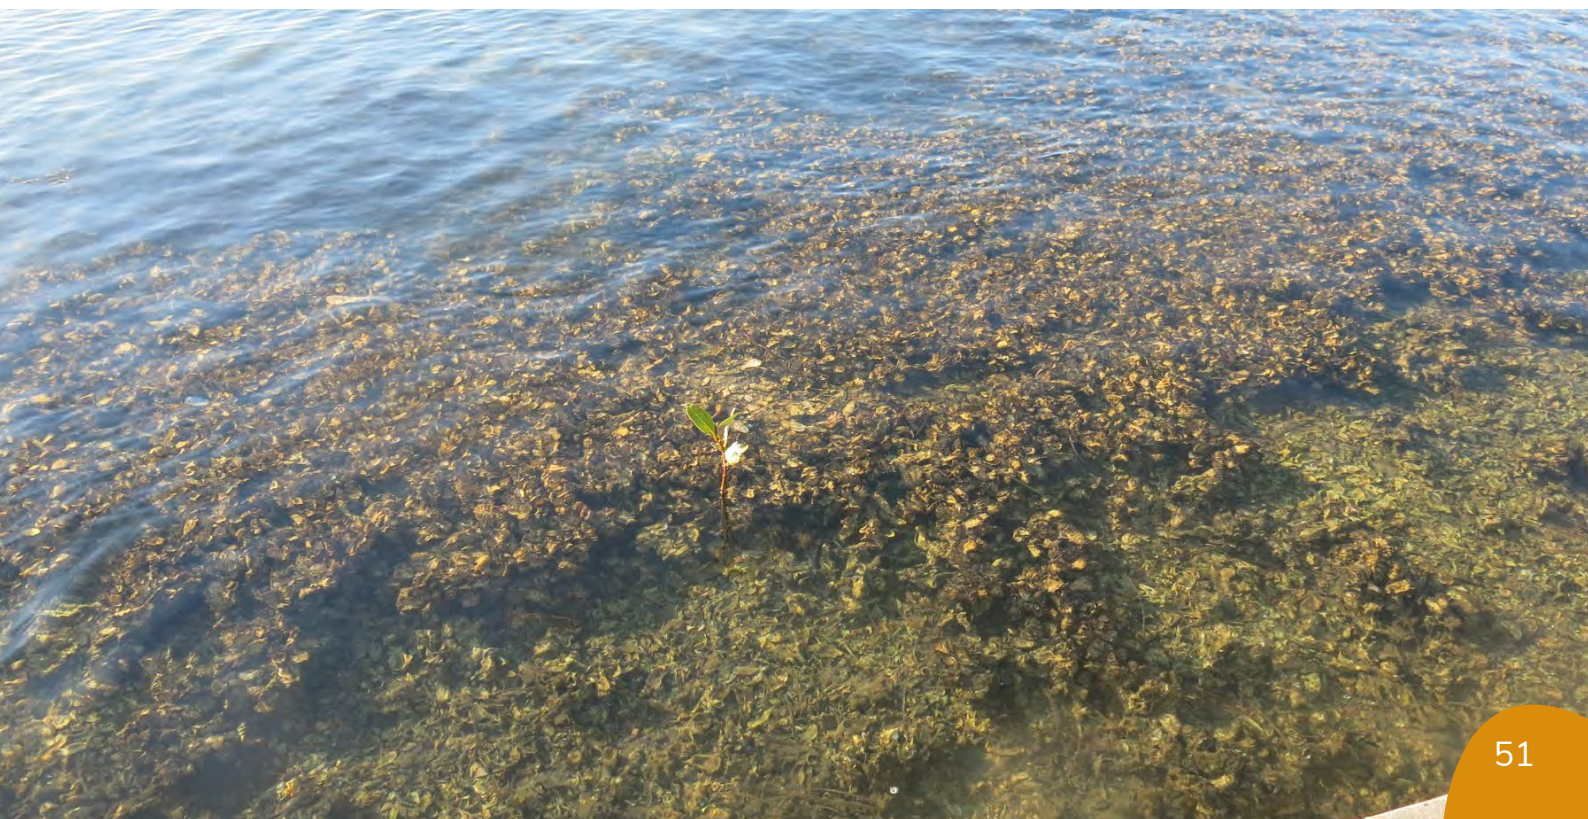
Figure 40: Mangrove regenerating amongst the newly installed oyster reef

Monitoring of the site was undertaken in late 2019 in conjunction with the University of Newcastle to see the effects of the installation. Newly recruited oysters were found at all sites where shells had been deployed, indicating recruitment and survival onto the deployed shells. Sediment accretion increased showing that the shells are acting as sediment traps, reducing resuspension and reducing wave action and bank erosion and a higher diversity and abundance of infauna at restoration sites indicates they are functioning as an important invertebrate habitat. Monitoring will continue to see the long term effects of the oyster reefs.

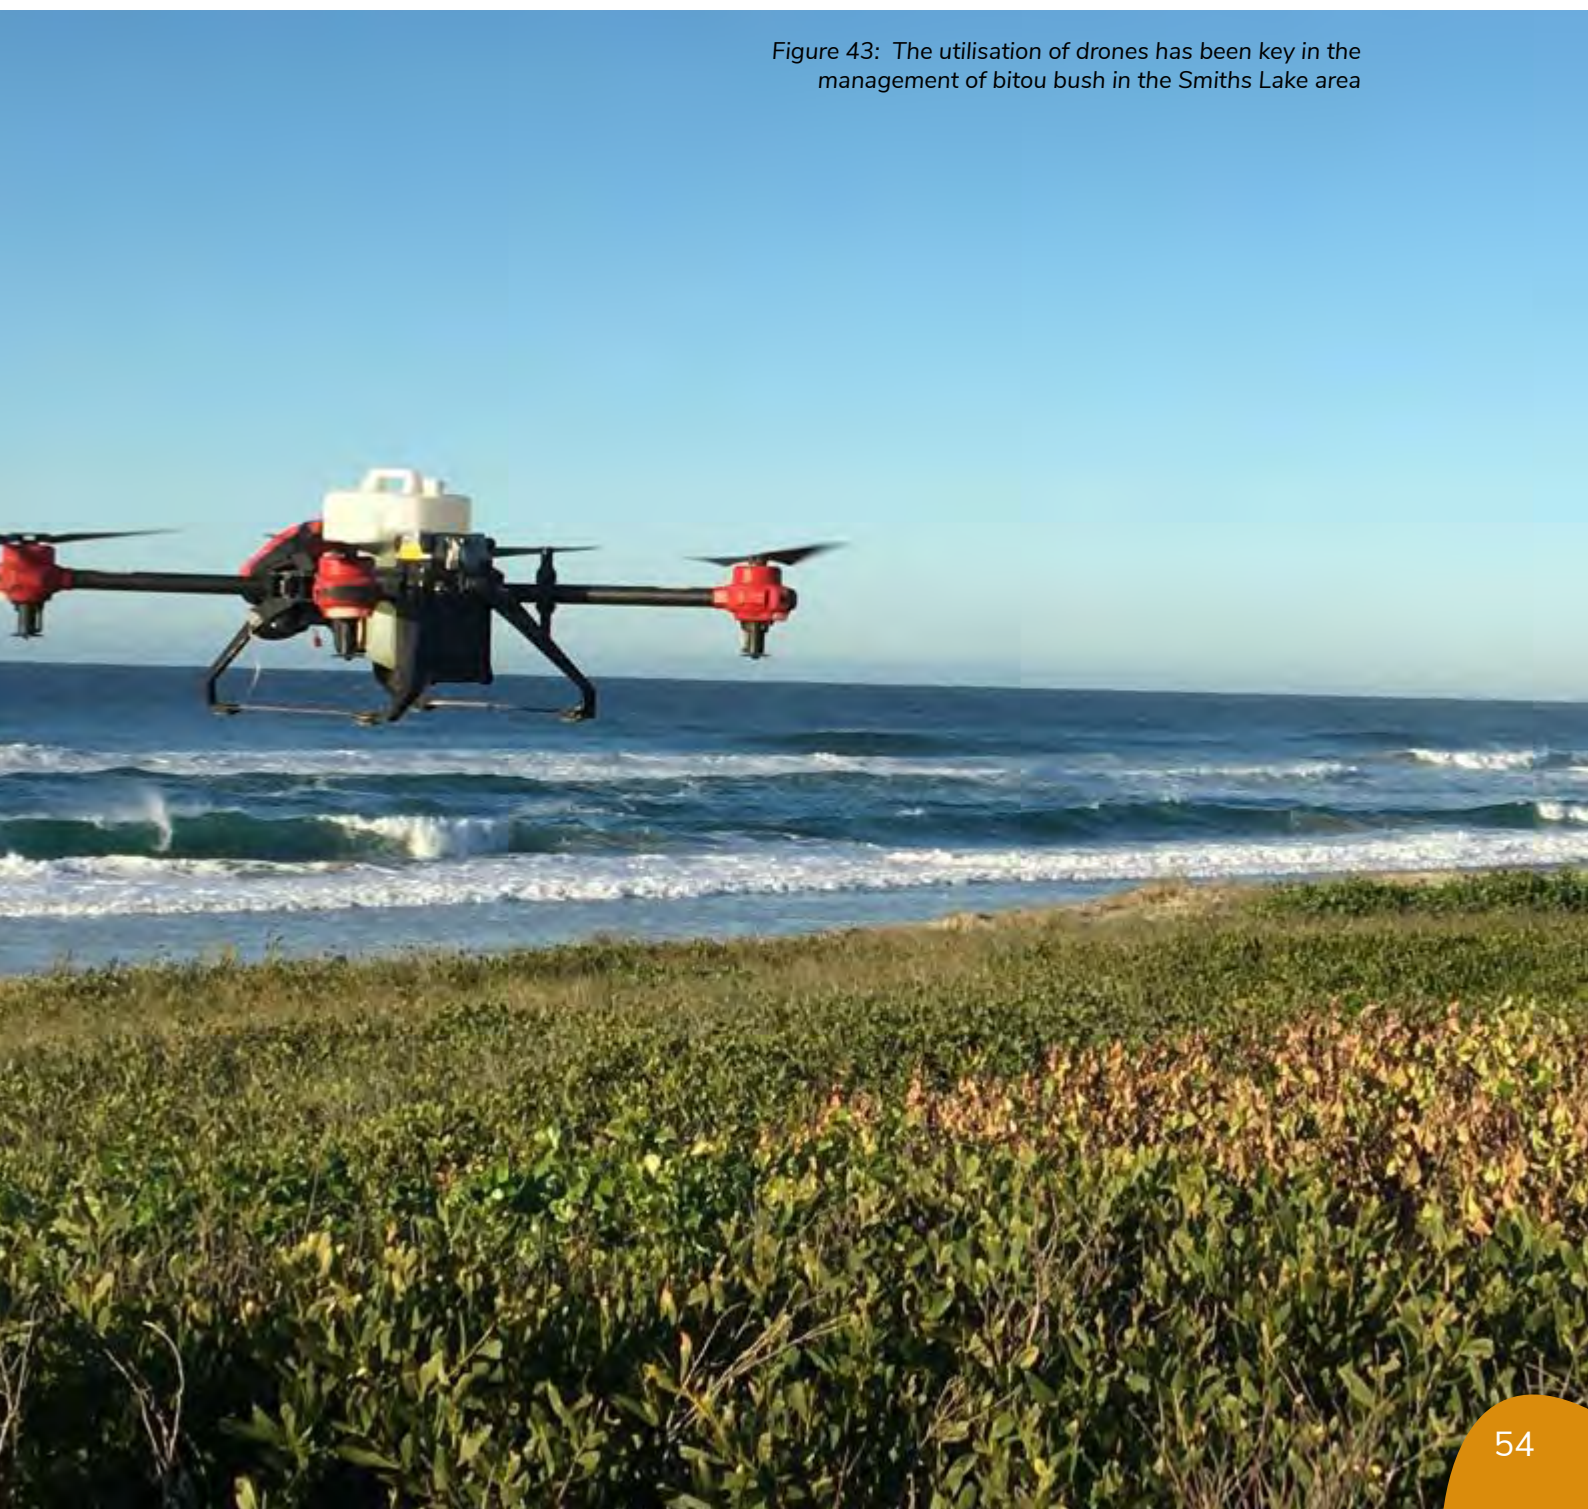
Figure 43: The utilisation of drones has been key in the management of bitou bush in the Smiths Lake area

The Smiths lake area has been subject to an integrated pest management program for the management of Bitou bush for more than a decade, boasting greater than 95% control of mature bitou where treated.

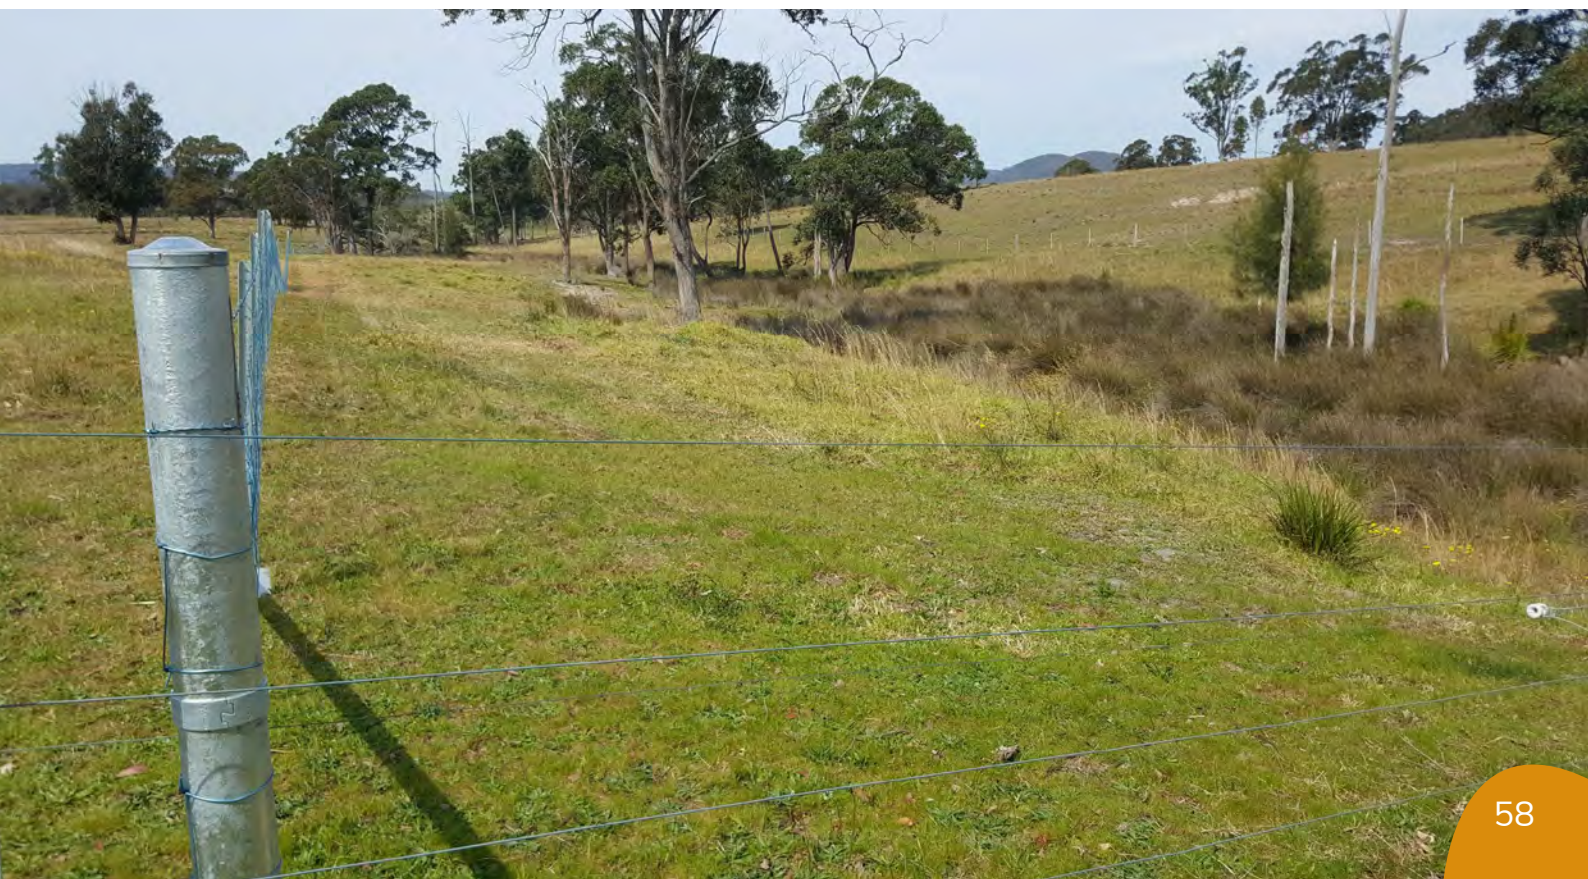
Figure 47: Fencing to keep cattle out of wetlands and riparian areas has been installed by local landholders to protect The Branch and Karuah Rivers

"The cattle get into the wetlands and pug the soil, generally making a mess particularly when it's wet. The new internal fence and water points keep the cattle out of the wetlands most of the year meaning we are able to get the most out of the good pasture and help protect the local environment."
