MIDCOAST
council

WATERWAY AND CATCHMENT REPORT CARD

2017

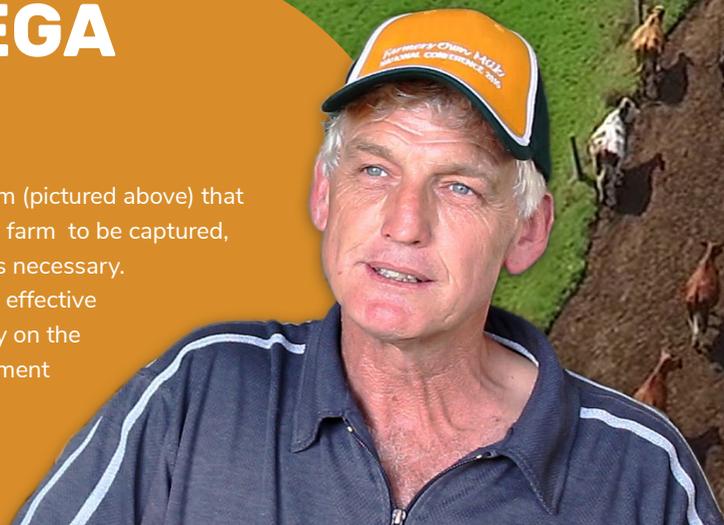
JULIAN BIEGA

Julian has installed an innovative system (pictured above) that allows the effluent created on his dairy farm to be captured, stored and irrigated on his paddocks as necessary. The new system has proven to be very effective with immediate changes in productivity on the irrigated paddocks and the reestablishment of a salt marsh in a nearby wetland.

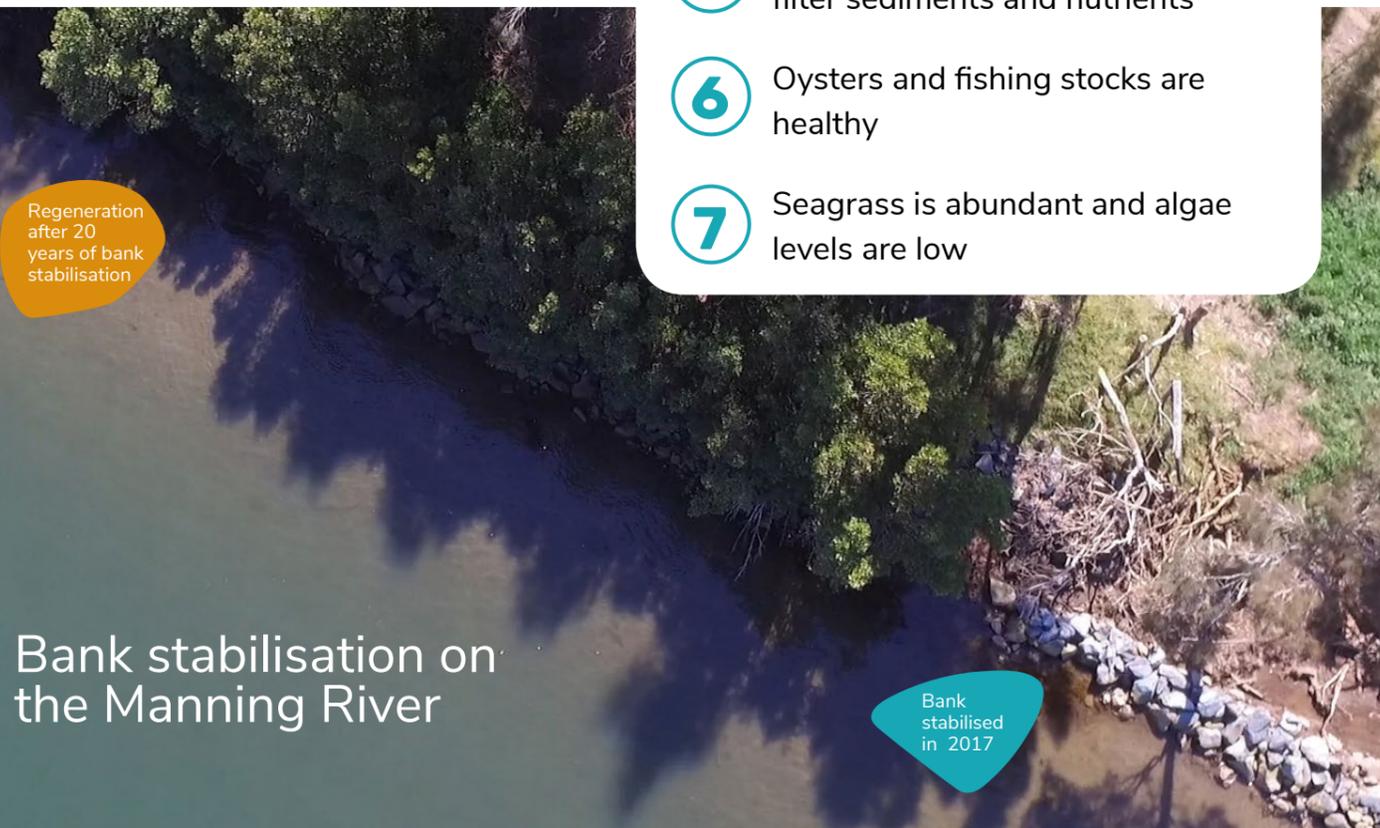
Bank stabilisation on the Manning River

Regeneration after 20 years of bank stabilisation

Bank stabilised in 2017

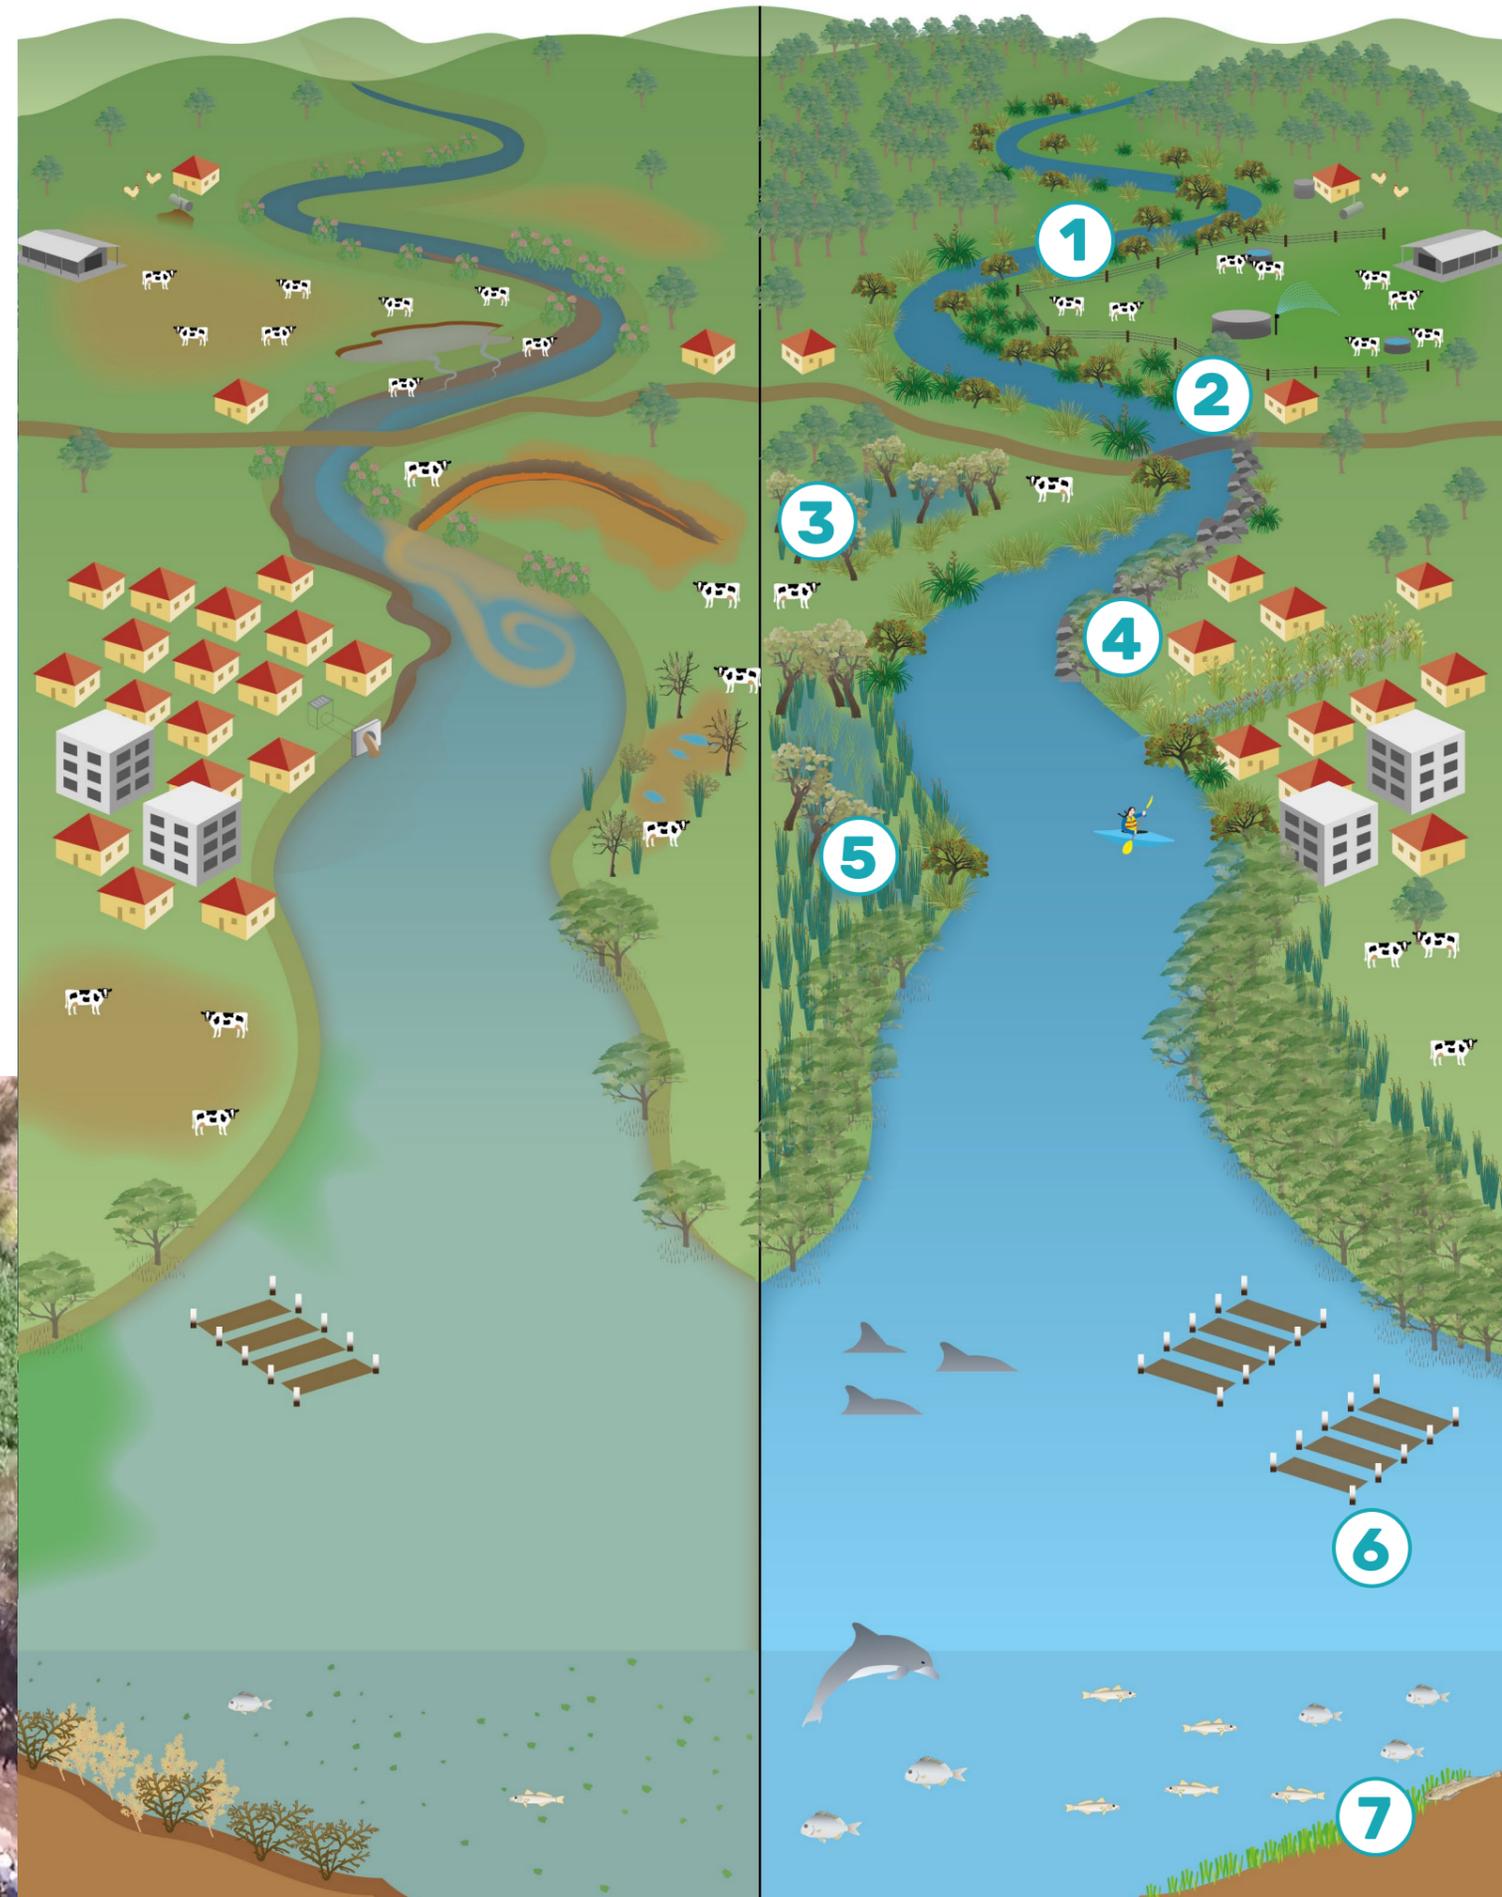
KEY FEATURES OF A HEALTHY WATERWAY

- 1 Dairy effluent is kept out of waterways and wetlands and used for productive pastures
- 2 River and estuary banks are stable and stock is excluded
- 3 Land is managed to avoid the disturbance of acid sulfate soils
- 4 Stormwater runoff from urban areas is filtered
- 5 Natural wetlands are healthy and filter sediments and nutrients
- 6 Oysters and fishing stocks are healthy
- 7 Seagrass is abundant and algae levels are low
