MIDCOAST
council

WATERWAY AND CATCHMENT REPORT

2019

MidCoast Council 2019 Waterway and Catchment Report
Prepared by:
MidCoast Council
Natural Systems

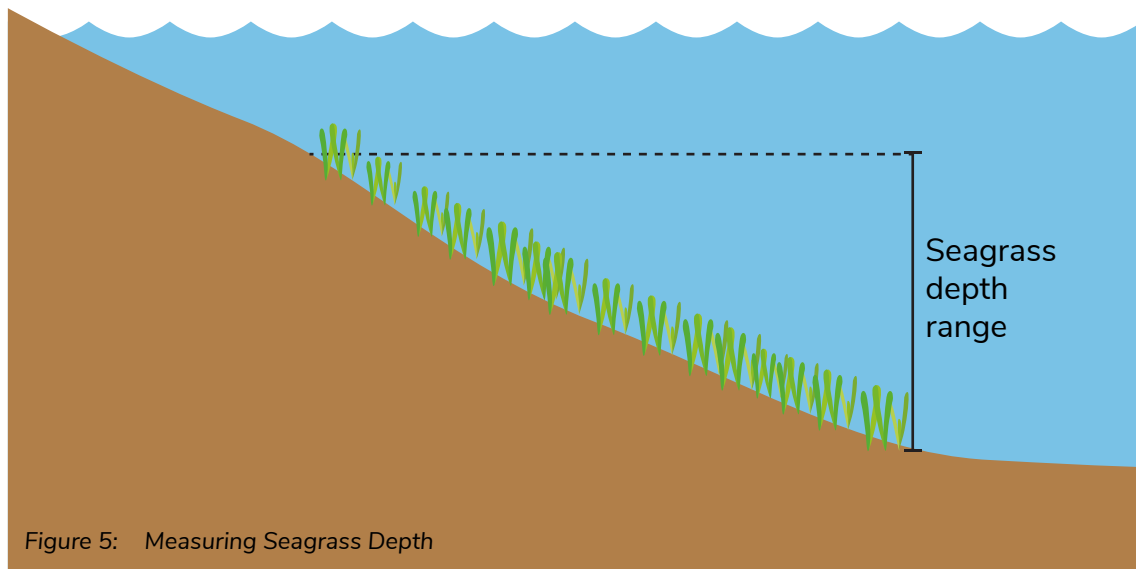
Figure 5: Measuring Seagrass Depth

A report card grade is calculated following the analysis method outlined in the New South Wales sampling and reporting protocols (OEH, 2016). Briefly, the seagrass depth range scores are based on not only the recorded depth range for a specific year, but also how that compares to the previous year, meaning how seagrass has progressed, recovered or regressed over time since the previous survey. The seagrass score is presented separately in the report card and does not affect the overall ecological health grade.

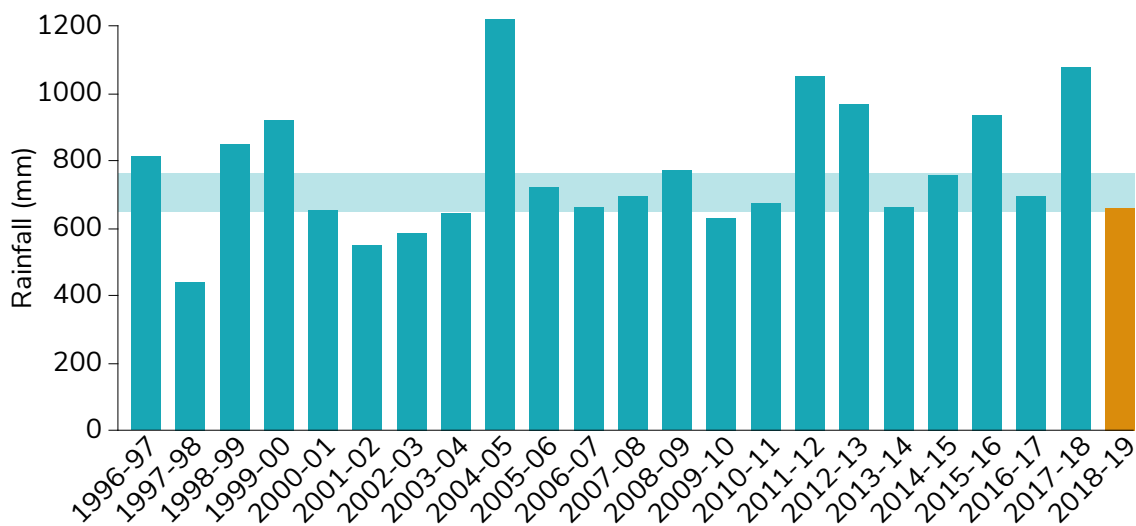
Figure 8: Data presented includes total rainfall

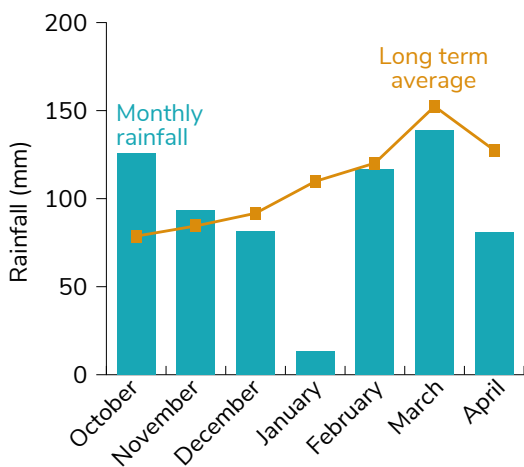
Figure 9: Monthly observed and long term average rainfall during the 2018-2019 monitoring program at Tuncurry Marine Rescue (bom.gov.au)

The rainfall data is taken from the Forster Bureau of Meteorology rainfall station (Tuncurry Marine Rescue) (www.bom.gov.au/climate/data). Similar trends were seen in data throughout the MidCoast Area.

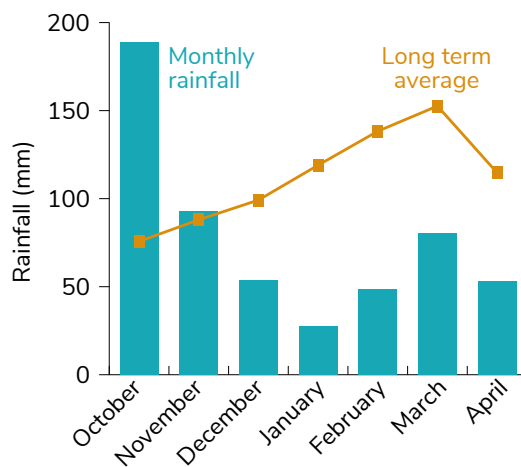
Figure 10: Monthly observed and long term average rainfall during the 2018-2019 monitoring program at Taree Airport (bom.gov.au)

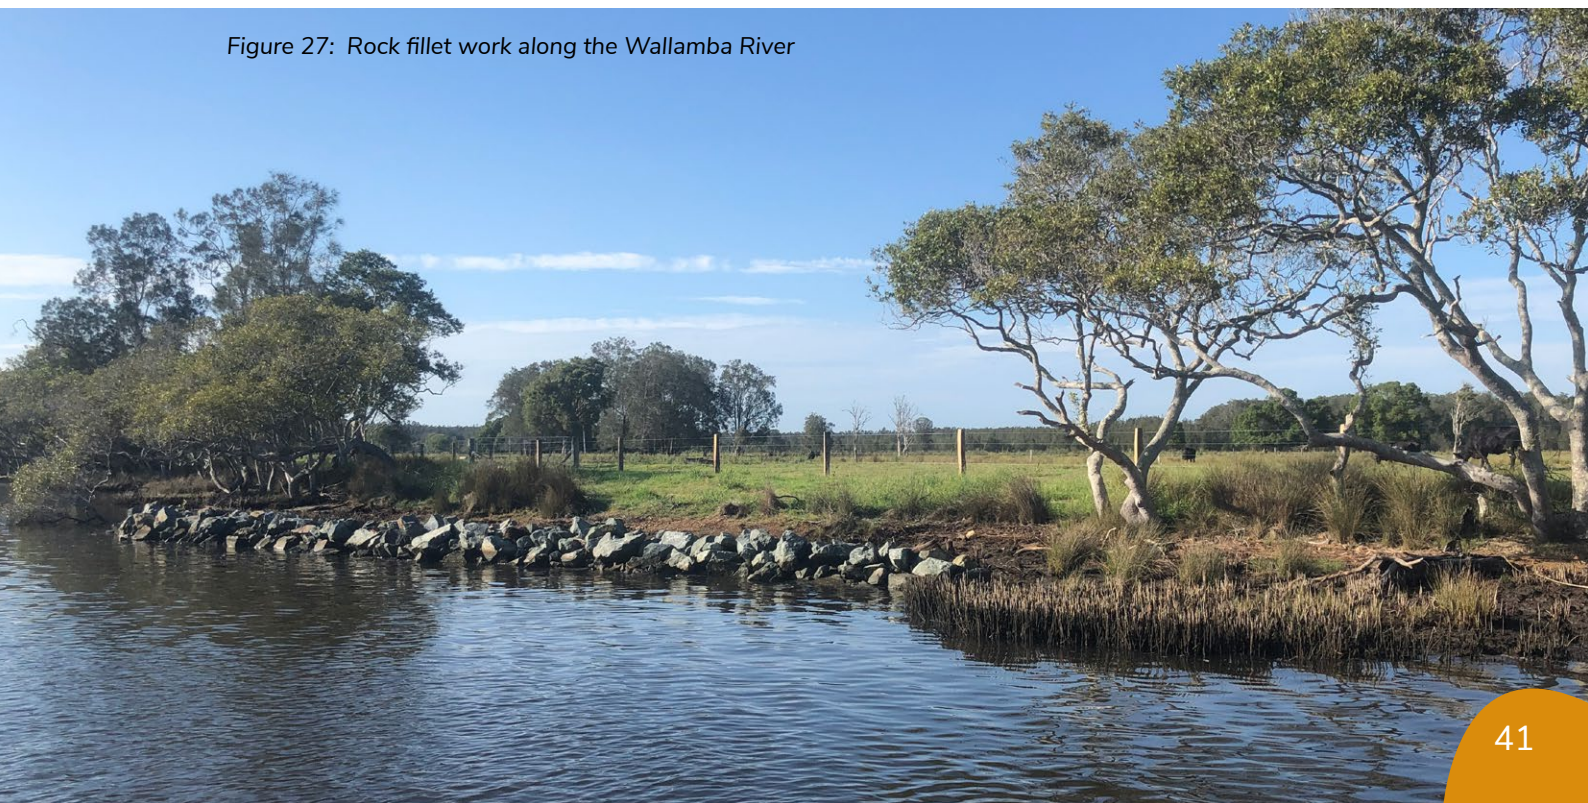
Figure 27: Rock fillet work along the Wallamba River

On-ground works commenced in July 2018 to address riverbank erosion and enhance riparian vegetation in the lower Wallamba River at Darawank with the construction of 840 metres of rock protection along a 2.15 kilometre stretch of degraded riverbank. The riverbanks had previously been subject to long term, unrestricted cattle grazing which had resulted in substantial damage to mangroves and saltmarsh in an important area for oyster production, recreational and commercial fishing. Grazing and the impacts of boat wash had seen erosion rates of up to 1m per year resulting in high levels of sediments and nutrients entering the waterway. Mangroves provide a highly effective buffer against shoreline erosion and the construction of rock fillets will allow for the natural recruitment of mangroves that will ensure the banks are sufficiently stabilised.

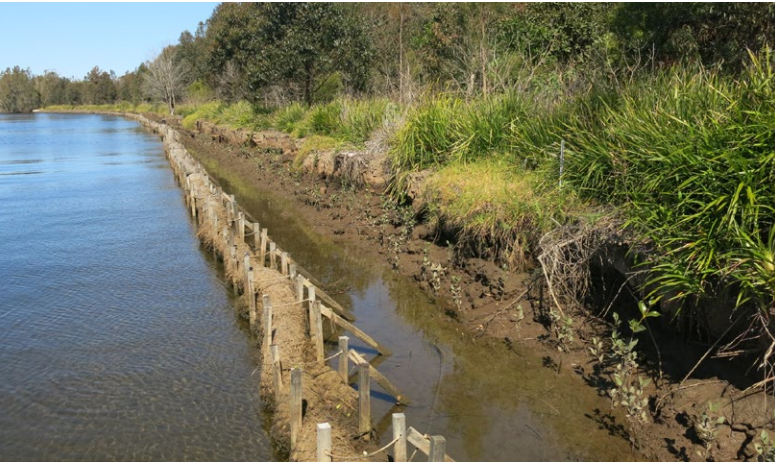
Figure 29: Erosion on the riverbank prior to installation of the Oyster Reef

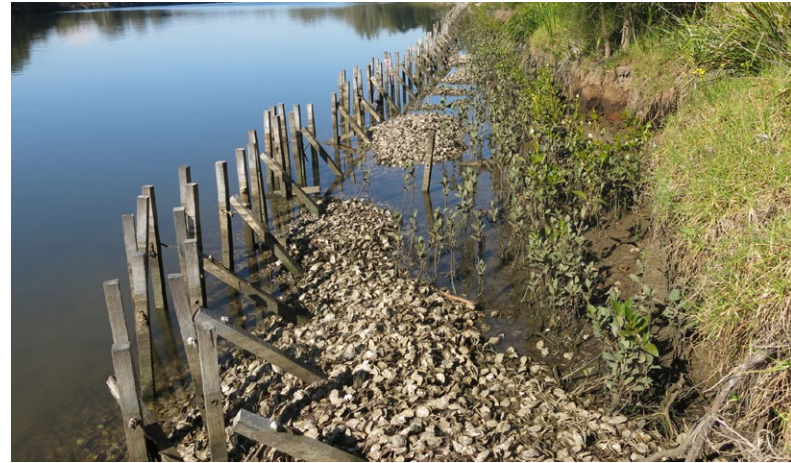
Figure 30: Erosion on the riverbank following installation of the Oyster Reef

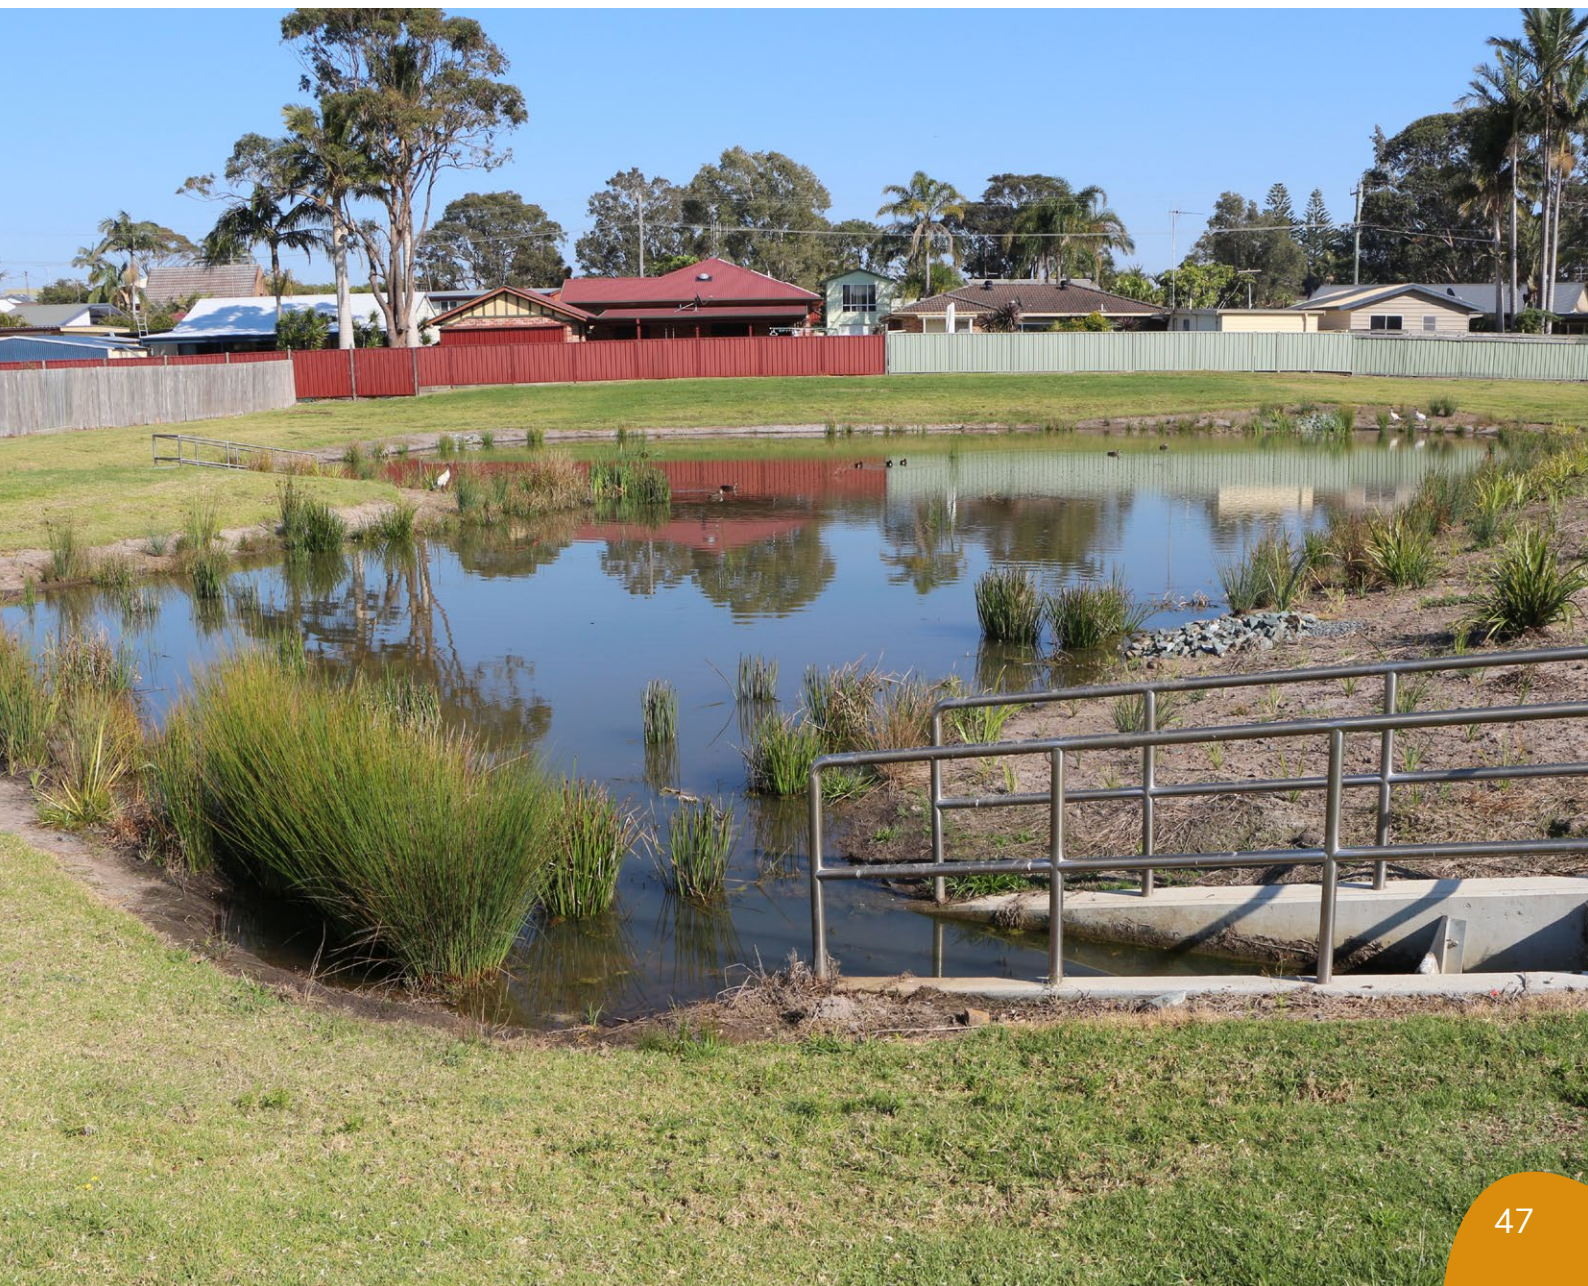
Figure 35: Stormwater quality improvement- Arlington Wetlands

This project compliments the other wetlands (8), raingardens (11) and gross pollutant traps (2) that have been constructed on public land in the Wallis Lake Catchment.

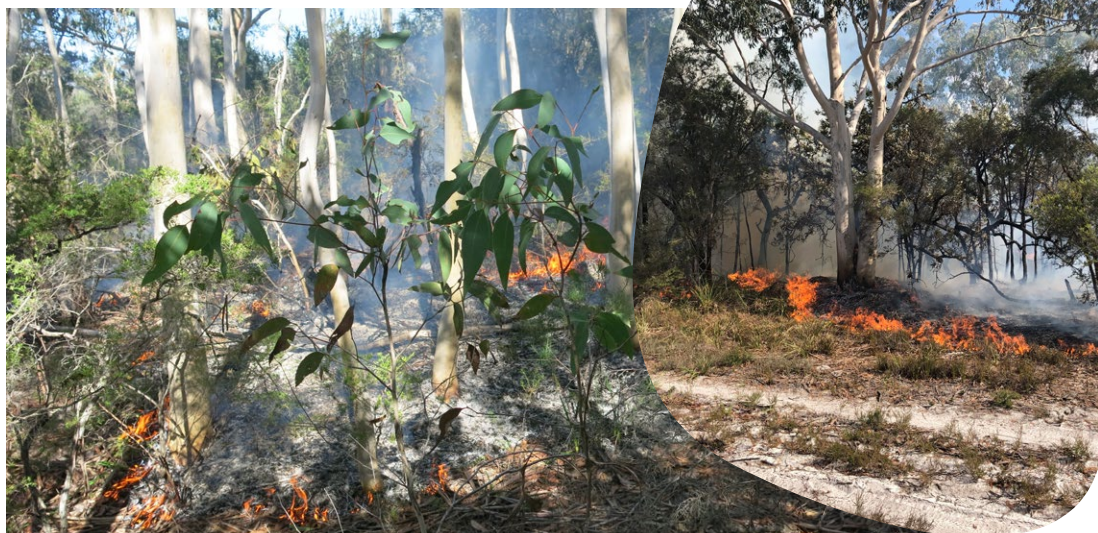
Figure 39: Ecological Burning at Bulahdelah Plain Wetland

In May 2019, council in partnership with Kleinfelder bushfire consultants commenced a low intensity ecological burn at Bulahdelah Plain Wetland. Ecological burning is an essential management tool designed to promote regeneration of endemic plant communities which in turn provides habitat for native animals.

To protect and enhance habitat for these species and other native fauna, Council initiated the ecological burn for over 20-hectares of conservation lands at the wetland. The burn was designed and undertaken for a variety of reasons including managing the land to deliver habitat variability and successional/seral staging as well as to provide significant fuel management strategically across the Wetlands. This assists in mitigating potential for a single wild fire event to adversely impact the whole Reserve area and particularly an area of biodiverse revegetation plantings (that would be susceptible to a wild fire event).

Favourable weather conditions made for a successful stage one burn. Spot fires were lit strategically utilising prevailing winds to ignite the ground fuel layer across approximately five hectares within the northern section of the burn area. The fire progressed well across the site and an effective and well contained burn was achieved. Stage two of the burn scheduled for the following day had to be postponed due to strong westerly winds. Burning was completed in late July.

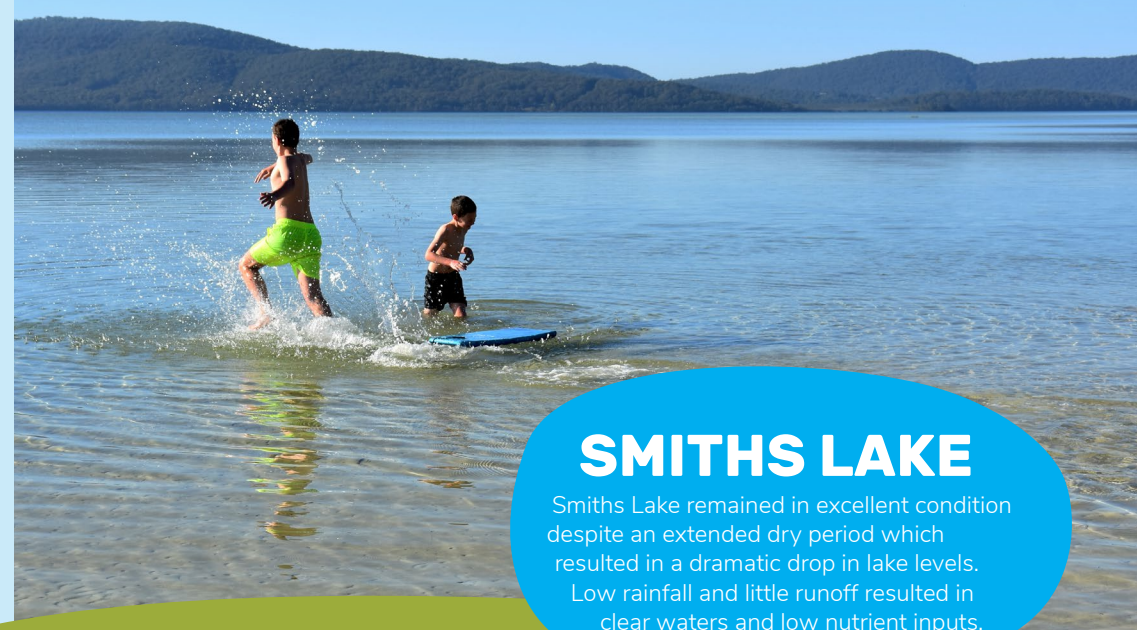
Overall grade: This represents ecological condition, it is a combination of algae and water clarity scores. Where there is no grade, no data was collected at these locations.

Seagrass depth range score: The seagrass score indicates how deep the seagrass is growing and if the seagrass area is expanding or contracting. Where there are no seagrass results, no data was collected at these locations.
