Great Lakes Coastal Hazards Study

Project Name:	Great Lakes Coastal Hazard Study – FINAL REPORT
Project Number:	3001829
Report for:	Great Lakes Council

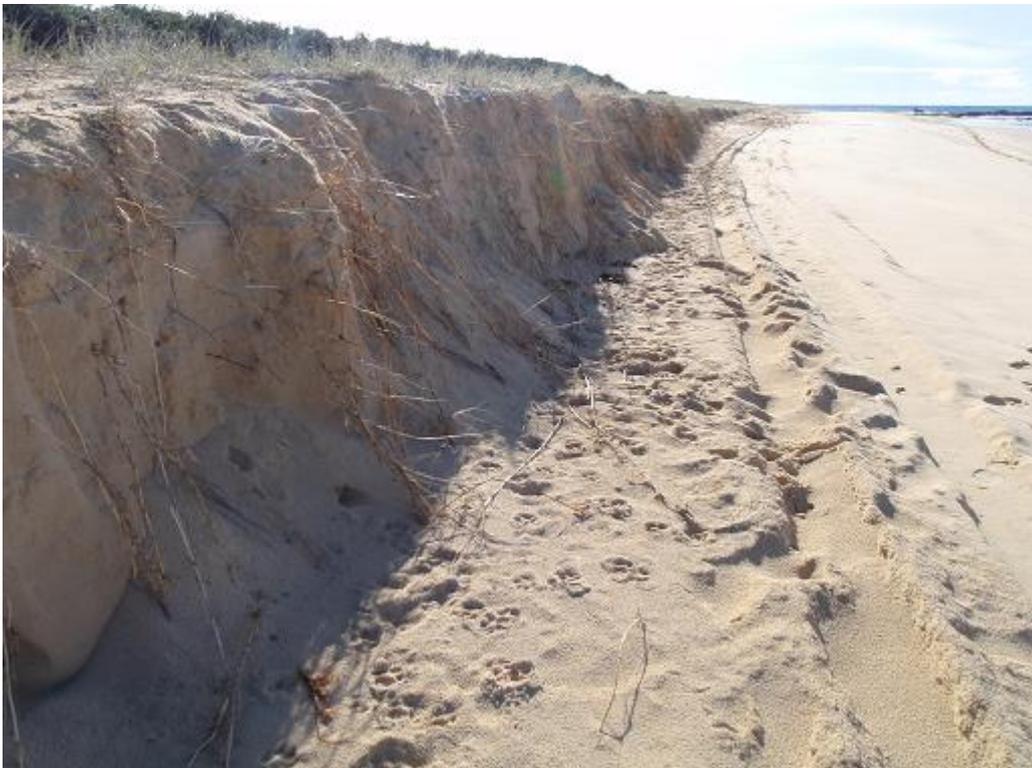
A significant erosion escarpment (around 2 m high) due to the full exposure to wave climate (Figure 10) was observed. However, there are large reserves of sand in the dune and the dune vegetation is in good condition. No public or private assets appear to be exposed to immediate coastal erosion risk in this area.

Figure 10: Erosion escarpment at the northern end of Nine Mile Beach (July 2010)

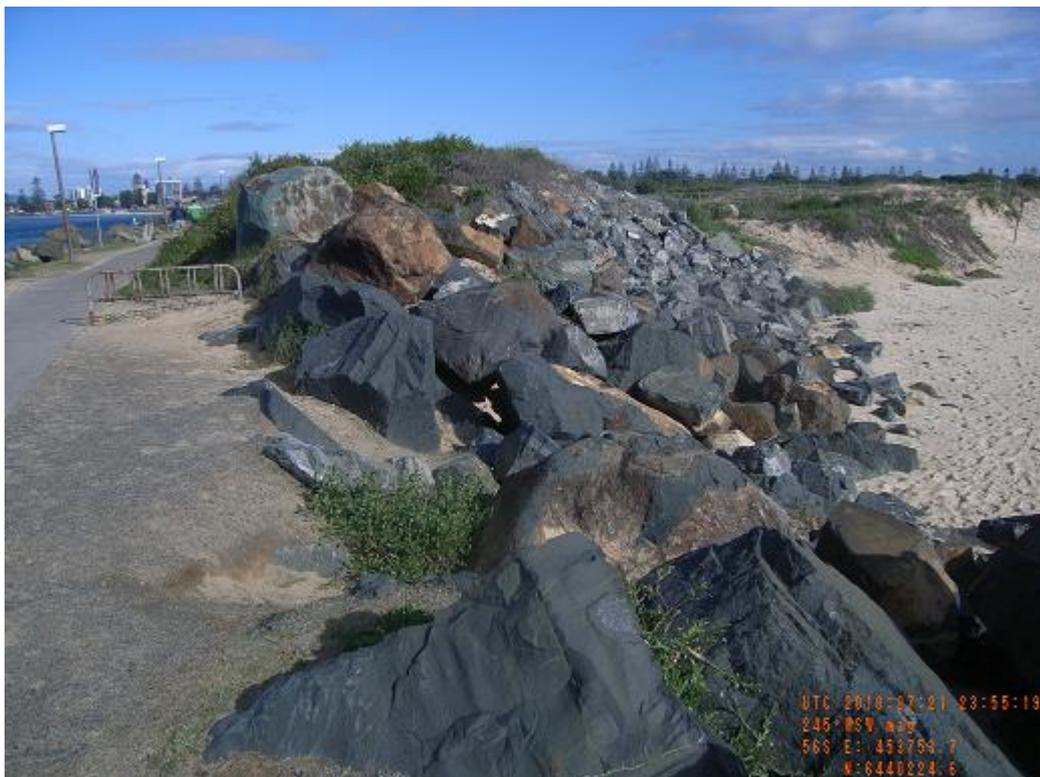
Figure 11: Failed seawall at the southern end of Nine Mile Beach and area of the seawall possibly subject to overtopping issues (July 2010)

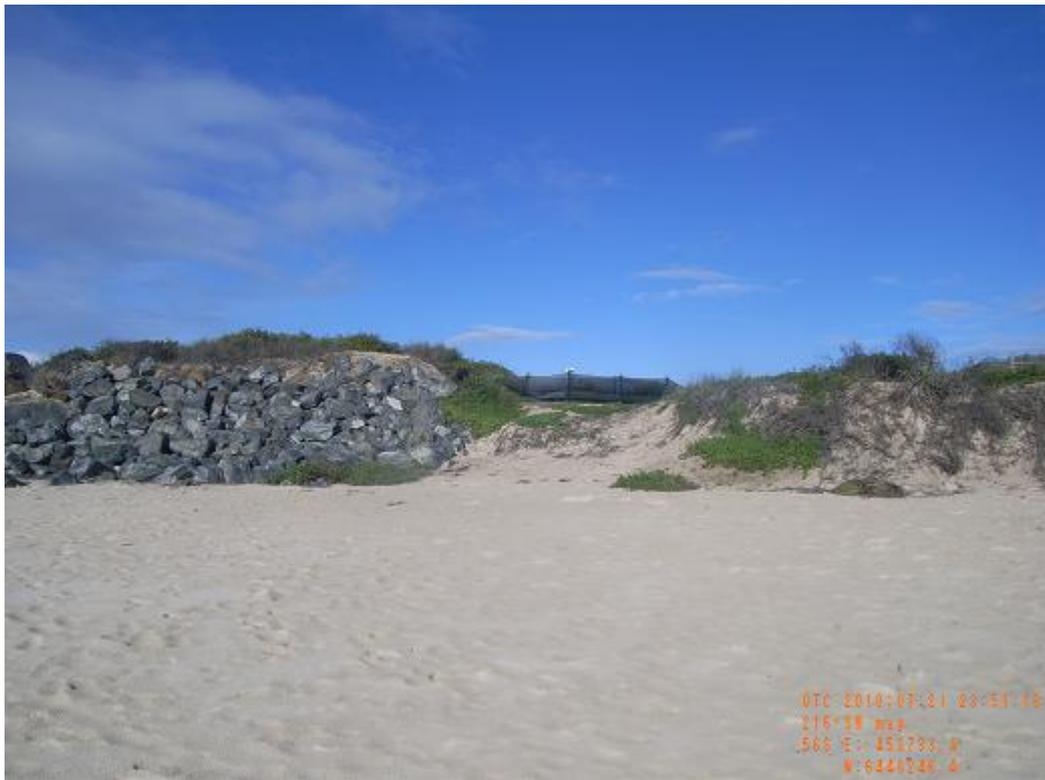
Dune rehabilitation was undertaken in 1993 in this area. The dune has been fenced and some wind protection has been installed to prevent dune blow-out (Figure 13). A two-metre erosion escarpment was observed behind the fences (Figure 14) but no development appears at immediate risk due to extensive dune sand reserves and healthy vegetation. The board and chain access to the beach is very steep which could lead to user safety issues (Figure 15).

Figure 13: Wind protection for dune at southern end of Nine Mile Beach (July 2010)

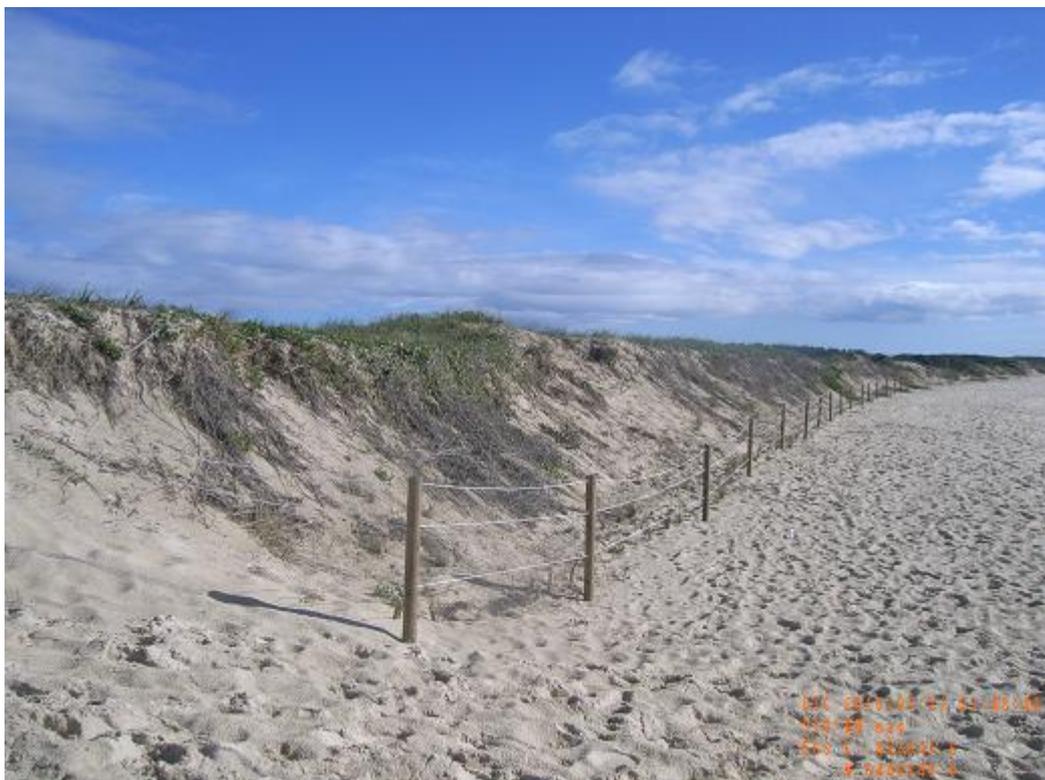
Figure 14: Storm bite behind the fences at the southern end of Nine Mile Beach (July 2010)

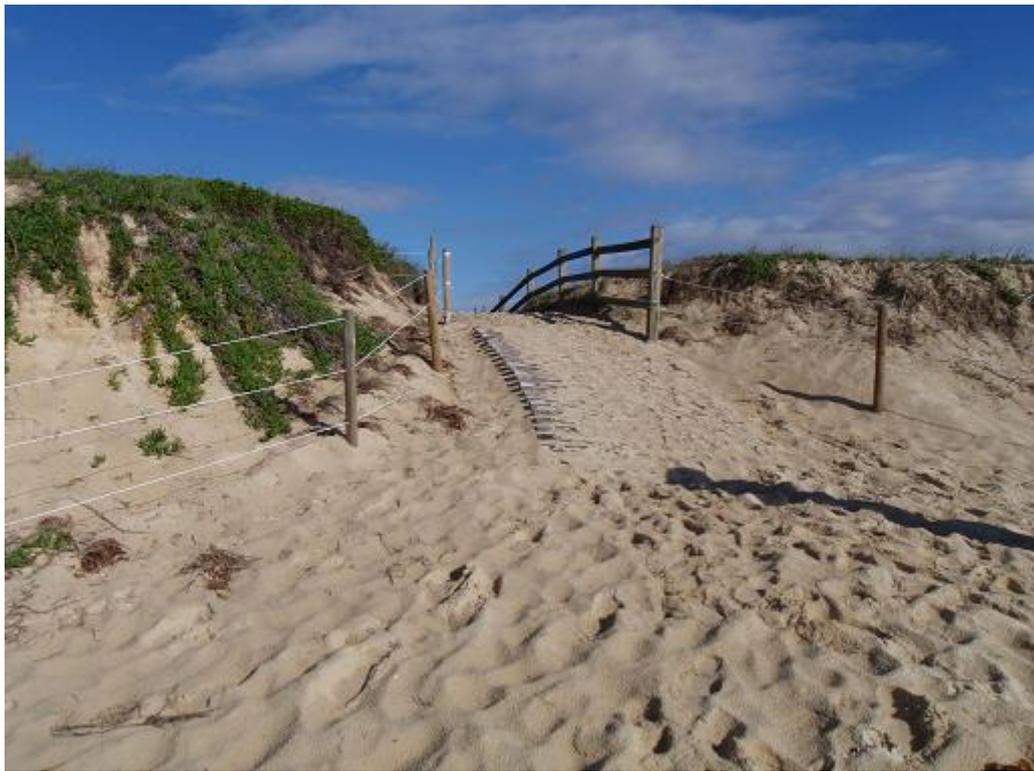
Figure 15: Board and chain access at the southern end of Nine Mile Beach (July 2010)

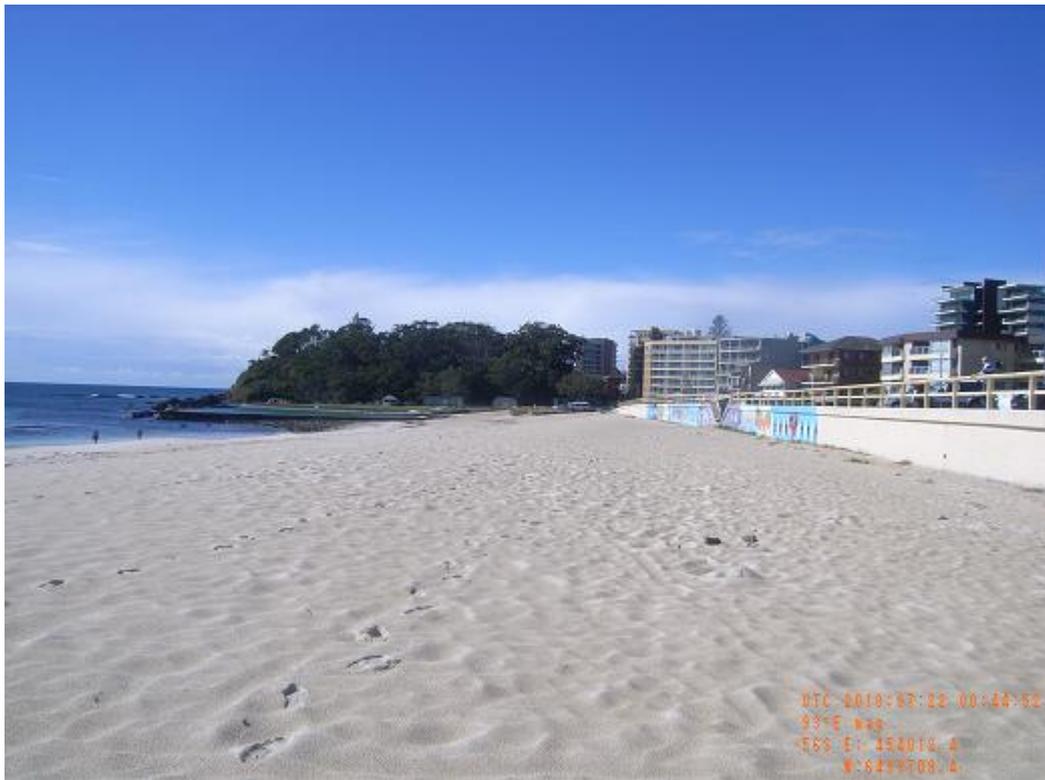
The southern half of the beach is backed by a vertical seawall protecting the roadway, car park and buildings located along the beach (Figure 19). A cafe and the SLSC are also protected by this vertical seawall (Figure 20). This seawall appears to be in good condition. However, the depth to which the seawall is founded is unknown. The integrity of the seawall is reliant on maintained adequate toe embedment following storm erosion to -1 m AHD.

Figure 19: Vertical seawall at Main Beach (July 2010)

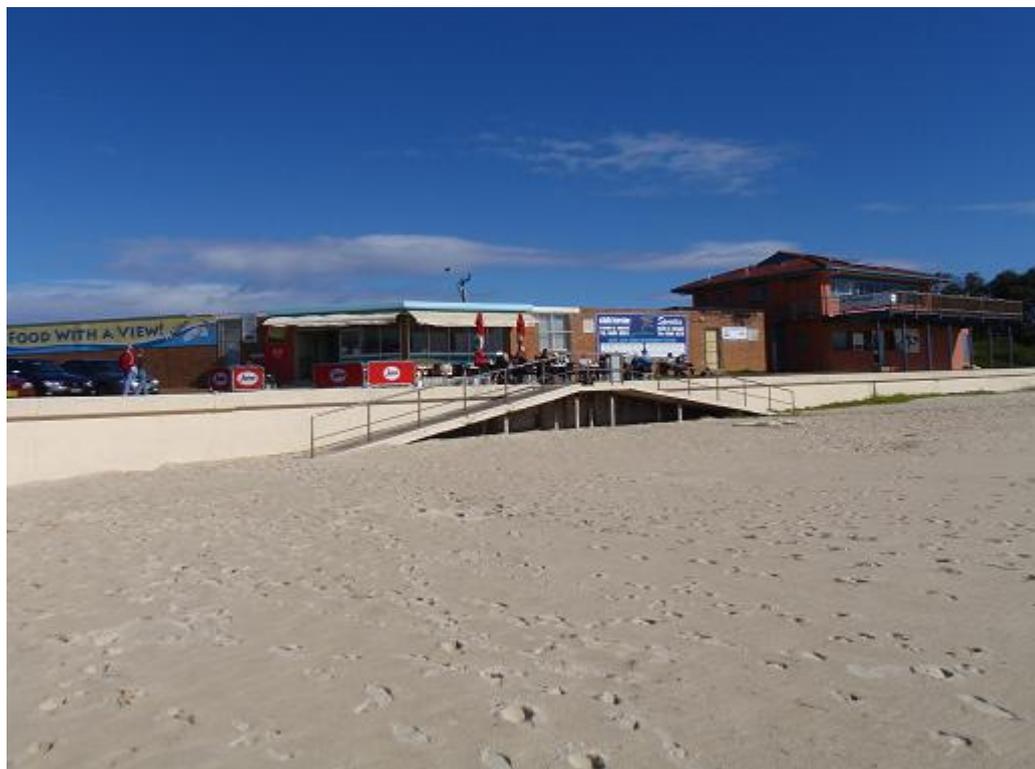
Figure 20: SLSC and cafe protected by vertical seawall at Main Beach (July 2010)

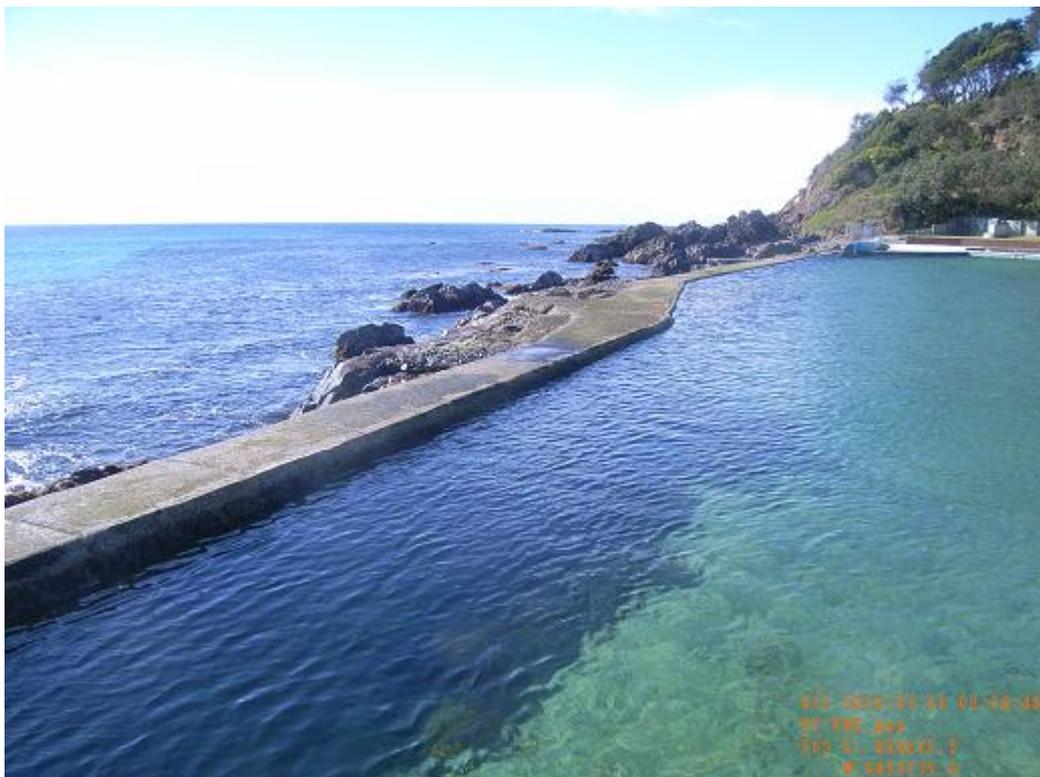
An ocean swimming pool has been built on the natural rock outcrop at the southern end of the beach (Figure 21). A stormwater outlet is located adjacent to the swimming pool and some rock protection has been placed in front of the outlet. Litter was observed on the rocks in front of this stormwater outlet (Figure 22). There are good facilities for day visitors (e.g pool, picnic area, shelters or change room).

Figure 21: Main Beach swimming pool (July 2010)

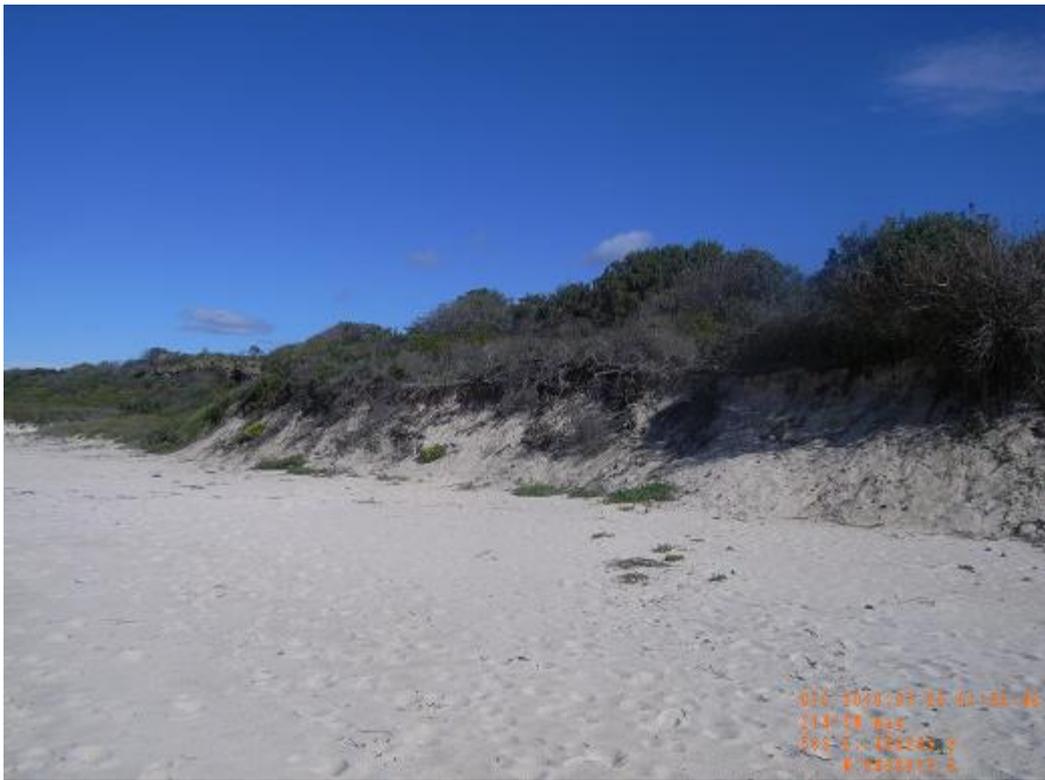
A significant erosion escarpment around three metres high was observed along the beach (Figure 29). A small creek flowing out of the Golf Course had been opened by heavy rains at the time of the site visit but it is expected that the creek entrance would be closed rapidly by sand buildup at the beach berm (Figure 30). An old board and chain access to the beach was damaged at the northern end and may need to be replaced (Figure 31).

Figure 29: Erosion escarpment along the northern half of One Mile Beach (July 2010)

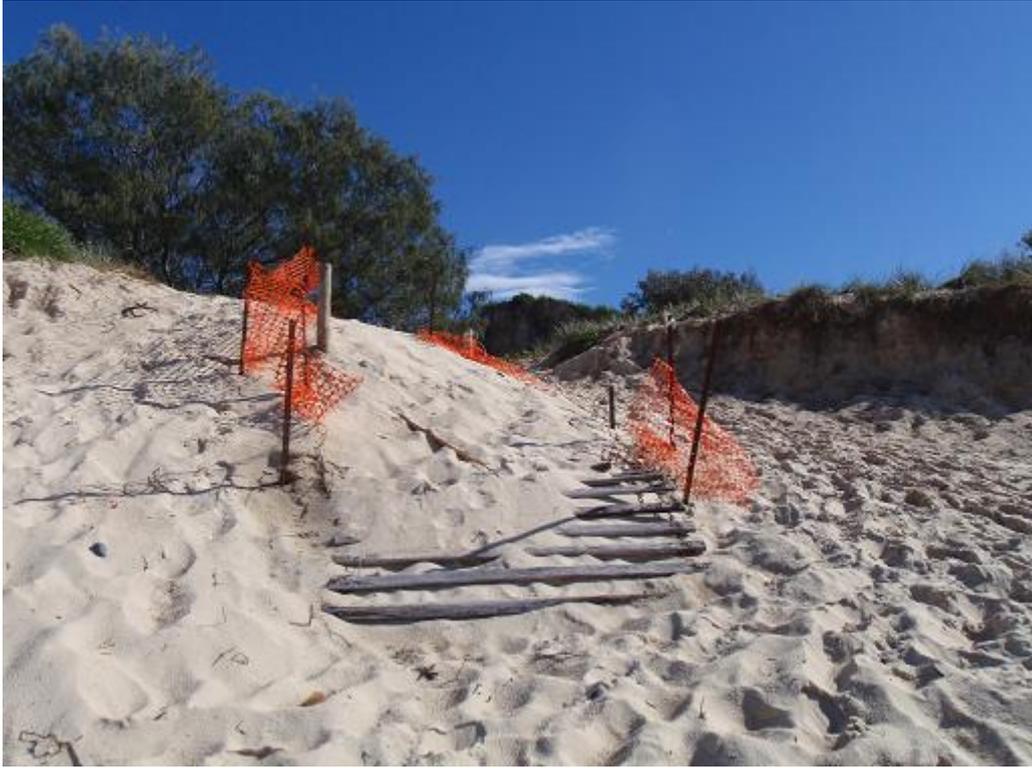
Figure 31: Damaged board and chain access to One Mile Beach (July 2010)

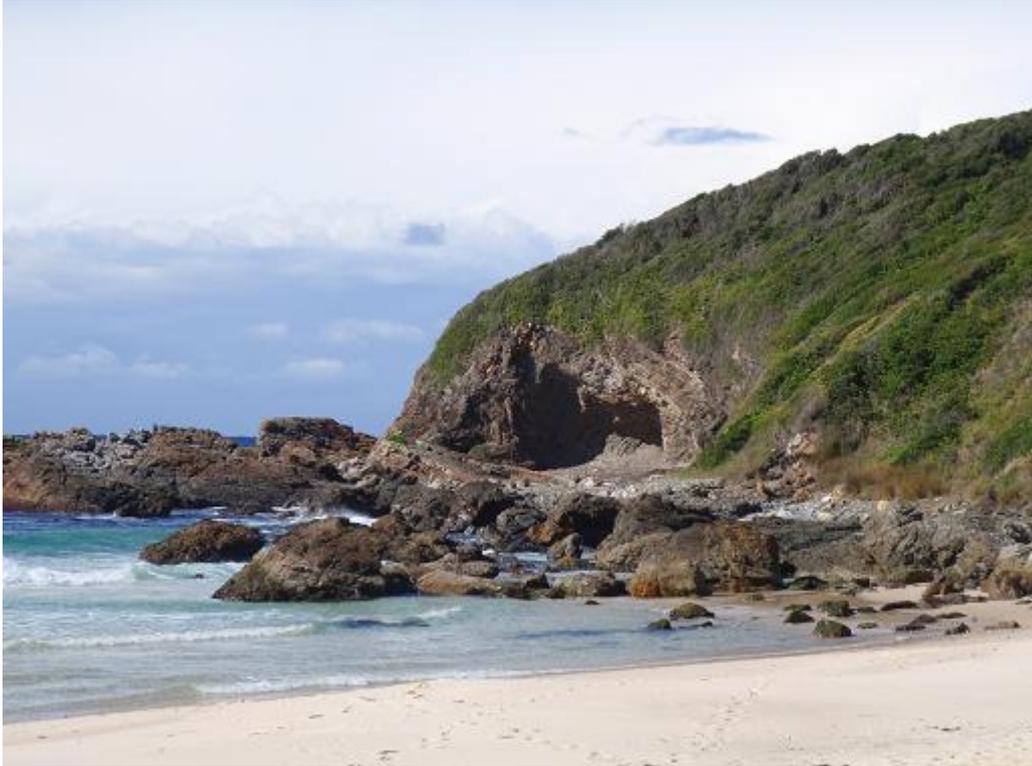
The surf club is relatively close to the beach and may be at long-term risk from coastal erosion or inundation. Houses are located further back from the beach but may be at long term risk from coastal erosion. The dune along the southern half of One Mile Beach (Figure 32) is well vegetated and seems relatively stable. A stormwater pipe in relatively good condition discharges onto the rock platform at the southern end of the beach. A large cavity was observed at the bottom of the coastal bluff at the southern end of the beach (Figure 33).

Figure 33: Large cavity at the bottom of the coastal bluff at the southern end of One Mile Beach

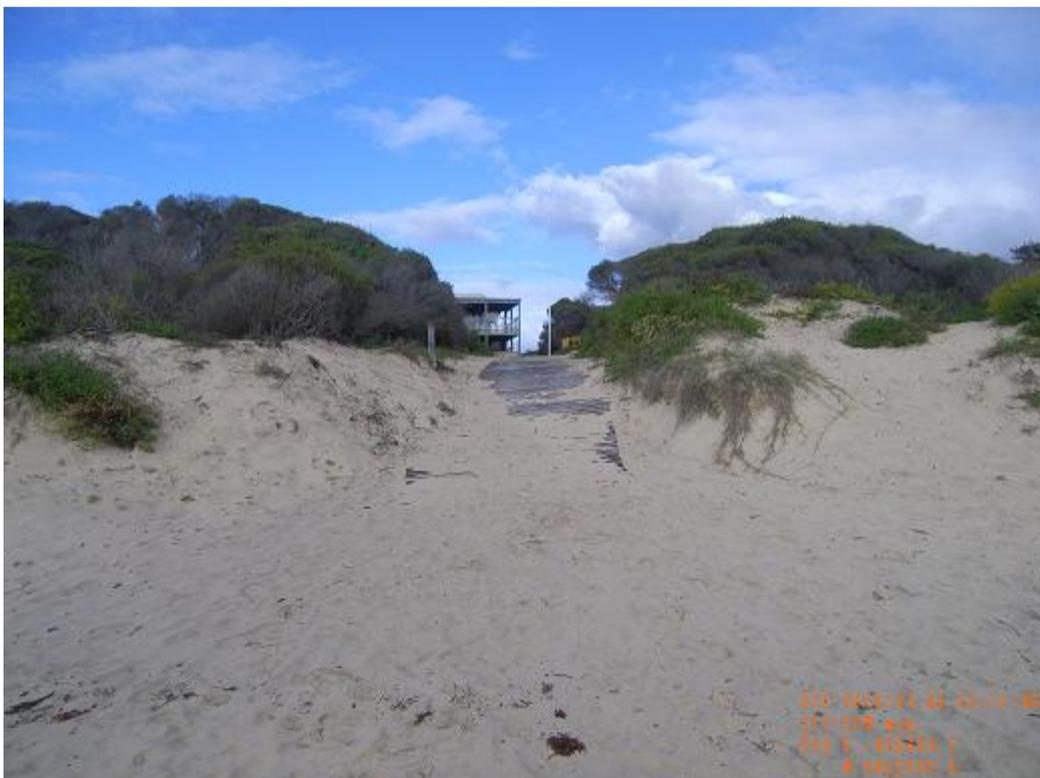
Elizabeth Beach is a pocket beach facing north-east. Large swells were observed at the beach at the time of the site visit. There may be possible sand movement between Shelly and Elizabeth Beach. A large escarpment around 1.5-2.0 m high was observed along the beach and the lack of incipient dune despite the wide berm indicates that the beach may be subject to recession (Figure 37). However, no infrastructure appears to be at immediate coastal risk. The surf club is being redeveloped. The toilet block and SLSC (Figure 38) may be at long-term risk from coastal erosion.

Figure 38: Elizabeth Beach SLSC (July 2010)

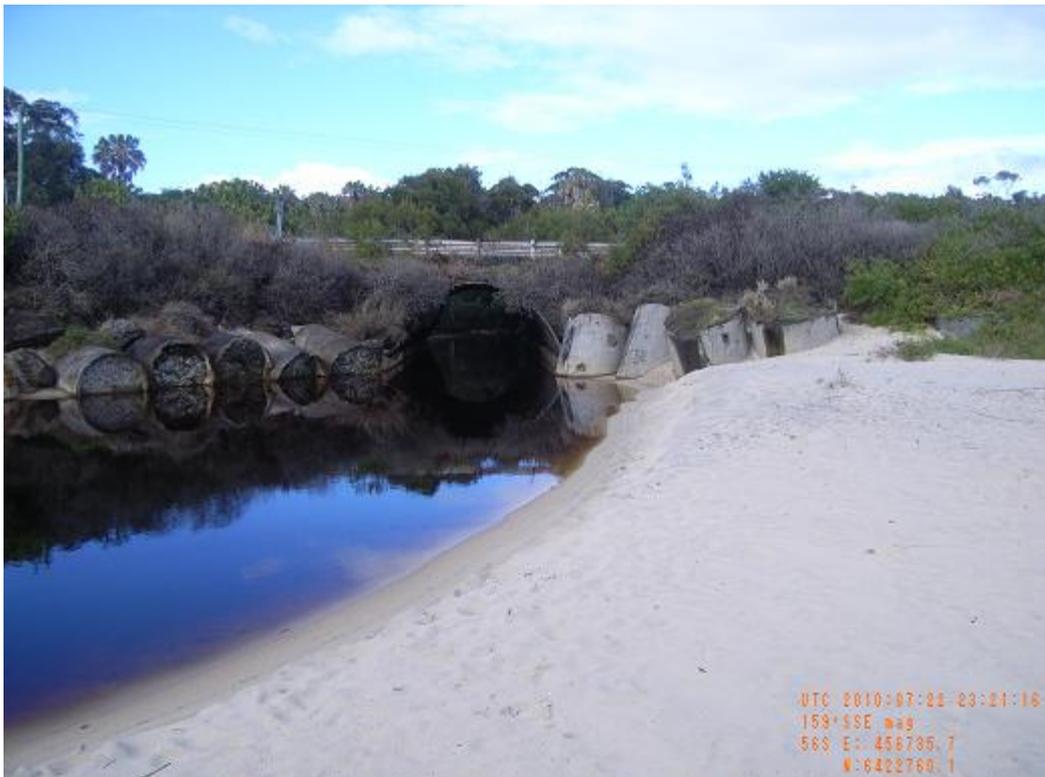
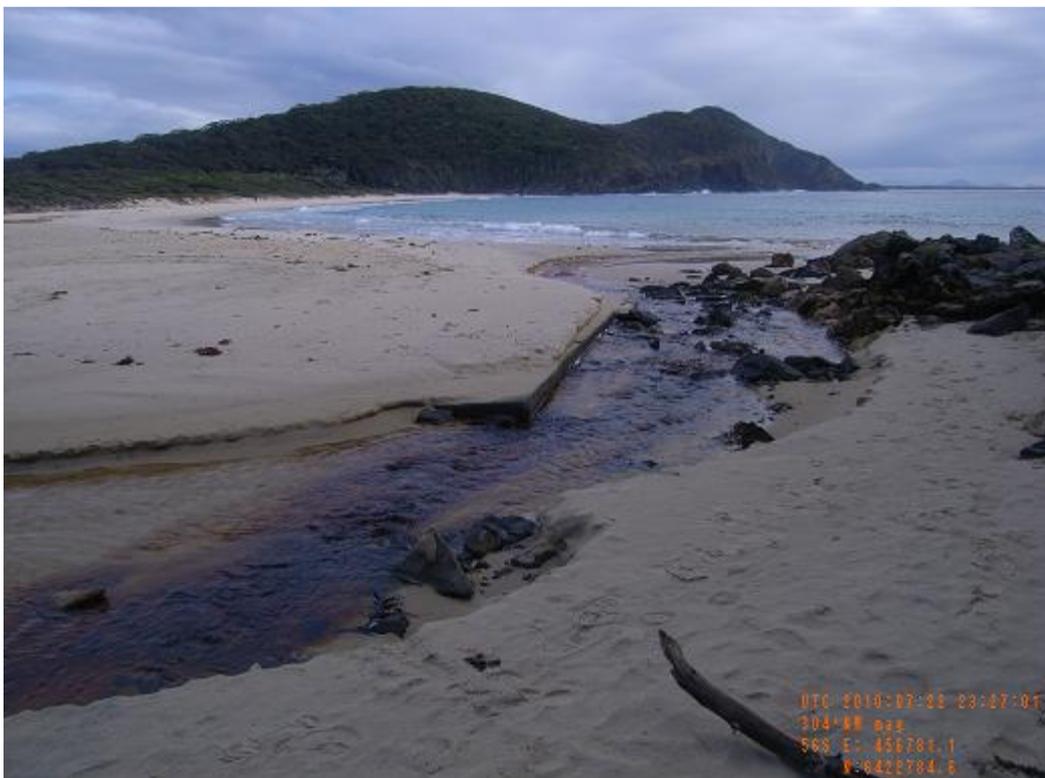
rocks without geotextile, and the gully has exposed a concrete apron covered with sand (Figures 39-40). This apron appears to be an old boat ramp. The arch used as a base for the bridge is corroding and appears to be close to the end of its design life. A 4WD access located at the southern end to launch boats from the beach appears to have been lost due to erosion.

Figure 39: Small creek outlet at the southern end of Elizabeth Beach (July 2010)

Figure 40: Gully created by the creek at the northern end of Elizabeth Beach and old boat ramp

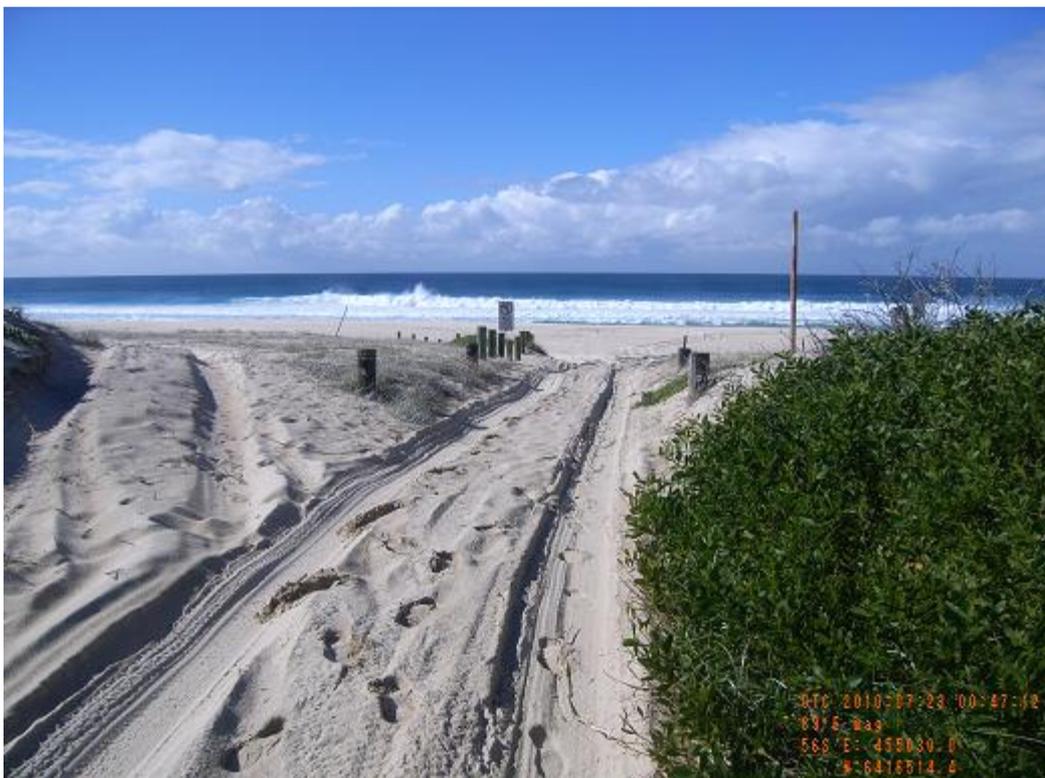
4WD access appears to be uncontrolled and fenced along the beach north of the entrance berm as existing fences have been cut and some 4WD tracks were observed through the incipient dune in violation of signs placed in the area (Figure 44).

Figure 44: Uncontrolled 4WD access at Sandbar Beach (July 2010)

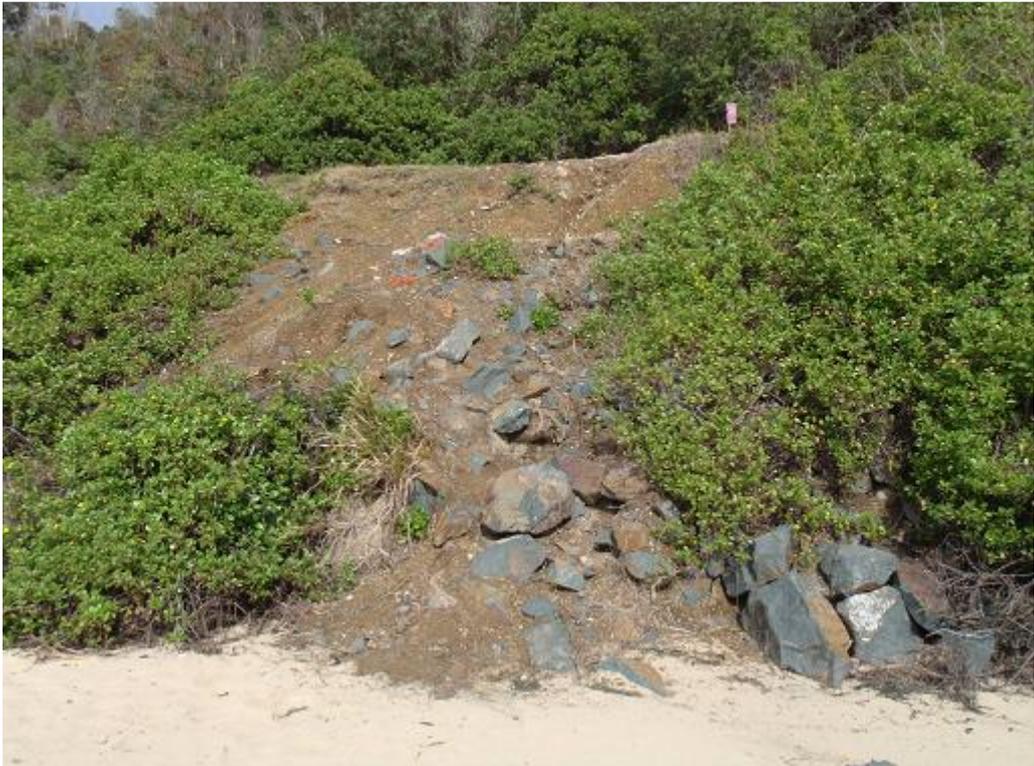
Figure 46: Landslip along Seal Rocks Road at Number One Beach (July 2010)

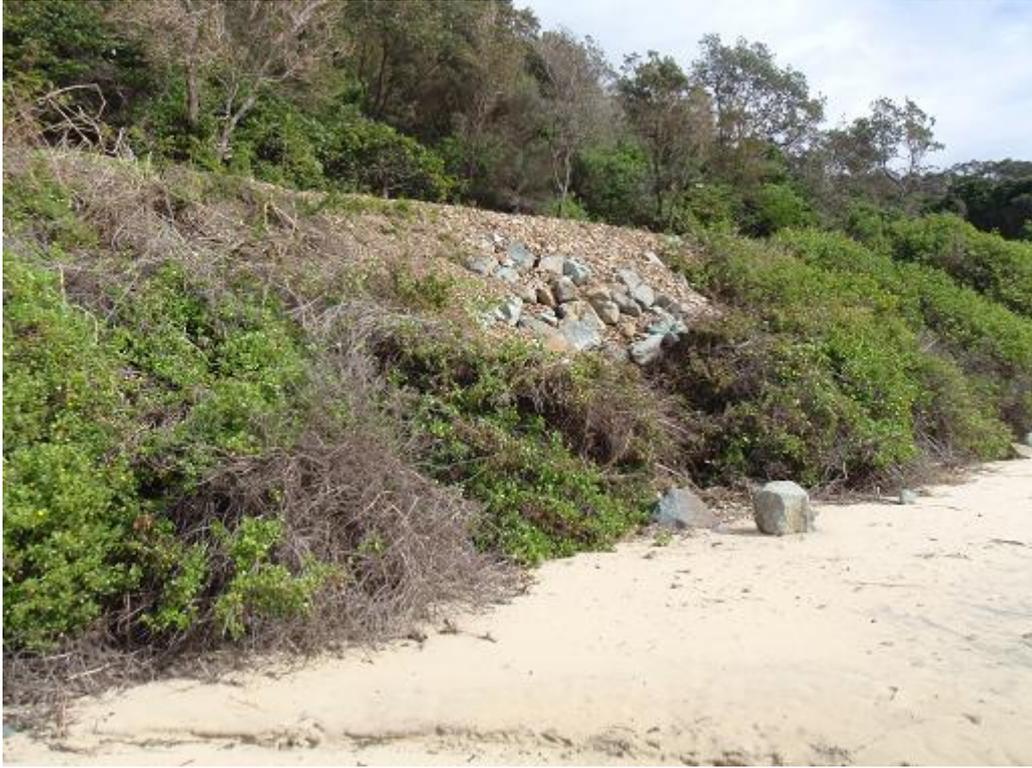
Figure 47: Dumped rocks to protect Seal Rocks Road at Number One Beach (July 2010)

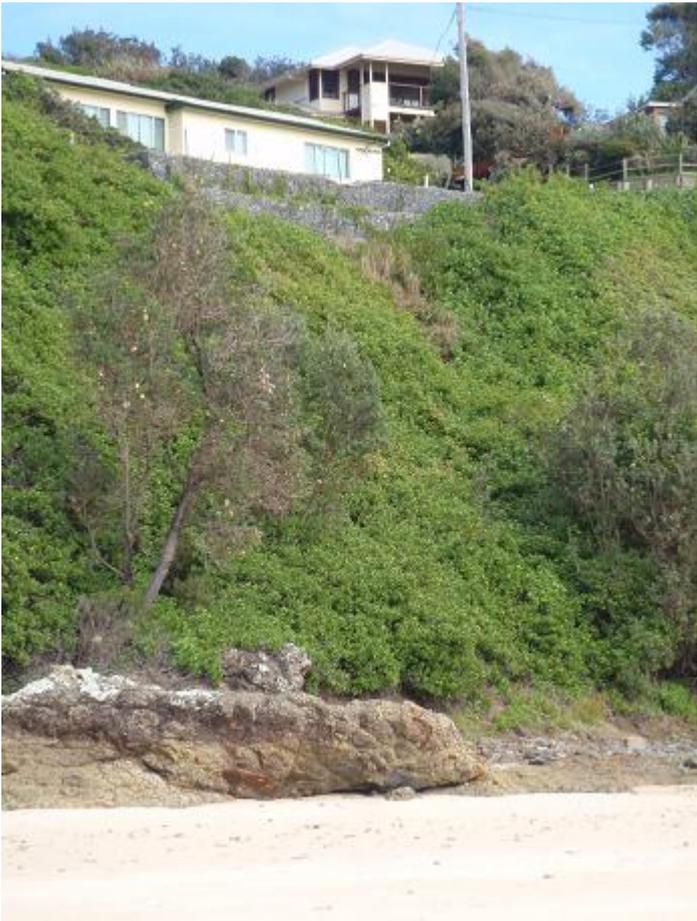
Boat Beach is less exposed to wave climate than Number One Beach but is subject to slope stability issues. Some gabions have already been put in place at the top of the bluff to protect Kinka Road (Figure 48). Some picnic tables were observed at the southern end of the beach. There is no dune and a visible erosion escarpment of 0.5-1.0 m along the beach (Figure 49) and some ad hoc erosion protection has been provided (Figure 50). A boat ramp has been undermined due to erosion (Figure 51). The road appears to be at risk from coastal erosion and slope stability.

Figure 48: Gabions at the top of the coastal bluff along Kinka Road at the western end of Boat Beach

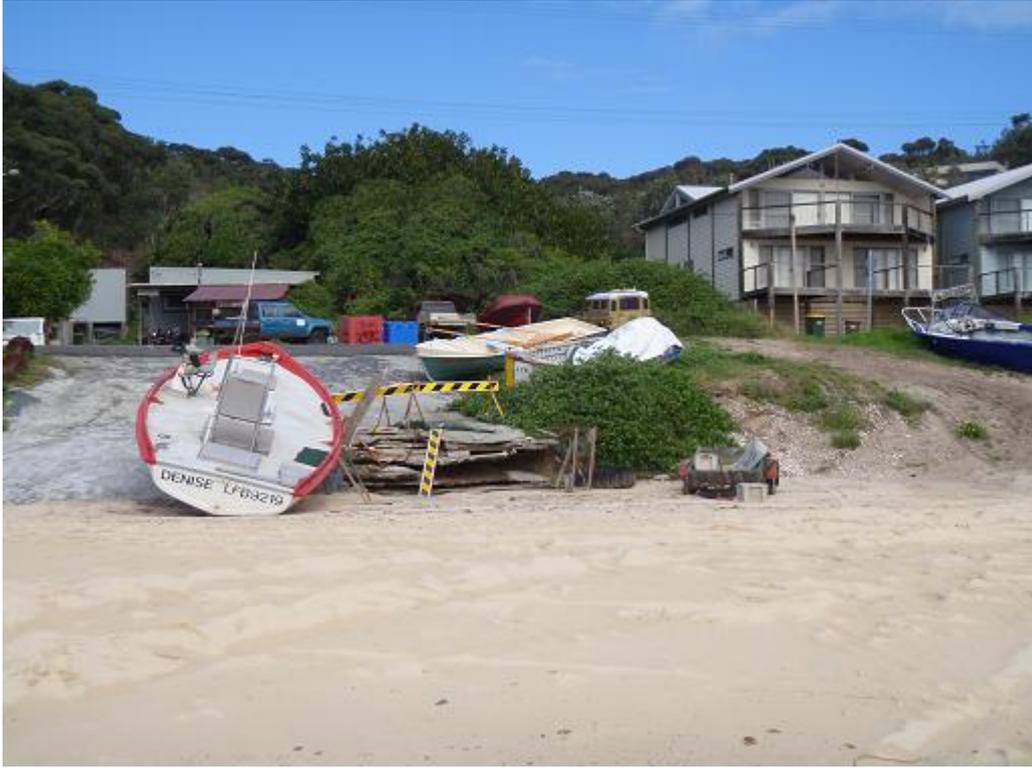
Figure 51: Damaged private boat ramp at Boat Beach (July 2010)

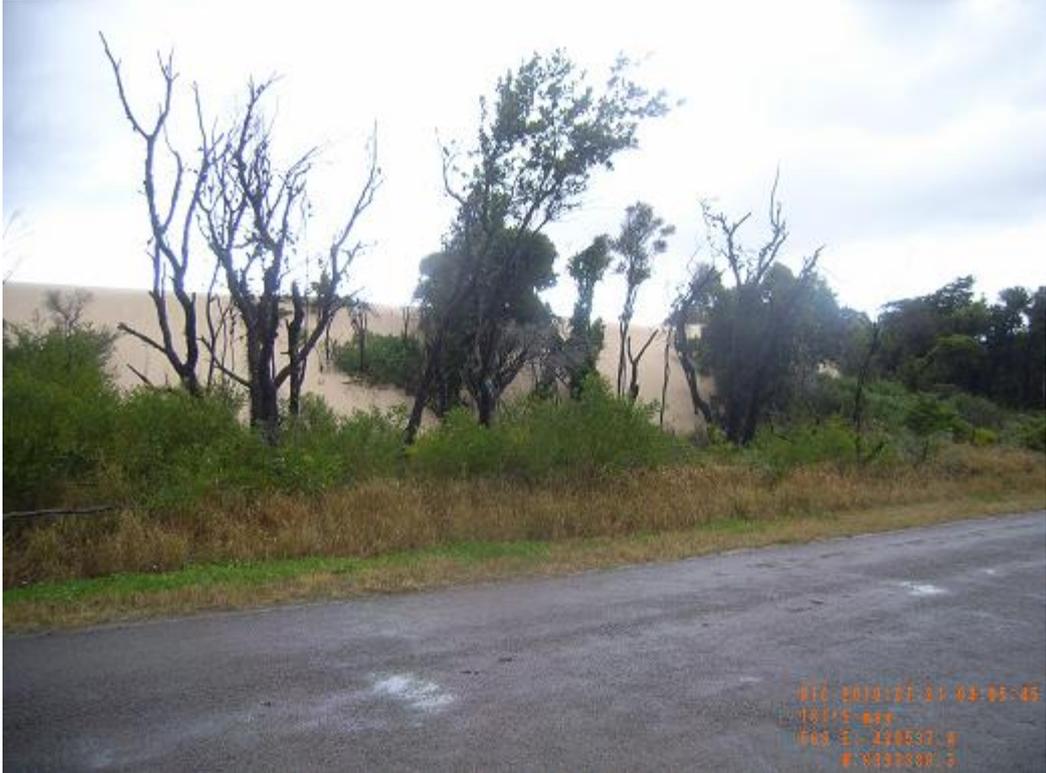
This part of the beach is located within Myall Lakes National Park. Transgressive landward movement of the dune due to wind was observed and the dune is close (i.e. around 20 m) to Mungo Brush Road in some areas (Figure 54).

Figure 54: Transgressive dune almost reaching Mungo Brush Road at the northern end of Bennetts Beach

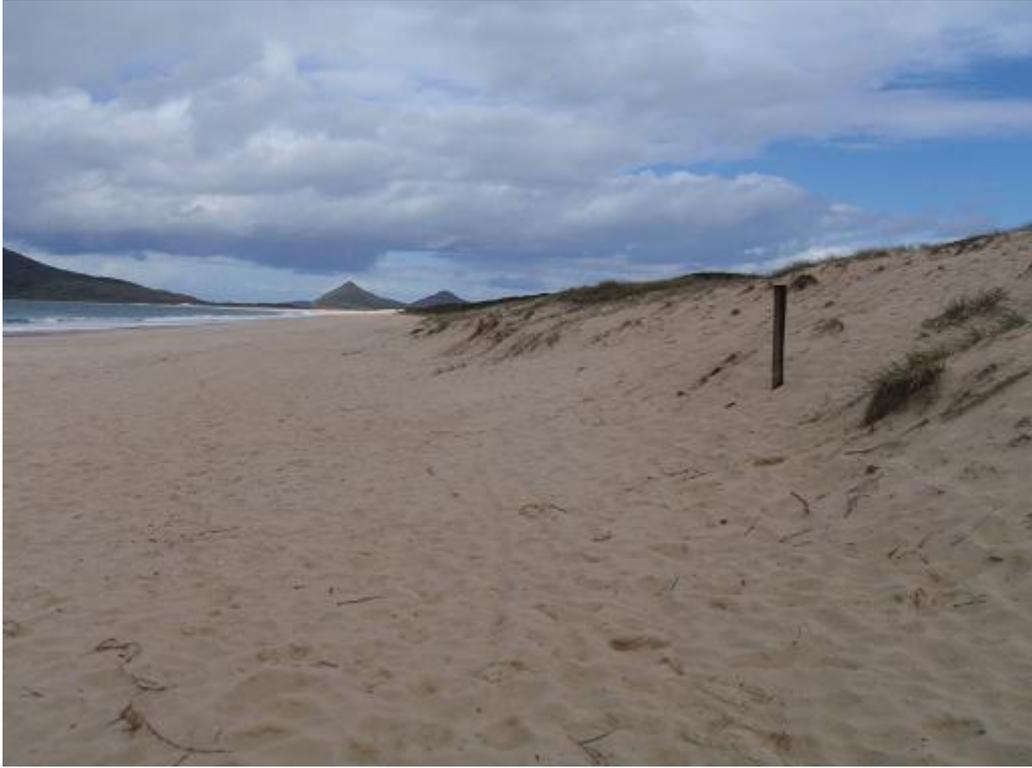
A remnant erosion escarpment was observed along the beach but the beach seems to have mostly recovered and stabilised (Figure 55). The surf club does not appear to be at immediate risk given the wide buffer provided by a well-vegetated dune (Figure 56) but may be at long-term risk. The houses and the road are located a significant distance from the foreshore and do not appear to be at risk from coastal erosion. Fencing of the dune should be maintained to avoid damage to dune vegetation due to uncontrolled access (people were observed walking over the dune during the site visit). Some fences have been damaged and need maintenance (Figure 57). The spit between Hawks Nest and Jimmys Beach (Yacaaba) is around 100 m wide. At this location, there is a dune blow-out issue due to an unprotected and unvegetated dune resulting in mobile sand driven by wind force. The dune is transgressing landward and is threatening the old access road (Figure 58). The dune fencing is damaged in some areas and some additional fencing is recommended to better establish dune vegetation and help stabilisation.

Figure 55: Remnant erosion escarpment visible along Bennetts Beach (July 2010)

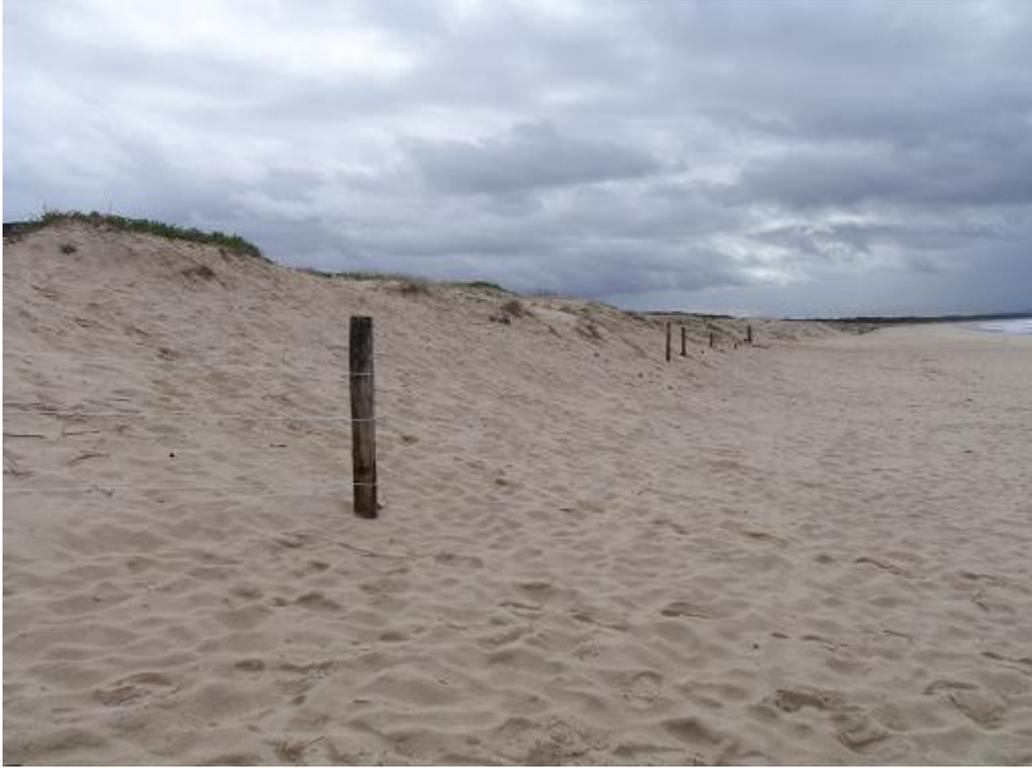
Figure 57: Damaged fences at the southern end of Bennetts Beach (July 2010)
