# Bedrock Based Coastal Hazard Revision for Blueys and Boomerang Beach

Reference:  
R.N2405.003.00.HazardLineRevision.docx  
Date: June 2014  
Confidential

Prepared for: Great Lakes Council

Prepared by: BMT WBM Pty Ltd (Member of the BMT group of companies)

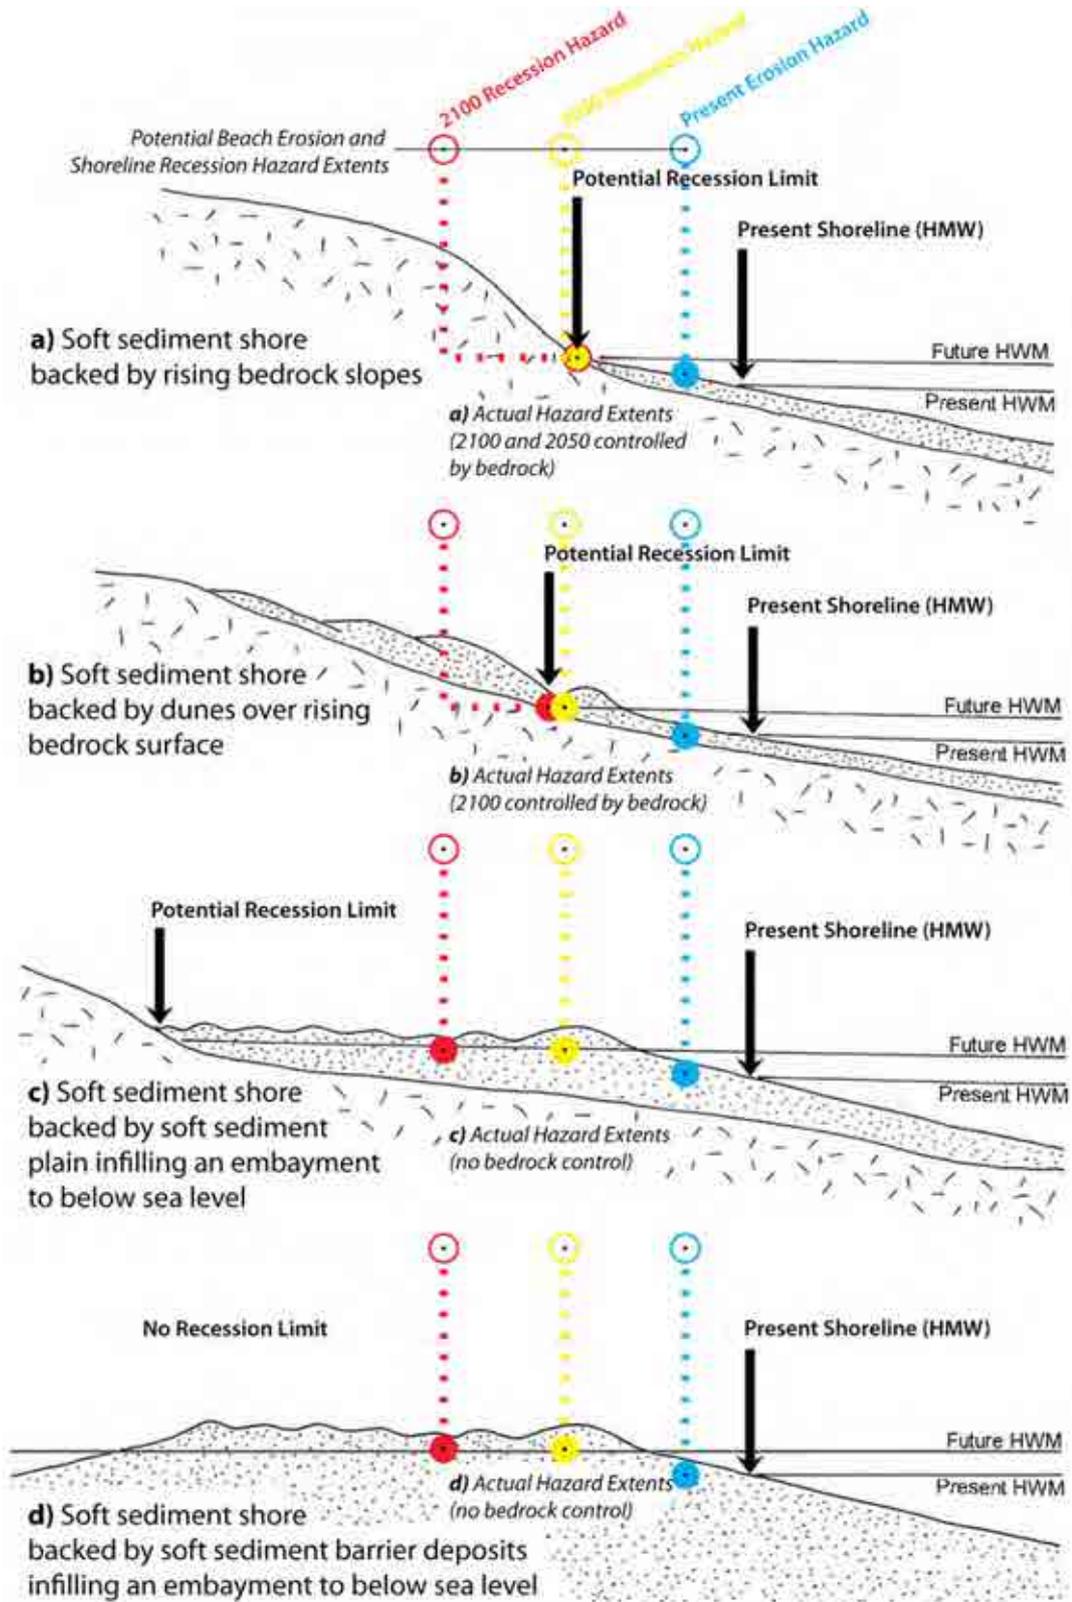
Figure 2-1 Conceptual Model: Maximum recession limits, as controlled by underlying bedrock topography, applied to coastal hazard definition (modified from Sharples and Donaldson, 2012)

The concept of bedrock control on shoreline recession is presented in Figure 2-1. Geological controls on coastal hazards are best incorporated into hazard definitions by identifying the limits to which an erodible shoreline can *in principle* recede to, prior to undertaking any hazard estimations. This is best achieved by mapping out the potential recession limit for a coastal compartment, which can be either exposed at the surface or buried beneath backbeach / dune sediments. A ~4 metre bedrock elevation has been identified as an appropriate level for limiting coastal hazards, as it is expected that coastal conditions over the next 100 years will allow wave action during large storms events to readily erode shoreline sediments up to this height (taking into consideration to wave setup, wave run-up and incremental sea level rise).

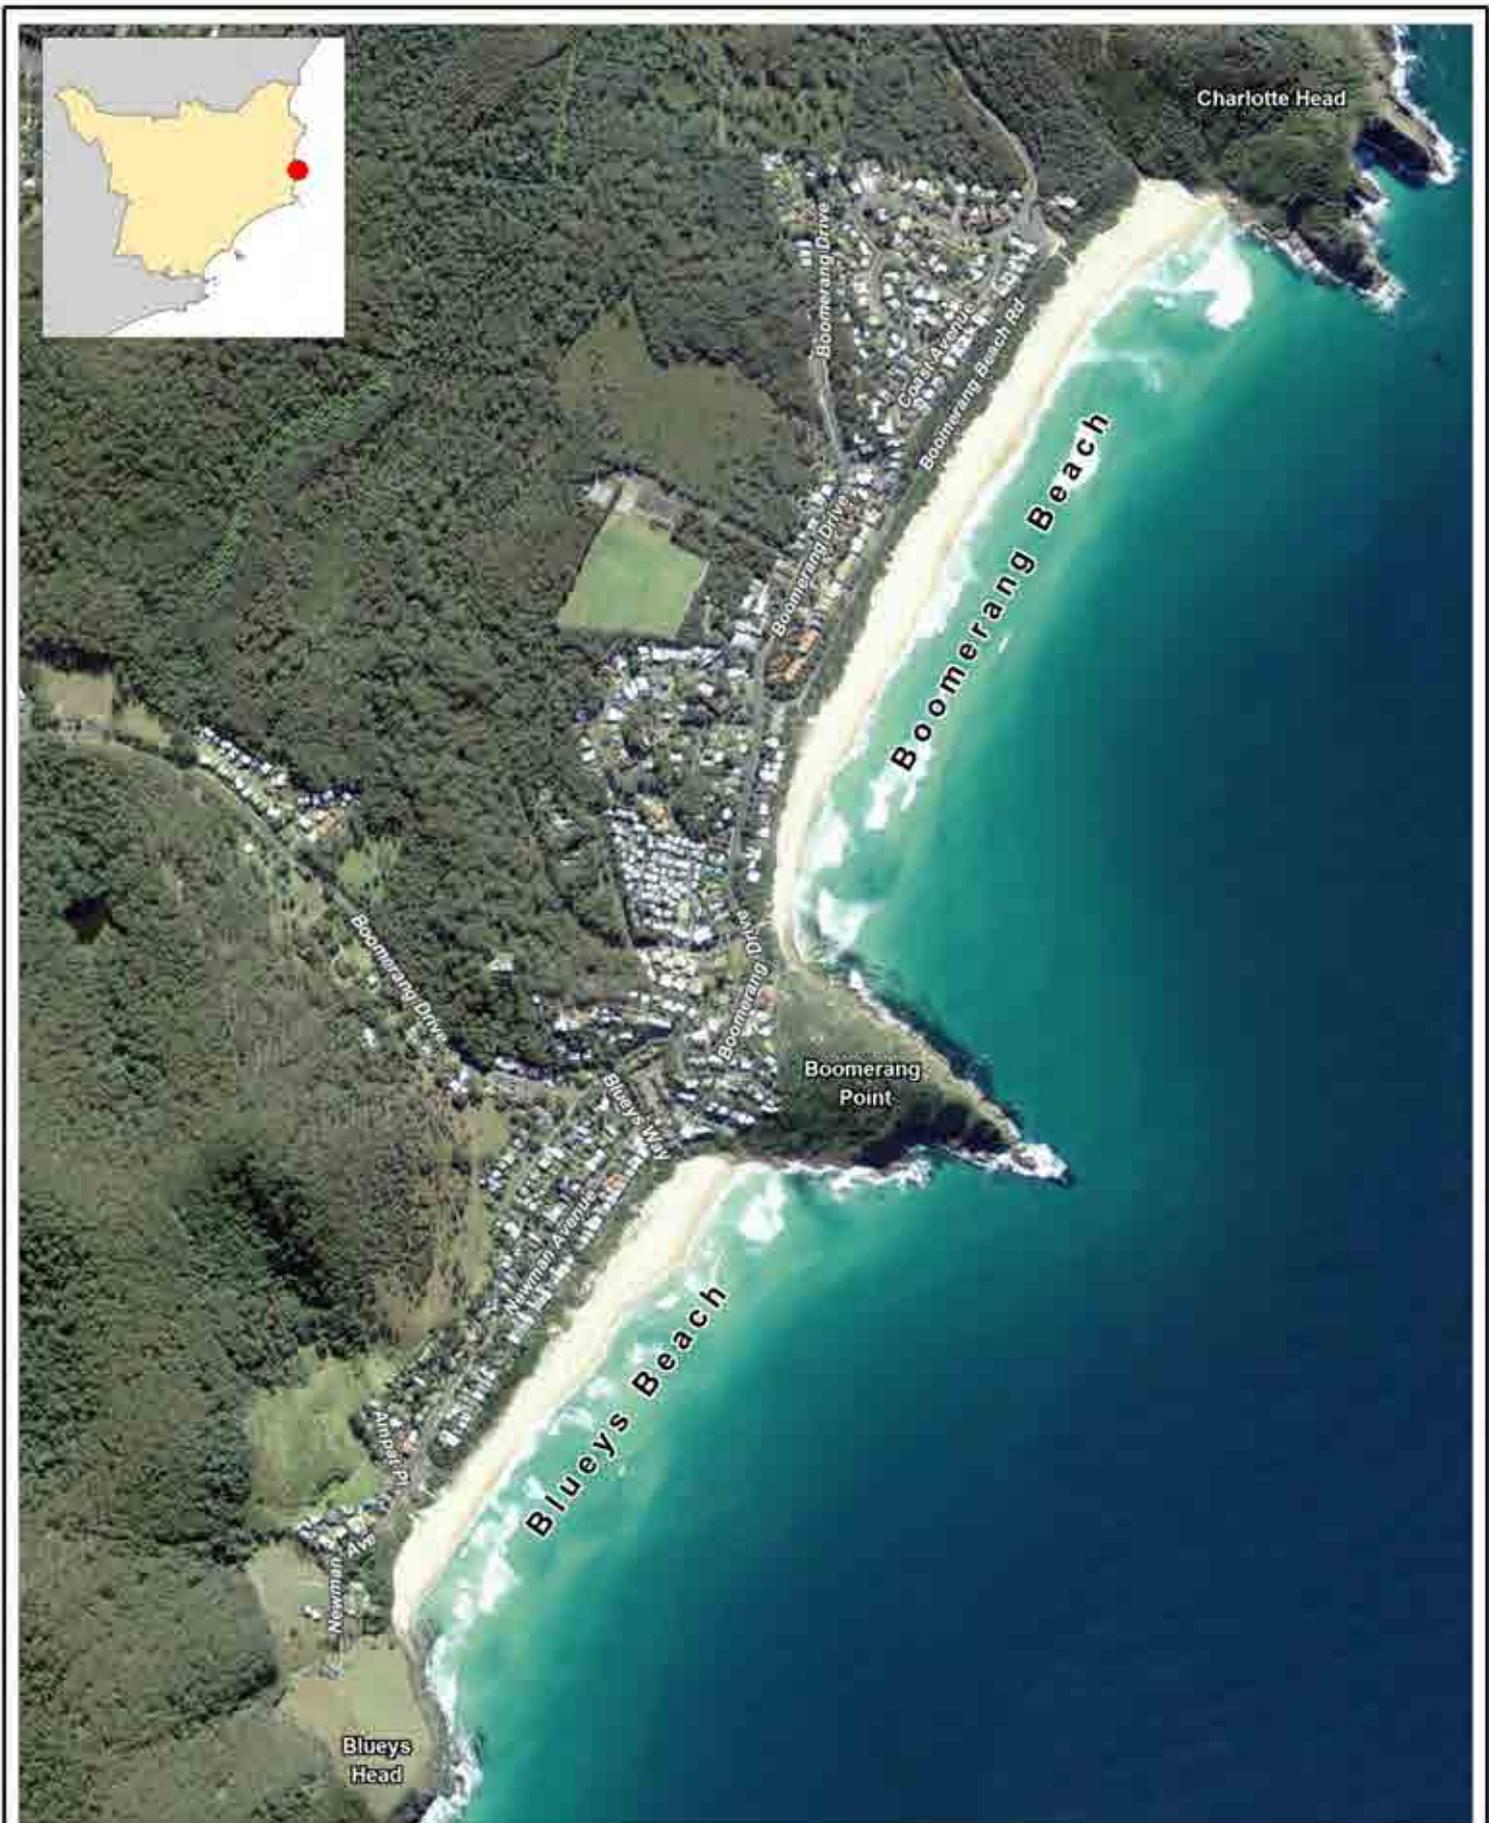
Figure:  
**3-1**

Title:  
**Blueys and Boomerang Beaches**  
**Great Lakes Council**

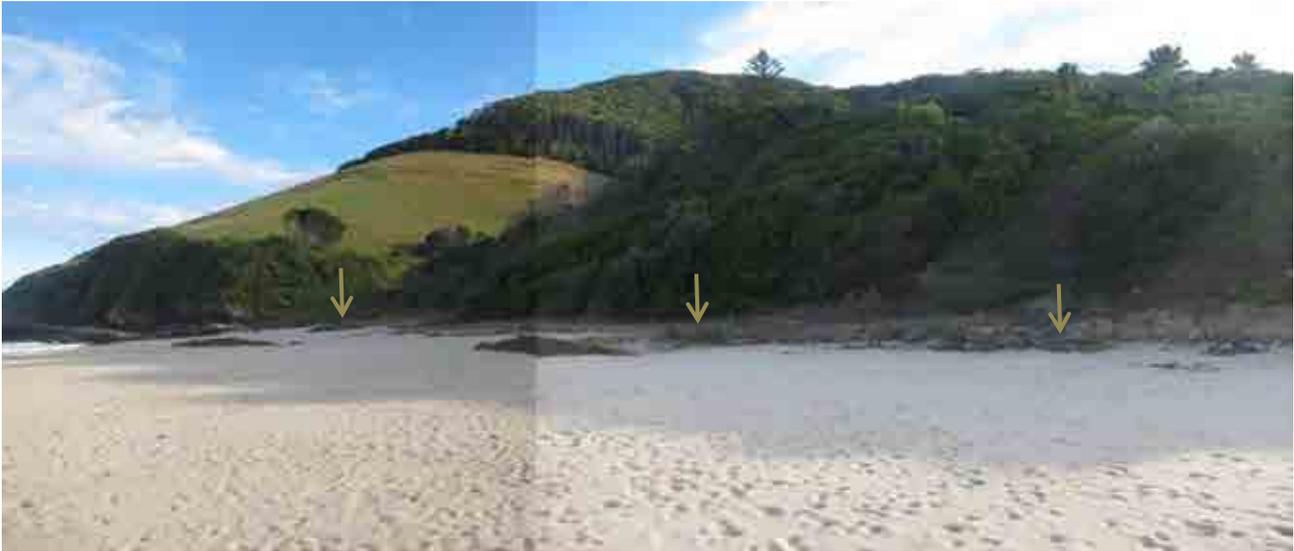
**Figure 3-2 Blueys Beach (looking south), showing the bedrock outcrops through the beach in the far southern corner**

Further investigation is required into the geotechnical nature of this feature, as an associated cliff / slope instability coastal hazard may exist if this landform feature is indeed a mass movement deposit (refer to Figure 3-2).

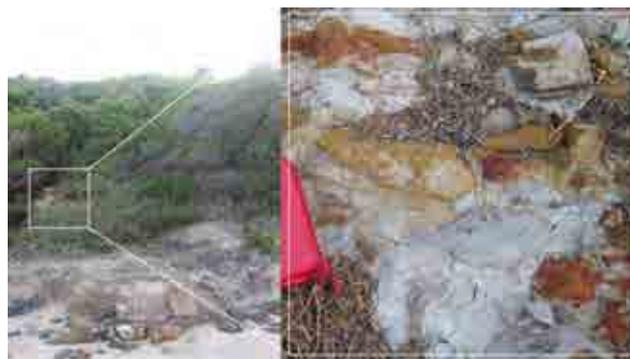
**Figure 3-3 Cohesive clayey gravelly substrate, Southern Blueys Beach**

The moderately rising slopes described above may have a coastal slope instability hazard that warrants further investigation. Outcropping above the bedrock base to these slopes is a poorly sorted and cohesive mix of boulders and gravels held within a clay rich matrix (refer to Figure 3-3). A subtle topographic feature that is not indicative of bedrock landform, is also located immediately landward of this exposure (see Figure 3-2). The origin and extent of this uncharacteristic landform feature has not been investigated in detail here (as it is not relevant to the beach erosion and shoreline recession hazard definition), however a cursory geomorphic interpretation suggests that it may form a relic mass movement deposit<sup>1</sup>. A more detailed assessment would be required to confirm this interpretation.

<sup>1</sup> The sedimentology and geomorphology of this anomalous surficial feature suggests it may comprise a mass movement (landslide?) deposit, based on the following:

- Poorly sorted nature of sediments exposed at coastal margins of the feature;
- Fan-like shape of the anomalous topographic feature, which is also bounded by erosion gullies; and
- Possible relation between this feature and an inferred underlying bedrock fault (which would cause a plane of weakness that could potentially triggered such an event); note that although no faults have been previously mapped at this location, examination of the high resolution (LiDAR) DEM as part of this assessment identified a relationship between adjacent bedrock incised creek on Blueys Head and bedrock fault lines (as noted from bedding discontinuities in the LiDAR along a number of northeast striking linear features).

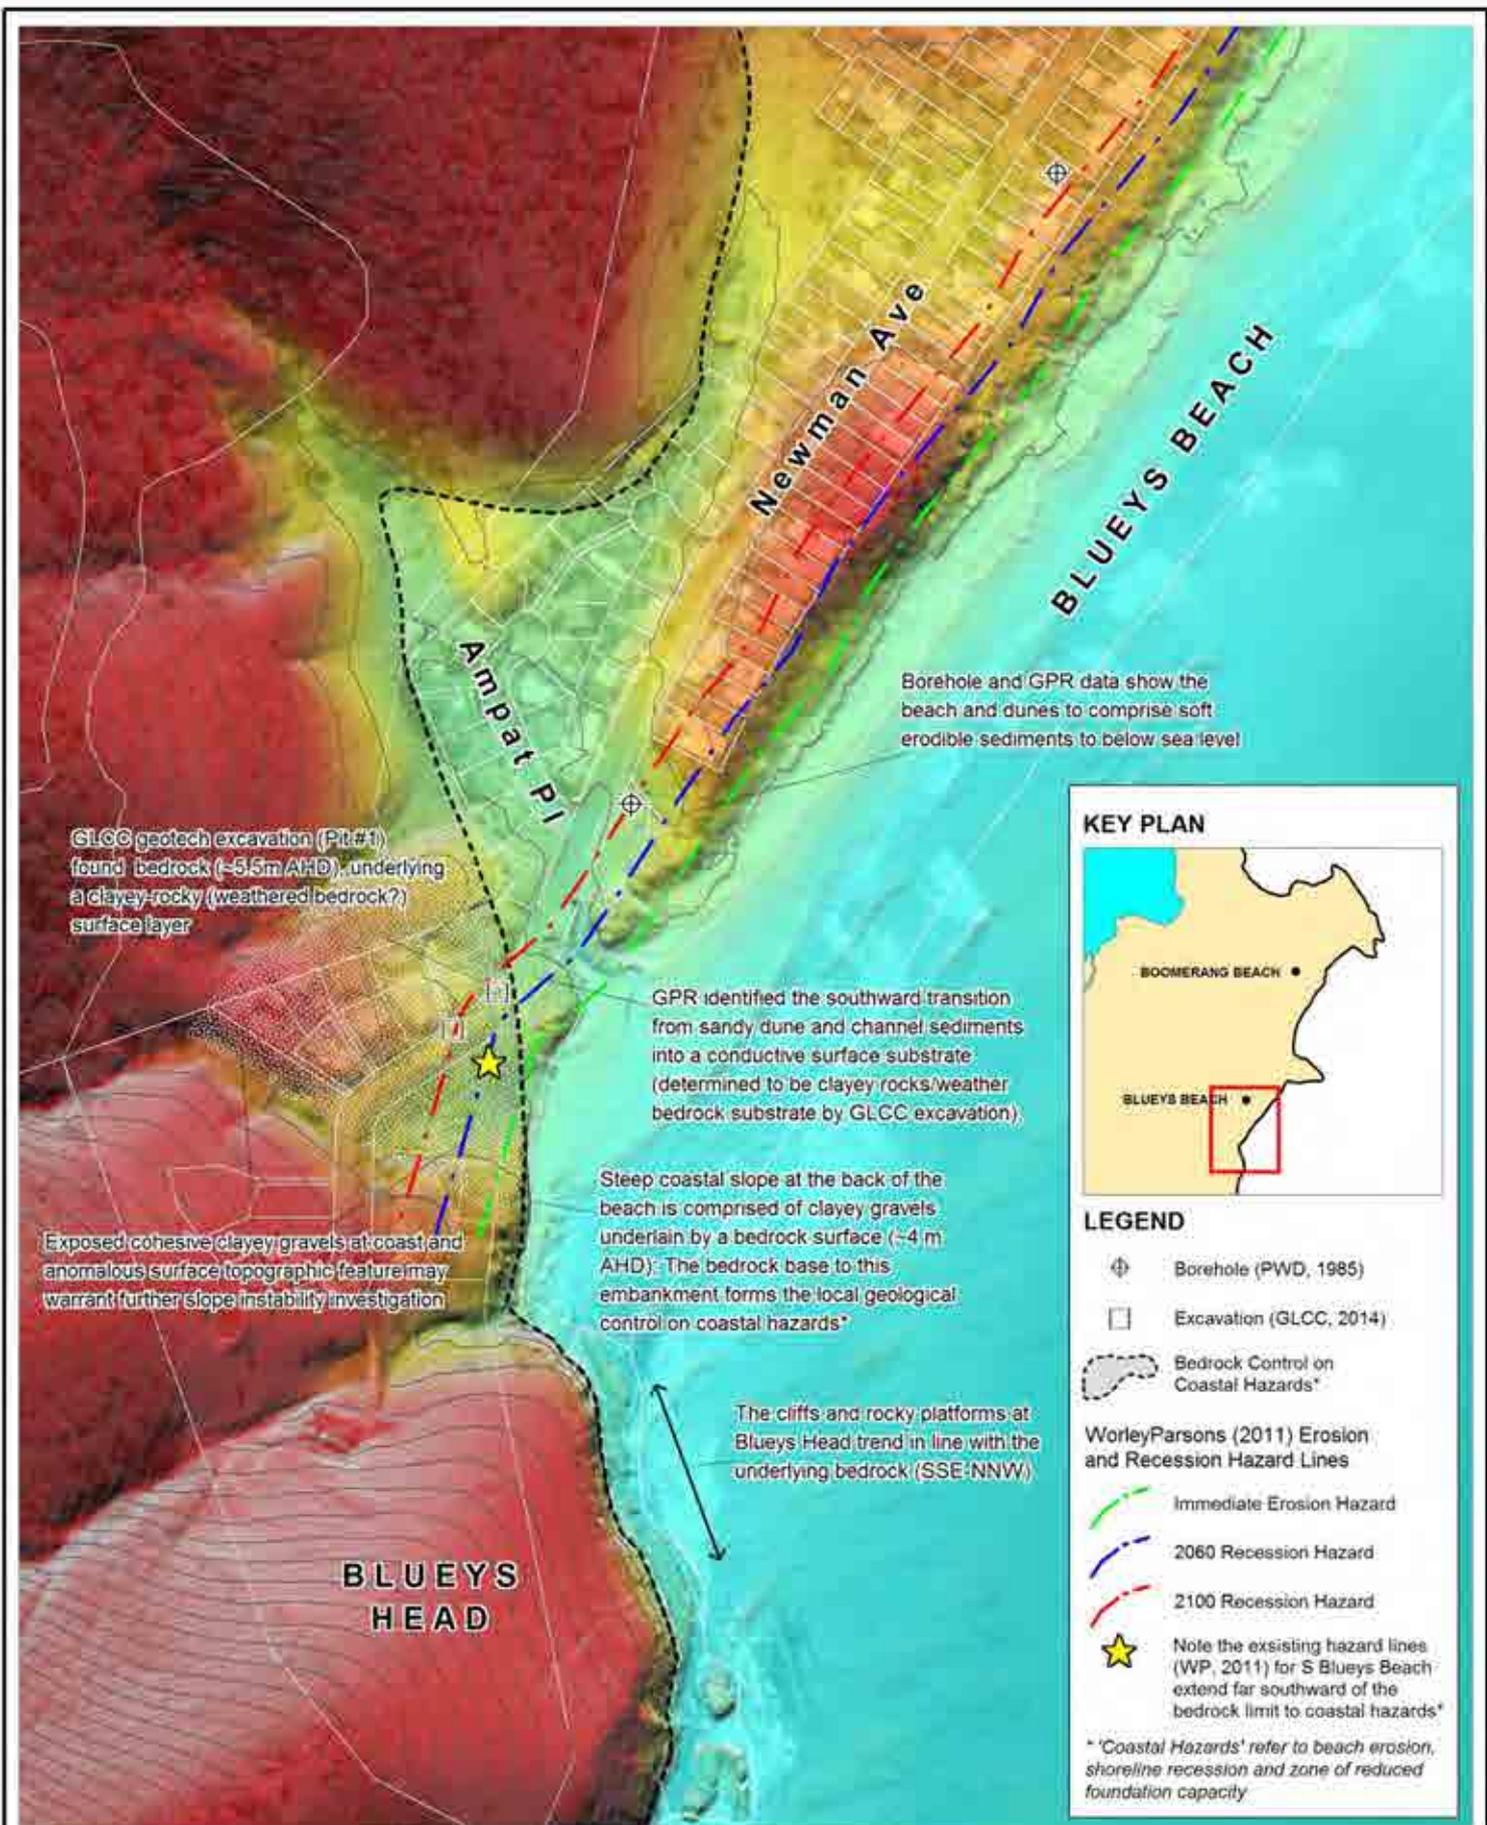
Figure:  
**3-4**

Title:  
**Bedrock Control on Coastal Hazards, Blueys Head  
 (Southern Blueys Beach)**

Landward of the southern beach / dune system, the geological limit to coastal hazards is interpreted to continue in a northerly direction from the rock exposures described above (refer to Figure 3-4). The nature of this geological limit to coastal hazards likely forms a relic rocky shoreline, which is presently covered by the adjacent dune sediments. The trend of this limit matches with the adjacent Blueys Heads cliffs (and underlying local bedrock structure). This interpretation is consistent with both the GPR data for southern Blueys Beach and the geotechnical excavation conducted by Great lakes Council: where the GPR survey shows obvious sedimentary bedding located to the immediate east of this inferred boundary (refer BMT, WBM, 2014; Figure B-1 and B-2); and the geotechnical excavation investigation which located stable bedrock substrate at 5.4 m AHD to the west of this boundary (refer to Appendix A).

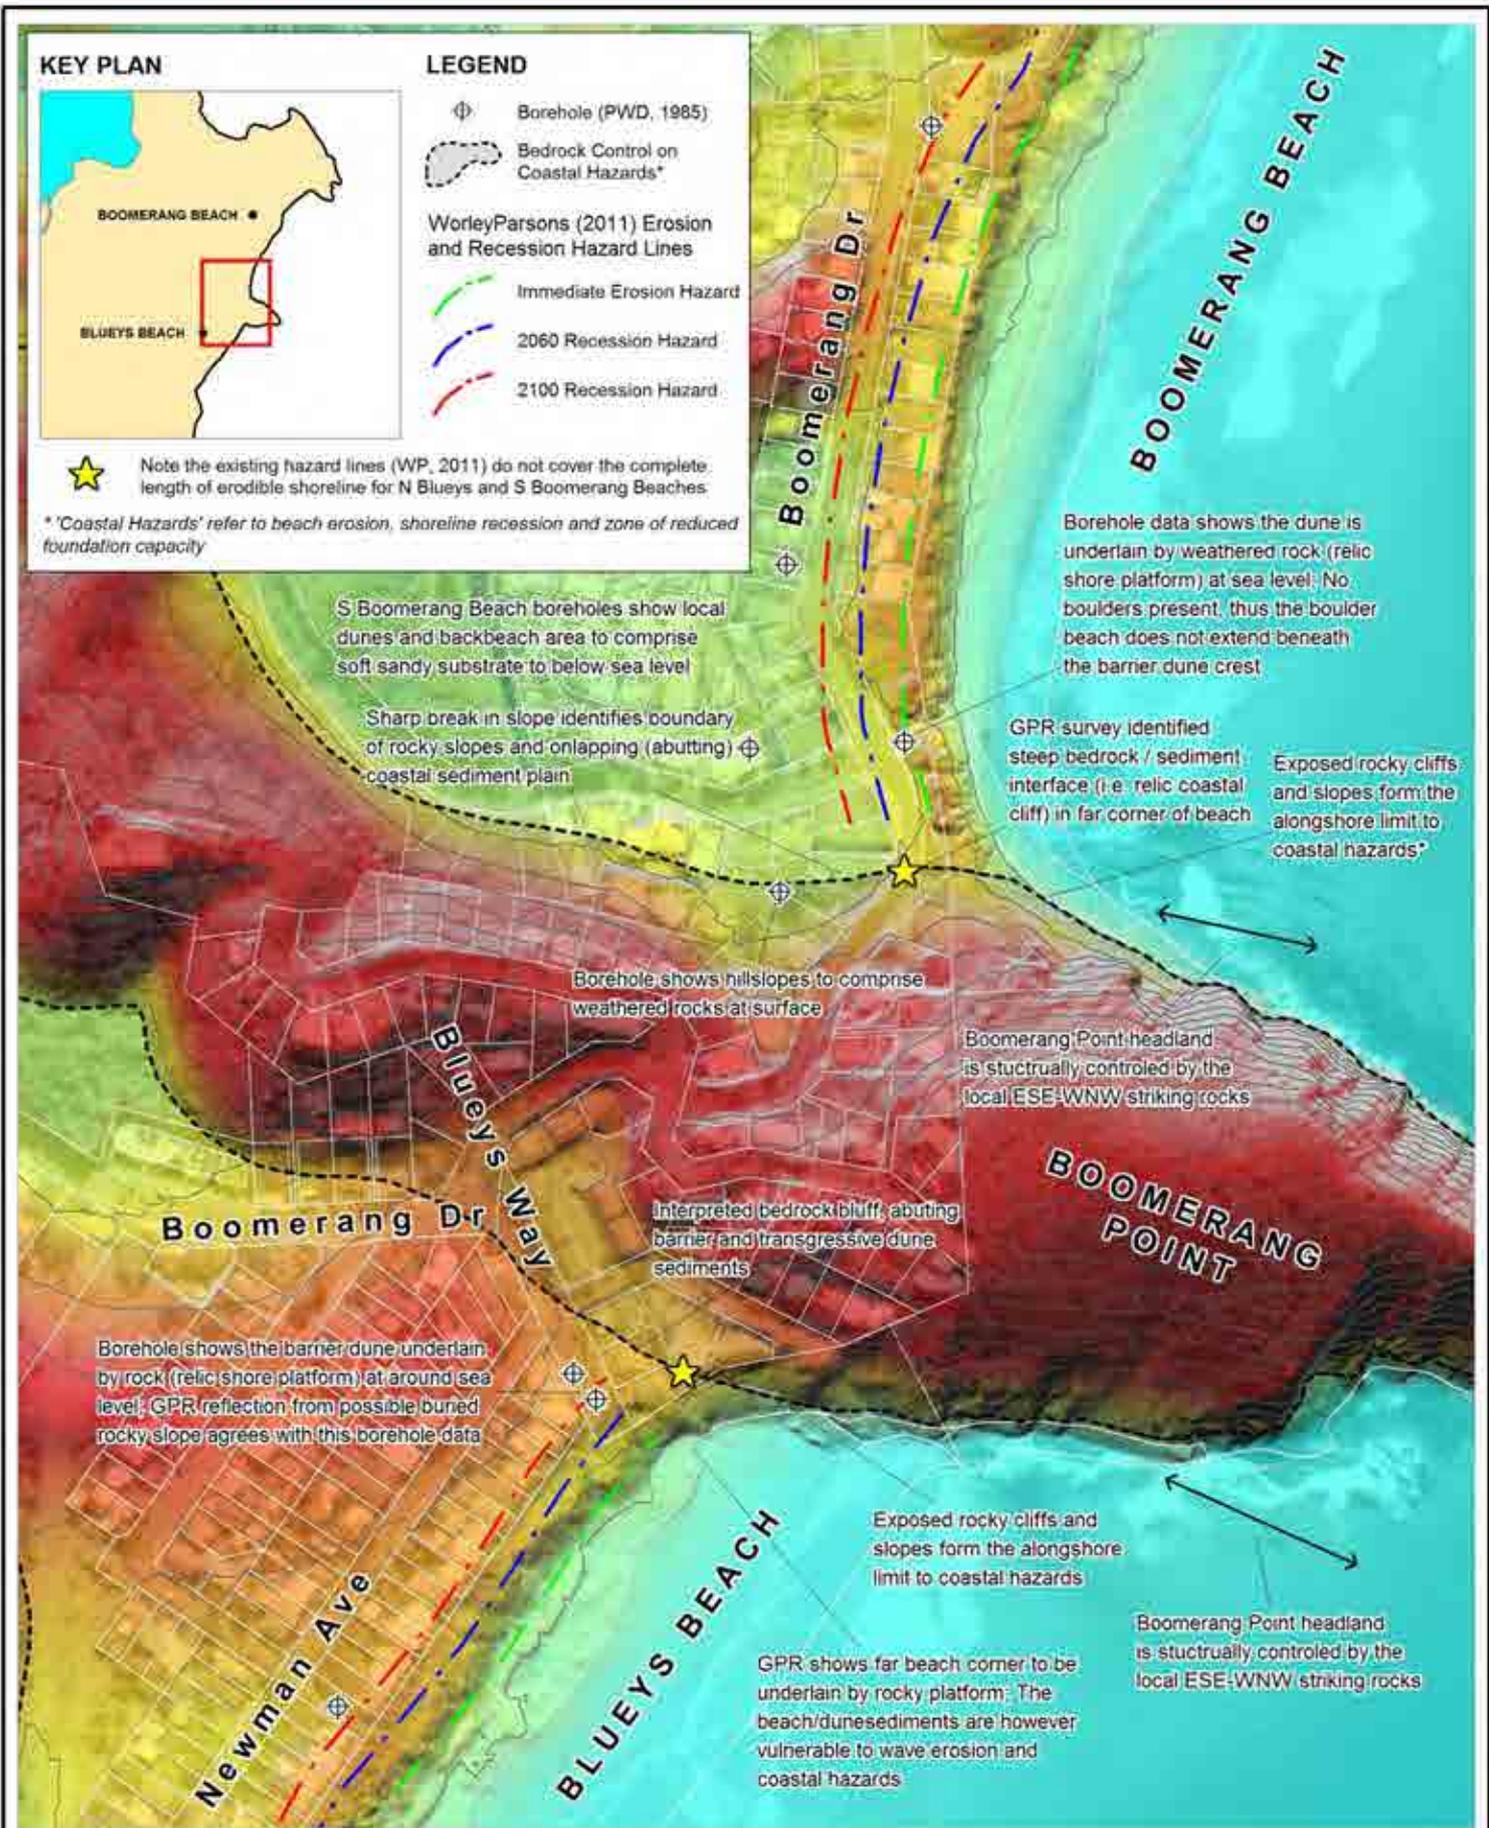
Figure: **3-5**

Title: **Bedrock Control on Coastal Hazards, Boomerang Point (Northern Blueys and Southern Boomerang Beaches)**

The backbeach geological limit to recession at northern Blueys Beach is controlled by the buried bedrock slopes that adjoin the Boomerang Point ridge line. The bedrock boundary located here likely takes the form of a relic coastal cliff that would have developed prior to the deposition of the Bluey Beach barrier dune landform. Considering the now active coastal cliffs are strongly controlled by the underlying bedrock structure (which has a local south easterly trend), the bedrock limit to coastal hazards is interpreted to extend inland and in-line with this geological trend. The interpreted geological recession limit as shown in Figure 3-5 is consistent with PWD (1985) borehole data and GPR surveys for this location.

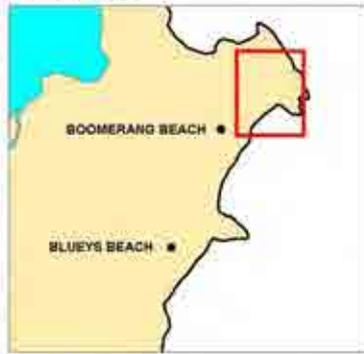
**KEY PLAN**

Note the existing hazard extent (WP, 2011) for N Boomerang Beach is consistent with the length of erodible shoreline

\* 'Coastal Hazards' refer to beach erosion, shoreline recession and zone of reduced foundation capacity

As detailed in the GPR study (BMT WBM, 2014) and mapped in Figure 3-6 , the bedrock control at the far northern end of Boomerang Beach likely extends landward of Charlotte Head beneath the beach and vegetated backshore slopes. The bedrock boundary is interpreted to continue onshore from the modern rocky cliff line in a north-westerly direction, in line with the local geological structure. Immediately south of here, the beach is assumed to be backed by high vegetated sand dunes that overly a buried rocky shore platform (at, or just below mean sea level). As such, the immediate backshore area of northern Boomerang Beach (between the car park and Charlotte Head) is vulnerable to coastal hazards.

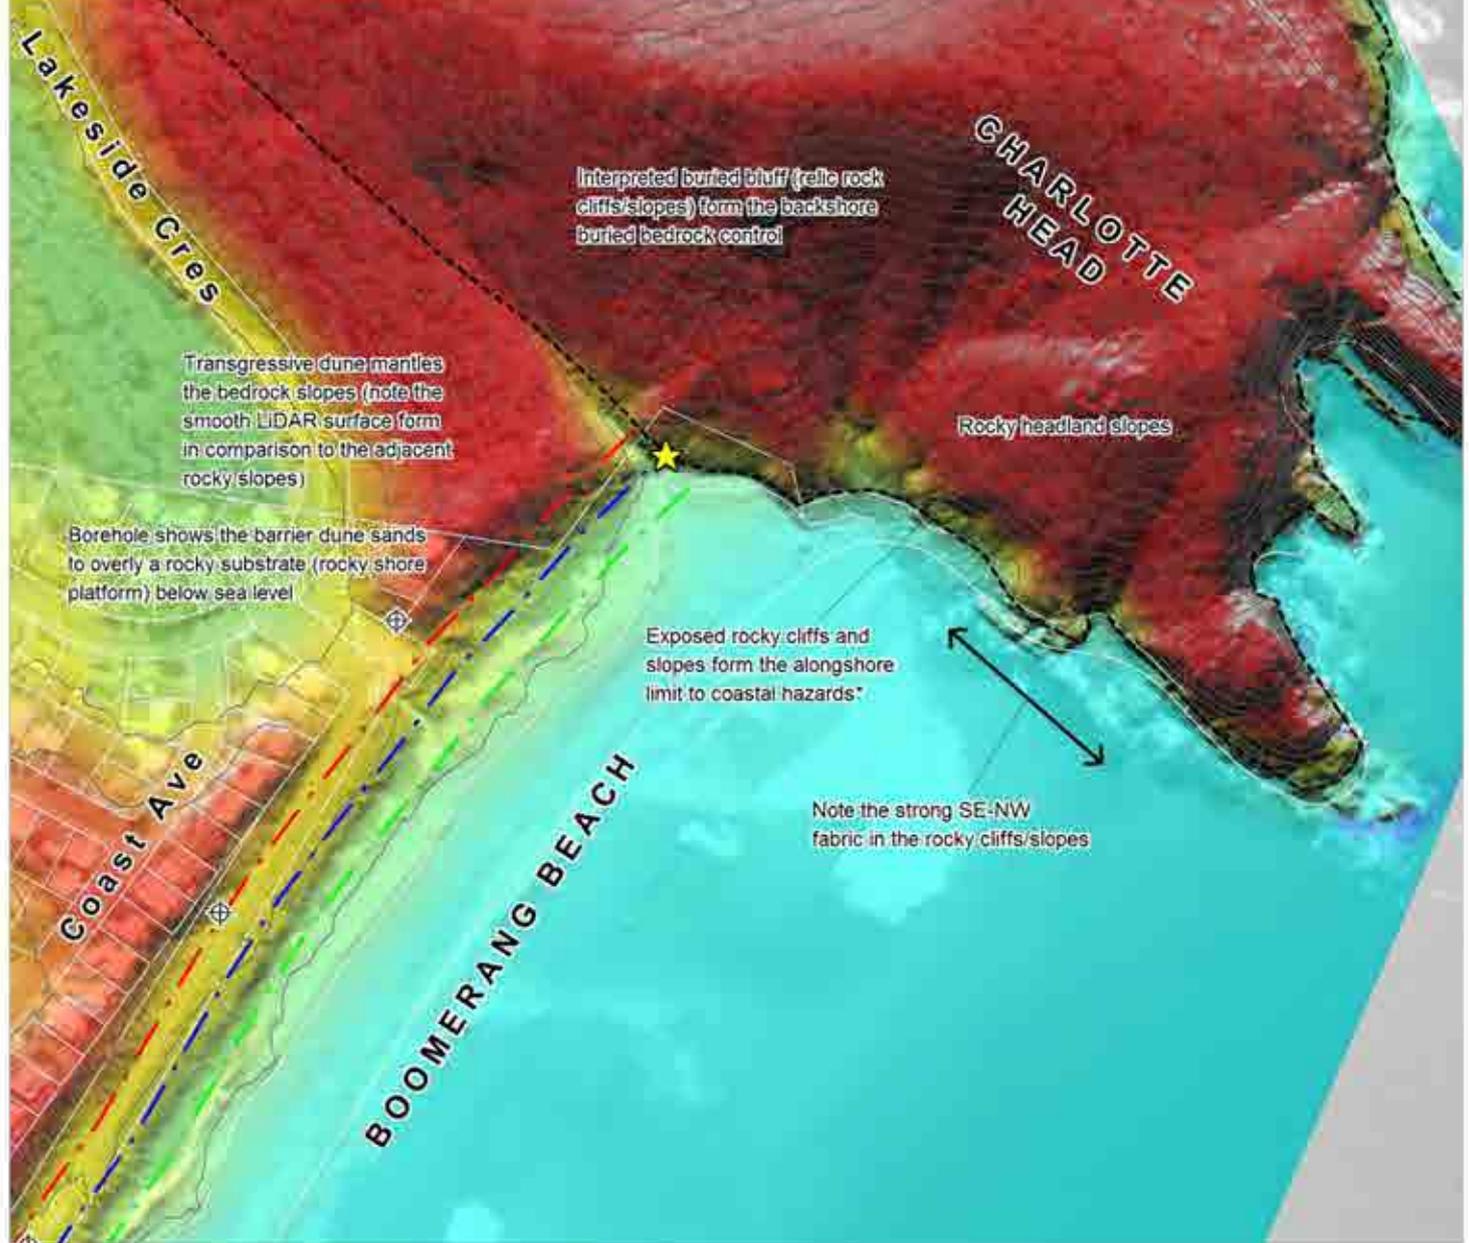
Figure:  
**3-6**

Title:  
**Bedrock Control on Coastal Hazards, Charlotte Head (Northern Boomerang Beach)**

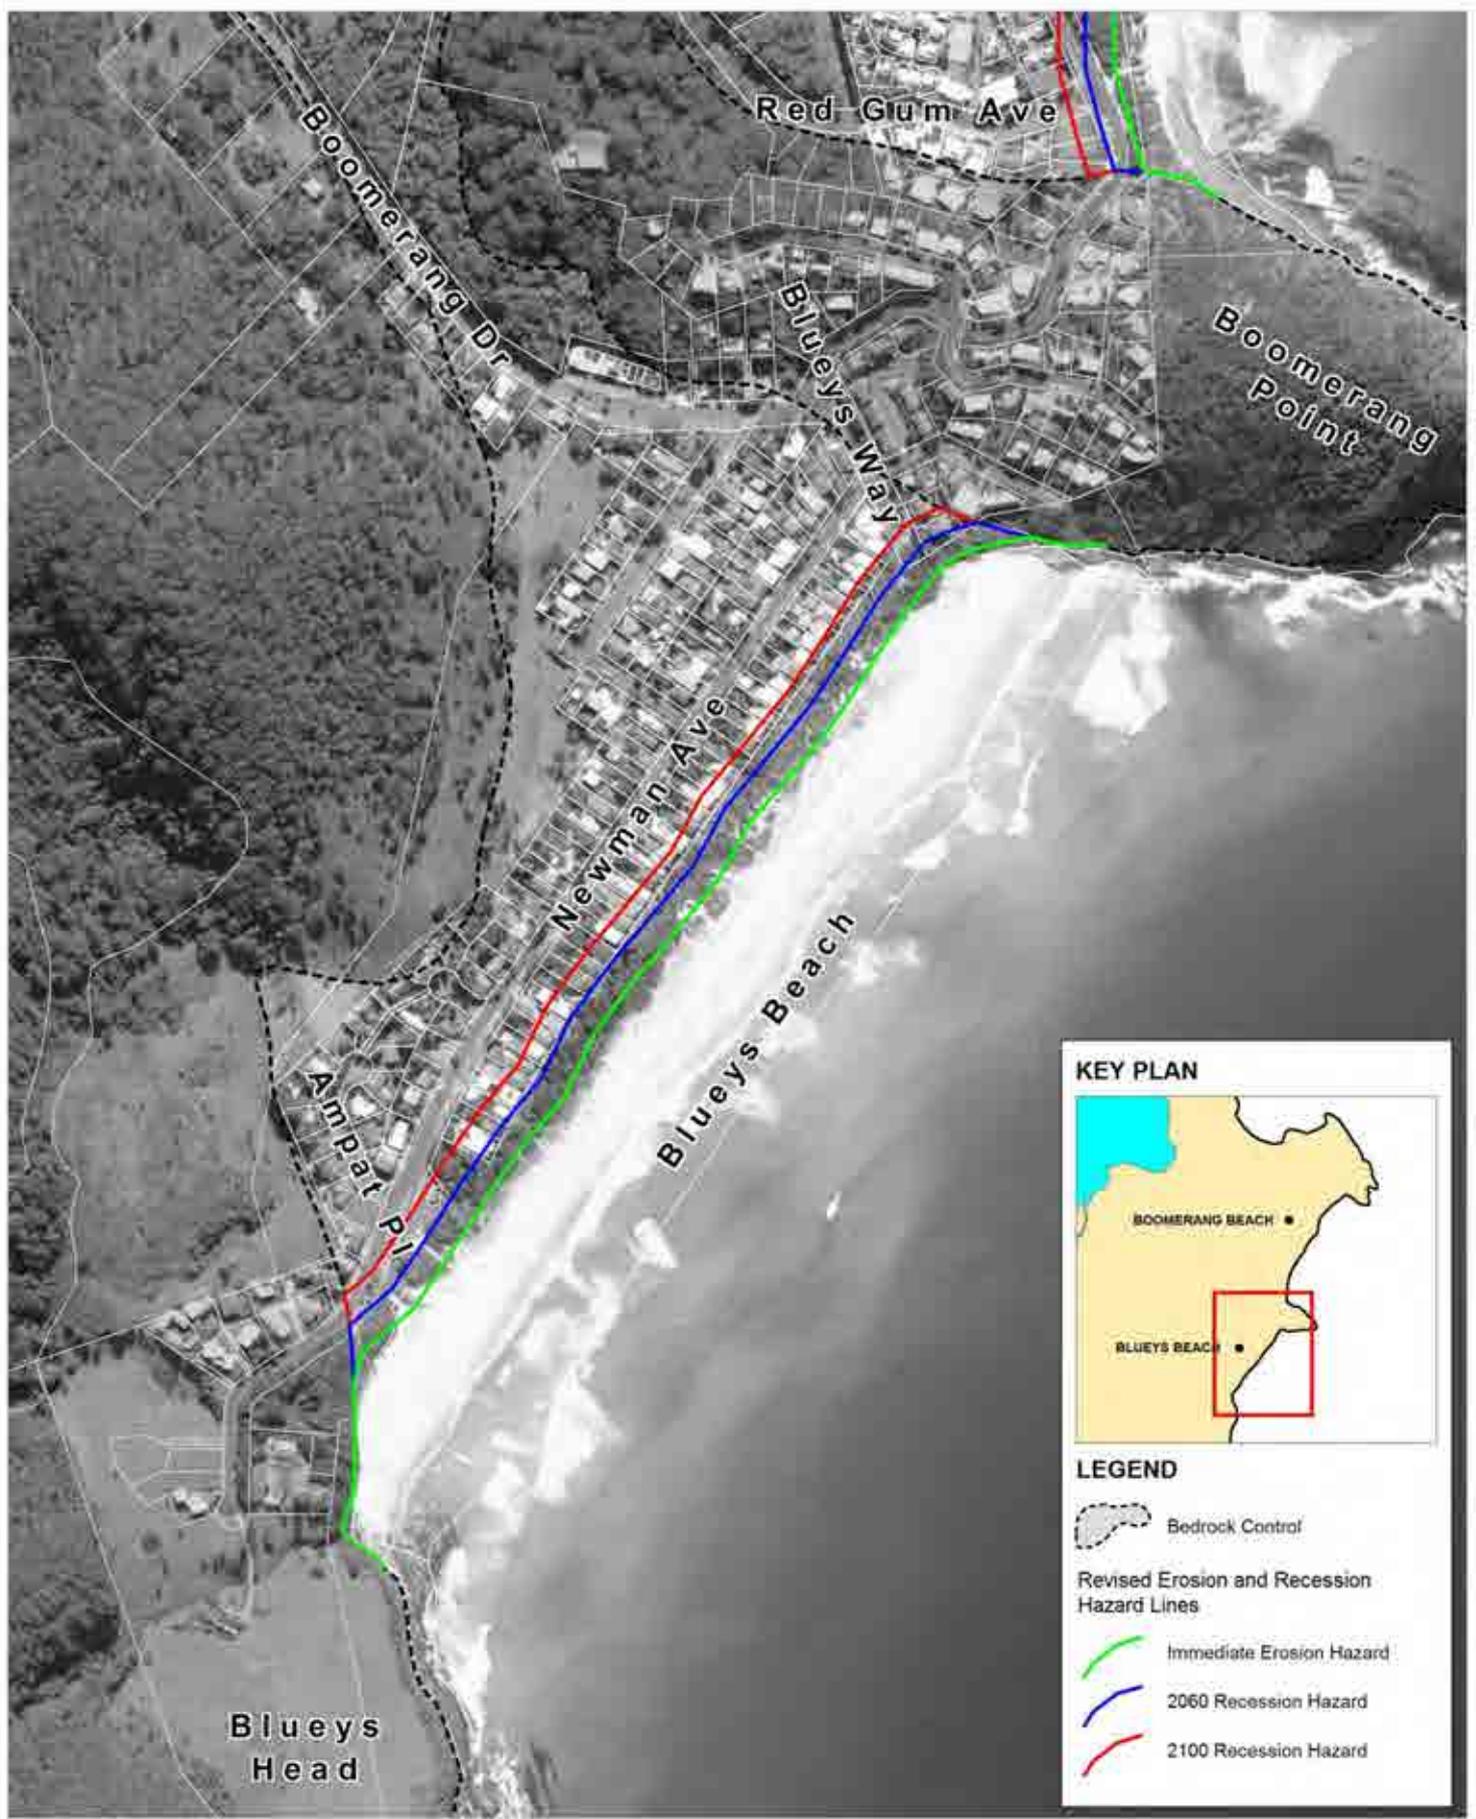
Figure: **4-1**      Rev: **A**

Title:  
**Bedrock Revised - Beach Erosion and Shoreline  
 Recession Hazard Map, Blueys Beach**

- The southern limit of Blueys Beach coastal hazard definition has been shortened to account for the backshore bedrock substrate that underlies the far southern vegetated embankment and adjoins Blueys Head to the south (refer Figure 4-1);
- The alongshore limits of coastal hazard definition for northern Blueys Beach and southern limit of Boomerang Beach has been extended to the flanks of Boomerang Point and now encompass the entire length of erodible shoreline in those areas (refer Figure 4-2 and Figure 4-3); and
- The coastal hazard mapping for northern Boomerang Beach remains largely unchanged, however the hazard lines are now tied into the Charlotte Head bedrock control (refer Figure 4-4).

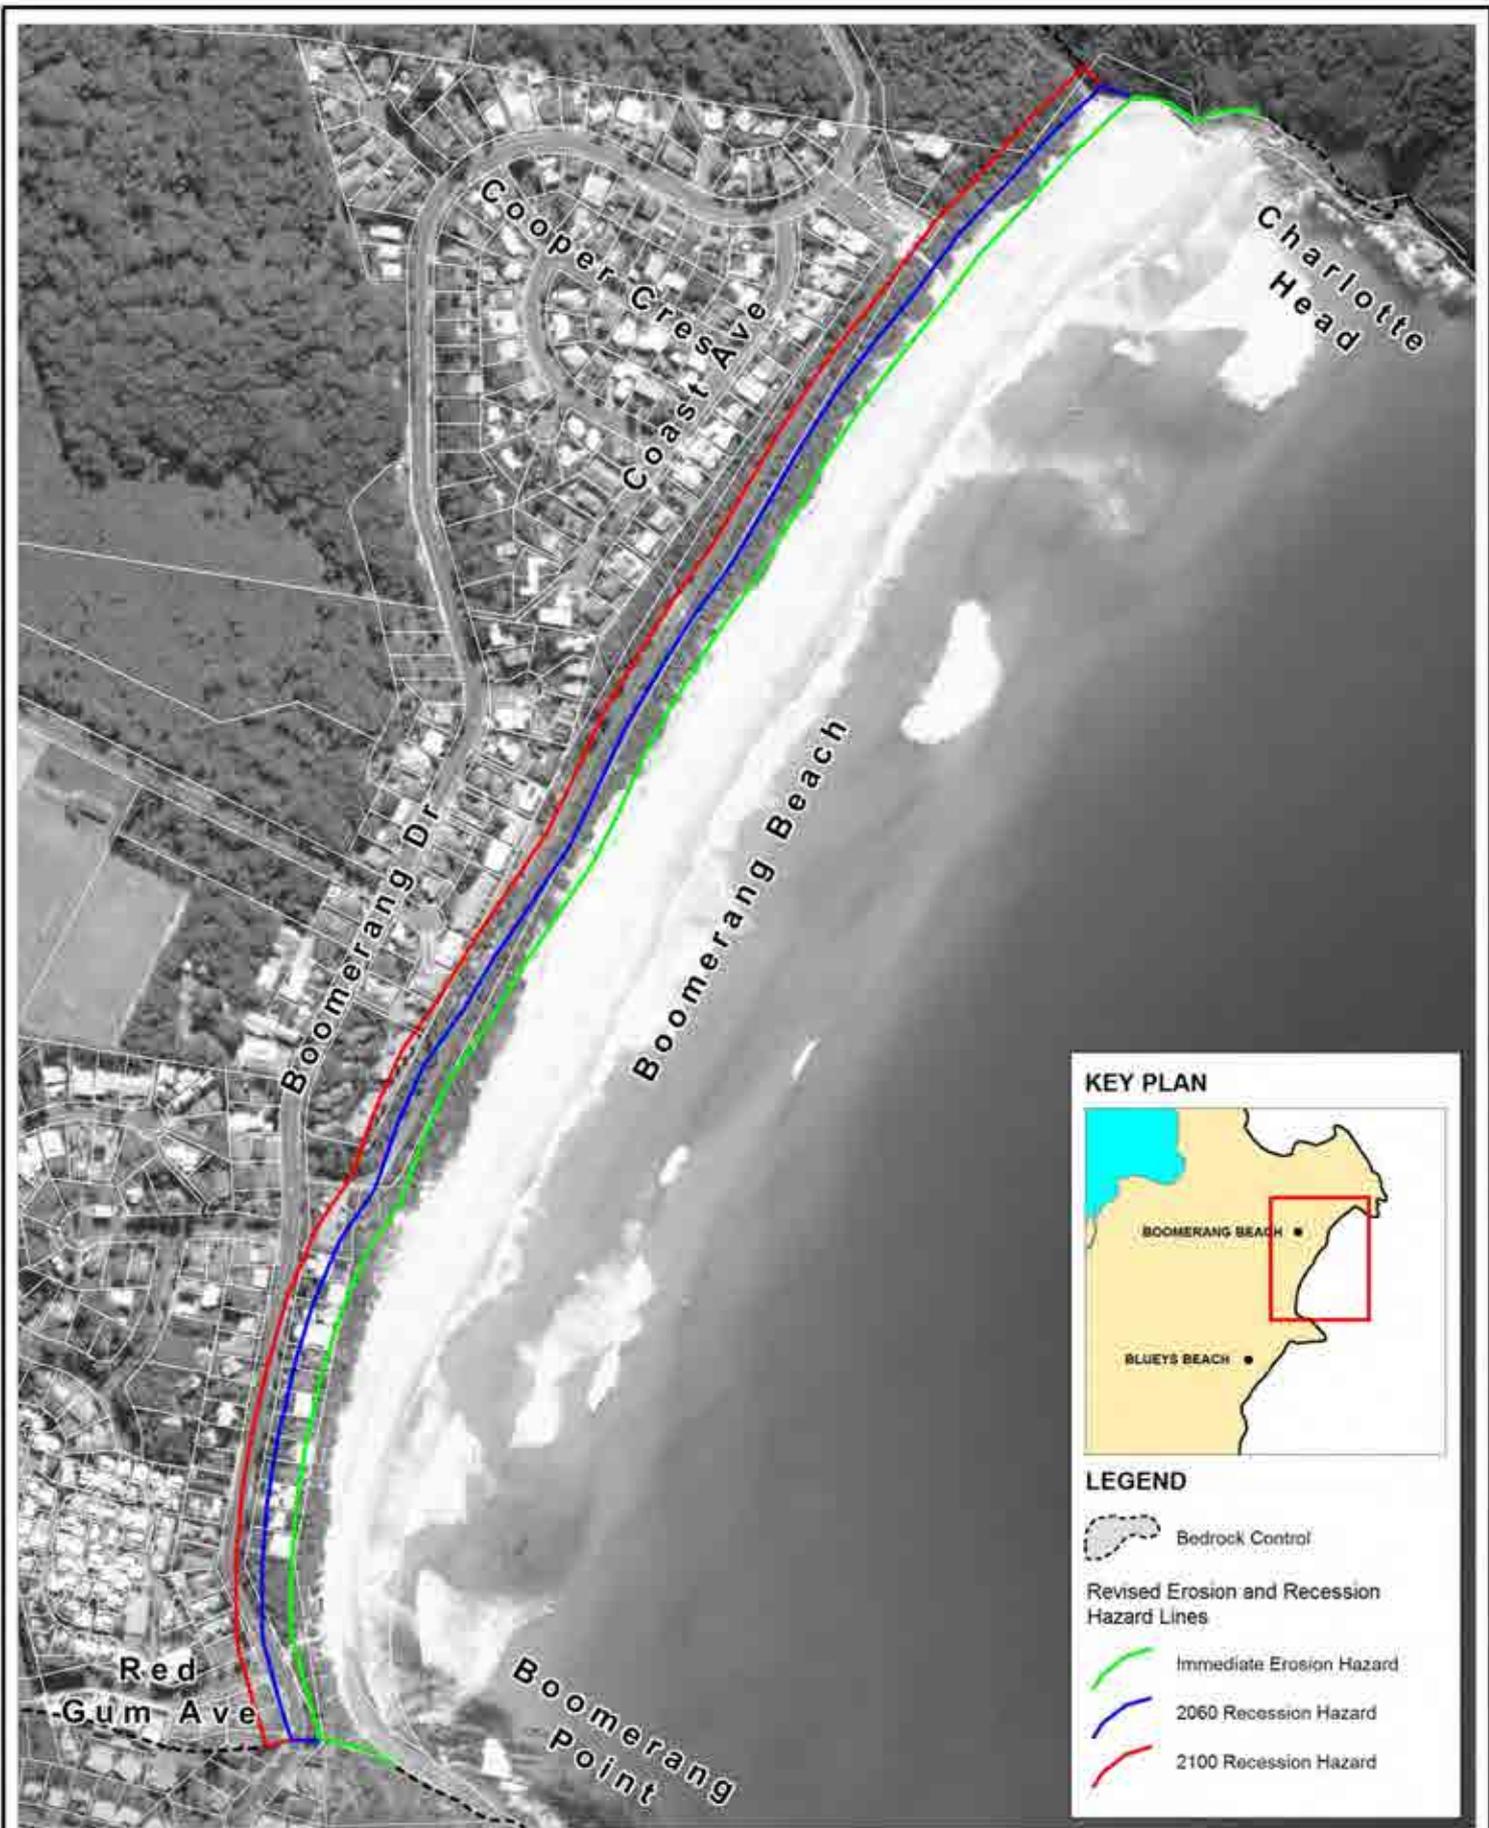
Title:  
**Bedrock Revised - Beach Erosion and Shoreline  
 Recession Hazard Map, Boomerang Beach**

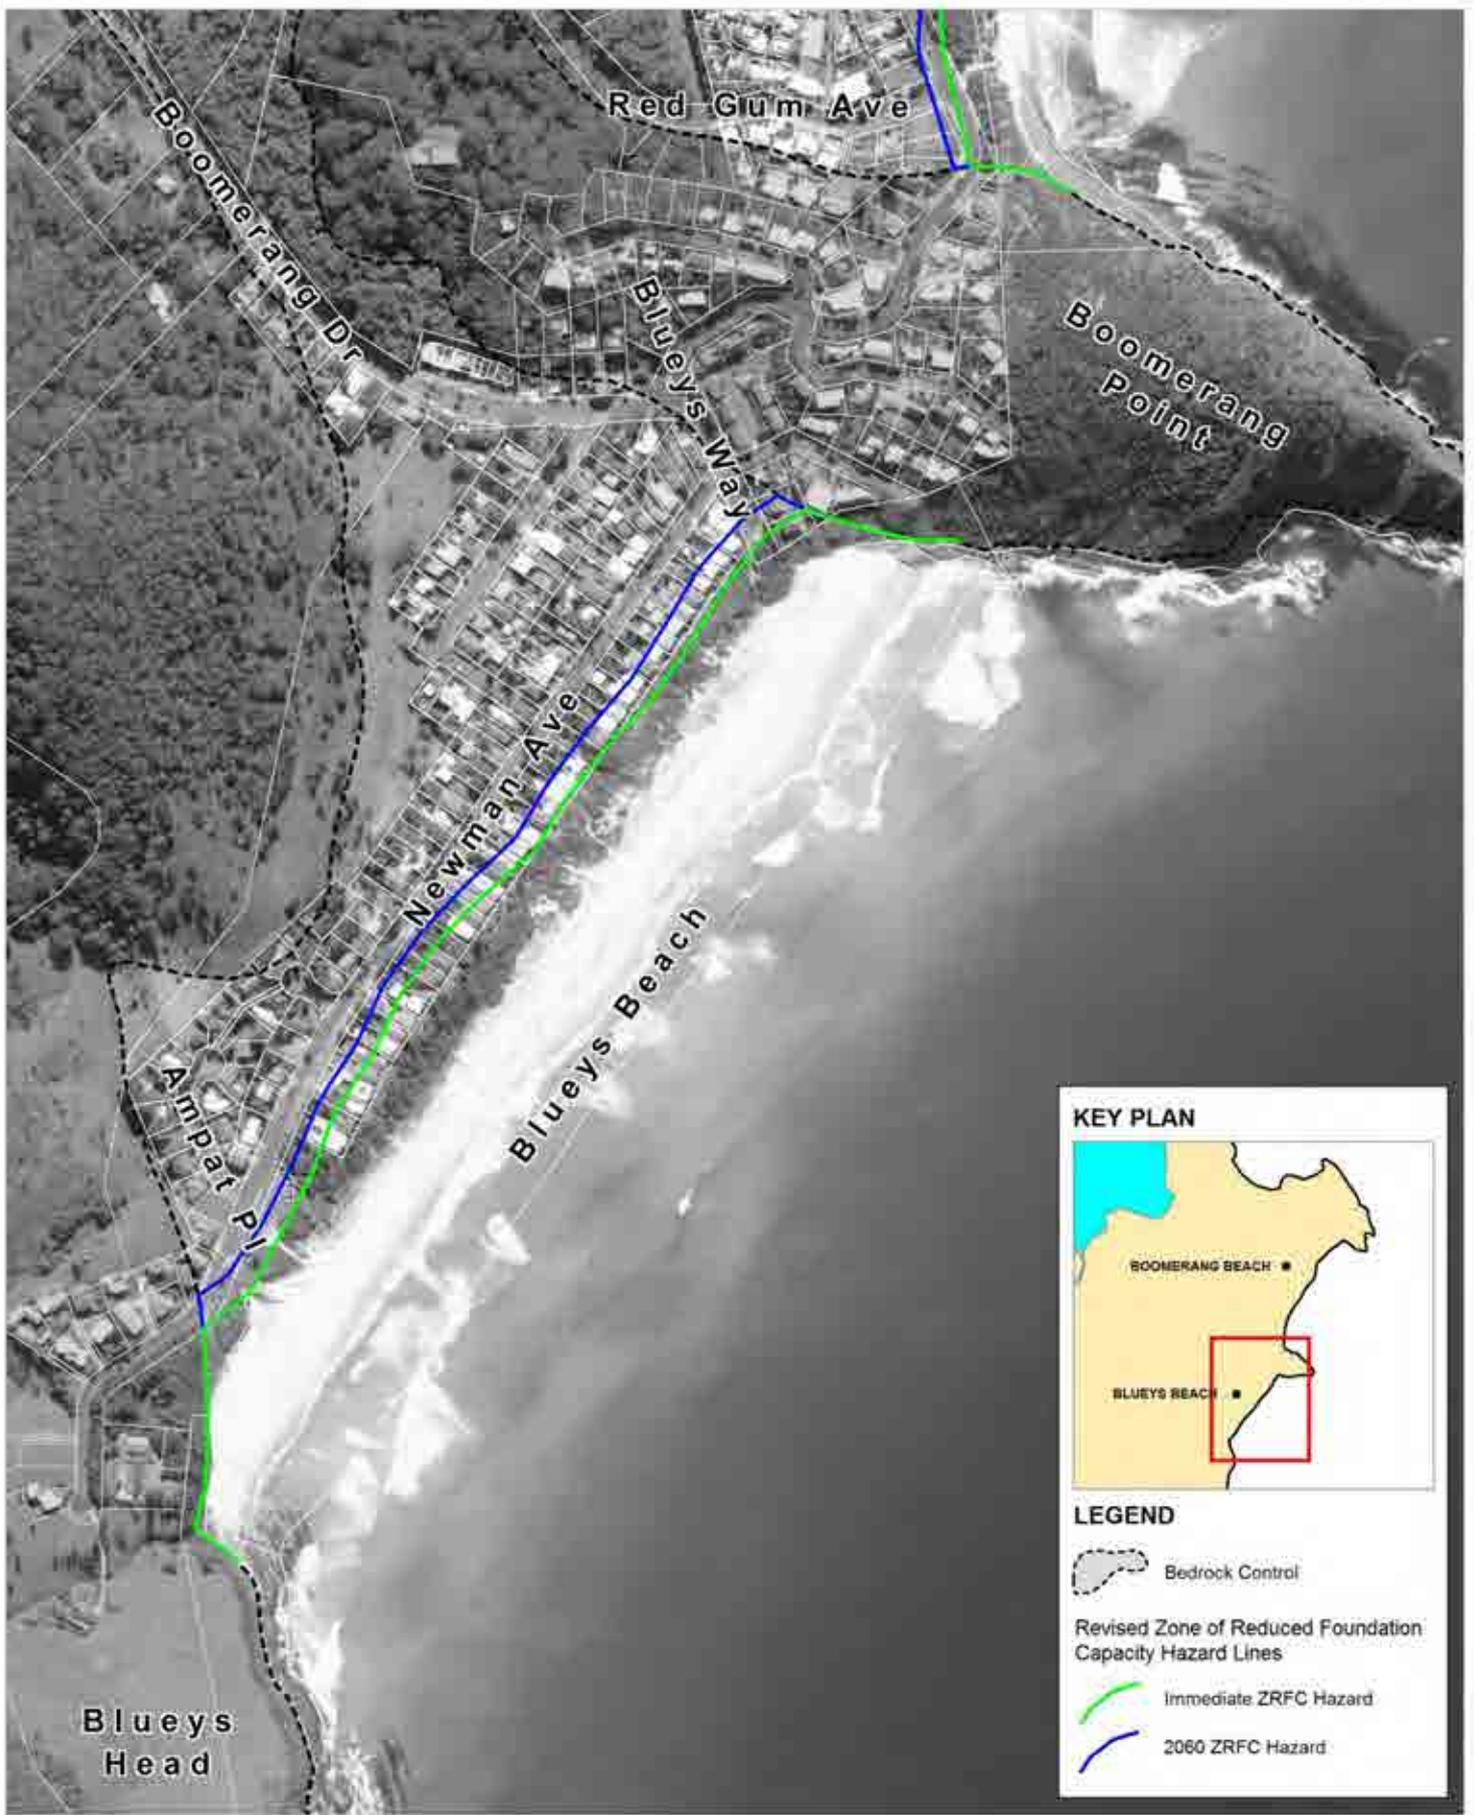
Title:  
**Bedrock Revised - Zone of Reduced Foundation Capacity Hazard, Blueys Beach**
