# Bedrock Based Coastal Hazard Revision for Blueys and Boomerang Beach

Reference:  
R.N2405.003.00.HazardLineRevision.docx  
Date: June 2014  
Confidential

Prepared for: Great Lakes Council

Prepared by: BMT WBM Pty Ltd (Member of the BMT group of companies)

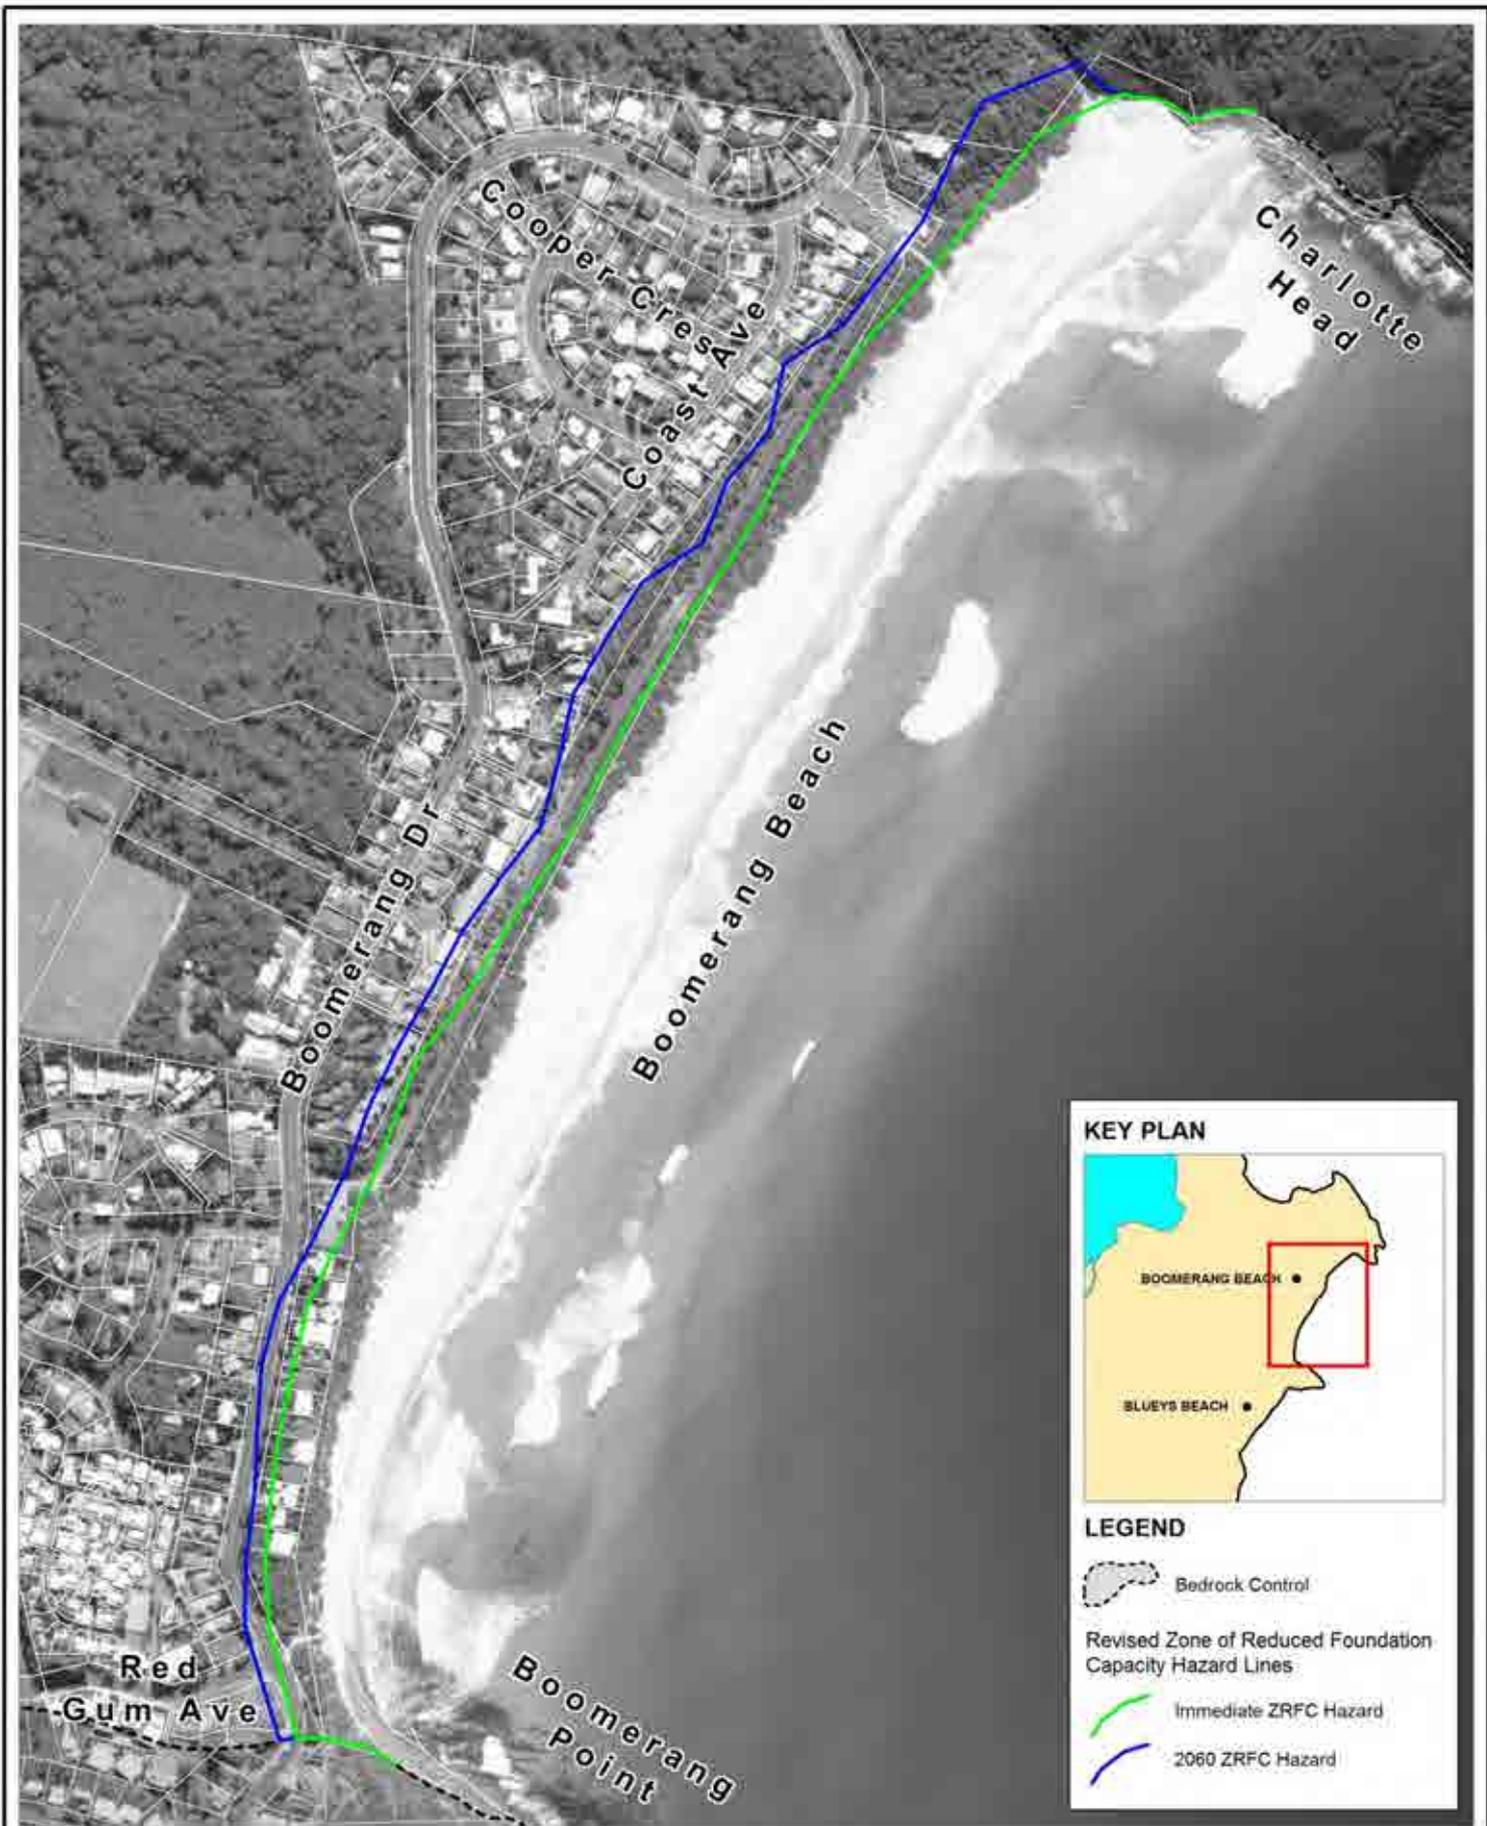
Title: **Bedrock Revised - Zone of Reduced Foundation Capacity Hazard, Boomerang Beach**

- The southern limit of Blueys Beach coastal hazard definition has been shortened to account for the backshore bedrock substrate that underlies the far southern vegetated embankment and adjoins Blueys Head to the south (refer Figure 4-1);
- The alongshore limits of coastal hazard definition for northern Blueys Beach and southern limit of Boomerang Beach has been extended to the flanks of Boomerang Point and now encompass the entire length of erodible shoreline in those areas (refer Figure 4-2 and Figure 4-3); and
- The coastal hazard mapping for northern Boomerang Beach remains largely unchanged, however the hazard lines are now tied into the Charlotte Head bedrock control (refer Figure 4-4).

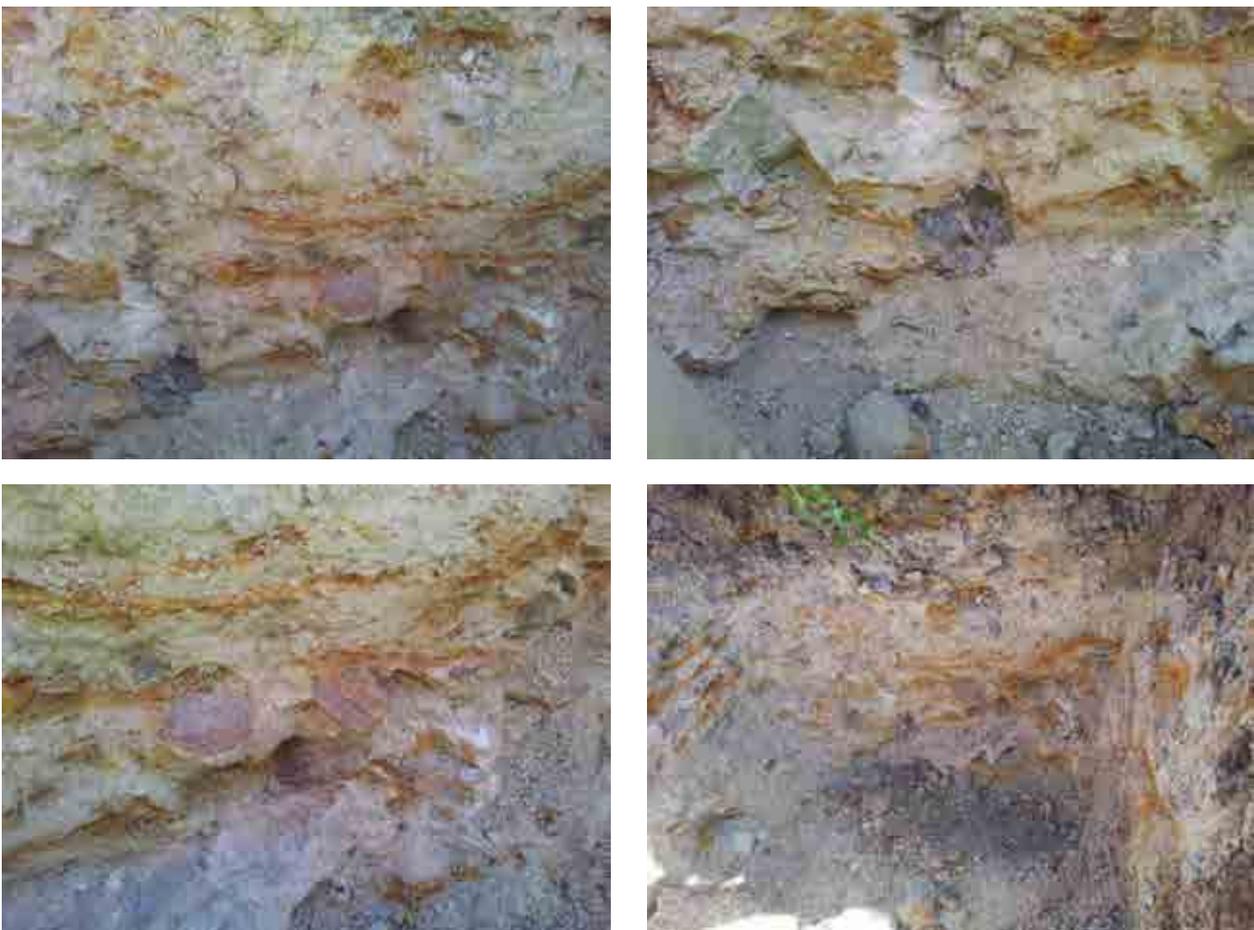
Figure A-1 Pit 1: Excavation Photographs (Geoff Love, Great Lakes Council)

PIT 1# = 32.3543; 152.5339  
 GL RL 6.7m AHD

Two geotechnical excavation pits were investigated by Geoff Love from Great Lakes Council at southern Blueys Beach on the 14<sup>th</sup> May, 2014. The investigation was conducted to a) clarify the inconclusive results received from the GPR investigation at this location (BMT WBM, 2014); and b) ultimately help define the coastal substrate at this location. It should be noted that the poor GPR results returned from southern Blueys Beach and south of the creek mouth, was due to the clayey nature of the coastal substrate as shown below.
