LOWER WALLAMBA RIVER RIVERCARE PLAN COMPANION BOOKLET

September 2003

The Lower Wallamba River, Rivercare Plan has been produced to assist landholders with the restoration and management of the Lower Wallamba River for future generations.

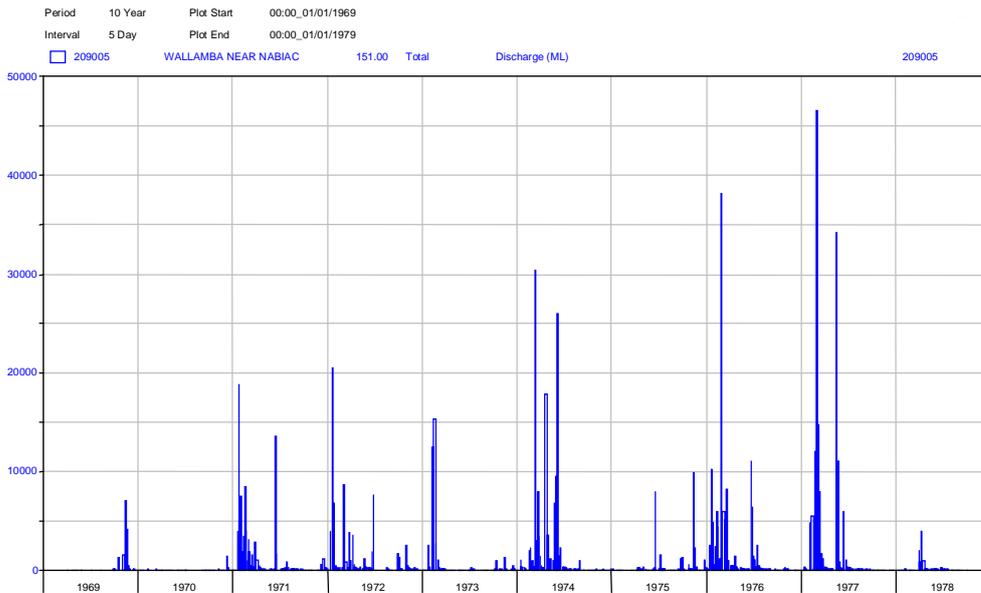
Figure 2: Flow / discharge hydrograph for Wallamba River near NABIAC.

The major flood events last century were in 1927, 1929, 1947, and 1978. The largest events were in 1927 and 1929 that saw major inundation of the flood plain including the township of NABIAC (PWD 1985). NB. Figure 2 did not record the true magnitude of the 1978 flood due to the recording station being damaged during the event!

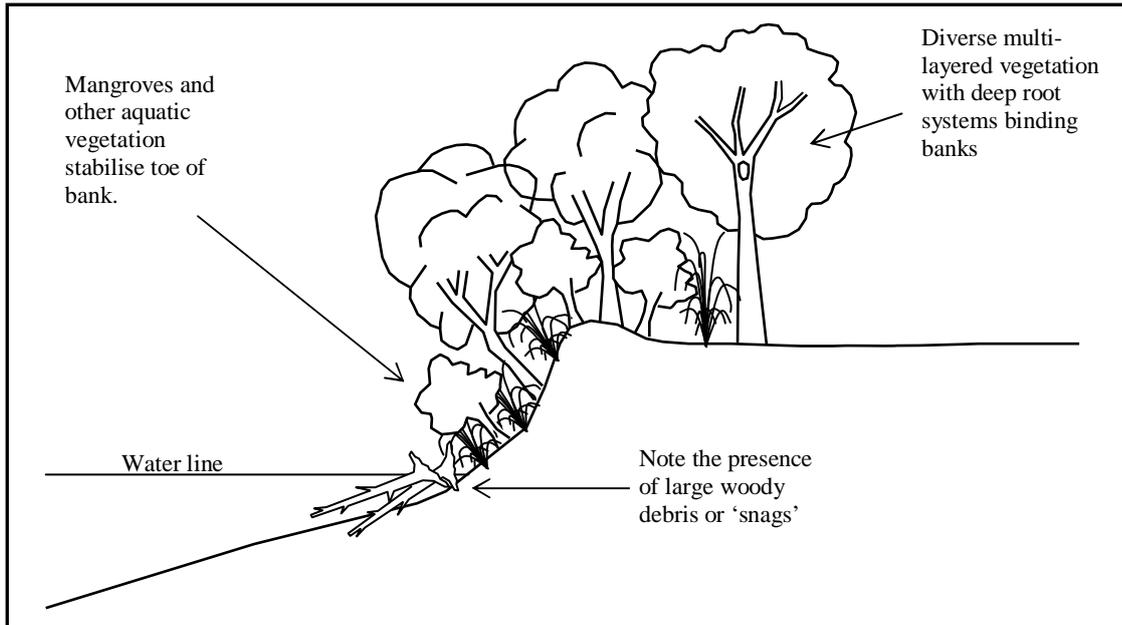
Figure 3: A stable bank in pristine condition.

Large woody debris in front of the bank provides both physical protection and is encouraging local areas of sediment deposition. Mangroves and other aquatic plants tend to colonise at the toe of the bank under these conditions. Mature upper bank vegetation further re-enforces the bank by reducing flood flow velocities, binding soil and reducing bank surcharge.

Clearly slumped vegetation, as described in Figure 5, is less stable than the situation depicted in Figure 3. The entire slumped area is prone to being removed by large floods and/or high wind following soaking rain when the trees will finally fall into the channel. If the trees that have fallen in become lodged at the base of the bank (either naturally or are physically moved and secured there) then the bank may start to stabilise again as depicted in Figure 3. If however, the freshly created LWD is either washed away or mechanically removed, then the situation, as depicted in Figure 6, will exist. Here, there is no LWD protection and little significant upper bank vegetation left. A new wave notch will develop and the process will start all over again, only this time faster as there is now no significant upper bank vegetation to arrest the process.

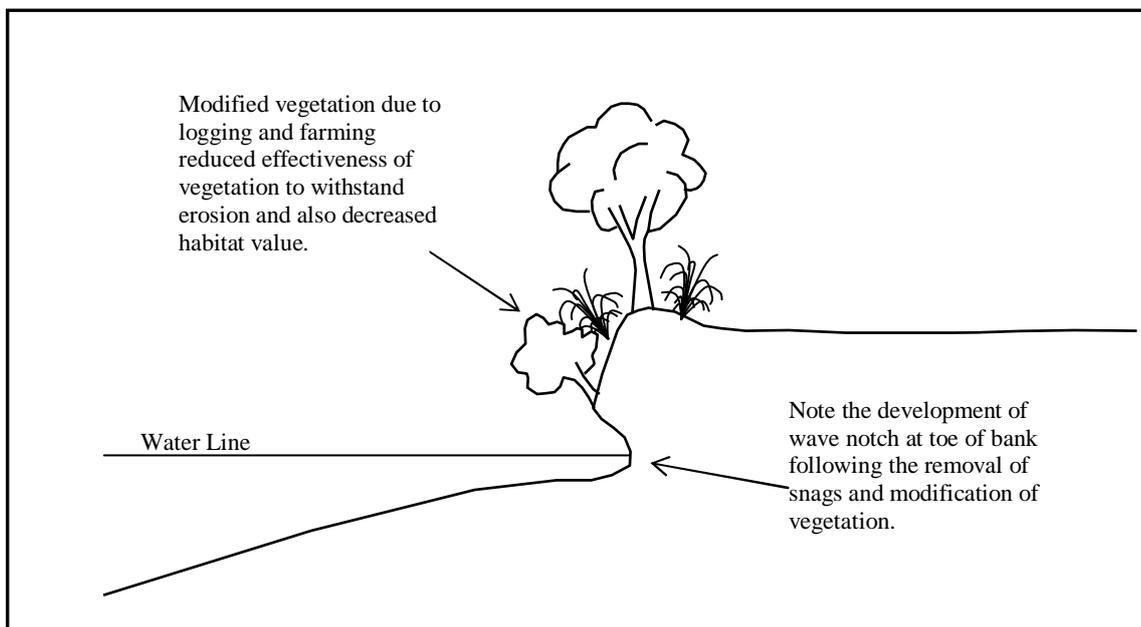
Figure 4: LWD protection has been lost and bank vegetation has been modified.

There has been a significant increase in wind wave energy reaching unprotected banks due to this modification. Furthermore, natural wave wash from wind generated waves has increased due to the introduction of wave wash generated from boating activities. The rate of development of the wave notch is related to the localised wave climate and the composition of the bank material.

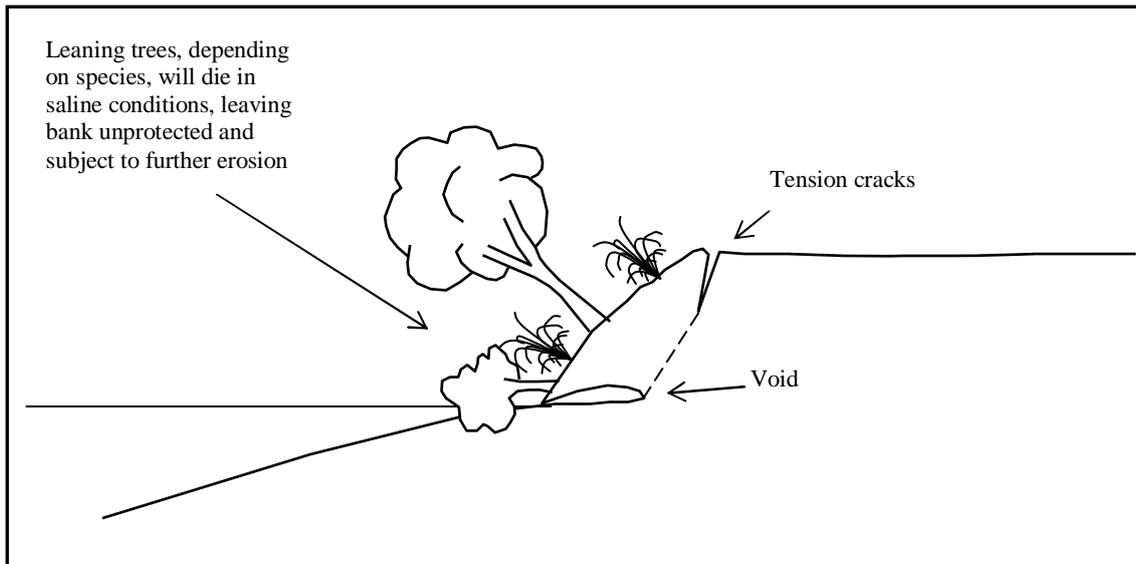
Figure 5: The wave notch has developed to such a stage that bank collapse has occurred.

Tension cracks are clearly visible on the upper bank, trees are leaning into the water and a void may exist under the root ball. In advanced cases the tension cracks may link up to the void to create significant holes in the upper bank. NB This situation may prevail for some time, as some trees are able to survive this slumping eg *Casuarina glauca* (Swamp Oak) seem particularly well adapted. As the entire root ball of the tree is now resting on the bench at the base of the bank, the physical protection provided may minimise further erosion for many years.

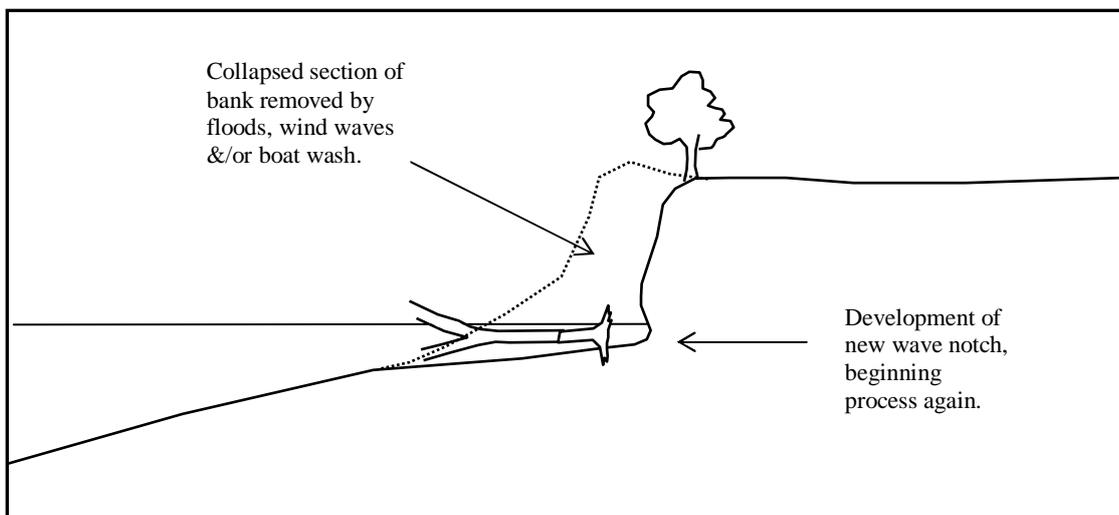
Figure 6: The slumped trees and bank material have been removed by floods &/or continued wind &/or boat waves.

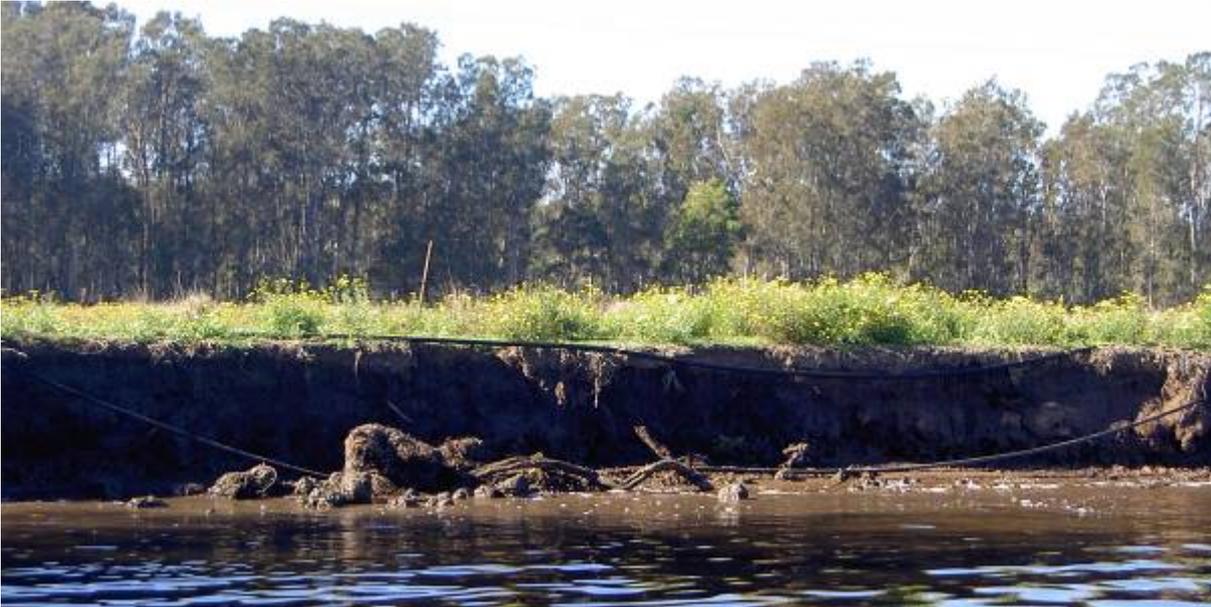
Figure 7: Example of Bank erosion opposite Gereeba Island, ARL 5km.

Note the exposure of the water supply line, the plume of sediment immediately adjacent bank and the slumped bank material.

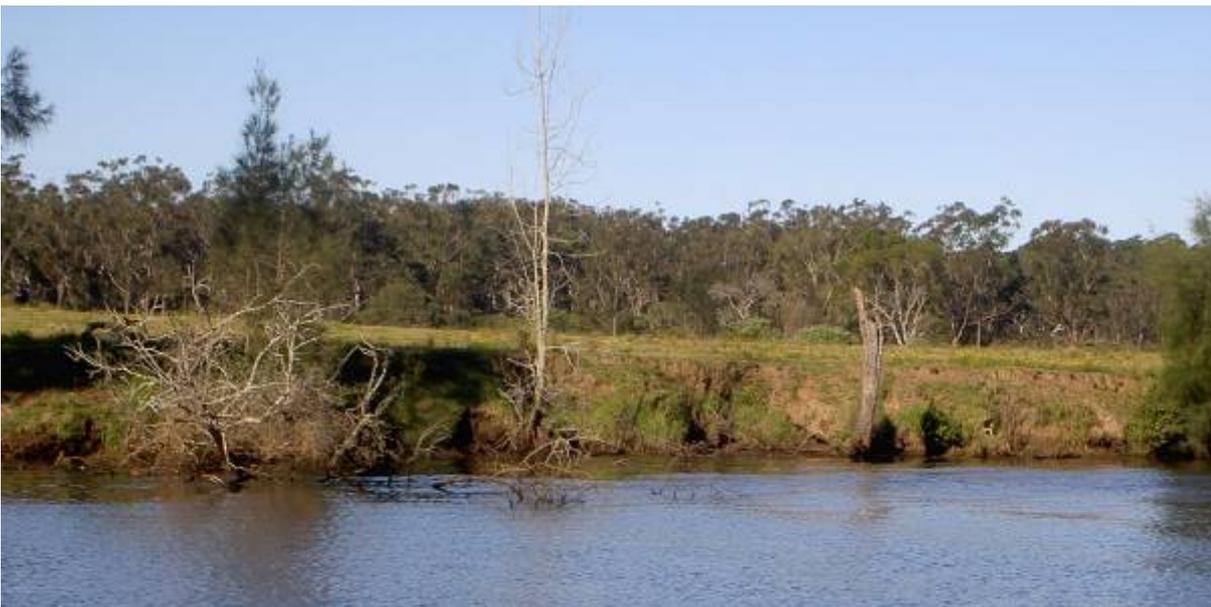
Figure 8: Slumping at ARL 21.5km.

Bank slumping is less common occurrence on Wallamba River. It typically occurs on the higher banks where vegetation has been cleared adjacent the riverbank, and where there is a lack of stock control in the riparian zone. It usually occurs on very wet banks where springs are discharged into the river. It frequently occurs after floods when the increase in shear weight from the saturated bank, causes the bank to collapse.

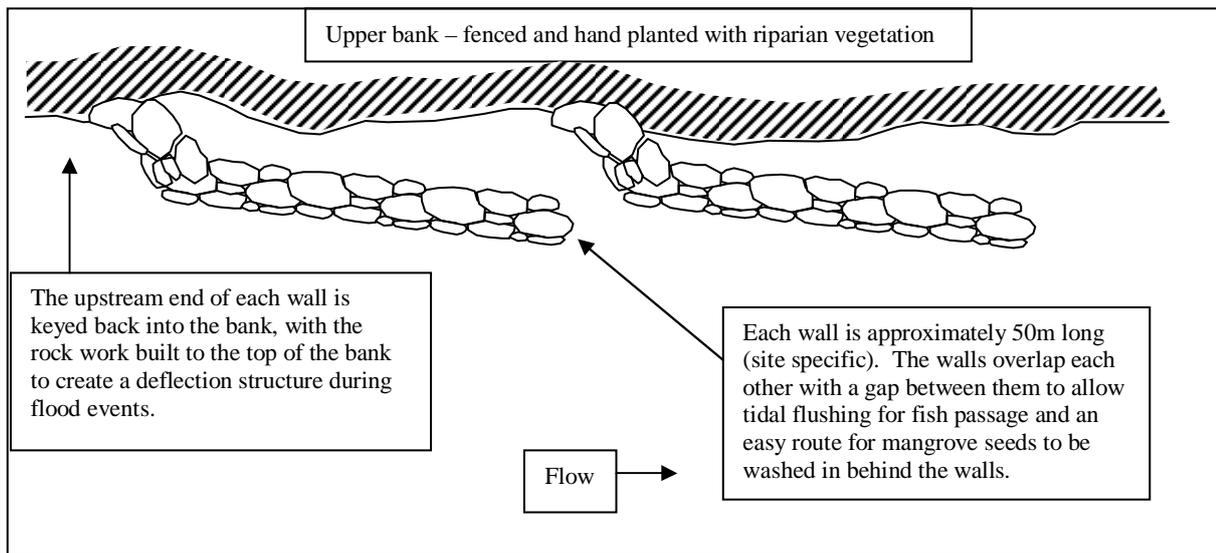
Figure 9: Plan view sketch of typical Rock Fillet wall arrangement.

The rock wave barriers are made up of a series of rock walls laid parallel to the bank and overlapping each other at the downstream end (see Figure 9). This design is used to allow fish passage and the recruitment of mangrove seeds to the area behind the walls at high tide. The upstream end of each wall is curved through 60-90° and taken to the top of the bank. This creates a rock deflection structure that protects the bank from high velocity flows along the bank face during floods. Walls are generally constructed to the height of mean high water.

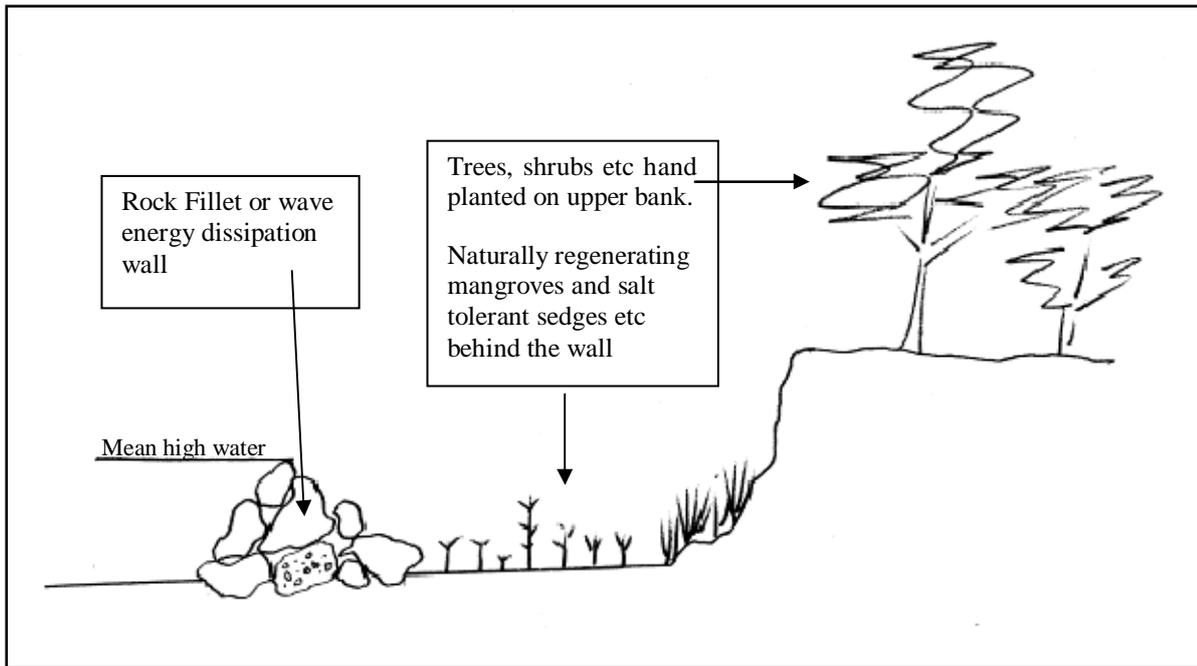
Figure 10: Cross-section showing the layout of a typical rock fillet project.

Rock wave energy dissipation walls are constructed parallel to the eroding bank. The distance from the bank depends on the slope and extent of the bench in front of the bank, and the reach of the machine used to place the rock. The wall is built to a height that corresponds with the mean high water. Mangroves and other salt tolerant shrubs and sedges will establish by natural regeneration where a seed source exists. The job is completed by hand planting an upper bank buffer of riparian trees and shrubs, or by encouraging natural regeneration.

The cost of constructing a project of this design is heavily dependent upon the local quarry rock prices, transport costs, and the machine hire to place the rock. As the cost of rock is very variable the prices quoted here can only be used as a guide. With rock delivered to site at the rate of \$35/m³ the price of such a project is \$100/meter of bank treated.

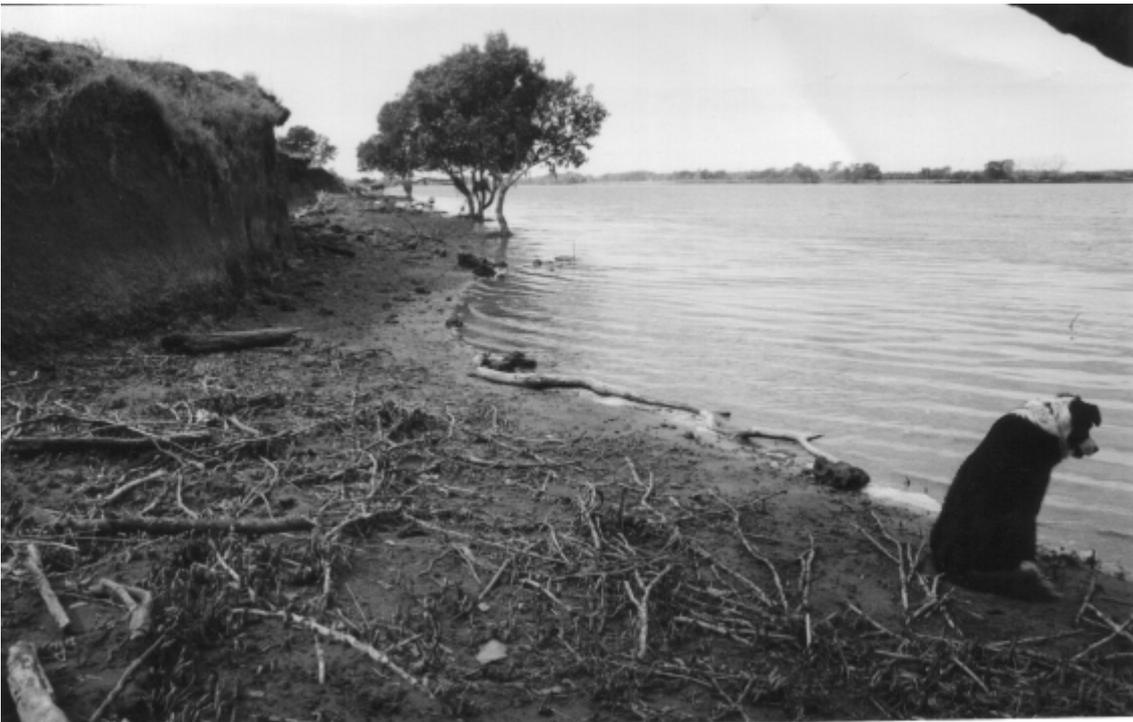
Figure 11: Project site pre-construction at Dumaresq Island in the Manning River, October 1999.

The bank had been eroding at the rate of approximately 500mm/year for many years. Wind generated wave action was cutting a 'wave notch' at the base of the bank which led to bank failure by sloughing. The talus (deposited bank material) was then removed by subsequent wave action and the process started over again.

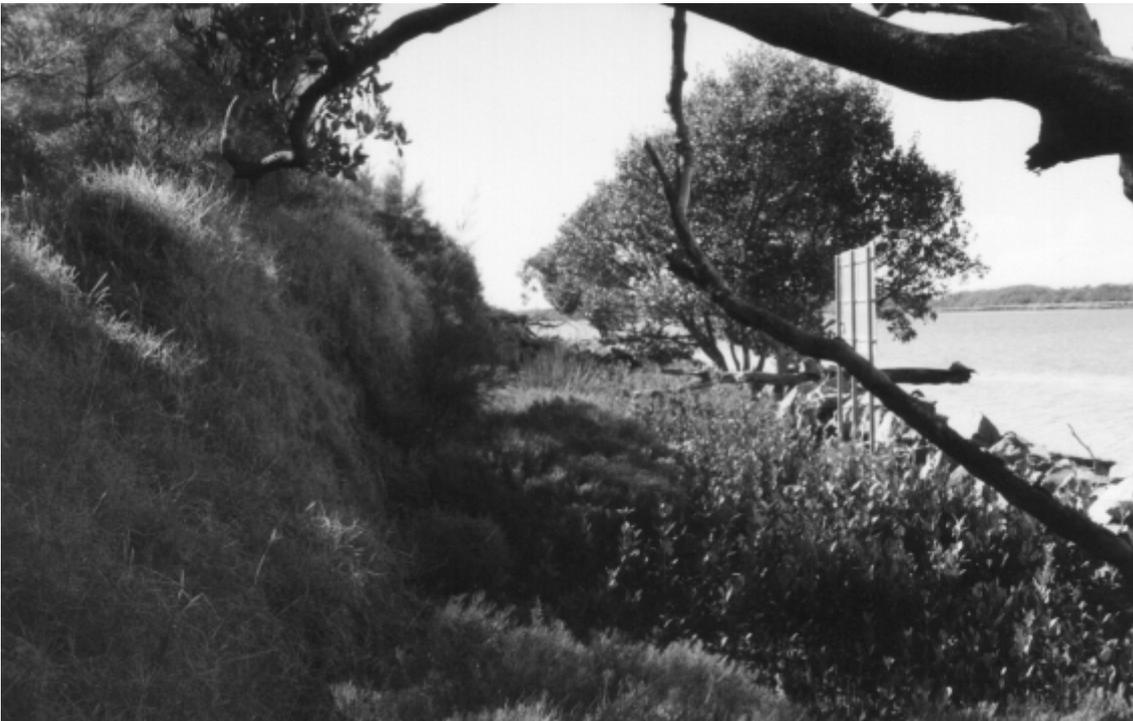
Figure 12: Same location as above, August 2002.

The installation of wave energy dissipation walls has led to the natural regeneration of mangroves by the hundreds. As the formerly vertical bank stabilises the slumped material is consolidated by salt tolerant shrubs and sedges, and mangroves (self-seeded). The area behind the walls is now a zone of net deposition. Sediment now accumulates where accelerated erosion was previously taking place.

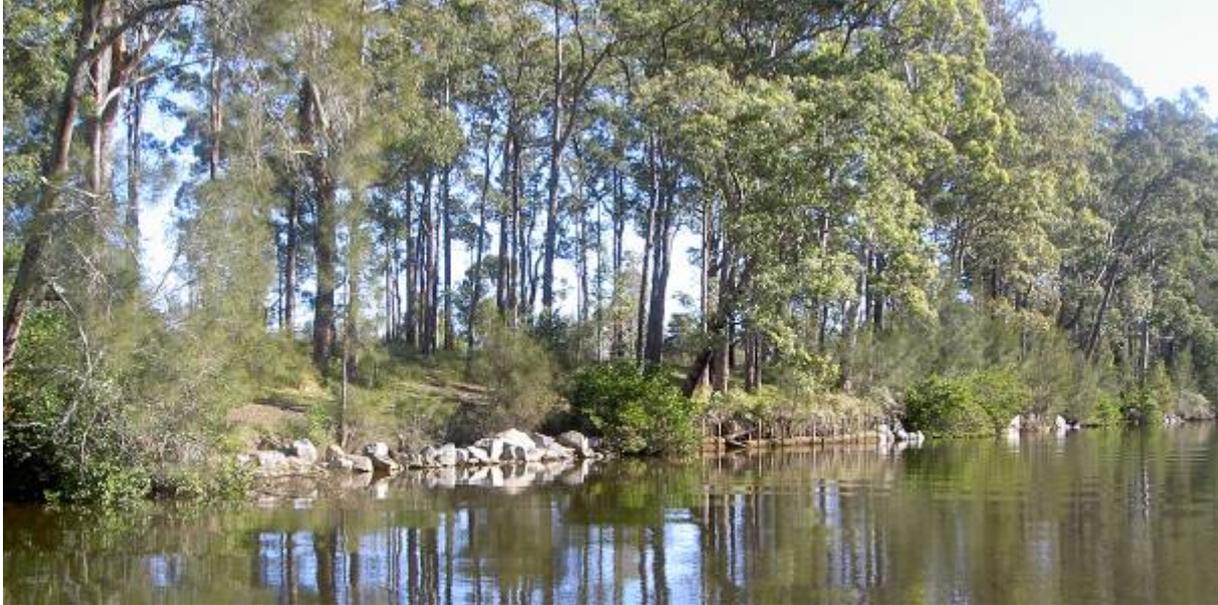
Figure 13: Coir Log Wall and Rock Fillet riverworks at ARL 19.7km.

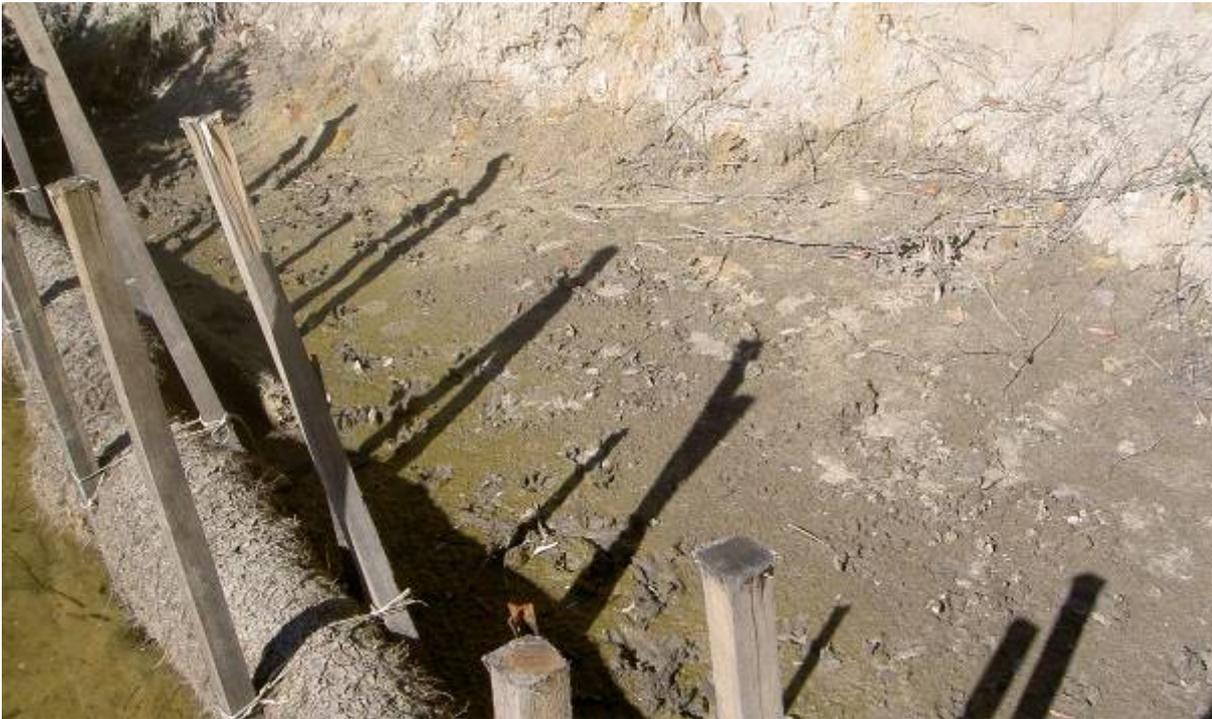
Figure 14: Sediment deposited behind recently constructed coir log walls, by May 2003 fresh.

Hard engineering structures, like those mentioned above, are not always feasible due to financial constraints of landholders. Additionally, these types of structures are not always necessary, eg lower energy sites. In this situation soft' structures maybe an option. These 'soft' structures operate on the same principles as the 'hard' structures, where by they aim reduce wave action reaching the bank, hence encouraging vegetation and sediment deposition, be it slumped bank material or flood deposits (see Figure 14).

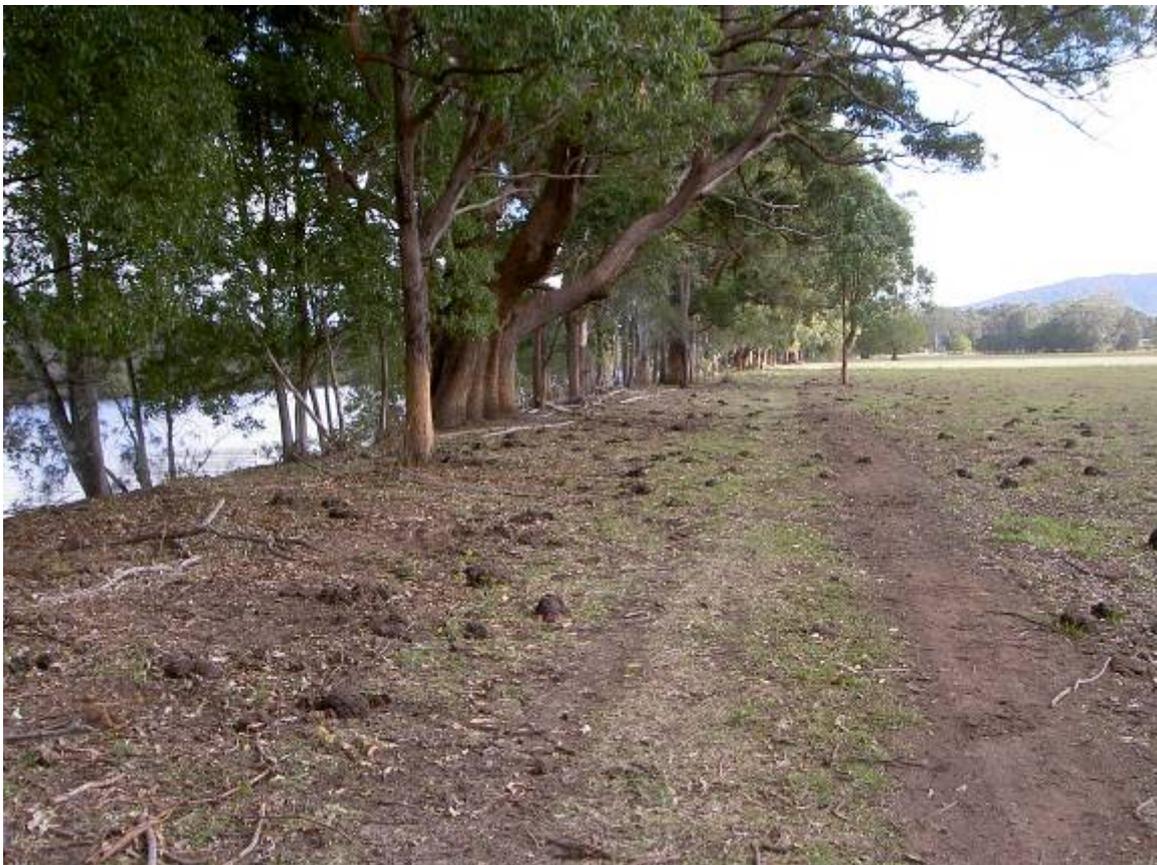
Figure 15: Example of stock damage to bank, soil, and vegetation regrowth.

Note how cattle utilise this area for shade. By doing so they contribute excessive nutrient to the river and Lake System.

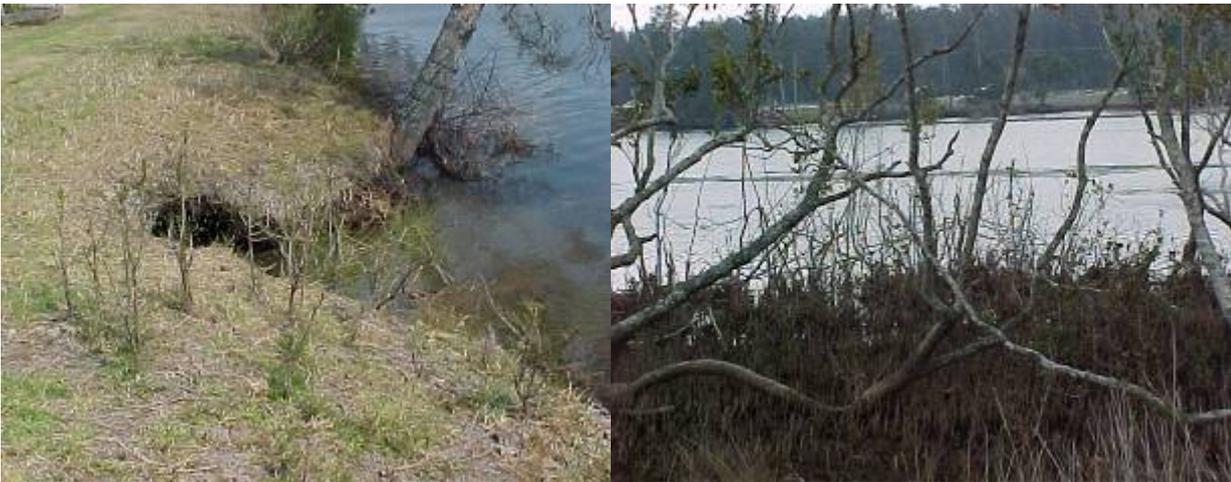
Figure 16: Examples of stock damage to Swamp Oaks and to Mangroves.

Note: These two native riparian species provide the first line of defence in reducing flood flow velocity and wave attack (wind and boat generated), and are they are integral to the early phases of “River Recovery”.

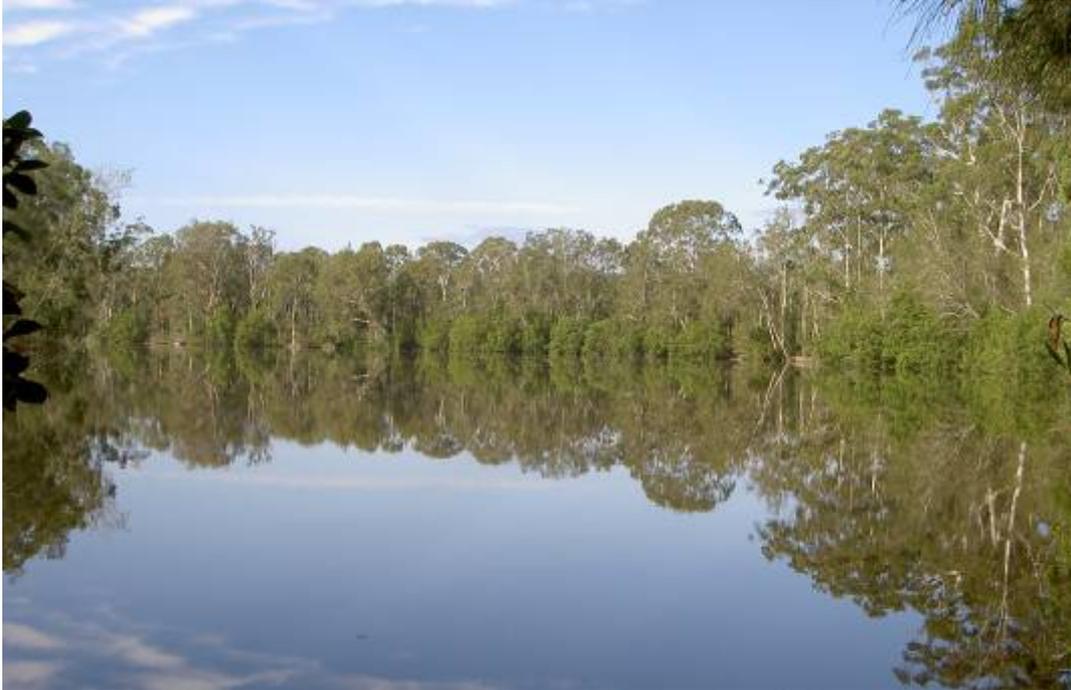
Figure 17: An example of well structured riparian vegetation.

Note the fringing line of mangroves and adjacent bank vegetation, both providing terrestrial and aquatic habitat, as well as providing bank stability.

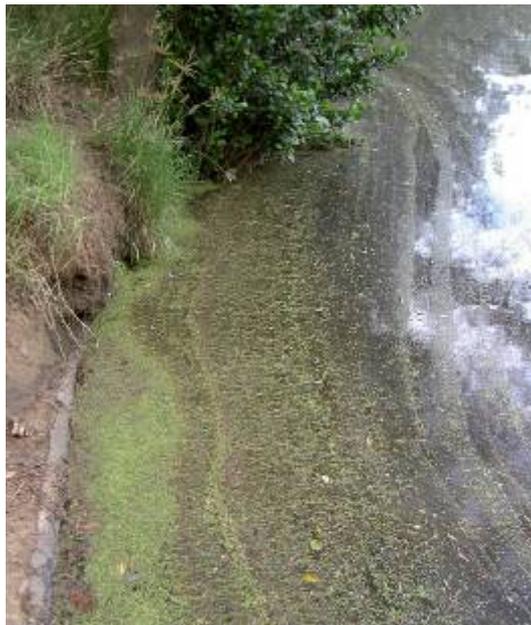
Figure 18: Duck weed (*Arozoella spp.*) in Wallamba River in March 2003.

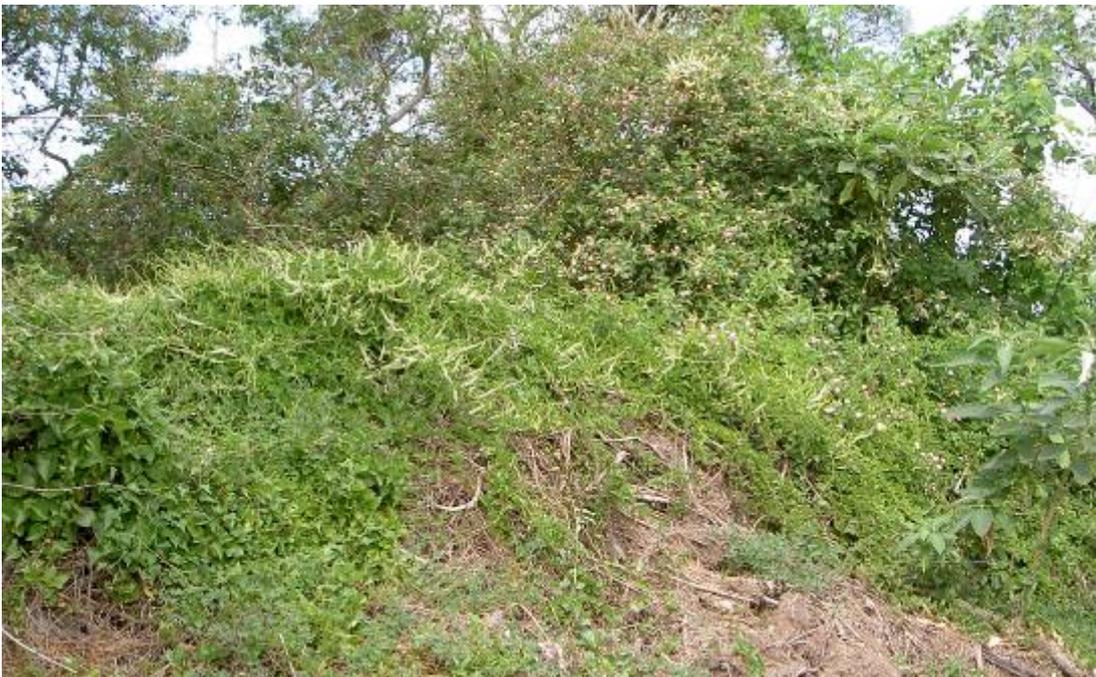
Figure 19: Example of Madeira Vine Infestation.

Note: Madeira or Potato Vine (*Anredera cordifolia*), as shown above, poses a major problem by smothering native vegetation and preventing the establishment of valuable riparian vegetation.

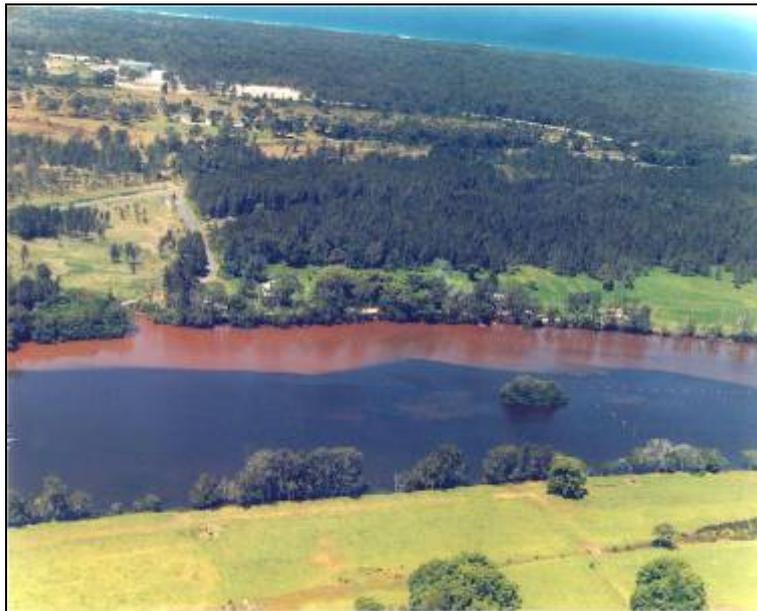
Figure 20: An acid sulphate plume entering the Wallamba River from Darawank Creek.

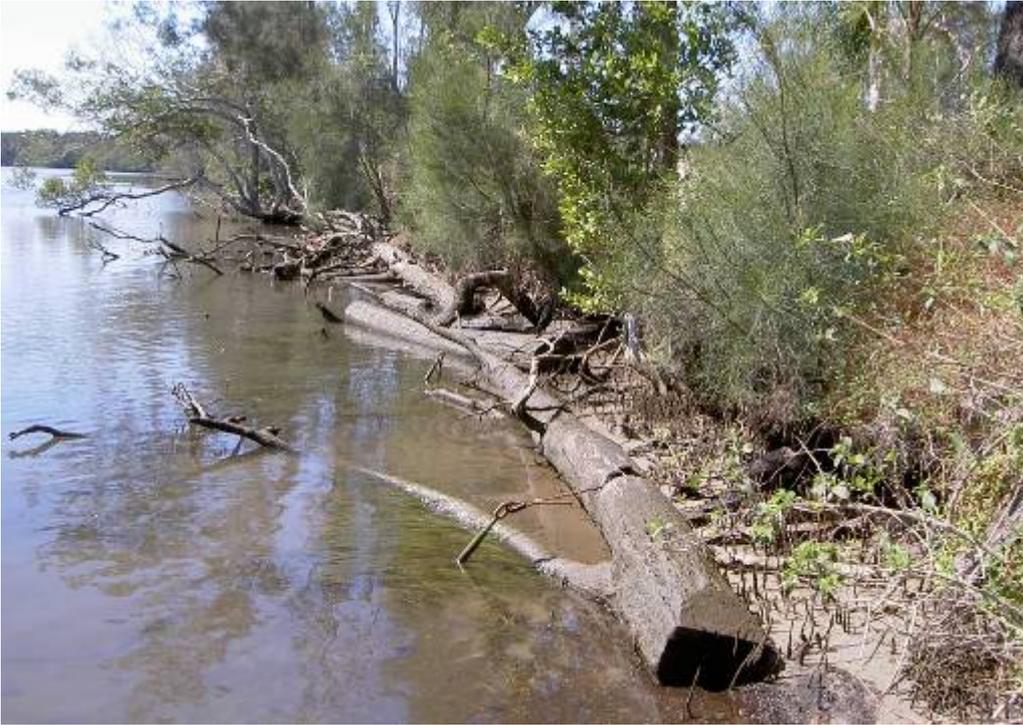
Figure 21: An example of log brushing adjacent Mann’s Road; ARL 7.5km.

Some people are of the opinion that logs within the channel zone should be removed. However, manipulation of LWD should only occur in certain circumstances under advice from DIPNR and NSW Fisheries, where LWD is causing excessive erosion. Usually such erosion is obvious because of a lack of adjacent bank vegetation. Relocation or reorientation is the preferred management technique and is sometimes known as ‘brushing’.

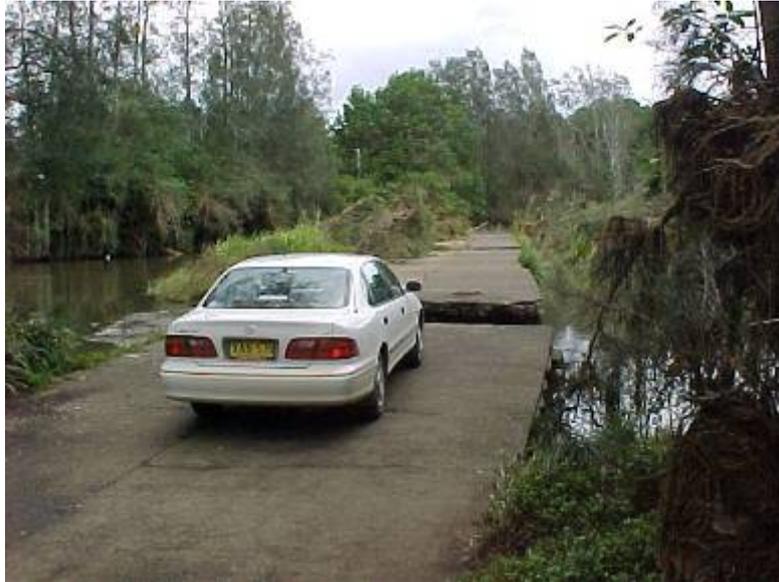
Figure 22: Clarkson's Crossing near Nahiack.

The upstream limit of the River Plan is located at Clarkson’s Crossing, about 200m upstream of the Pacific Highway at Nabiac. Clarkson’s Crossing is one such structure. NSW Fisheries have cut slots in the concrete slab to allow for fish passage, but much like pipes, the slots tend to concentrate minor flows and make it extremely difficult for fish to swim upstream.
