Mid Wallamba River RIVERCARE PLAN

including lower Firefly Creek &
lower Khoribakh Creek

March 2005

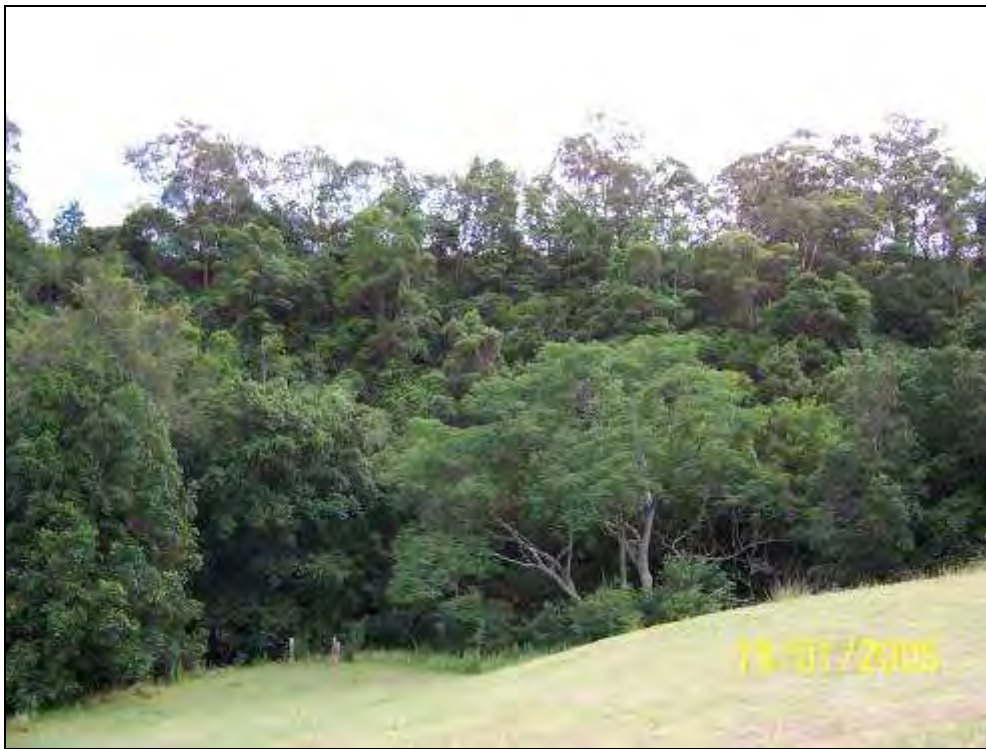
Figure 2: The distinction between the riparian rainforest vegetation in the foreground and the sclerophyll community on the valley slopes in the background.

In Figure 2 below we can see the distinction between the rainforest vegetation type growing along the stream and the sclerophyll forest growing on the valley slopes.

On a catchment scale these factors include climate, topography, soil, fire and competition from other flora. Of these the most influential factor along the stream is the fire regime. By simply being located along the stream the fire potential within the existing vegetation is significantly reduced and the rainforest assemblages have been retained over time rather than being replaced by sclerophyll forest.

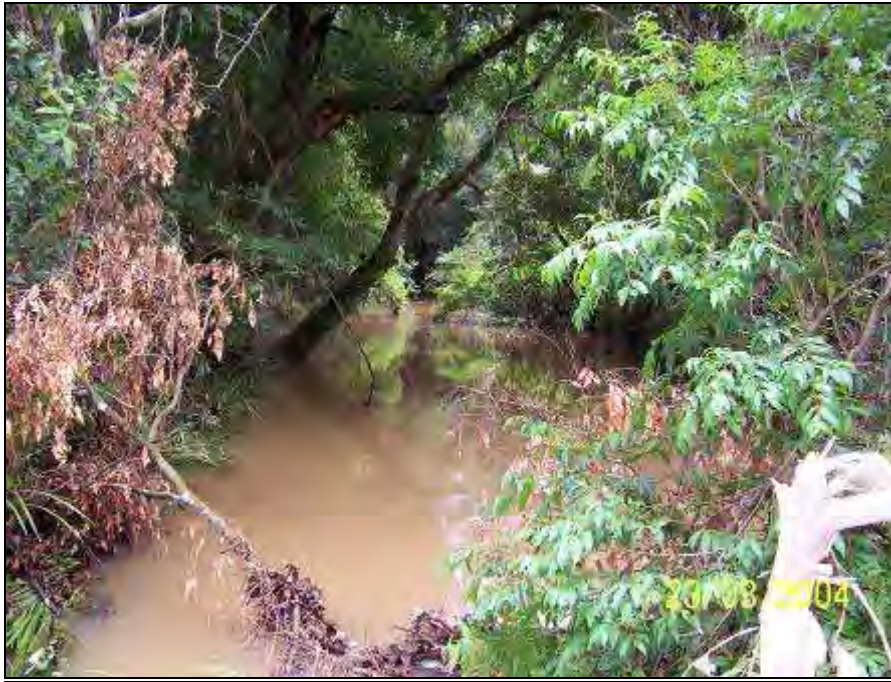
Figure 3: A typical pool reach located on the Wallamba River.

Pools are typically located where bedrock lines the channel and on the outside of bends. Shallow, smaller pools can be found on the downstream side of large woody debris aligned across the streambed. These pools of varying size, shape and depth provide a range of habitats for fish and other aquatic animals and plants, helping to maintain a balanced, healthy riparian ecosystem.

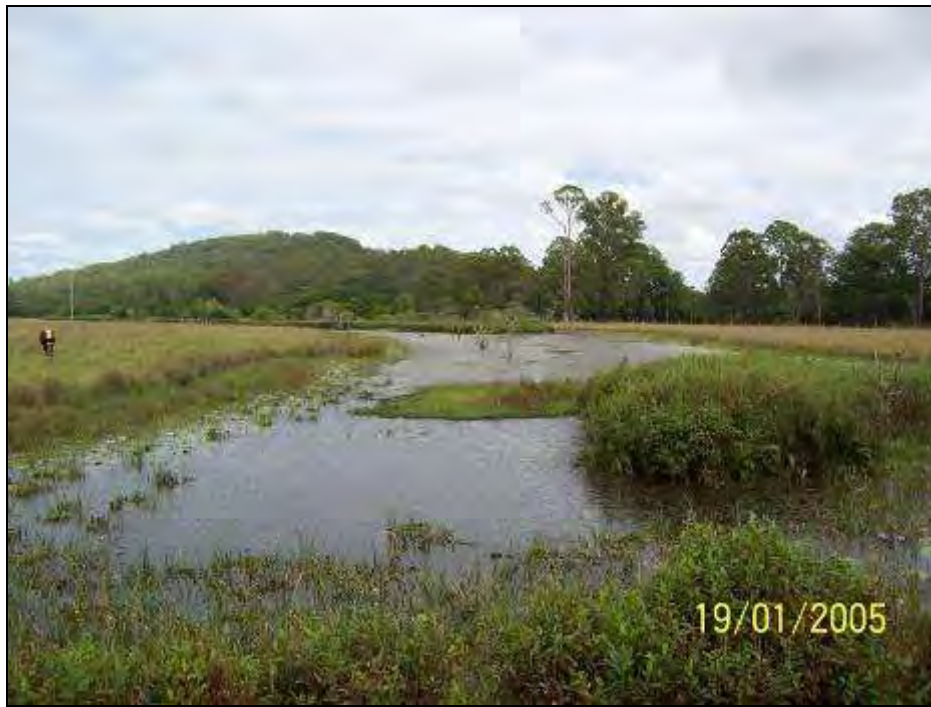
Figure 4: A unique billabong / wetland in a terraced (ancient, disused) floodplain near Nabic is an important refuge for native flora and fauna, especially in times of drought. This wetland is now used as a farm dam.

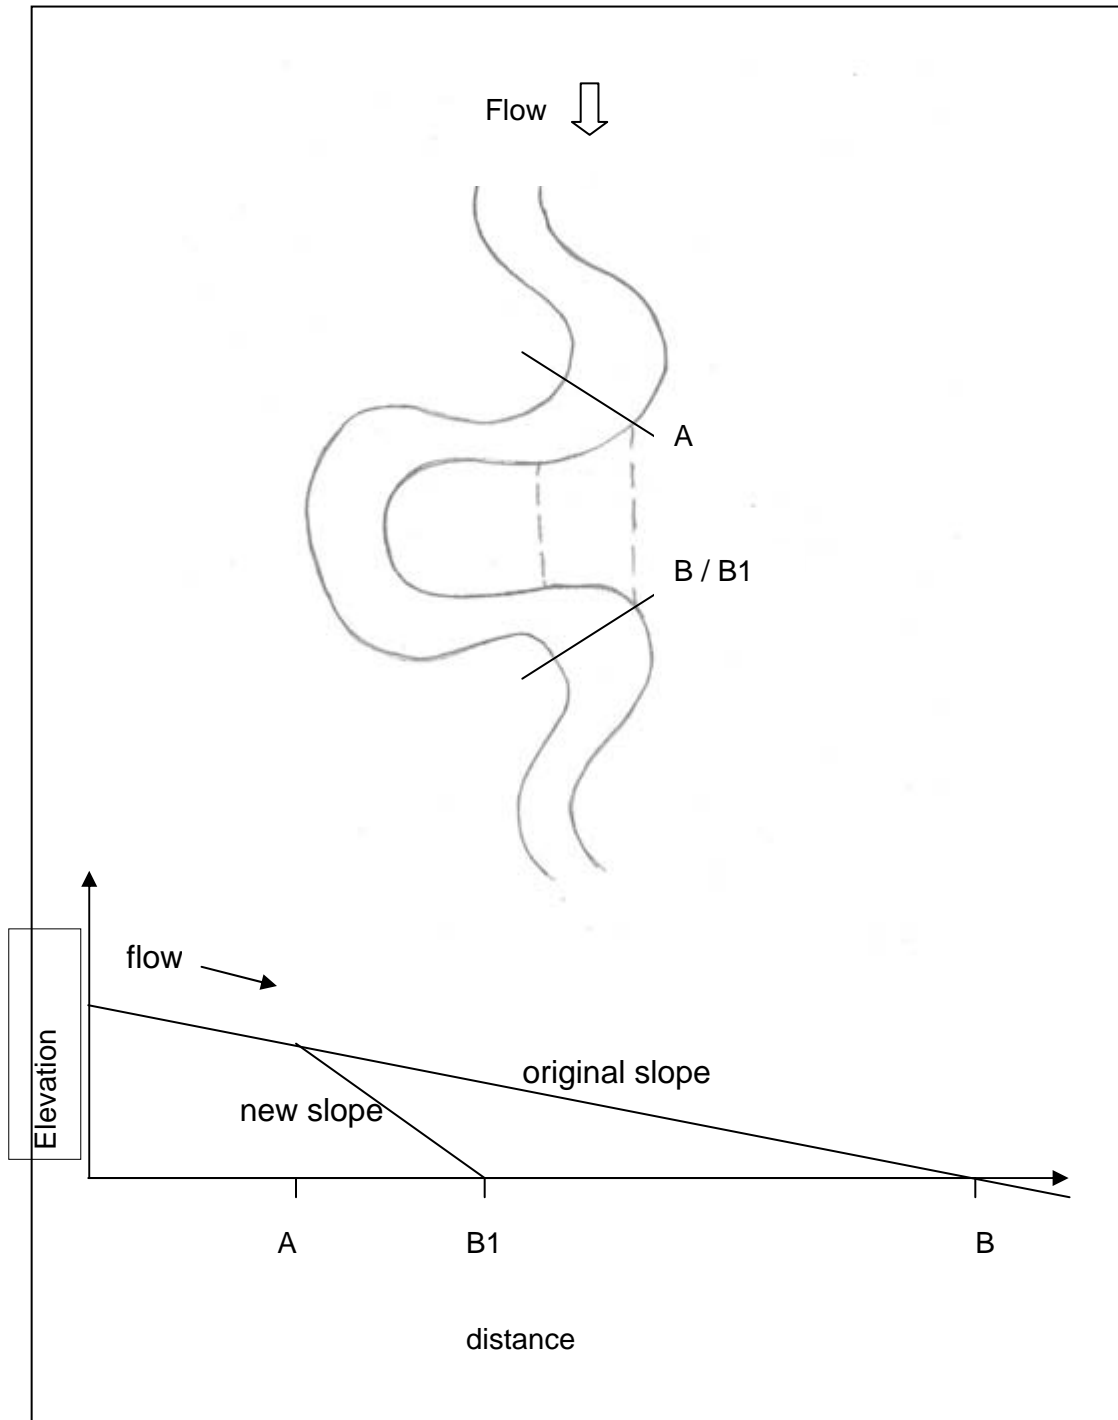
Figure 6: Changes in the slope of the stream following shortening of channel length (known as a 'meander cutoff').

When a channel cutoff takes place, the slope of the channel increases. This is a direct result of the reduction in channel length (due to the cutoff) over which the stream flows. Erosion is more likely to occur when the slope of the channel is increased as water flowing through has a greater velocity. Cutting through meanders is therefore not good for stream management.

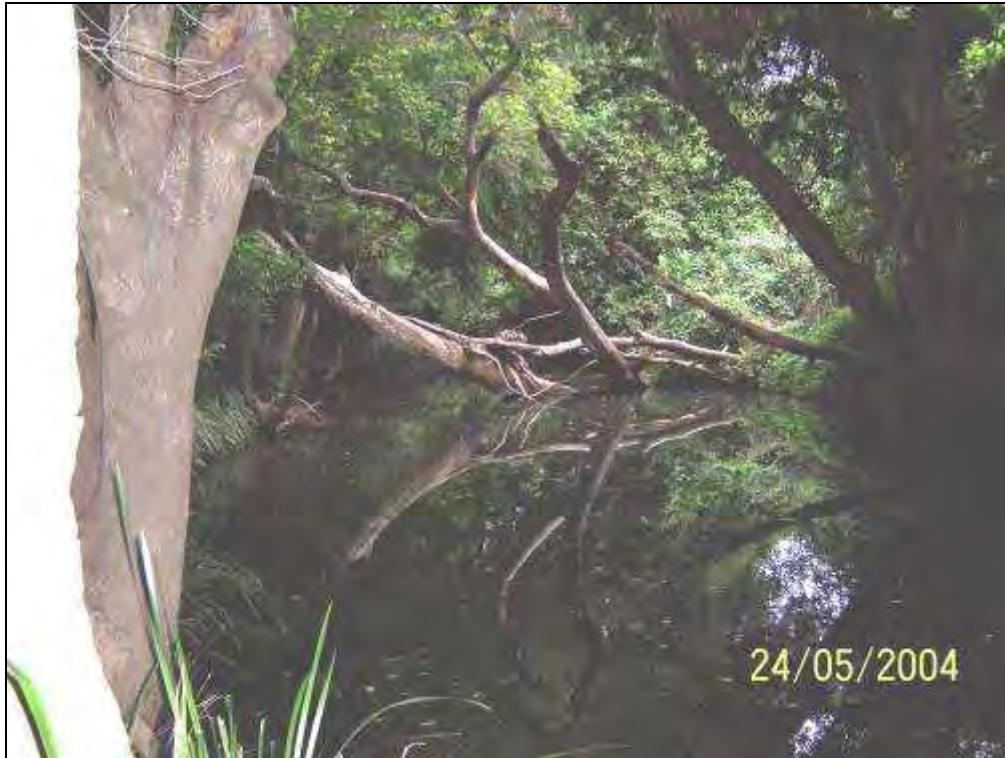
Figure 7: A typical section of the stream illustrating the heavy loading of large woody debris (snags) required to provide stability to the channel.

There is however an even more important control operating in the stream which acts to reduce flow velocity and stabilise the streambed. This control is snags, otherwise known as large woody debris (LWD). Stability is provided when they are embedded in the stream during a flood and they take on a role similar to that of steel reinforcement in concrete. The erosion of streambeds can be offset by the presence of snags embedded in the streambed. When debris is aligned along the toe of the stream it can also act as buffering against the scour of floodwaters.

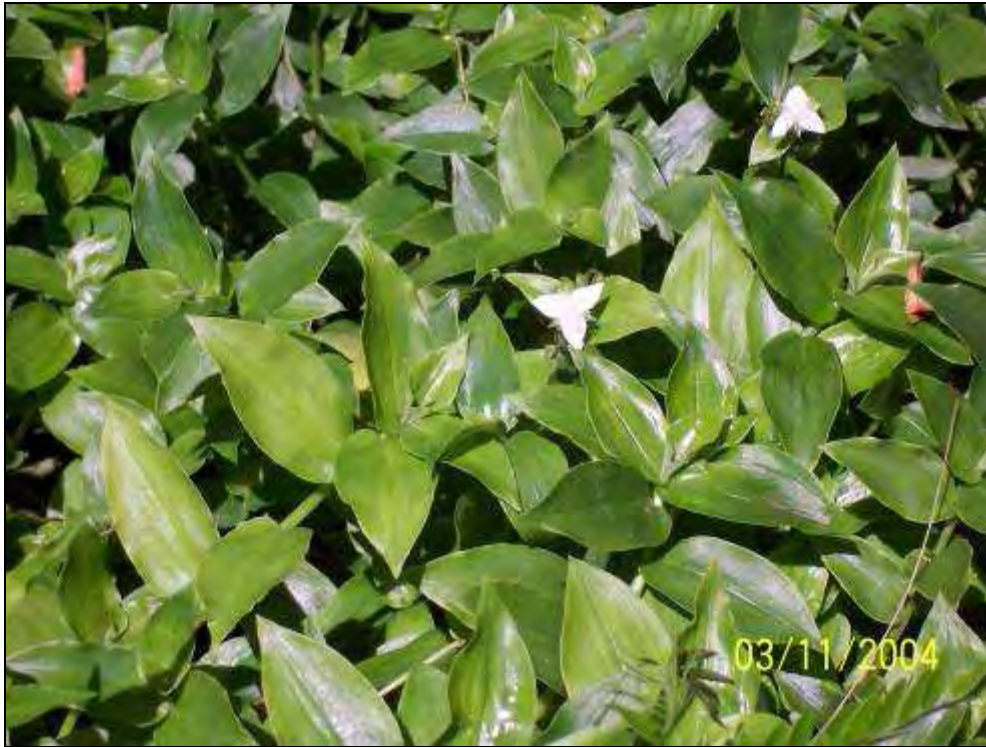
Figure 8: Wandering Jew smothers the ground preventing germination of native seed.

Wandering Jew forms a blanket along the ground. This blanket significantly reduces the number of native saplings, which would come up under normal circumstances. How does Wandering Jew achieve this? By limiting the amount of light which reaches the ground surface and producing a more moist, friable soil texture in which seedlings struggle to germinate.

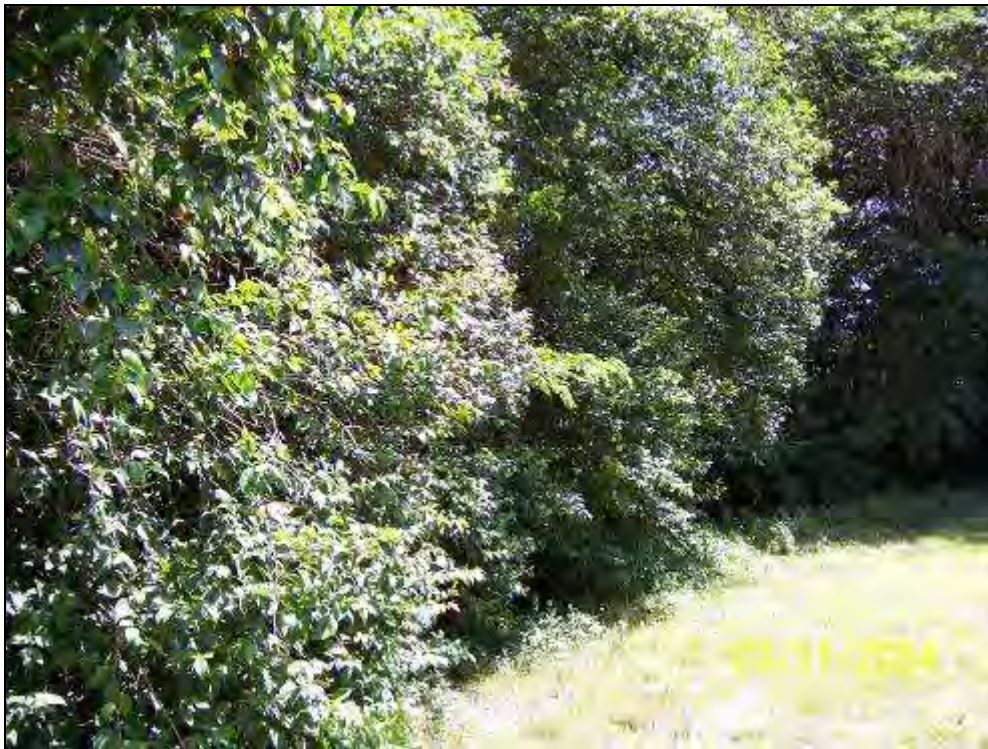
Figure 9: A section of streambank lined with established Broad-leaved Privet near Barry's Road.

Broad-leaved Privet is less widely distributed, it is not as common in the upper parts of the Wallamba River or on Firefly Creek. It is however the dominant weed along the mid Wallamba River, particularly in the Waterloo Creek area from just downstream of the Wallanbah Road / Waterloo Road turnoff (just downstream of the Soper property), to just downstream of the Dargavilles Road crossing (near the Fresen property). The relative smaller distribution of this weed means that at the moment, it could potentially be significantly reduced from the local catchment. This would however require substantial government and community resources, which are unfortunately unlikely at this point in time.

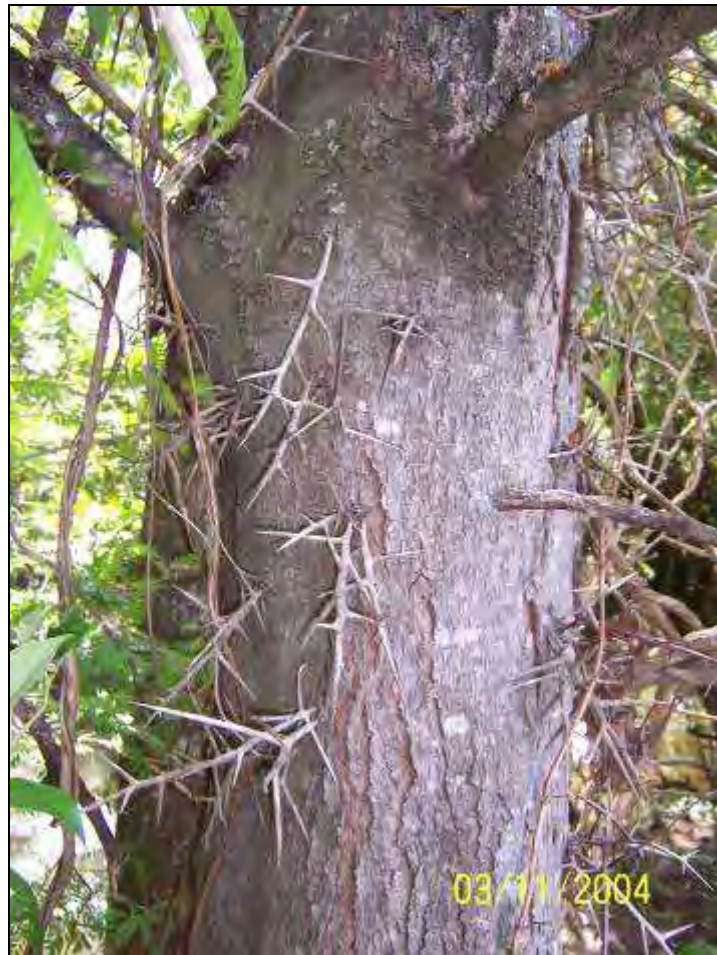
Figure 10: The distinctive trunk of Honey Locust.

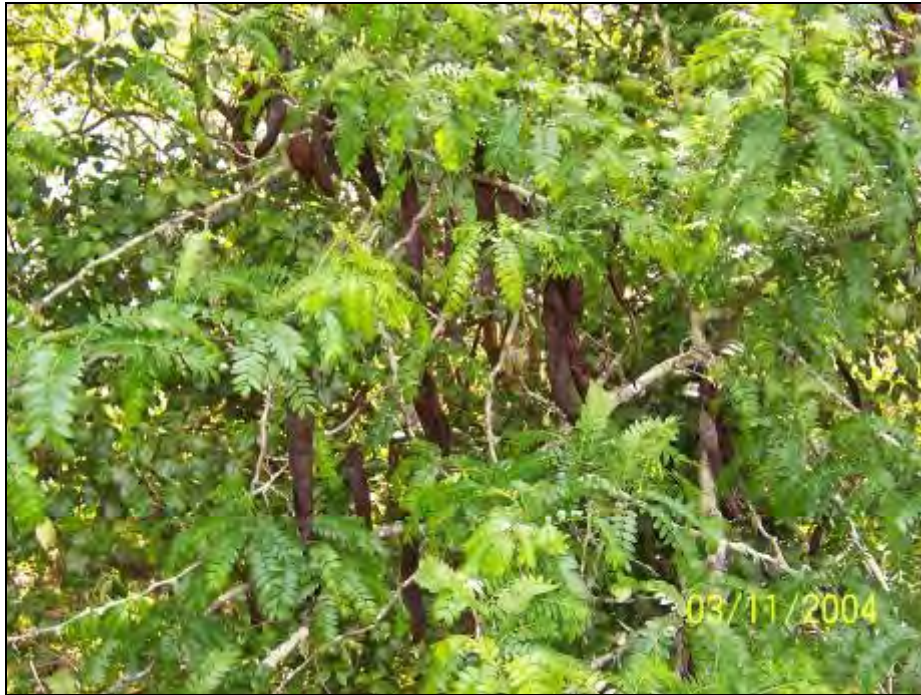
Figure 11: The deciduous bright foliage and bean-like seed pods are a distinguishing feature of Honey Locust.

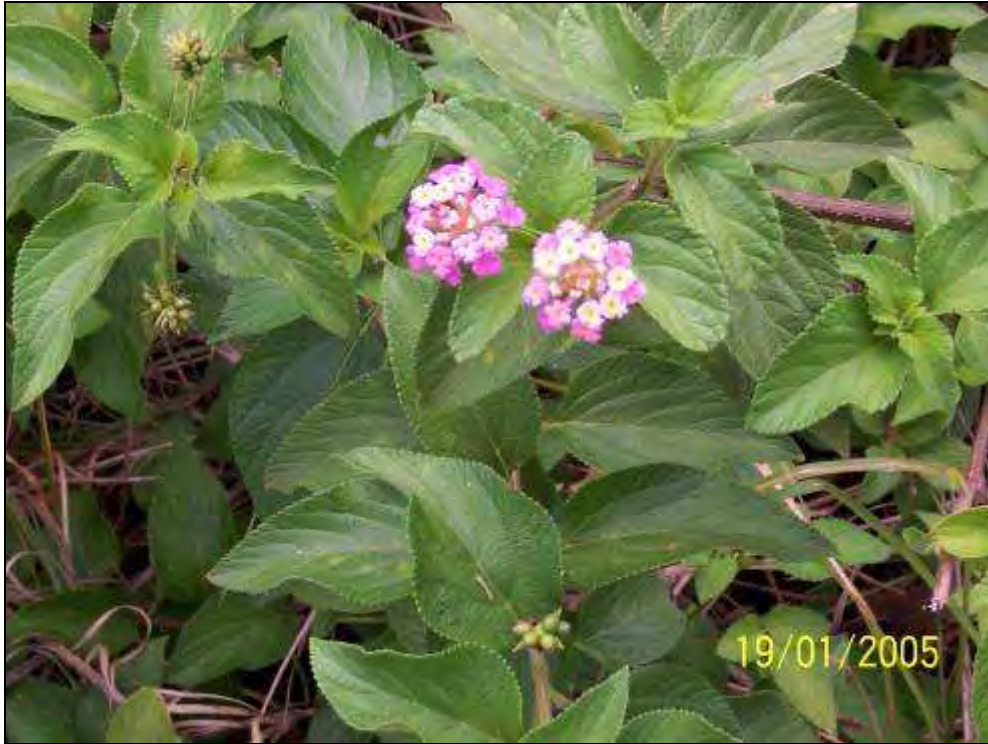
Figure 12: Lantana in flower

A number of dense, impenetrable thickets have taken over the native riparian vegetation along the Wallamba River, Firefly Creek and Khoribakh Creek. It competes for resources with and reduces the regrowth of native species as well as contributing fuel to fires. It has no serious animal or disease predators in the local area and has a remarkable ability to regenerate, regrowing vigorously from root and stem suckers as well as seed dispersed by birds, foxes, wind and other vectors. It also has the potential to grow into the upper canopy of mature native trees. It is a serious threat to biodiversity in the Lower North Coast.

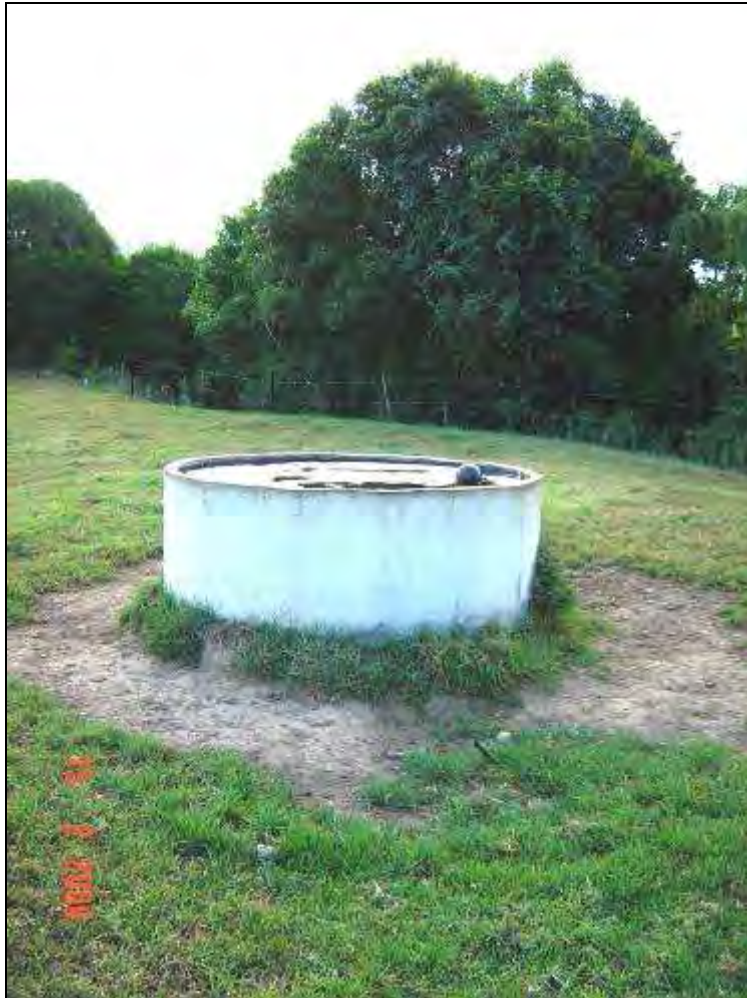
Figure 15: The regenerative capacity along this section of stream (background) has been increased by limiting livestock access. Alternative watering has been supplied in the form of stream water pumped to a dam for reticulation to water troughs throughout the property.

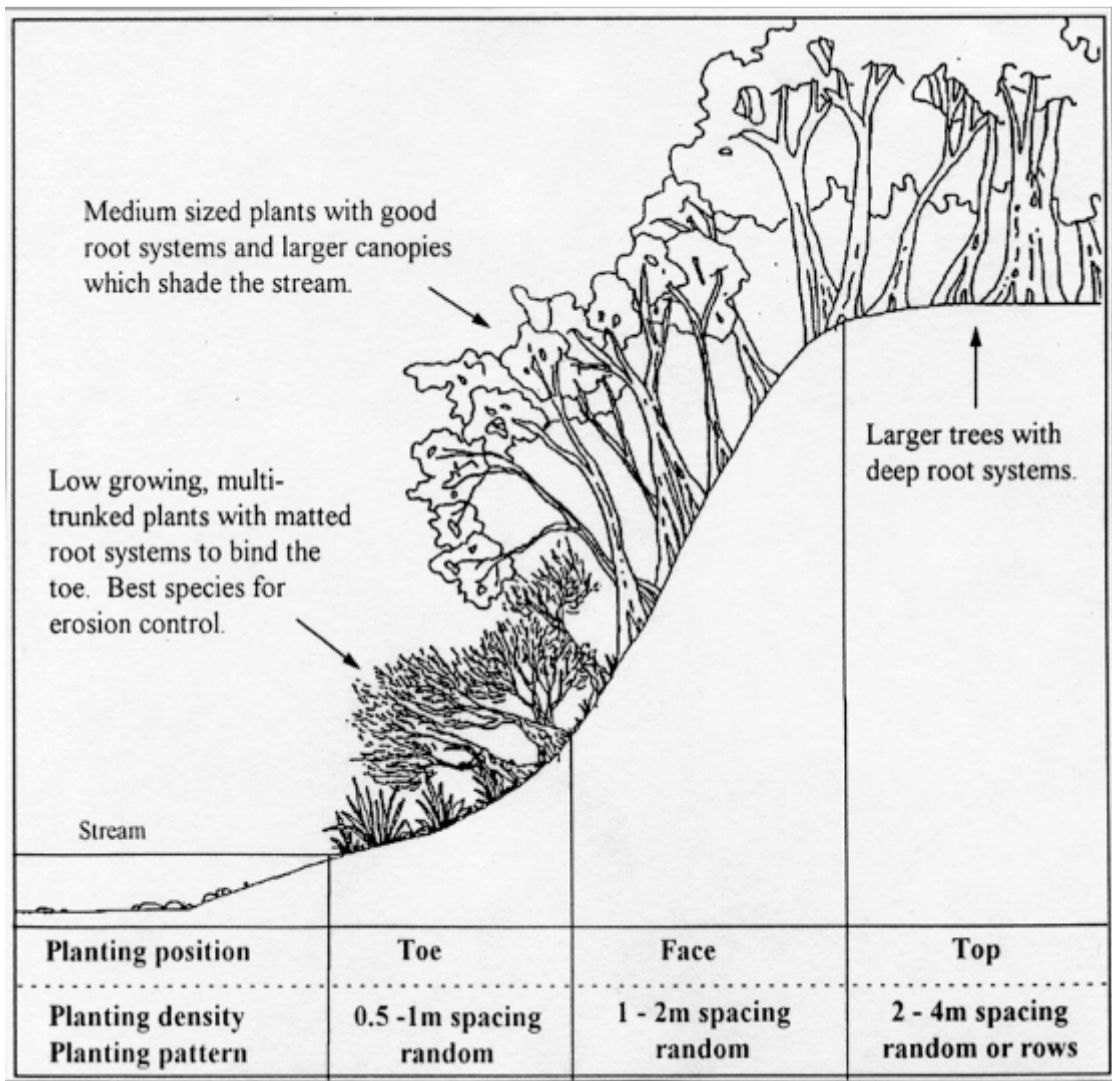
Figure 16: Plant species selection and planting position.
(Source: Raine & Gardiner 1995)
