## APPENDIX A: SUMMARY OF PREVIOUS REPORTS

## Lower Pindimar Natural Foreshore Protection Guideline

# CONCEPTUAL DESIGN Foreshore Protection Pindimar Boat Ramp

**APPENDIX I: RECOMMENDED EROSION MANAGEMENT AT KIORA ST., WARRI ST., AND PEEL ST. OUTLETS**

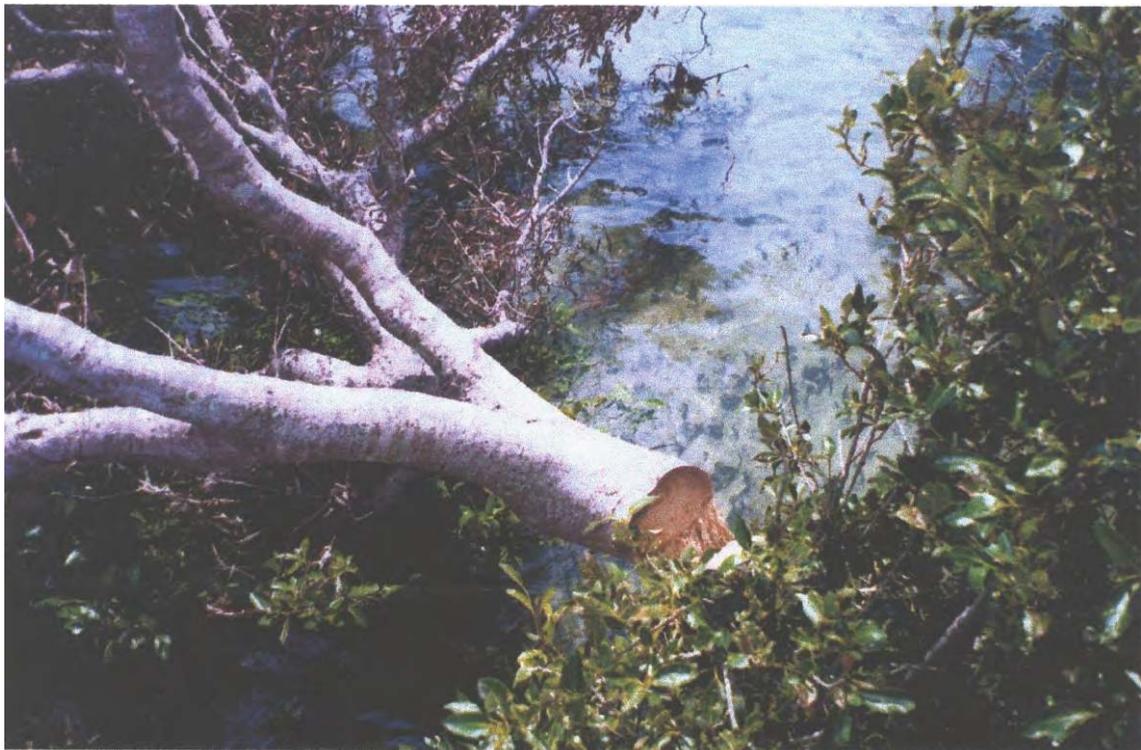
**Figure 10-1 Photograph 5 by NSW Fisheries (2003), illustrating illegal cutting of mangrove trees at Pindimar**

However, the letter concluded that while it was possible that some of the dieback observed at Pindimar may be due to attack by the Moth larvae, the illegal destruction of mangroves was also clear and evident. DPI Fisheries reinforced that cutting down mangroves without a permit is a punishable offence under Section 205 of the *Fisheries Management Act 1994*, incurring fines of up to \$220,000. Further, permits to harm mangroves would not be issued for the simple act of improving water views or aesthetics. The letter iterated that on the spot penalties or court prosecution would be issued to any resident caught damaging mangroves.

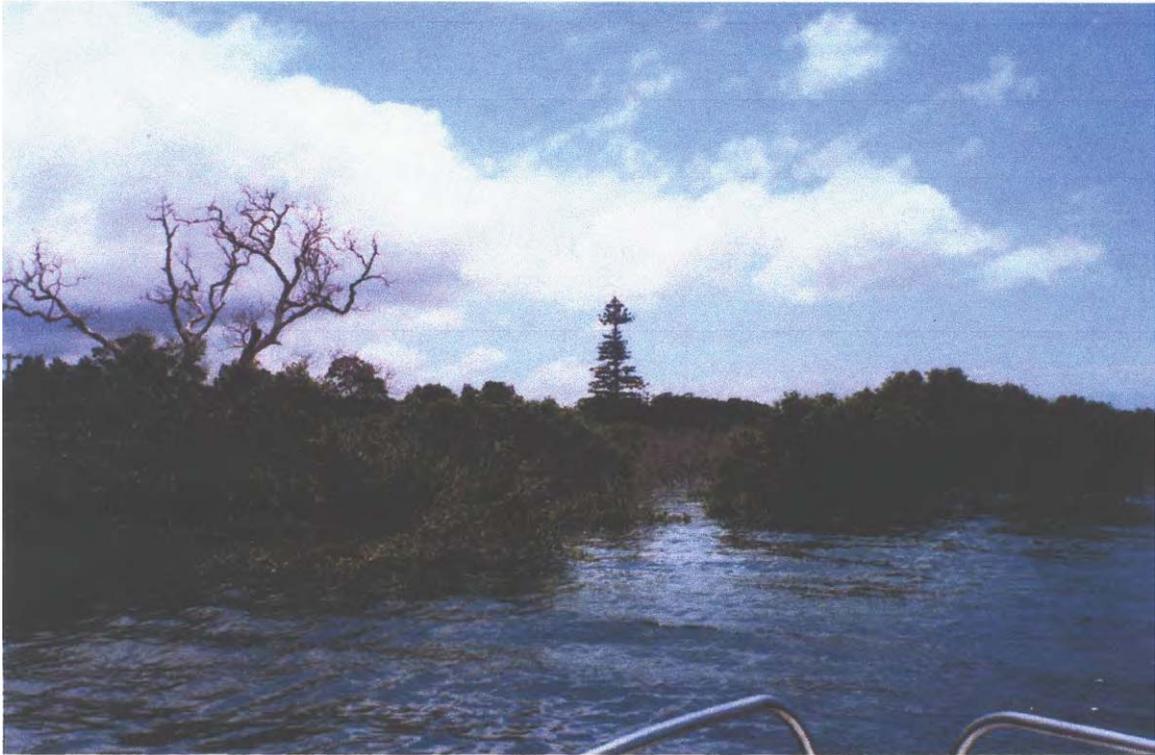
Figure 10-2 Photograph 4 by NSW Fisheries (2003), illustrating illegal poisoning of large mangrove trees at Pindimar

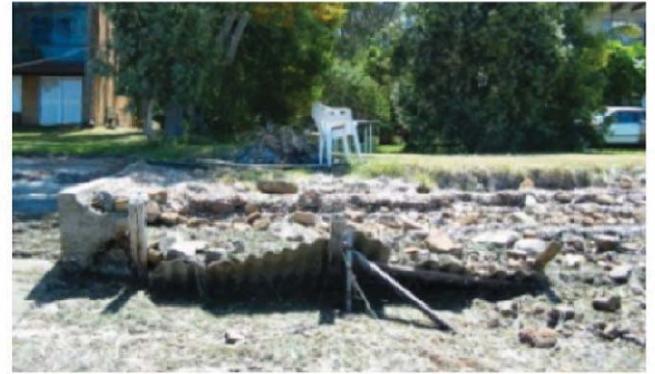
**Example of erosion at Pindimar**

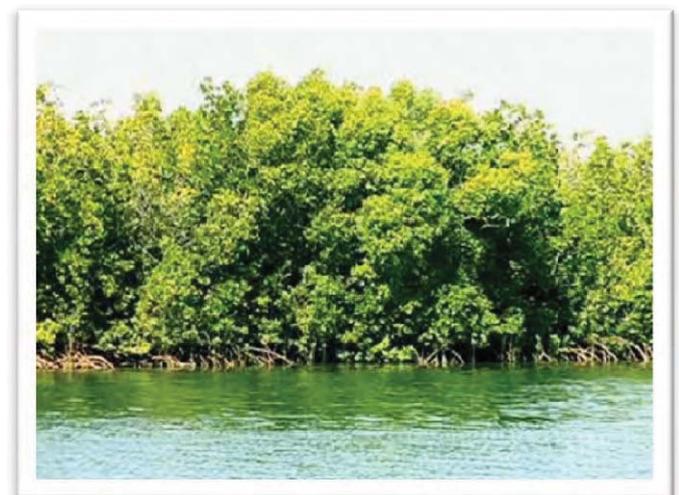
**Mangroves provide natural protection to the shoreline**

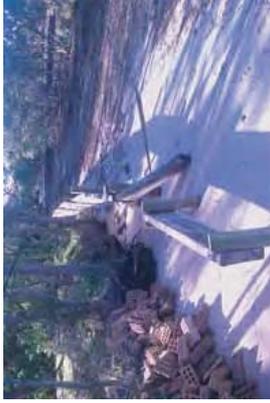
When vertical walls replace gentle slopes, there is no reduction in wave energy before the waves reach the wall. This means that the full impact of waves is felt at the shoreline, and the reflected wave energy erodes the sediment at the base of the wall. When isolated seawalls are constructed in the middle of a natural foreshore, the wall also causes erosion in the adjacent soft shoreline. This is called an 'edge effect'.

Waves crash over the top of seawalls and wet the soil behind. If the seawalls are solid and don't allow drainage (like concrete, wood or cemented rocks) water may pool behind the wall and build up pressure that can cause the wall to collapse. On the other hand, if water drains too freely through the seawall, the fill behind the wall may wash out, forming 'sinkholes' that can also cause the wall to collapse.

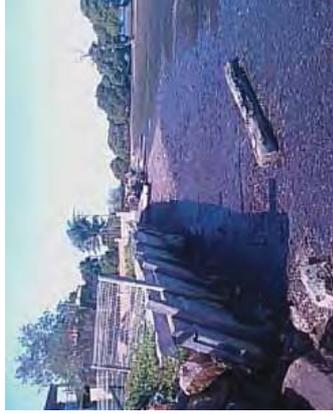
In Lower Pindimar, high, vertical walls have also caused problems with wrack decay. Rather than being deposited at the high tide mark where it is able to dry and decompose quickly, the wrack is instead deposited in the low tide zone at the base of the walls, decaying to form an organic ooze. The ooze may destroy the seagrass and be poisonous to other marine animals. Healthy seagrasses are a nursery for juvenile fish, so they are vital for good fish stocks in the estuary.

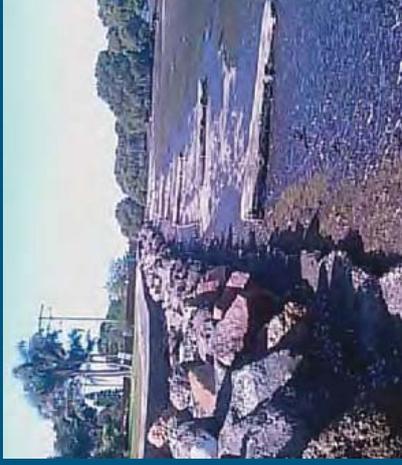
Groynes can capture sediments drifting along the shoreline, but this causes erosion of the shoreline further up because there is no sand being transferred along the shore. In Lower Pindimar, the groynes do not appear to be capturing sand, which means there is little or no transport of sand along the shore. This also means the groynes are unnecessary. Instead, groynes are a danger to the public attempting to walk along the shoreline.

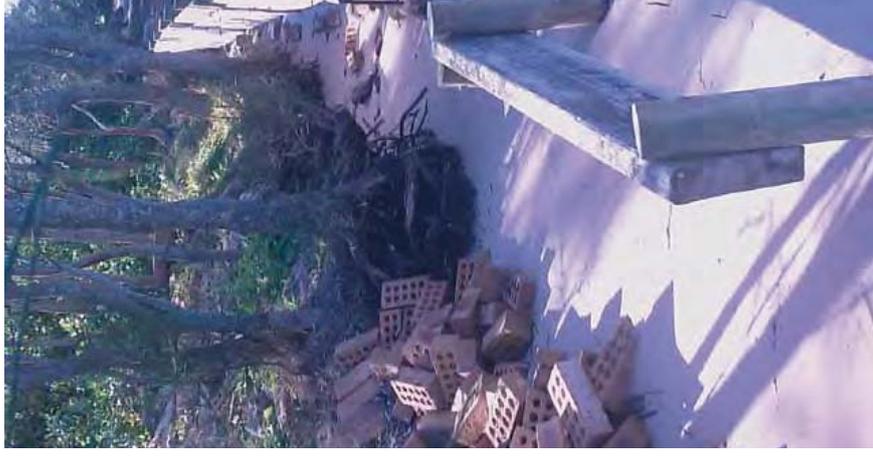
When vertical walls replace gentle slopes, there is no reduction in wave energy before the waves reach the wall. This means that the full impact of waves is felt at the shoreline, and the reflected wave energy erodes the sediment at the base of the wall. When isolated seawalls are constructed in the middle of a natural foreshore, the wall also causes erosion in the adjacent soft shoreline. This is called an 'edge effect'.

Waves crash over the top of seawalls and wet the soil behind. If the seawalls are solid and don't allow drainage (like concrete, wood or cemented rocks) water may pool behind the wall and build up pressure that can cause the wall to collapse. On the other hand, if water drains too freely through the seawall, the fill behind the wall may wash out, forming 'sinkholes' that can also cause the wall to collapse.

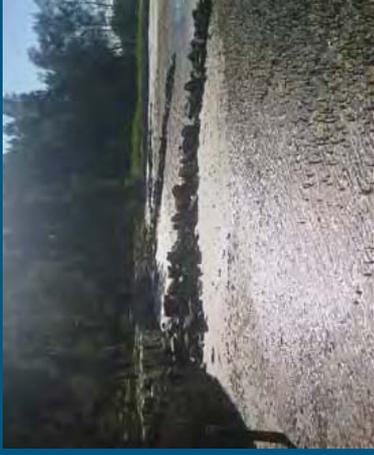
In Upper Pindimar, sand naturally moves along the shore towards the north. Groynes can capture the sediment, but this causes erosion of the shoreline further up because there is no sand being transferred along the shore. Groynes are also dangerous to the public attempting to walk along the shoreline.
