Greater Taree  
City Council

# State of the Manning

2014 Report Card

# The State of the Manning Report Card measures the ecological health of the Manning River estuary.

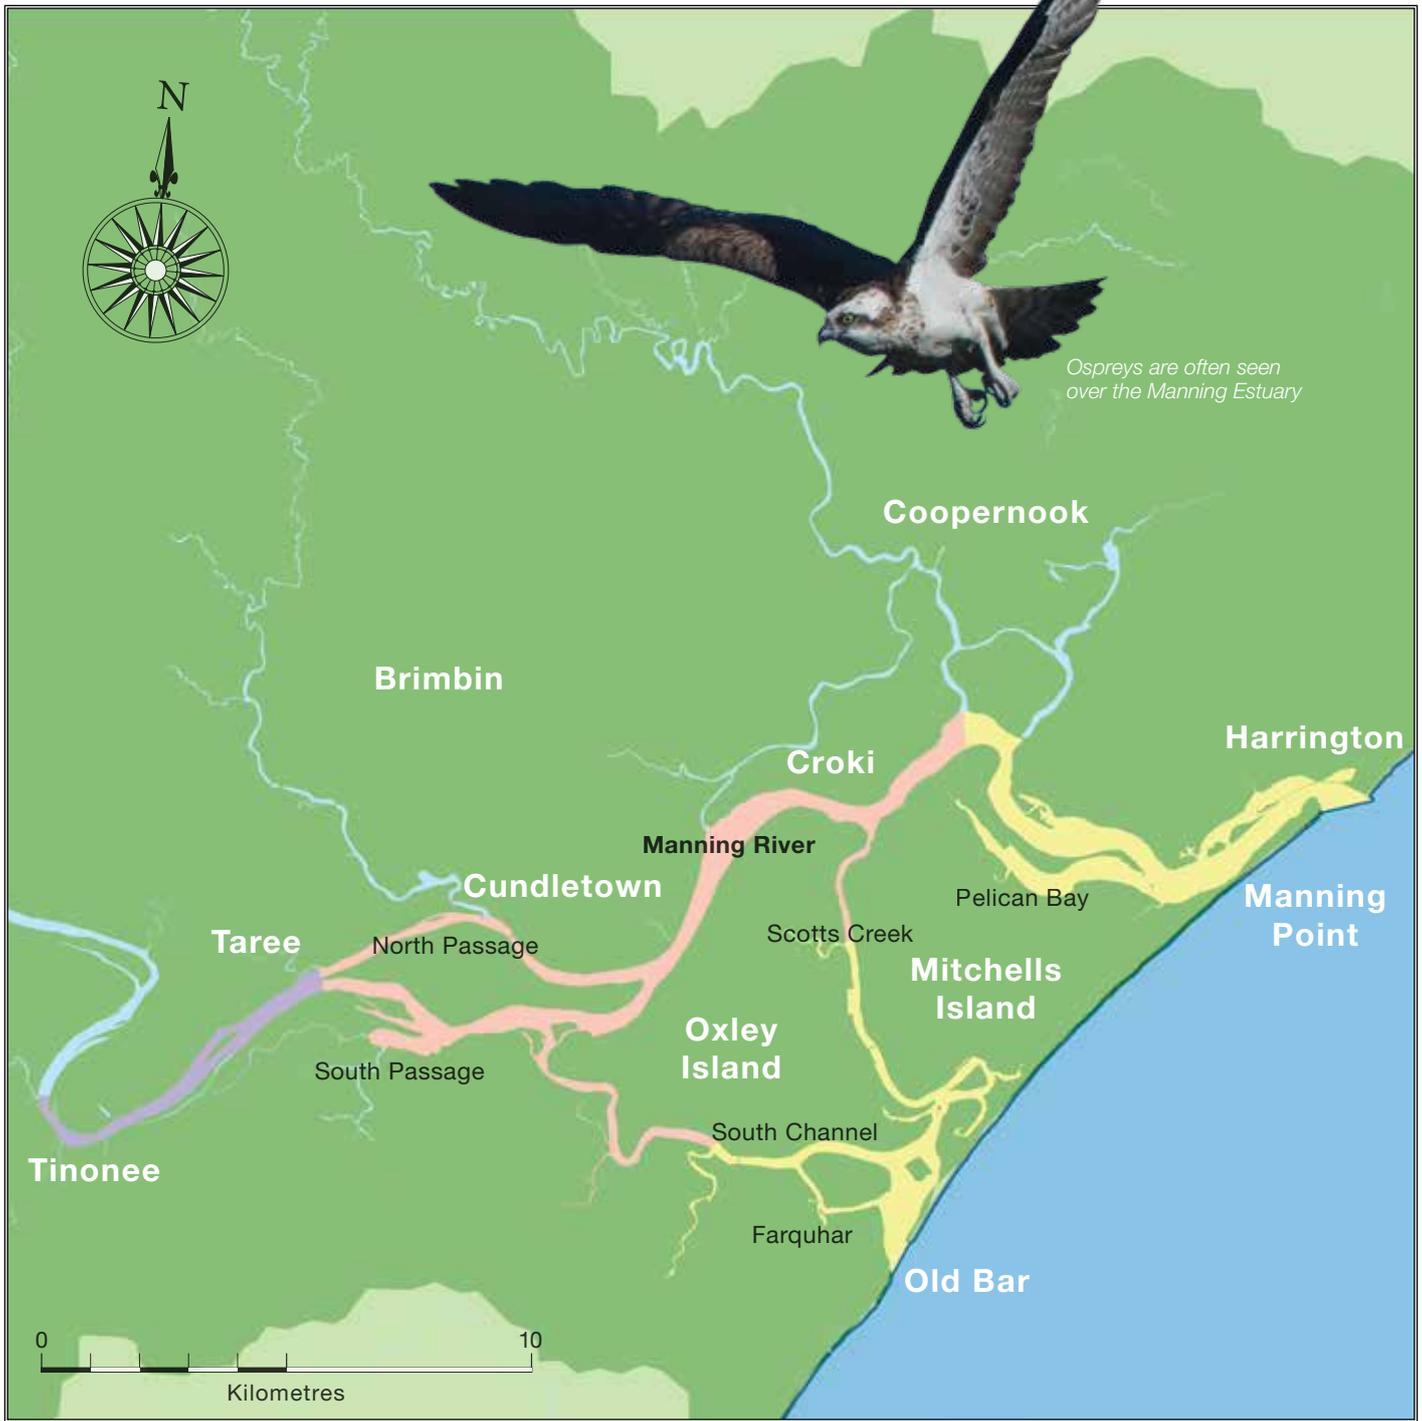
# Manning River Estuary Sampling Zones

In developing the Report Card, the Manning River was divided into three zones: the upper, middle and lower estuary (see map). Six water monitoring transects were undertaken monthly between November 2013 and April 2014. Water quality data and seagrass depth was used to calculate the overall report card grade for each zone of the estuary.

- Waterways
- Lower Estuary
- Middle Estuary
- Upper Estuary
- Manning Catchment

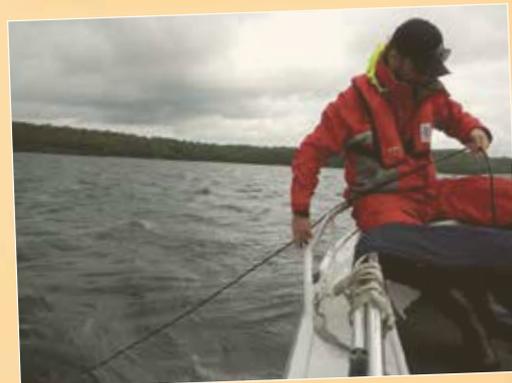
Taking water samples  
Image courtesy of NSW Office of Environment & Heritage

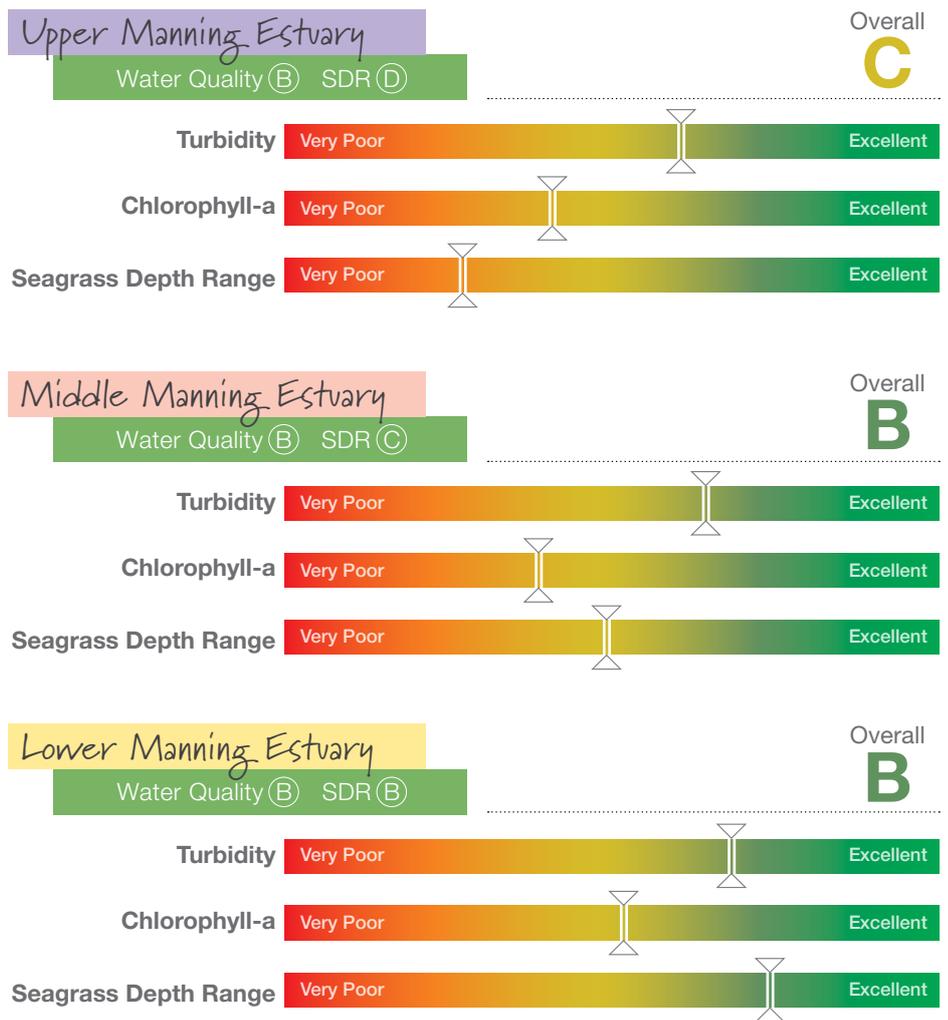
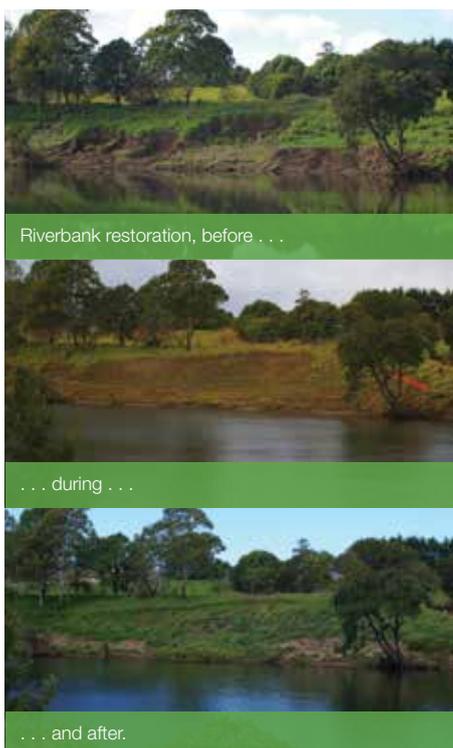
Overall, water quality in the Manning River estuary is fair to good.

The river experienced high turbidity levels following periods of rainfall, particularly in the middle section of the estuary. This is likely to have a significant impact on the health of the system if the intensity and frequency of rainfall events increase and sources of sediment from the catchment are not reduced.

Chlorophyll-a concentrations were consistently high in the estuary, which indicates that the system is currently acting as a massive nutrient sink. It was the high chlorophyll-a levels that had the most impact on the water quality component of the report card gradings, particularly within the upper estuary.

Differences in turbidity, chlorophyll-a and salinity can all influence seagrass growth. Seagrass depth was poor in the upper estuary but increased with distance downstream with good depth readings recorded in the lower estuary.

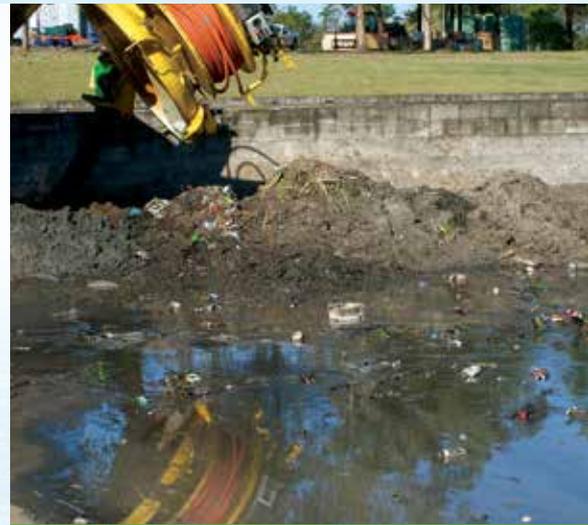
Cleaning of Gross Pollutant Traps

- ✓ erosion control improvements on unsealed gravel roads, which are a huge contributor of sediment to the river;
- ✓ the protection and stabilisation of eroding riverbank sites at Wingham and Taree through the construction of rock fillets and re-establishment of native vegetation;
- ✓ the control of invasive environmental weeds such as Sharp Rush, which degrade coastal wetlands and limit the ability to filter out nutrients;
- ✓ regular inspections of on-site sewerage management systems located near waterways to ensure they are operating effectively; and
- ✓ the refurbishment of a major gross pollutant trap on Browns Creek to stop litter from entering the Manning River.

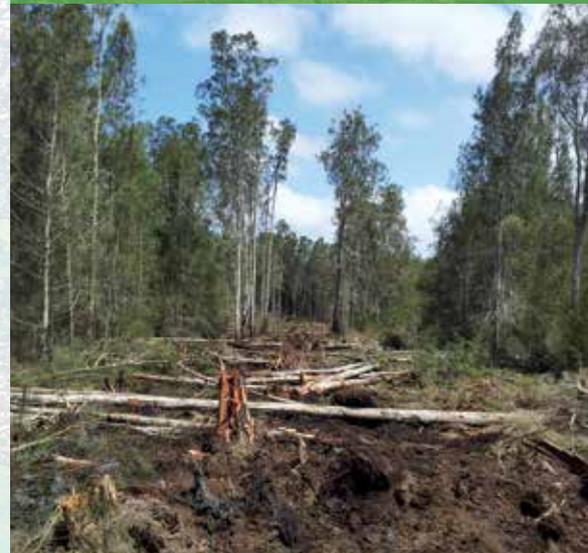
Infilling of drain at Big Swamp

Council has already initiated significant on ground works through the Cattai Wetlands and Big Swamp projects to address some of the impacts on water quality within the lower Manning estuary caused through the disturbance of acid sulfate soils.
