Environmental Site Assessment Report

Palms Oasis Caravan Park
321 Boomerang Drive
Blueys Beach NSW 2428

Environmental Site Assessment (ESA) Report

Report Issued: April 2016

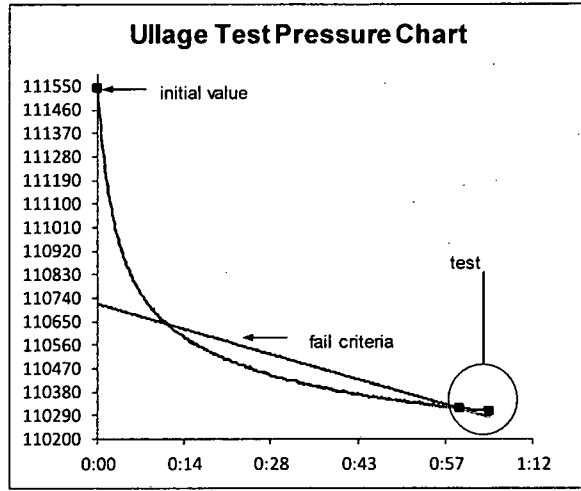
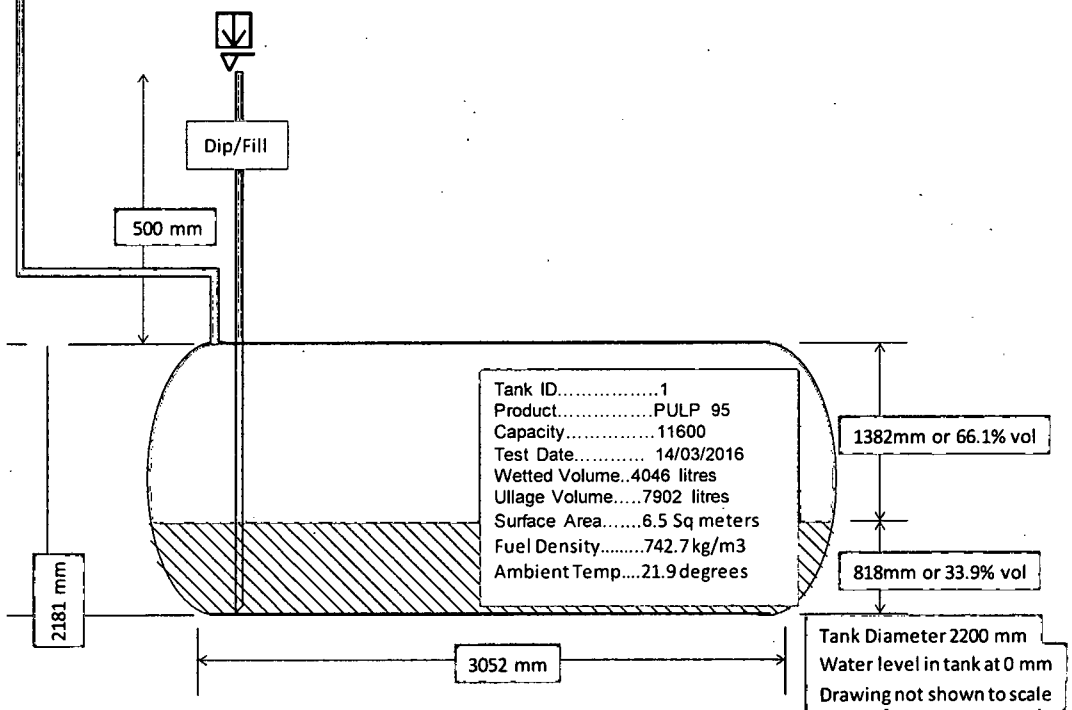
PULP 95 Tank 1

Mass Test	Time	Units
Mass 1	11:48:40 AM	5.64064
Mass 2	11:51:28 AM	5.64065
Mass 3	~11:54:08 AM	5.64066
Mass 4	12:43:48 PM	5.64149
Mass 5	12:46:58 PM	5.64149
Mass 6	12:49:38 PM	5.64150
Mass 7	3:03:29 PM	5.64163
Mass 8	3:06:10 PM	5.64164
Ullage Test	Time	Pascals
Initial Value	13:26:05	111546
Test 1 Value	14:25:55	110316
Test 2 Value	14:30:55	110309
	dP/dT(Pa/5min)	-7
	Pass limit (Pa/5min)	-33.6

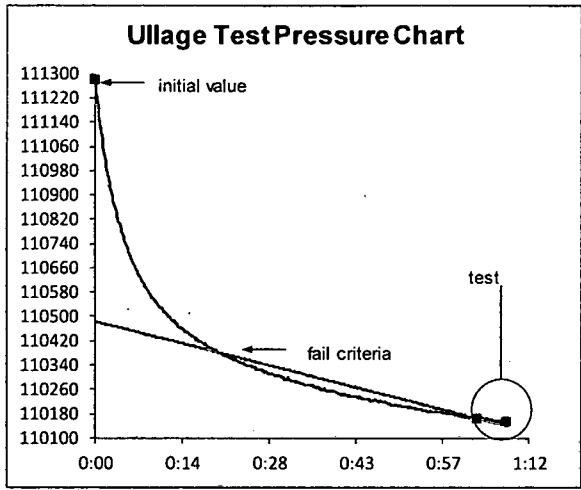
ULP Tank 2

Mass Test	Time	Units
Mass 1	11:48:53 AM	3.46629
Mass 2	11:51:40 AM	3.46629
Mass 3	11:54:21 AM	3.46629
Mass 4	12:47:11 PM	3.46654
Mass 5	12:49:50 PM	3.46654
Mass 6	12:52:17 PM	3.46655
Mass 7	3:03:42 PM	3.46669
Mass 8	3:06:23 PM	3.46669
Ullage Test	Time	Pascals
Initial Value	13:31:05	111279
Test 1 Value	14:34:25	110165
Test 2 Value	14:39:25	110154
	dP/dT (Pa/5min)	-11
	Pass limit (Pa/5min)	-25.2

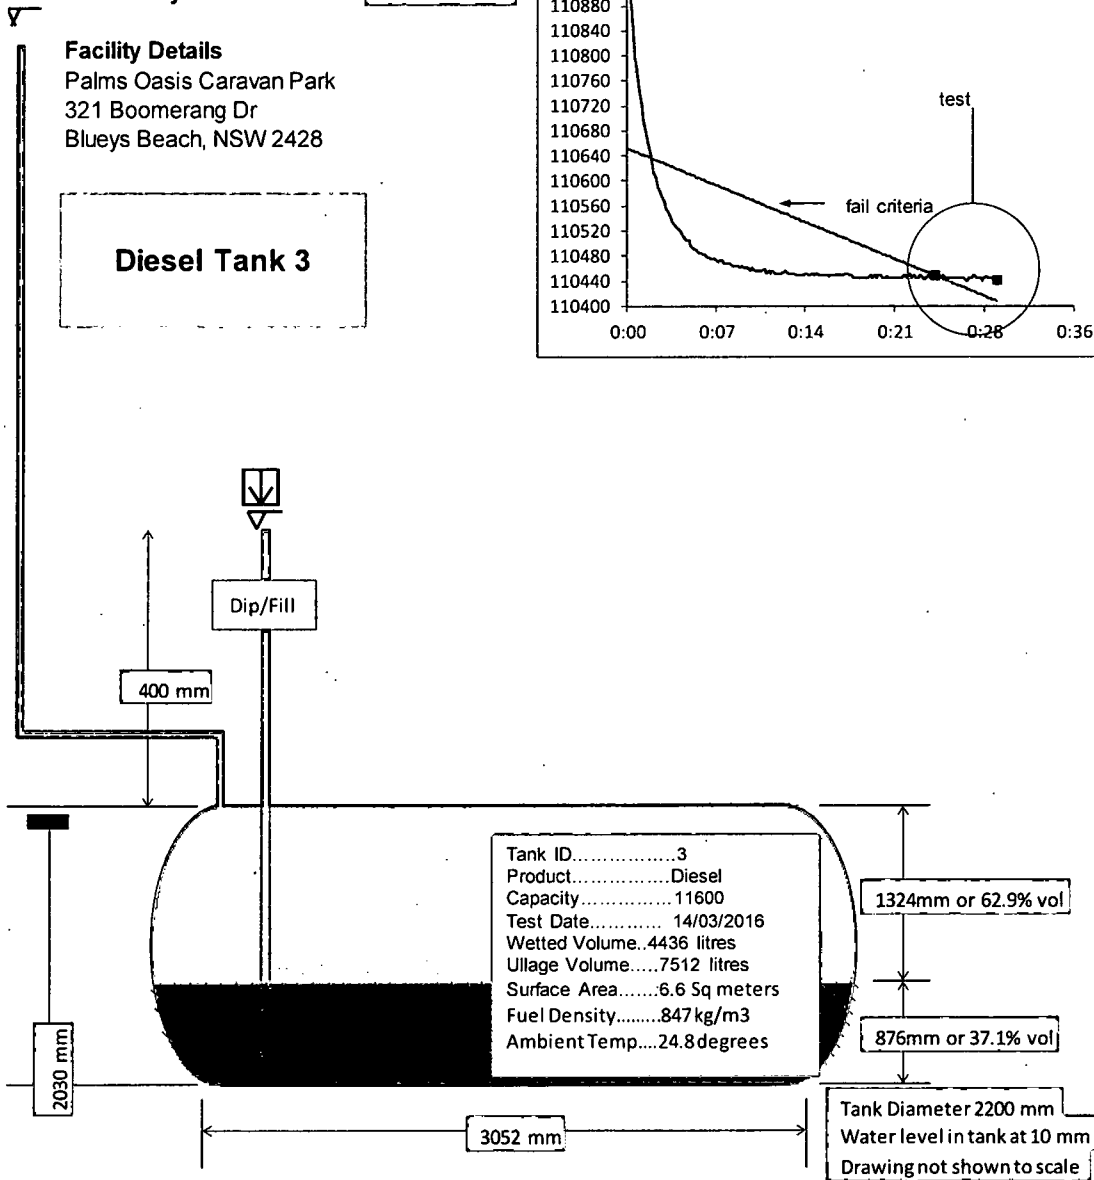
Diesel Tank 3

Mass Test	Time	Units
Mass 1	3:16:03 PM	6.91261
Mass 2	3:18:25 PM	6.91262
Mass 3	3:20:46 PM	6.91263
Mass 4	4:02:53 PM	6.91337
Mass 5	4:05:13 PM	6.91338
Mass 6	4:07:42 PM	6.91339
Mass 7	4:57:49 PM	6.91295
Mass 8	5:00:07 PM	6.91296
Ullage Test	Time	Pascals
Initial Value	16:17:40	110961
Test 1 Value	16:42:29	110449
Test 2 Value	16:47:29	110442
	dP/dT (Pa/5min)	-7
	Pass limit (Pa/5min)	-40.9
