Report on
Acid Sulfate Soil Assessment

Proposed Rezoning
Sanderling Ave, Hawks Nest

Prepared for
Lands Advisory Services Pty Ltd

Project 91588.01
April 2020

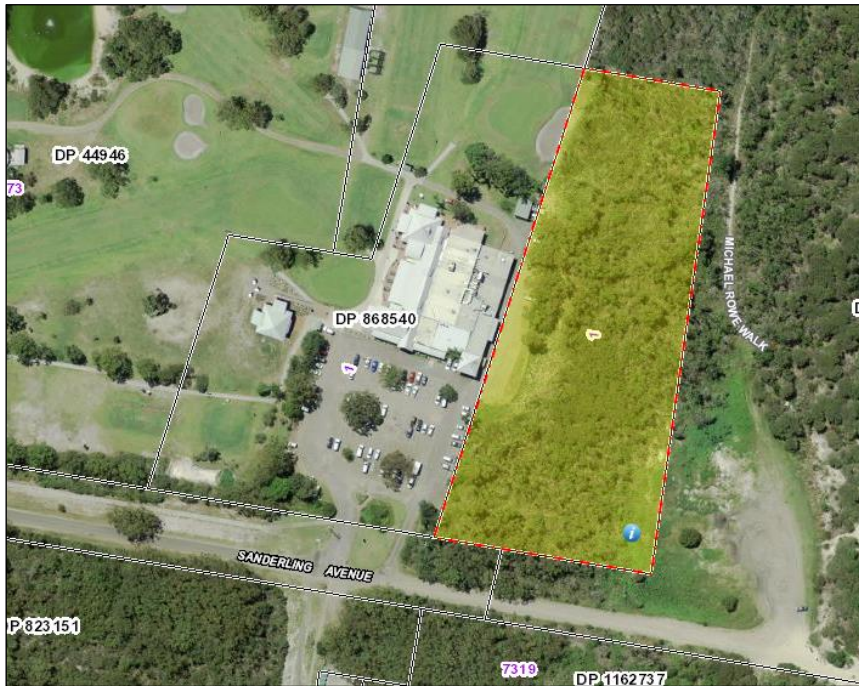
Figure 1: Subject site (in yellow)

The site is identified as Lot 1 DP 1234229, Sanderling Avenue Hawks Nest, within the Mid-coast Council local government area. The site is approximately 1.48 ha in area and is shown in Drawing 1, Appendix B and Figure 1 below.

The site is bounded to the north and east by vacant vegetated land, to the south by Sanderling Avenue and a holiday park and to the west by the Hawks Nest Golf Club.

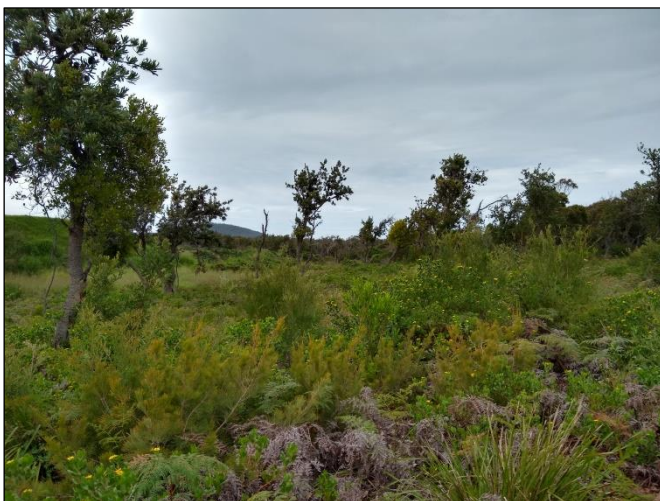
Figure 2: Site Conditions of South Eastern Corner.

The site contains a dense ground cover of vegetation such as ferns and small shrubs. Trees are sparsely spaced around the site. General conditions are shown in Figure 2 and Figure 3.

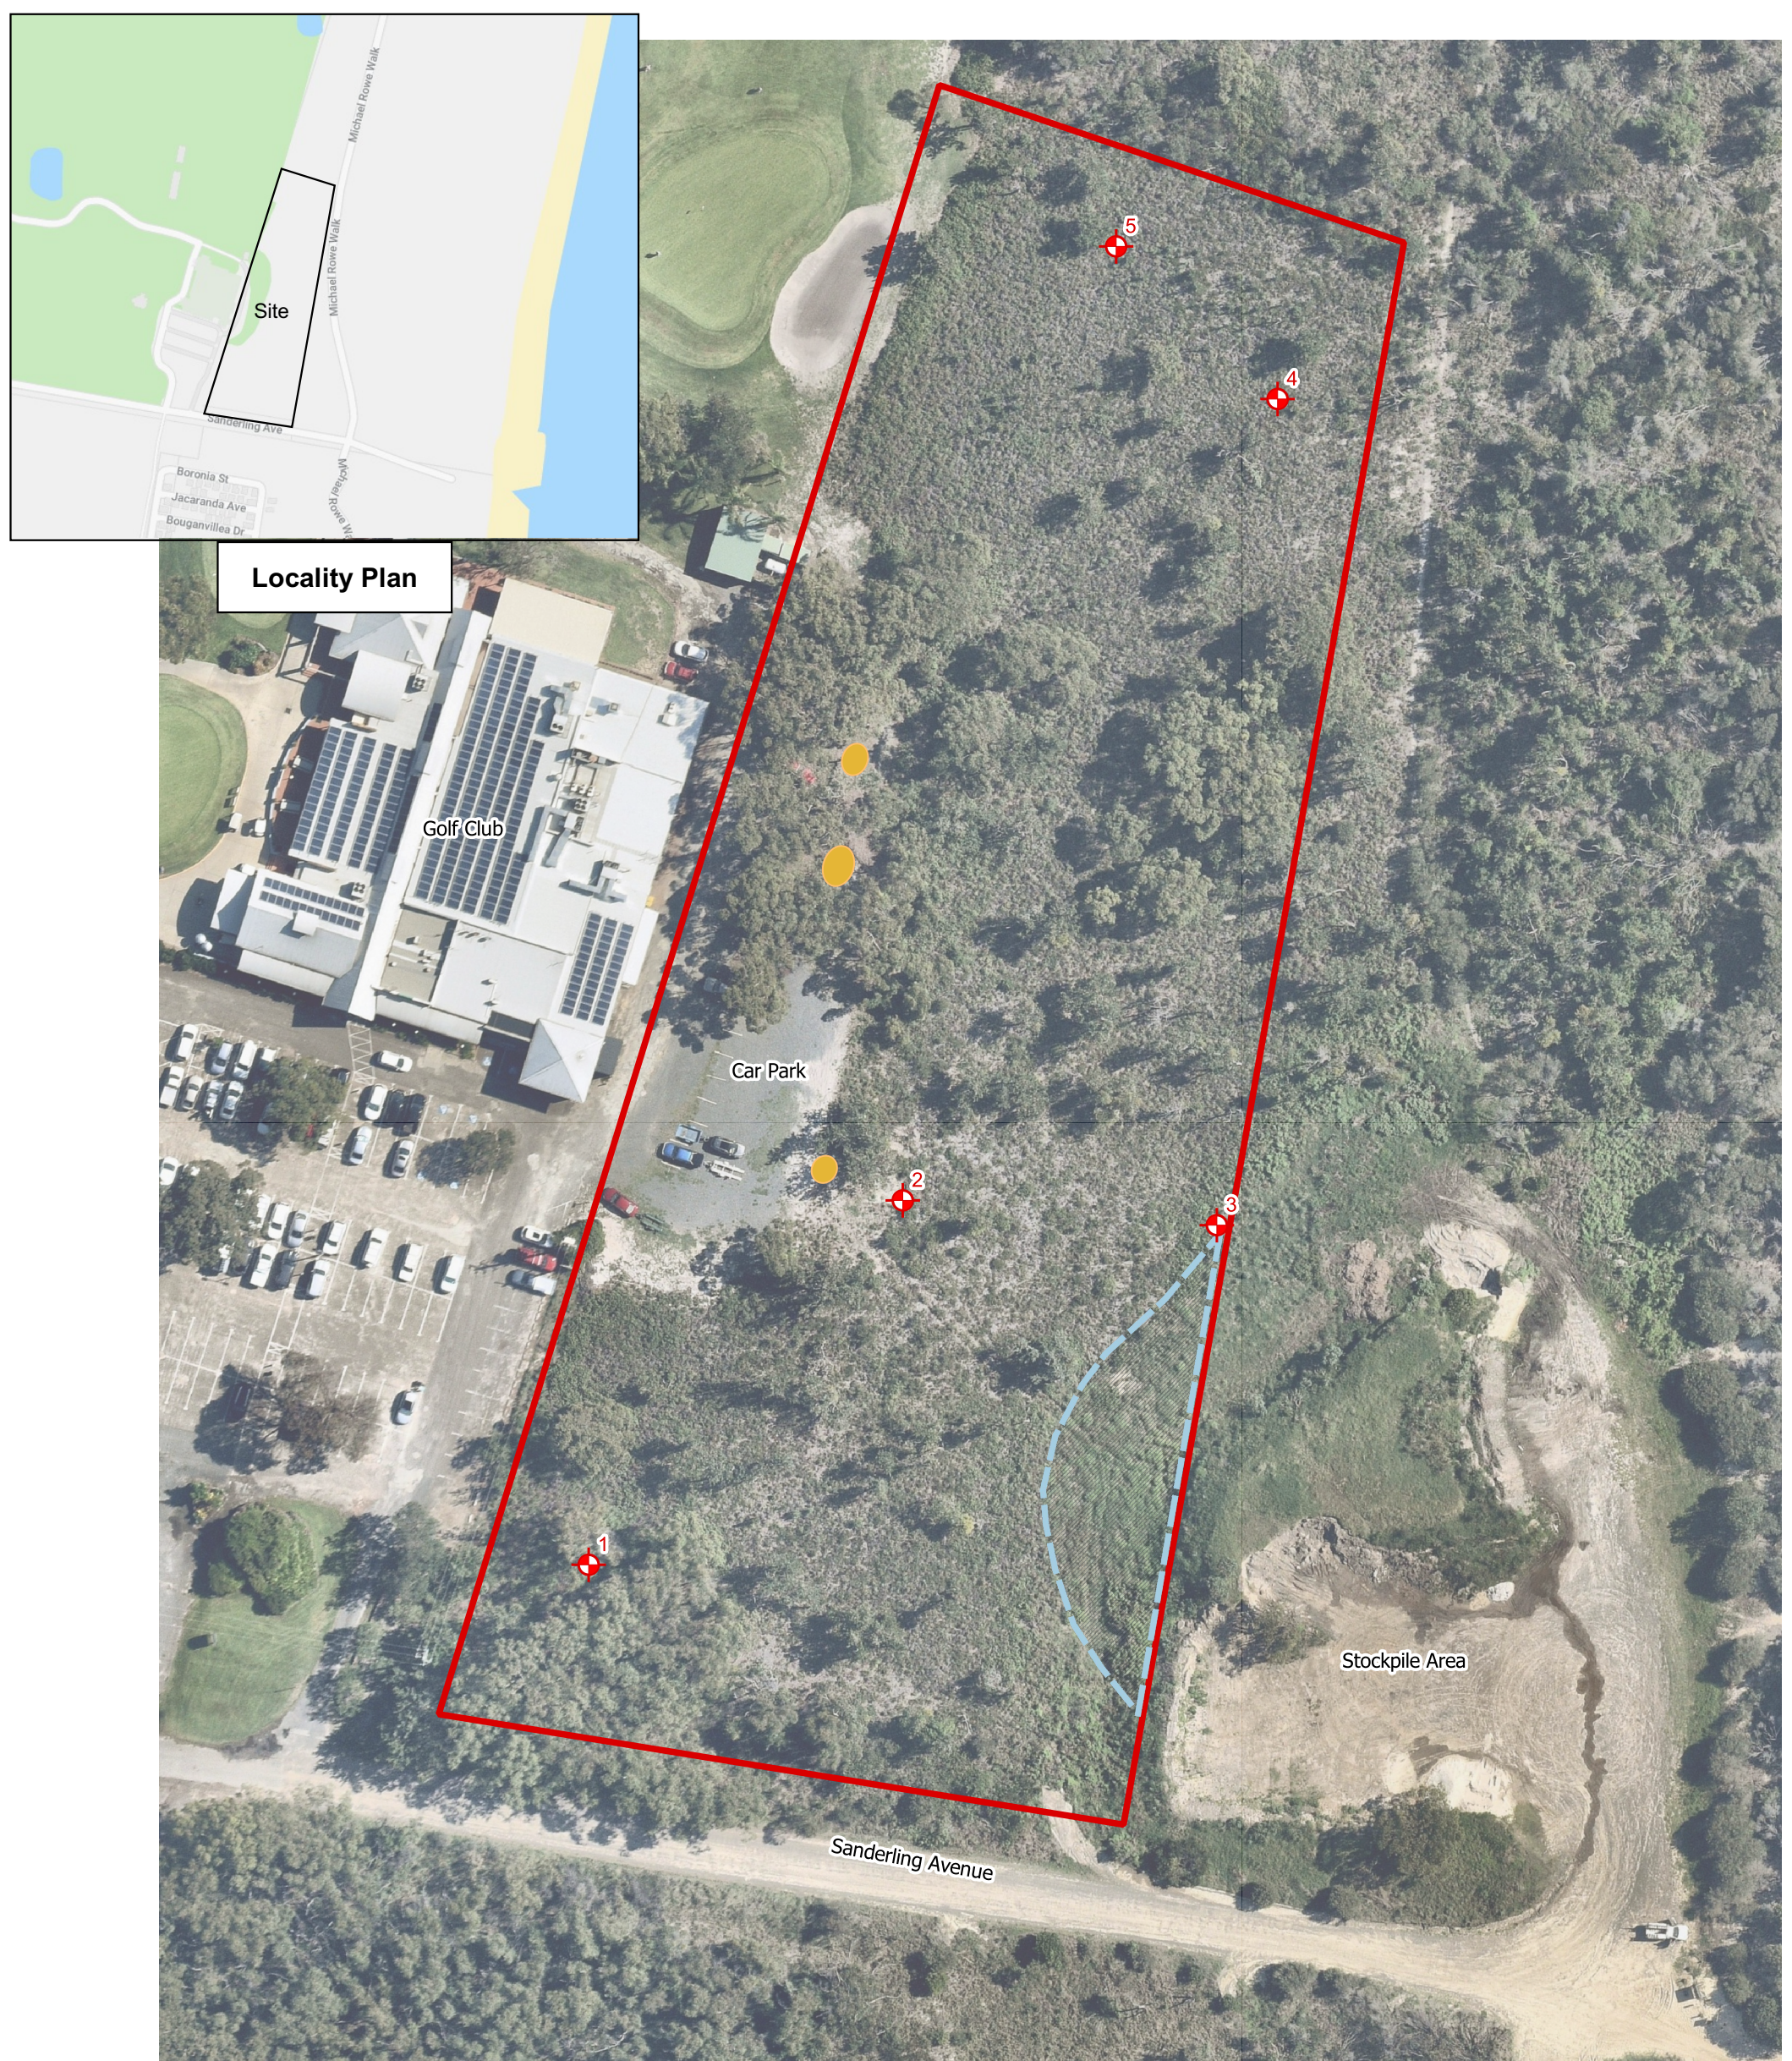
Drawing 1 – Test Location Plan

Drawing adapted from Nearmap Image dated 11.02.2020.
 Test locations are approximate only and were located using hand-held GPS.

A geotechnical engineer from DP logged the subsurface profile and collected samples for identification and testing purposes. The approximate test locations were recorded using site features and a hand-held GPS (Accuracy approximately ± 5 m) and are shown on Drawing 1, Appendix C.
