Report on
Preliminary Geotechnical Investigation

Proposed Service Centre
37 - 41 Bengal Street, Coolongolook

Prepared for
Turnbull Planning International Pty Ltd

Project 91401.00
December 2019

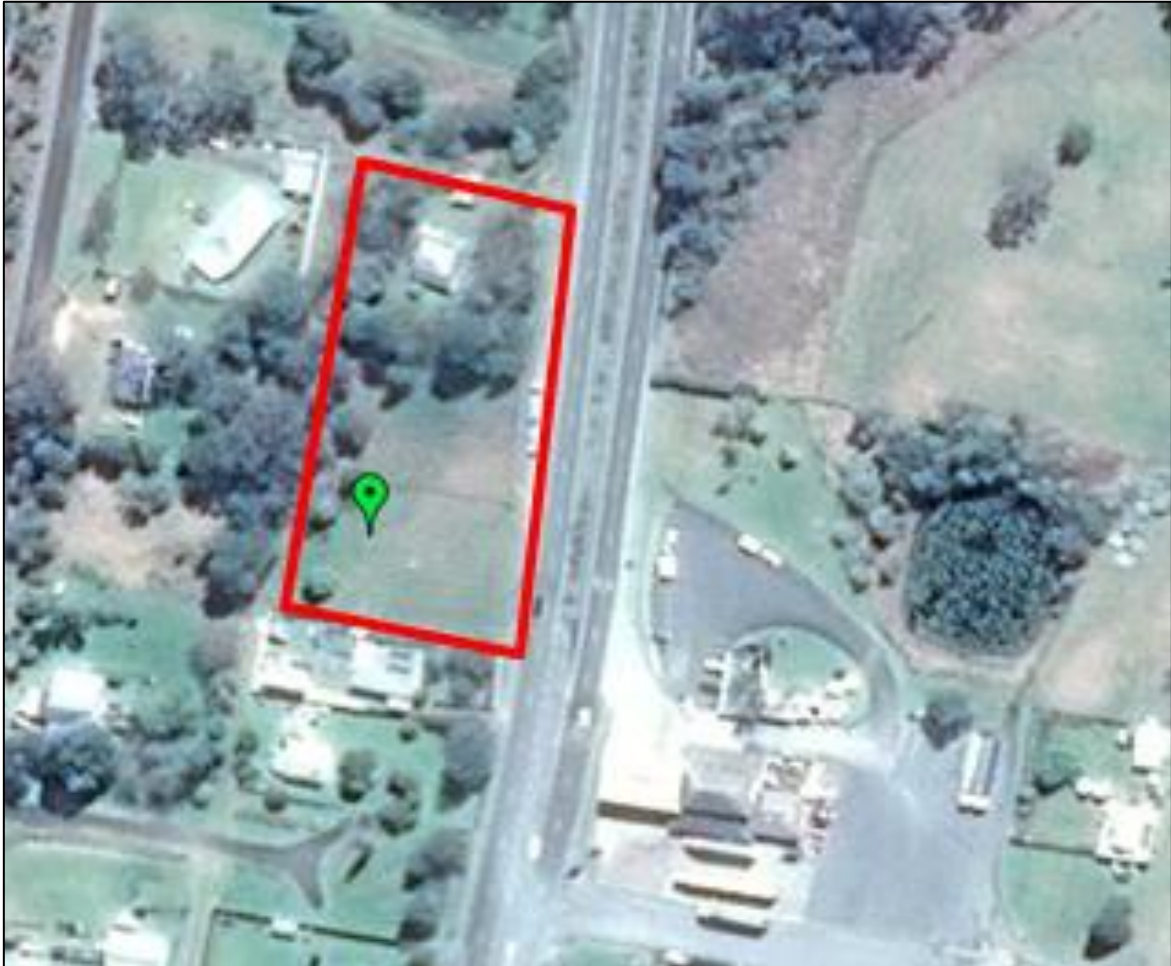
The site is located at 37 to 41 Bengal Street, Coolongolook and is identified as Lots 7 to 9 in DP 758278 (refer Figure 1).

Figure 1: Aerial image of site (sourced from GoogleEarth)

The site is approximately 6200 m² in area and roughly rectangular in shape.

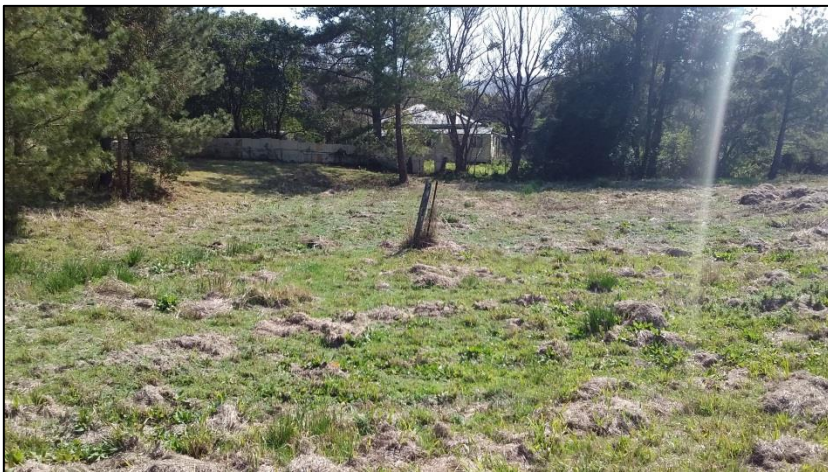
A prominent gully passes through the site, entering in the south-western corner and flowing into a culvert under the Pacific Highway on the eastern boundary of Lot 9.

Figure 5: Broad gully passing through the site

Because the site appears to be a natural drainage path, rainfall on adjacent upslope properties tends to migrate as surface runoff or subsurface seepage to the subject site and results in high soil moisture contents and shallow groundwater within the broad gully. In order to manage the site during earthworks, it is suggested that appropriate drainage measures are installed within the broad gully to collect and transport the run-on water to the formal stormwater system downstream of the site. In this regard, it is noted that there is an informal stormwater channel in the south-western corner of the site. The ability to place and compact filling within the gully will be highly dependent on prevailing weather conditions at the time of construction and prior drainage measures installed.

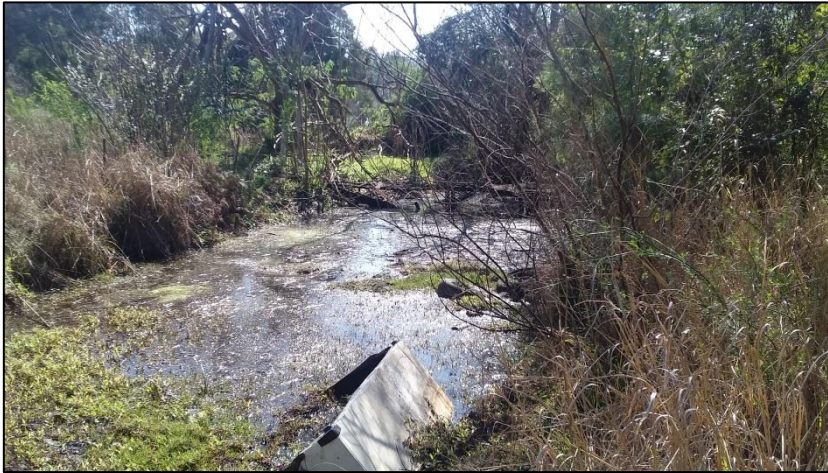
An existing water body is located to the west of the residence (refer Figure 6). The depth of the water is not known.

Figure 6: Water body in north-western area of site

The quantity of site re-grading (cut and fill) is not known at this stage. It is noted, however, that a broad gully runs through the site and that a small water body is located in the north-western corner of Lot 9. Hence some surface water diversion and drainage works together with placement of engineered filling is likely to be required.

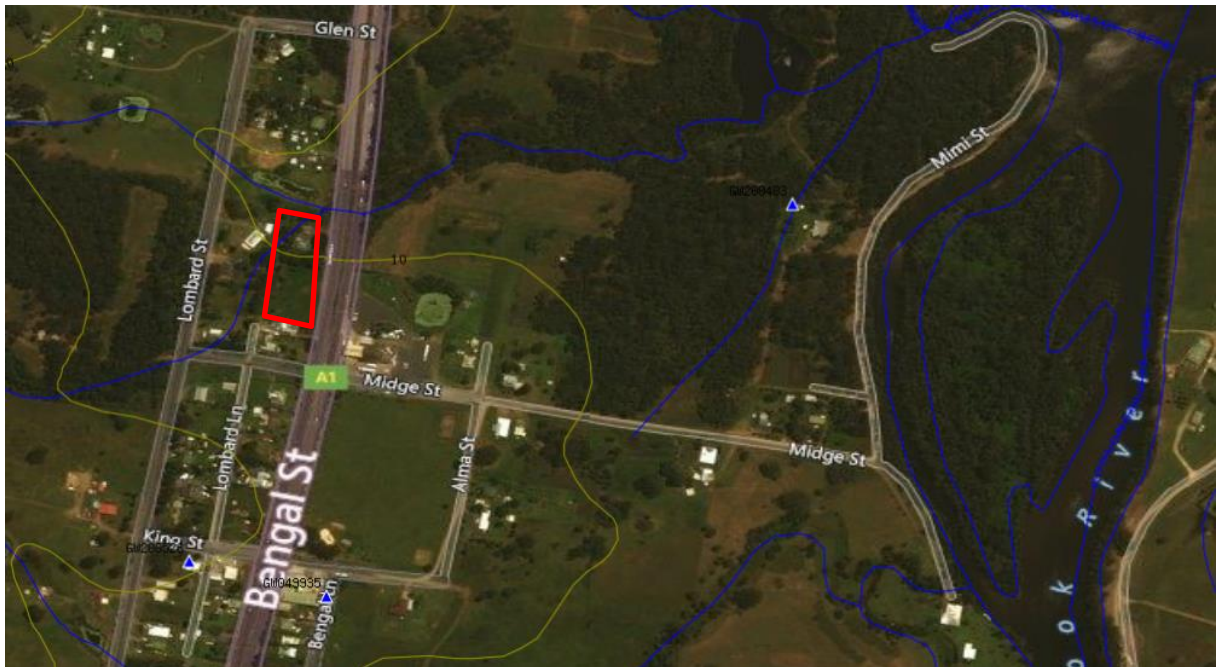
A groundwater bore search undertaken with the Department of Infrastructure, Planning and Natural Resources indicated that three registered groundwater wells are located within 500 m of the site, as follows and as shown in Figure 7:

- GW200526, located approximately 300 m south of the site and upgradient;
- GW049935, located approximately 350 m south-south-east of the site and across gradient; and
- GW200403, located approximately 550 m east-north-east of the site and downgradient.

Standing groundwater within the bores were recorded at depths of 4 m (GW200403) and 5 m (GW049935). No groundwater details were provided in the report for GW200526. The subsurface conditions recorded in the wells included predominantly clay over shale and basalt bedrock. Groundwater at the site is expected to flow into the broad gully and then in a north-easterly direction under the highway before entering Coolongolook River, approximately 900 m to the east of the site. This water body is considered to be the nearest environmentally sensitive receptor.

Figure 7: Aerial image of the surrounding area, watercourses and registered groundwater bores

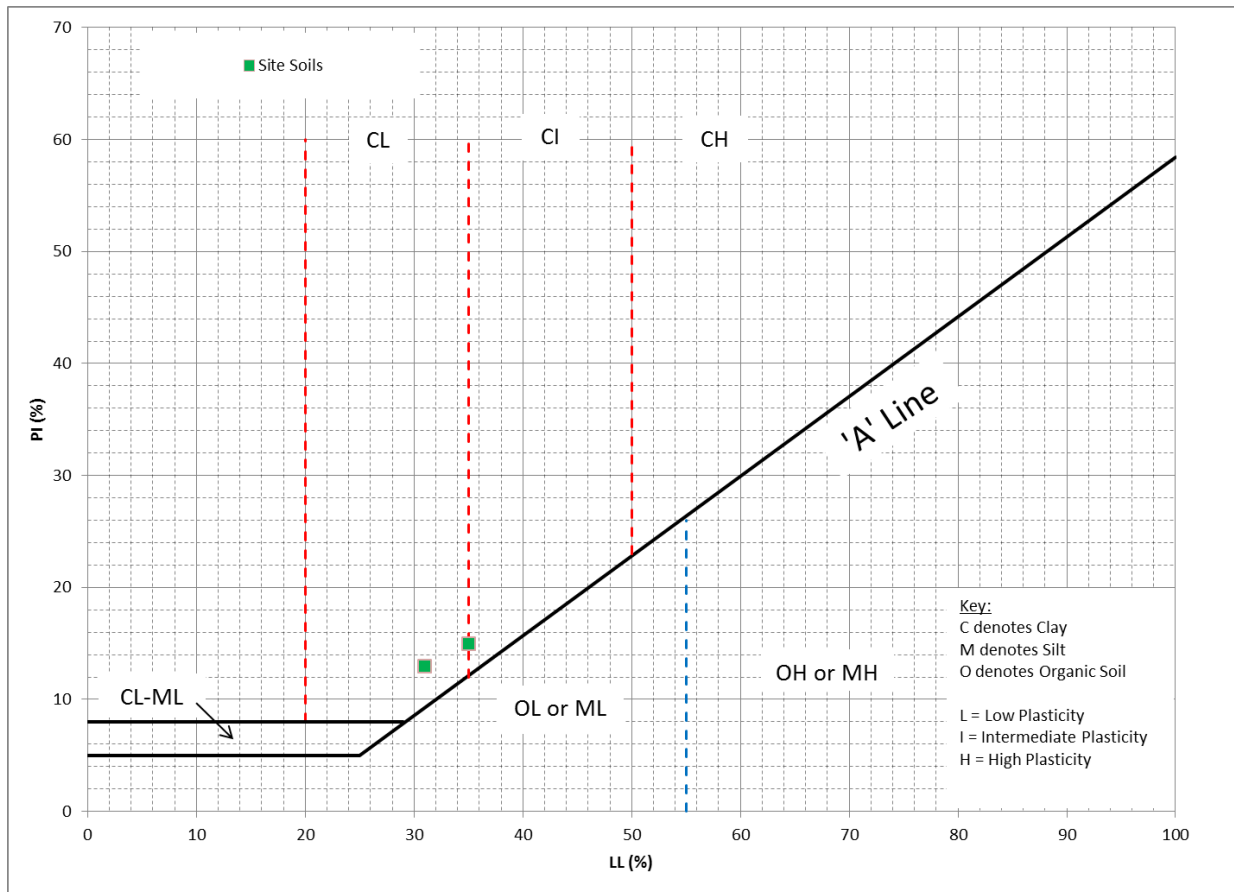
The results of the testing indicate that the clayey silt is of low to intermediate plasticity (refer Figure 8).

Figure 8: Graphical representation of Atterberg Results
