2013 waterway & catchment report card

for Wallis, Smiths and Myall Lakes

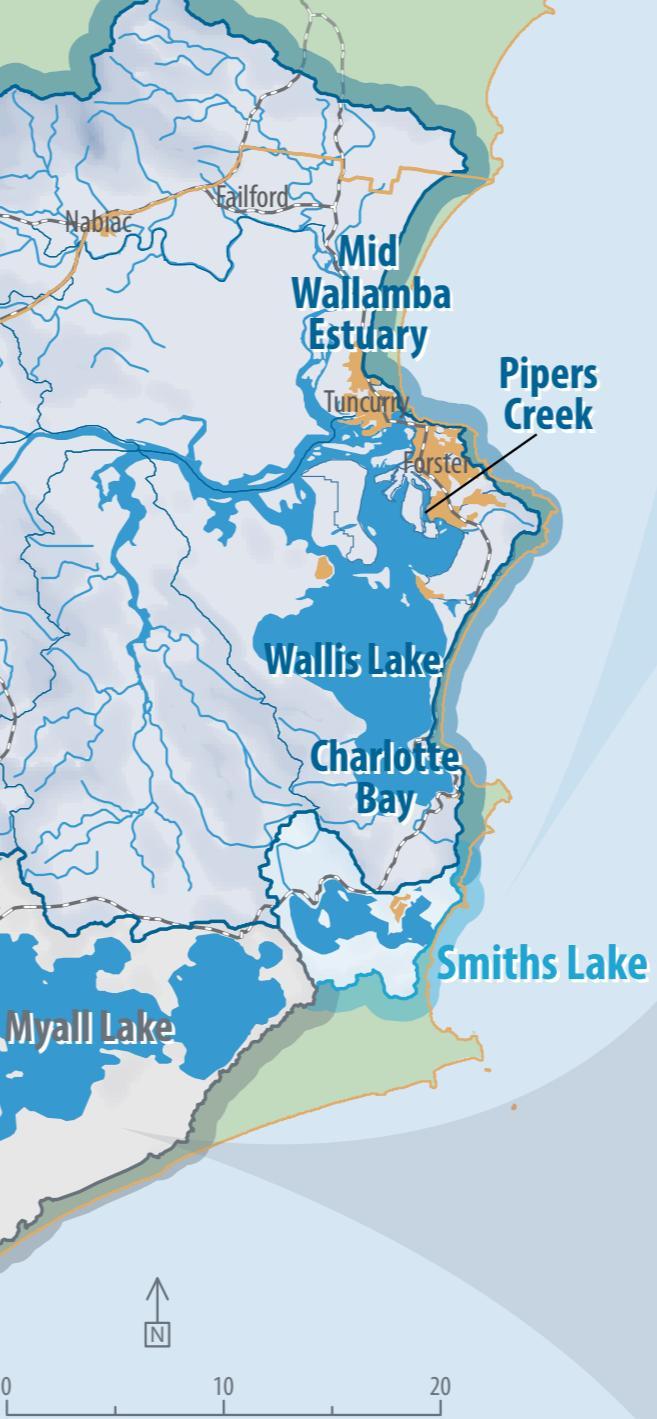
Catchments of Wallis, Smiths and Myall Lakes

Wallis Lake Catchment

Myall Lake Catchment

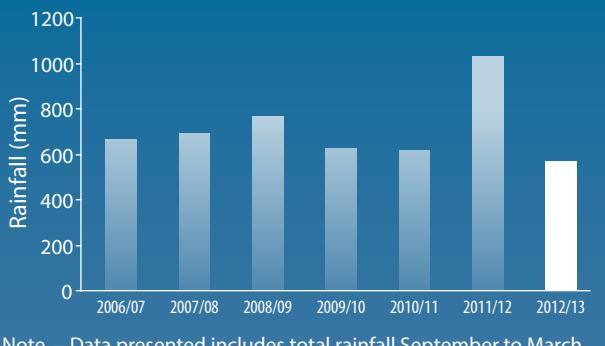
Rainfall results

The amount of rainfall that occurs around the period of sampling for the report card (September – March) influences the report card results. If there is more rain, there is more runoff in the catchment resulting in greater quantities of sediment and nutrients entering our waterways. 2012/13 rainfall was significantly less than recorded in 2011/12.

Note – Data presented includes total rainfall September to March from Forster Bureau of Meteorology rainfall station
