P1628 TL Pet Resort Charlotte Bay assessment

Proposed pet resort, 96 Coomba Road, Charlotte Bay NSW

Traffic, Parking and Access Review

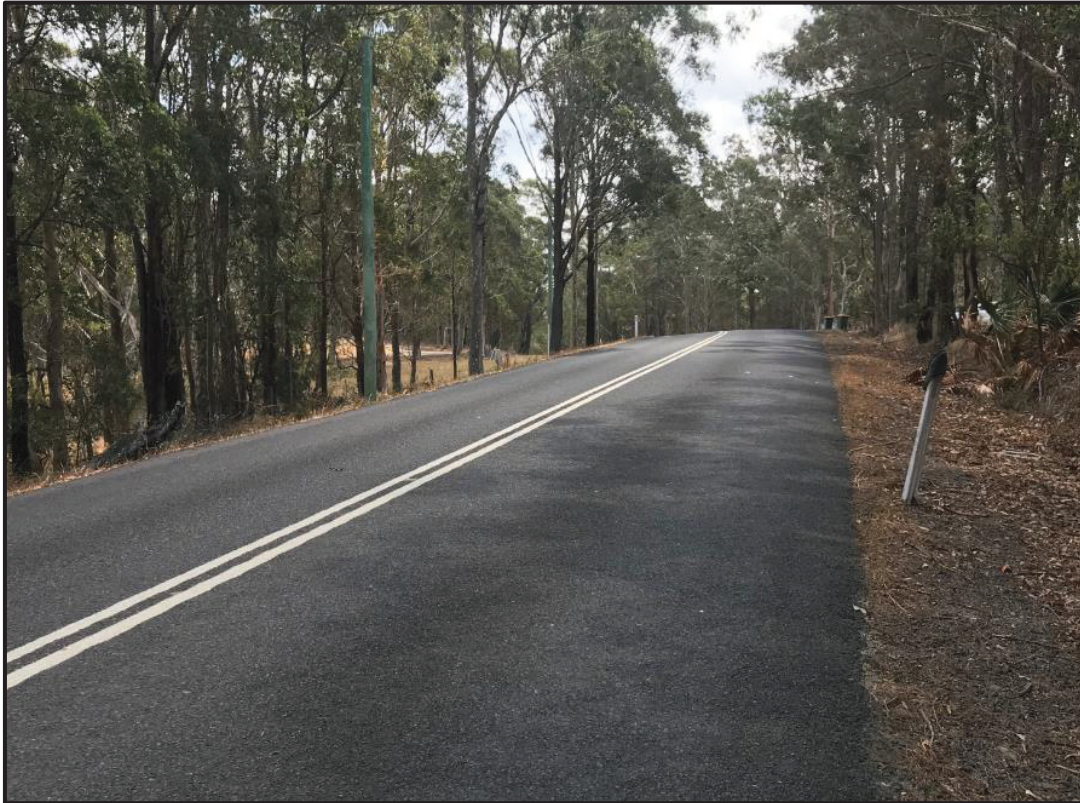
- This is a sealed road providing a single lane of travel in both directions
- It is approximately 6-7 meters wide, with no formal shoulders or footpath
- It is rural in nature providing access to a number of rural residential lots as well as access to small farm holdings
- It provides a connection between The Lakes Way to the south and rural land towards Coomba Park to the north. It does not provide a through road and as such typically carries local traffic only
- Traffic flows on this road are very low, associated with local residential access as well as some larger vehicles associated with the various rural land holdings in this location
- It operates under the posted speed limit of 80 km/h in the vicinity of the site

Photo 1 – View along Coomba Road showing typical cross section in vicinity of the subject site.

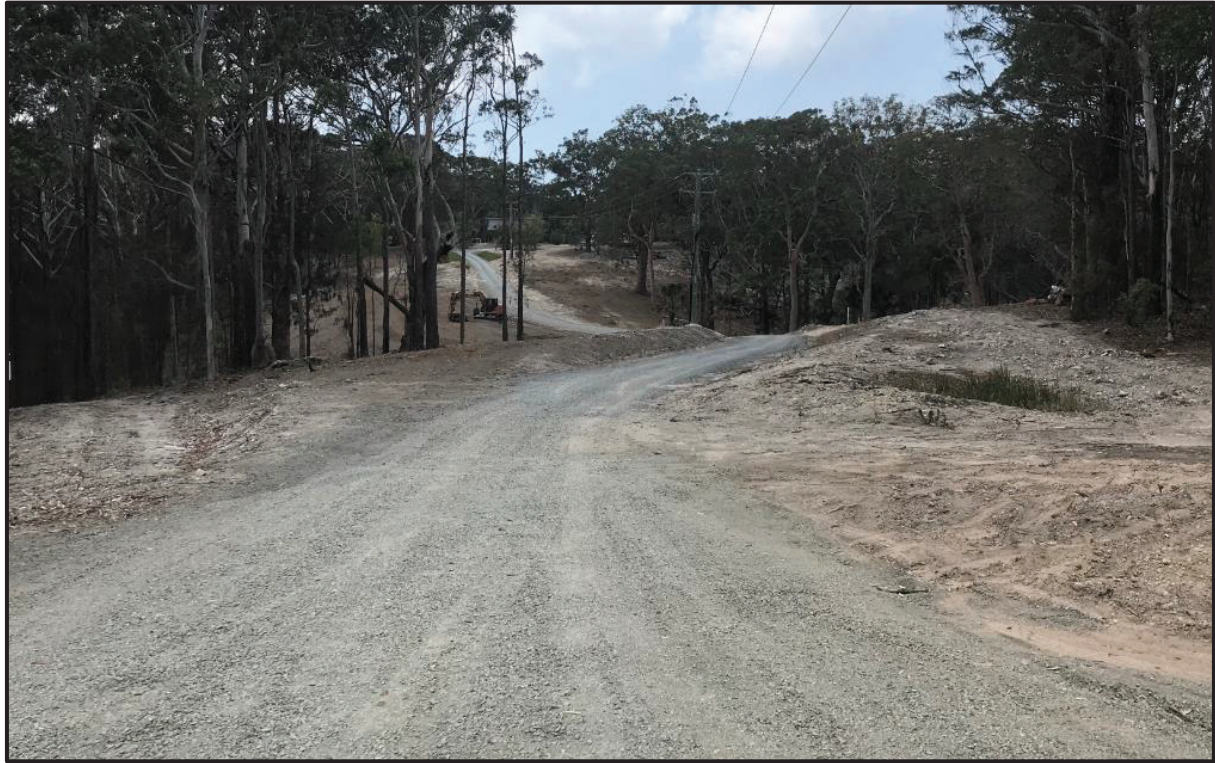
- A combined driveway providing access to the subject site and provides access to 7 approved rural lots
- Provides an unsealed roadway allowing for 2-way traffic movements
- Approximately 5 meters wide with no footpath or sealed verge
- Provides access to 7 lots, with the subject site being one of these lots
- Connects to Coomba Road via give way driveway type connection with Coomba Road being the priority road

Photo 2 – View along access driveway to 96 Coomba Road showing typical cross section and alignment

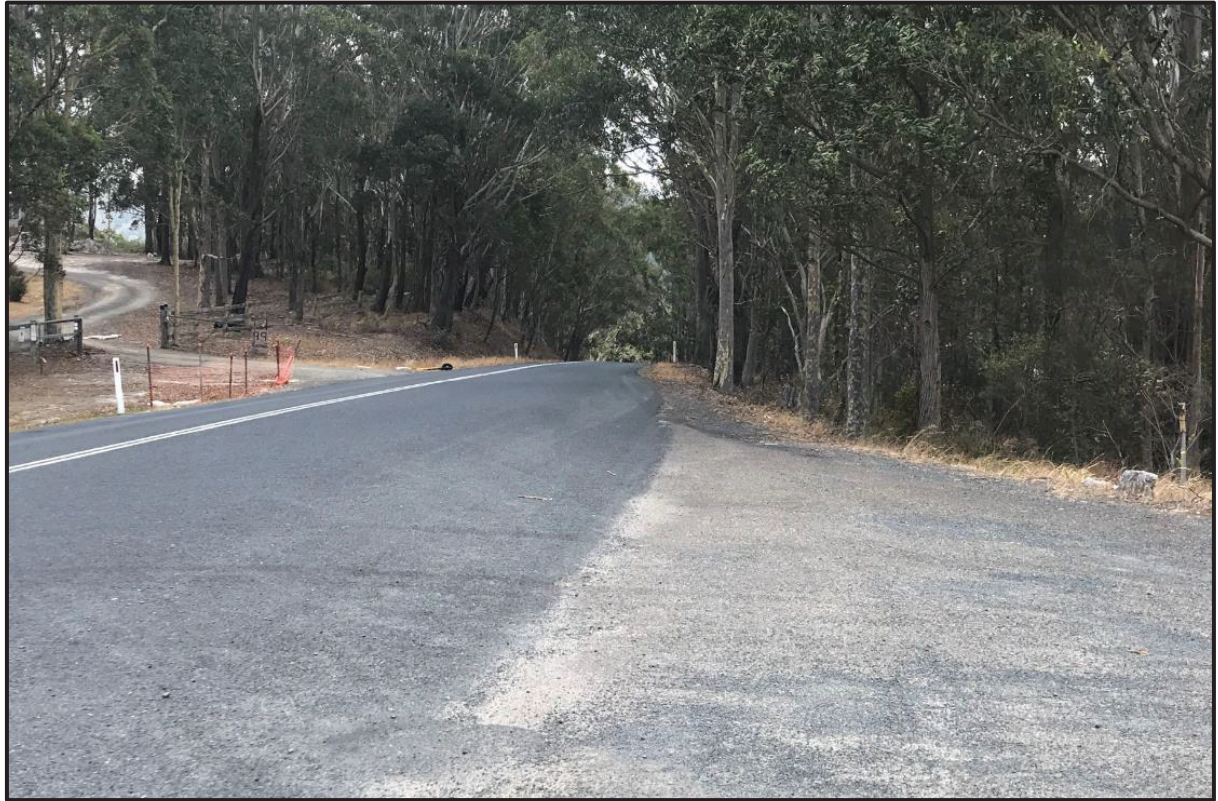
Access to the subject site is provided via a simple driveway connection to Coomba Road. The connection is located on the brow of a hill on Coomba Road and provides for access to the approved 7 lot subdivision. The speed limit at this location is 80 km/h and the alignment of the road, both vertically and horizontally does not encourage drivers to speed. Visibility for drivers entering and exiting the site has been measured on site against the requirements of Austroads, allowing for Safe Intersection Sight Distance (SISD). The visibility to the right for a driver exiting the site was measured at 105 metres whilst to the left was measured at 122 metres. From Austroads, the SISD requirement for an 80 km/h speed zone is 170 metres minimum and 181 metres desirable. It can be seen that the existing approved access does not comply with these requirements.

The sight distance has also been checked against stopping sight distance requirements. The RTA Road Design Guide provides advice on stopping sight distance and Table 2.1.1 of this design guide indicates that for a posted speed limit of 80 km/h the stopping sight distance is 100 metres for a level road. In the locality of the subject site access, the access is located on the top of a brow, with cars travelling uphill to this location reducing the distance required to stop accordingly.

The measured sight distance of 105 metres to the right and 122 metres to the left meet the requirements for stopping sight distance and therefore would allow a driver to observe a vehicle exiting the access driveway to the subject site and brake to avoid an accident.

Photo 3 – vView to right for a driver exiting the access road onto Coomba Road

Whilst the visibility available meets the requirements for stopping sight distance, it is considered that road safety could be enhanced with the provision of advanced signage to warn drivers of the access road and the potential for vehicles to be exiting. Sign W2-206A_N could be considered on both approaches to improve road safety for existing road users and also users associated with the proposed pet resort.

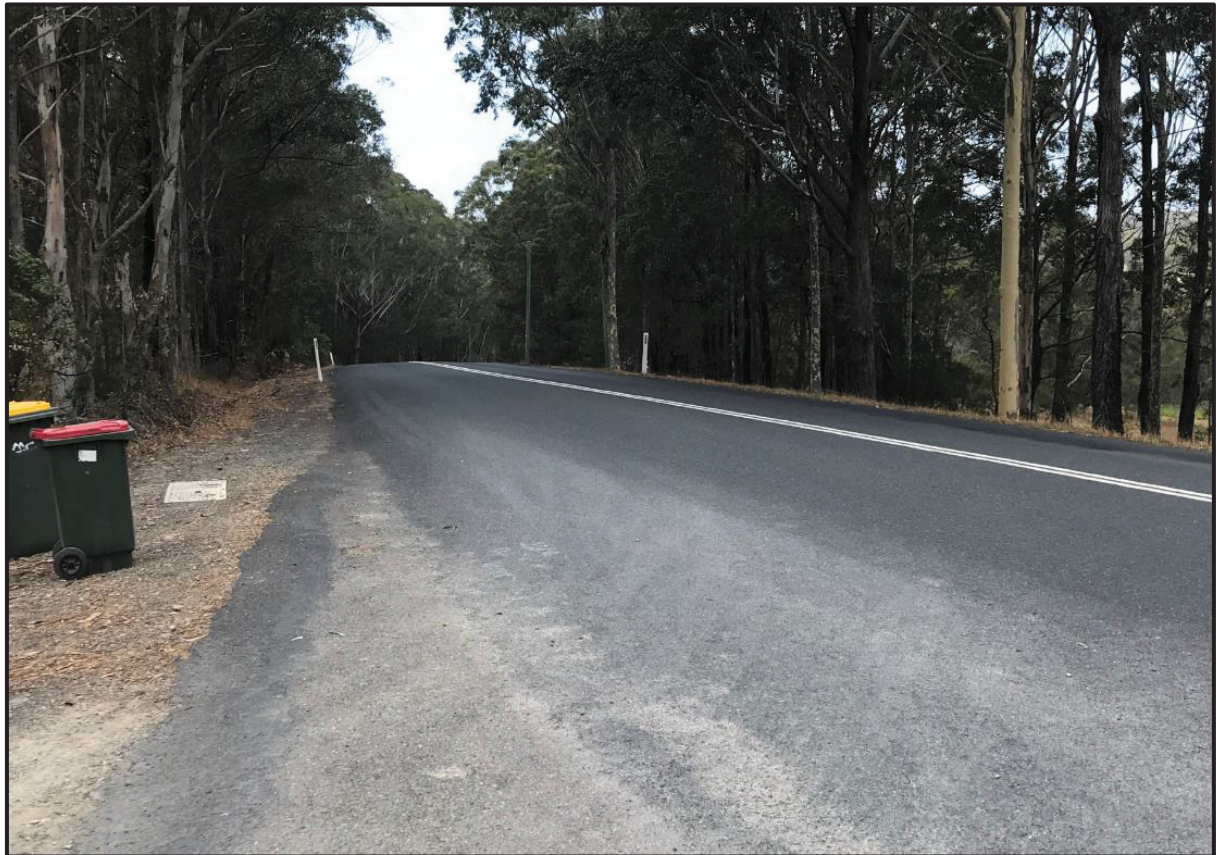
Photo 4 - View to left for a driver exiting the access road onto Coomba Road

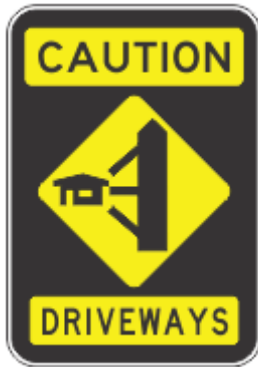
Figure 1 – Suggested signage to advise drivers of the existence of the existing access road to 96 Coomba Road.

As discussed above, the major impact is the site access due to limited sight distance being available at the approved subdivision access point. The sight distance has been measured on site and meets the requirements for stopping sight distance, enabling a collision between a vehicle travelling along Coomba Road and a vehicle exiting the access to the pet resort to be avoided. The provision of the advanced warning sign to advise drivers of this access point could be considered to improve road safety at this location.
