Document type
Remedial Action Plan

Site Location
321 Boomerang Drive, Blueys Beach, NSW

REMEDIAL ACTION PLAN PALMS OASIS CARAVAN PARK BLUEYS BEACH

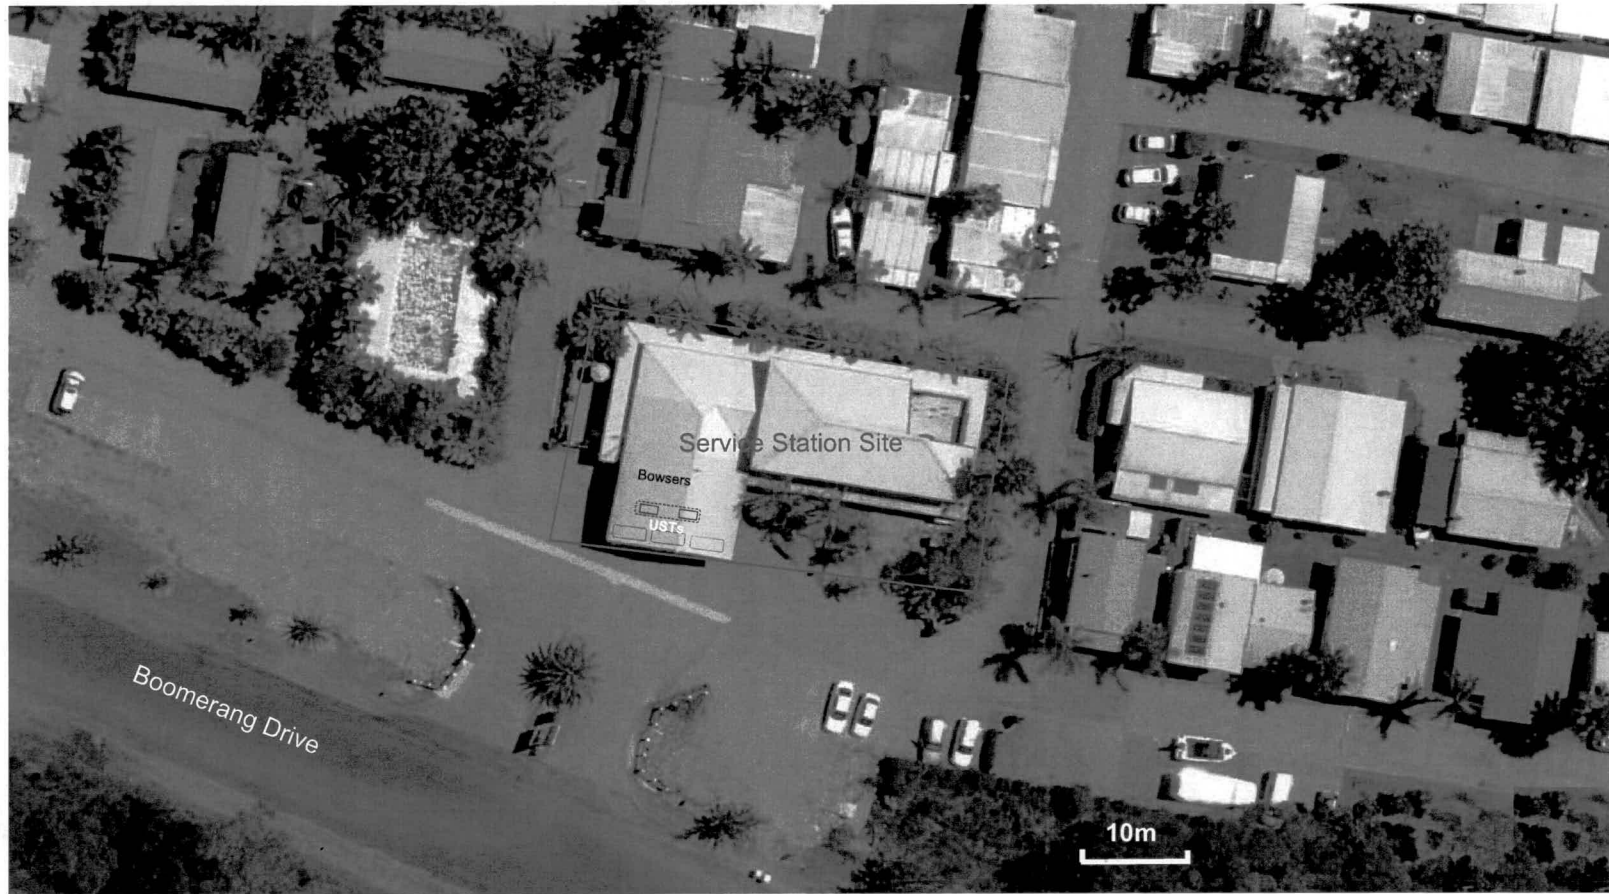
Palms Oasis Caravan Park – Service Station RAP - Site Layout

The UPSS to be excavated and removed comprises three Underground Storage Tanks (USTs) and associated pumps, vents and fuel lines. The site layout and UST locations are shown on **Figure 2**.

The USTs are located on-site in the forecourt of the service station on the Boomerang Drive frontage, on the southern side of the caravan park site (refer to **Figure 2**).
